Bickerdike Allen Partners

**Review report on Concrete Testing
Shakespeare, Cromwell & Lauderdale Towers
The Barbican, London**

16 March 2012

Prepared for: City of London Corporation

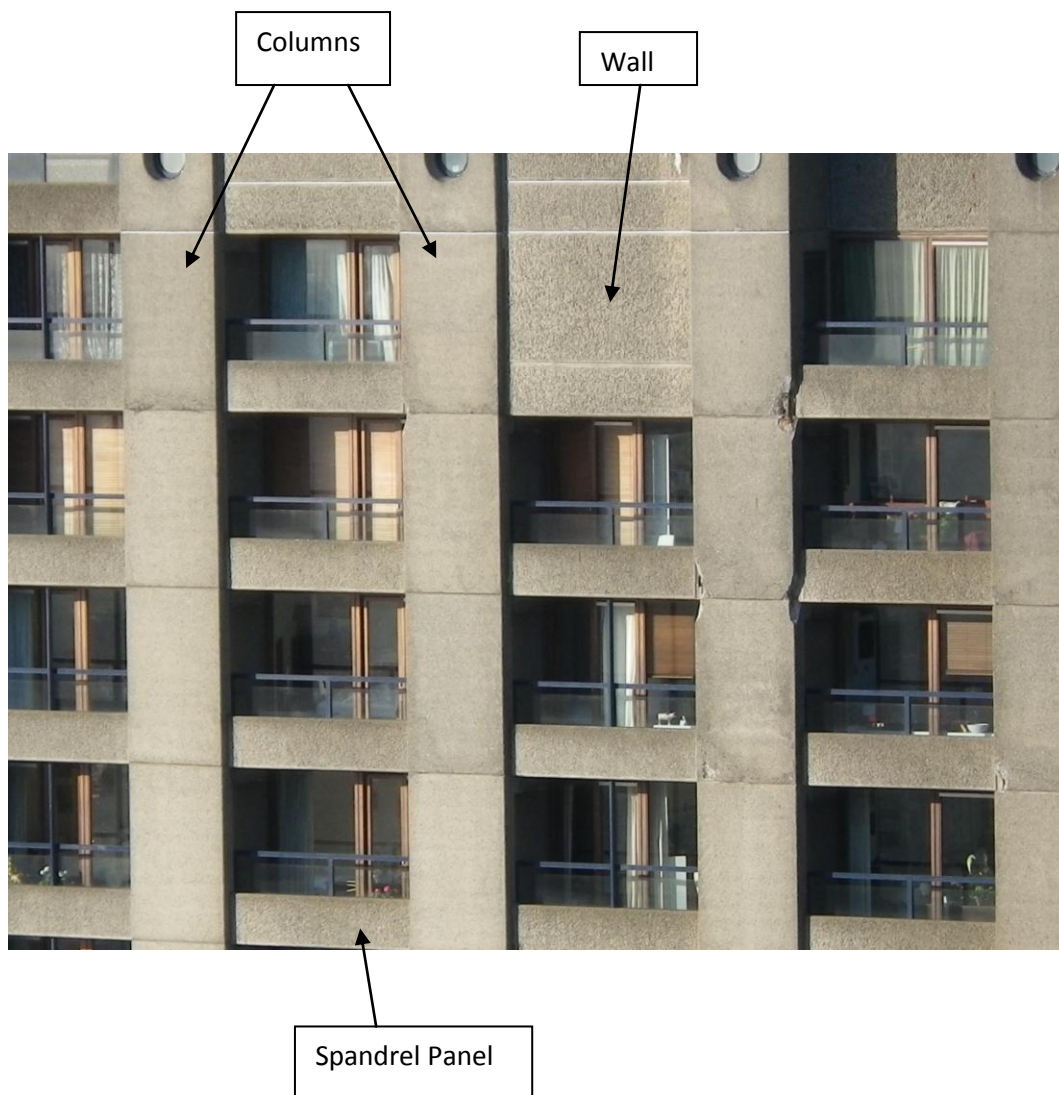
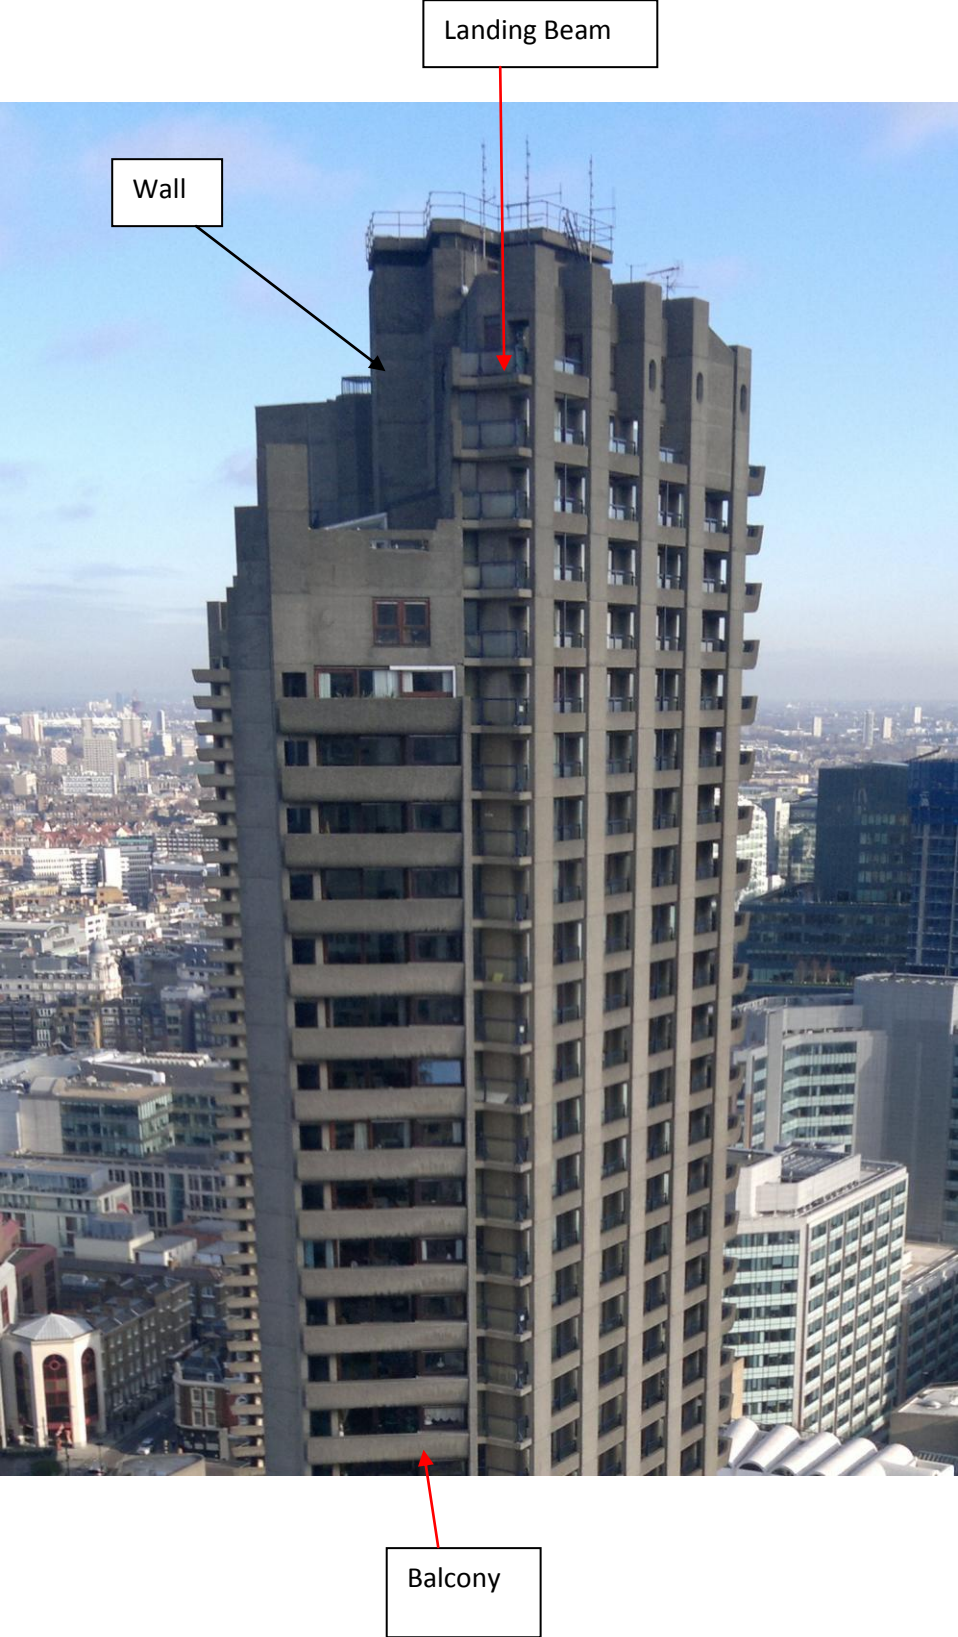
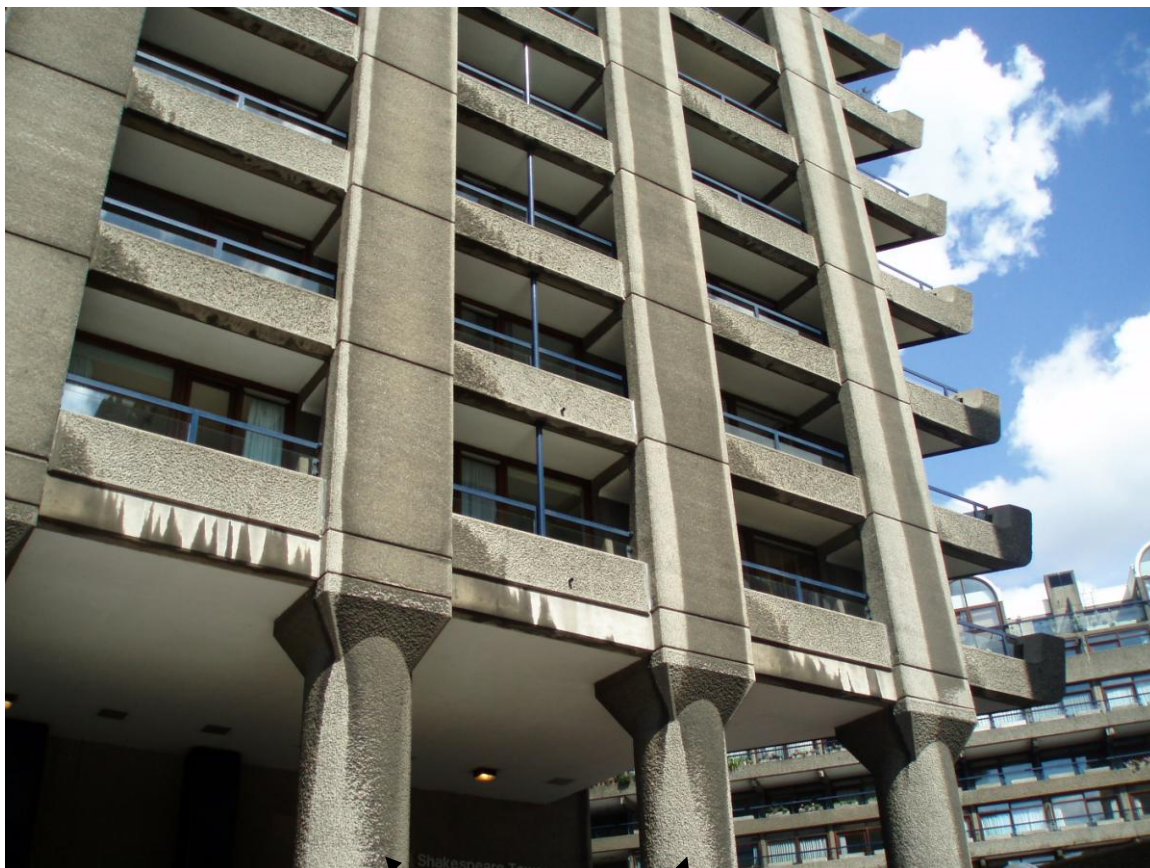
Figure 1
Elements of the buildings

The Elements tests are illustrated in Figure 1.

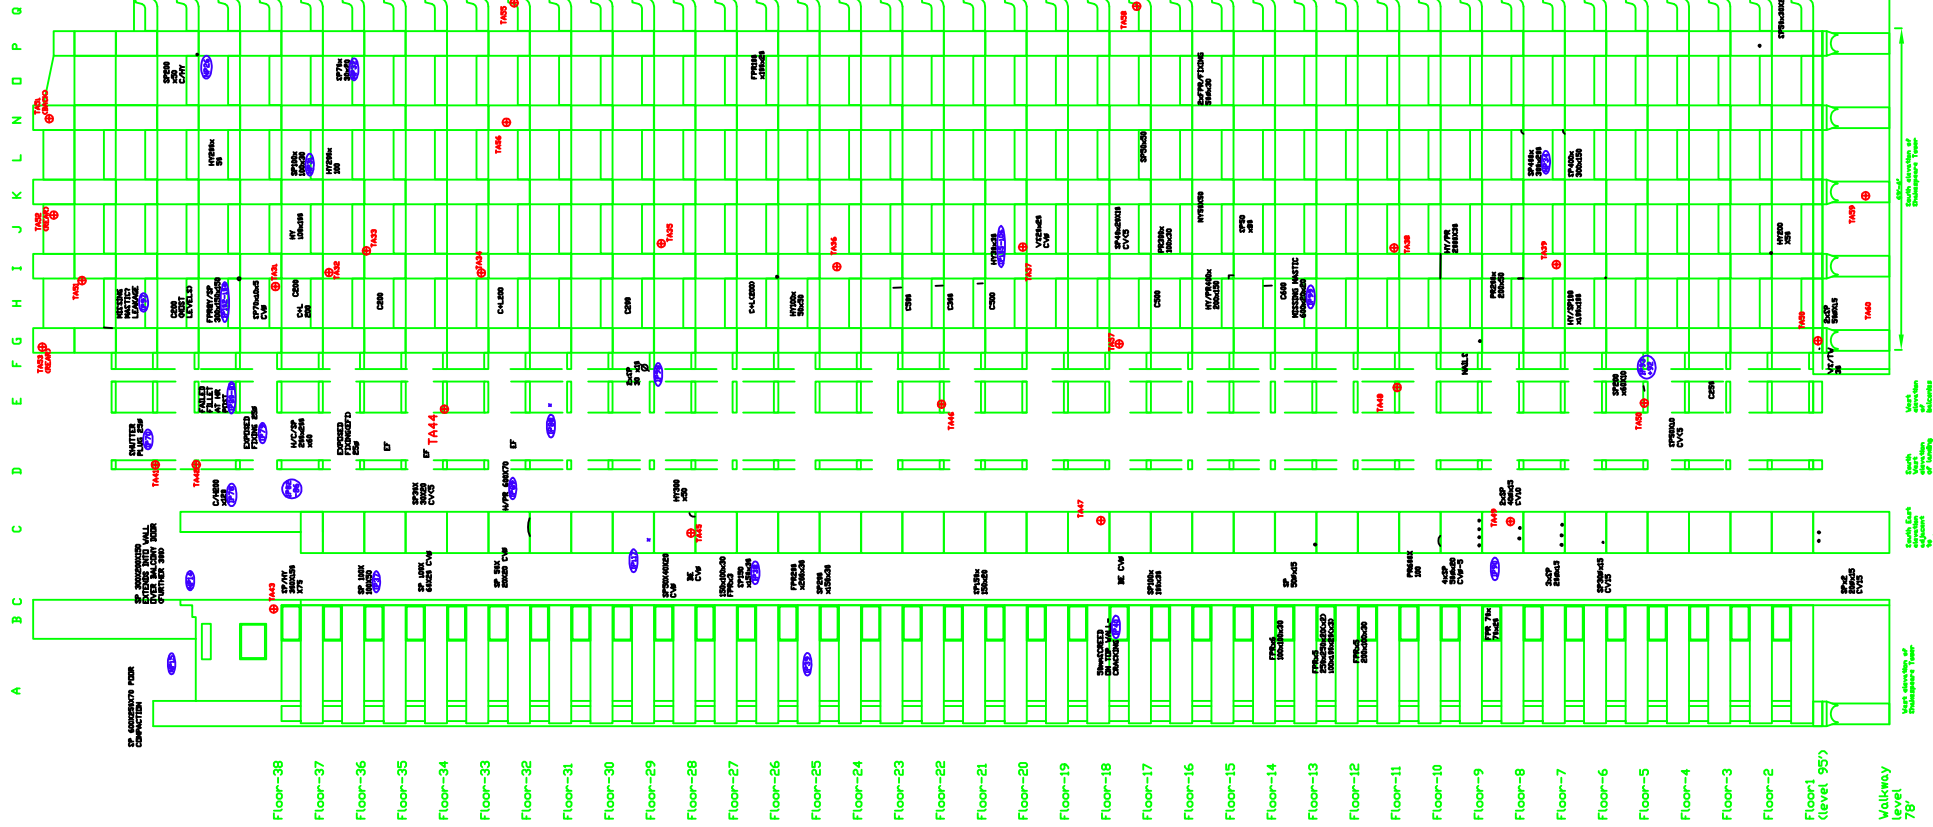
SHAKESPEARE ELEVATION A - SOUTH

4.1 The observations and measurements from the safety survey are shown in the elevation drawings which are attached in **Appendix A** to the paper copy of this report at size A1, however in the electronic copy these are not easily read at A3 size.

- 4.4 The minimum spot cover for each area is shown in Appendix A and few show values less than 20mm. The minimum values in Table 1 are very localised; where they are 0 they are exposed bar ends or where the steel is visible in honeycombed concrete. Unless associated with spalling of the concrete cover the low cover would usually relate to locally misplaced reinforcement where the next bar would be deeper into the concrete.
