| Hampstead Heath Consultative Committee Hampstead Heath, Highgate Wood & Queen's Park | 09/03/2015 23/03/2015 |
| Subject: Hill Garden Pergola | Public |
| Report of: The City Surveyor (CS 044/15) | For Information |

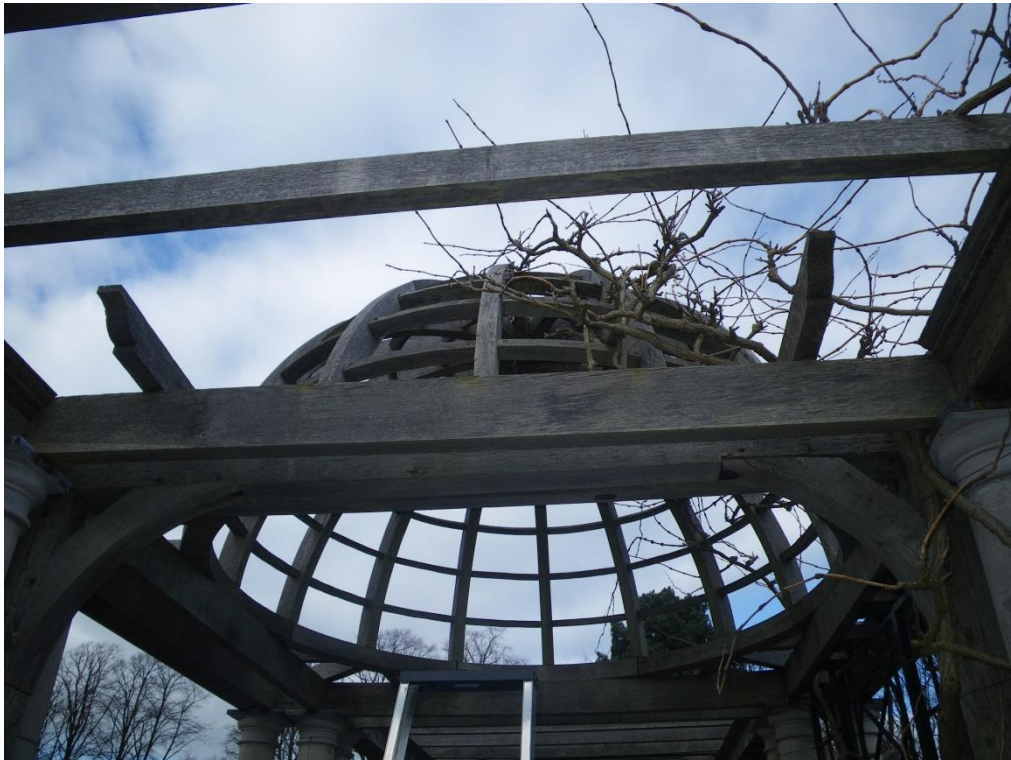
The individual oak members of the timber superstructure have undergone quite extensive movement such as shrinking, bowing and twisting which is typical of unseasoned timber. Some timber features, such as the balls and finials, have

Section 1: dome shaped timber superstructure

The condition of the pergola timber superstructure will be regularly monitored. The entire superstructure is planned to be refurbished or replaced in about 10 years' time although its condition will be monitored to try to maximise its life whilst it is in a safe condition.

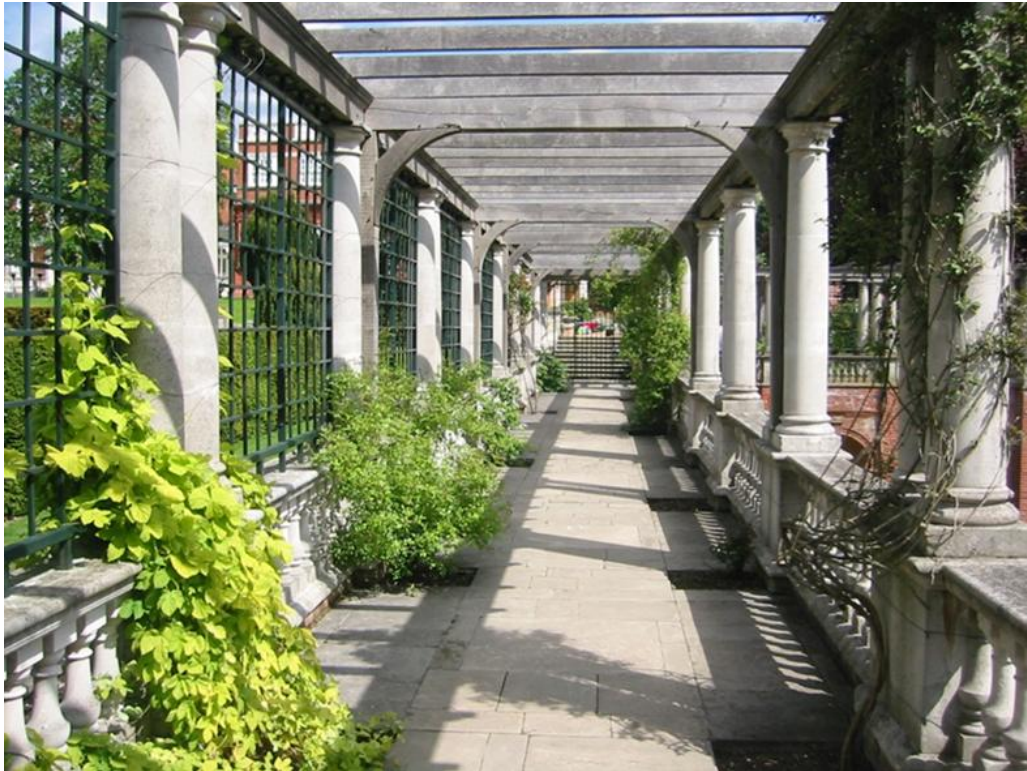
The condition of the planting beds and walkway surfaces are satisfactory but the absence of effective waterproofing is causing deterioration of the structure below particularly to the brickwork and steel beams.

Section 1: showing upper level walkway with stone balusters and columns and planting beds which extend into the void between the paved surface and the structural slab.

A tanking system should be introduced within the planters to contain the root systems and water from the irrigation systems, together with an effective method of draining excess water from the void area. The existing planting will need to be removed to enable these works. These works should be undertaken in advance of any full scale renovation projects.

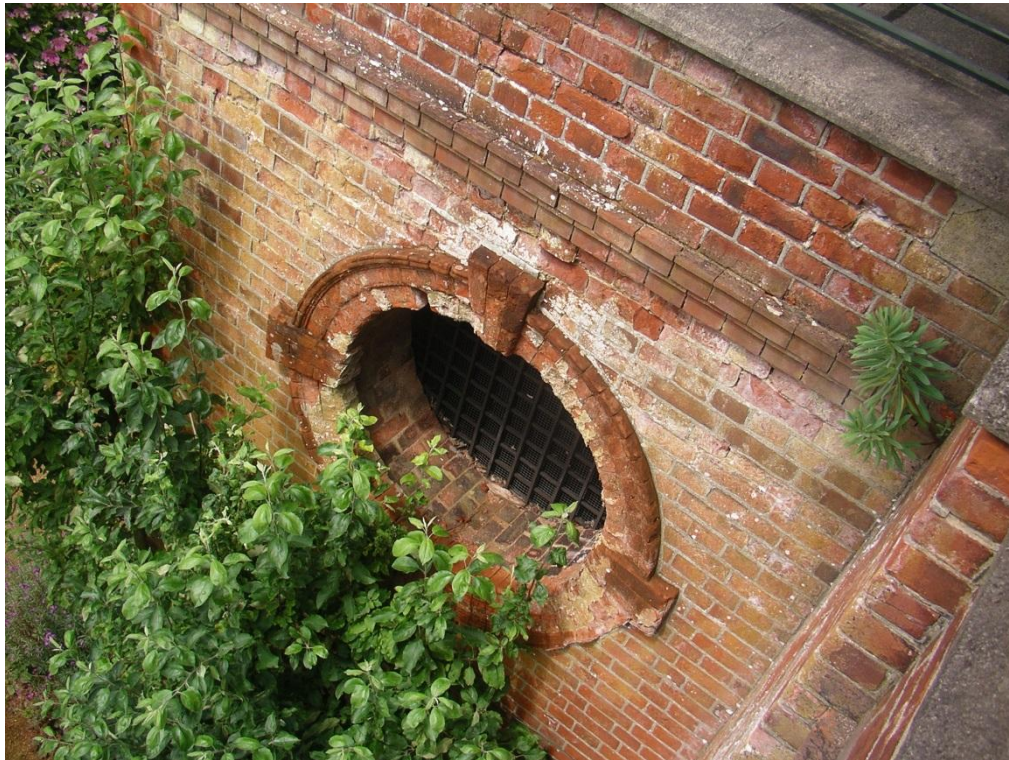
Section 1: brickwork deterioration around a circular window feature and efflorescence below the level of the structural slab to the walkway.

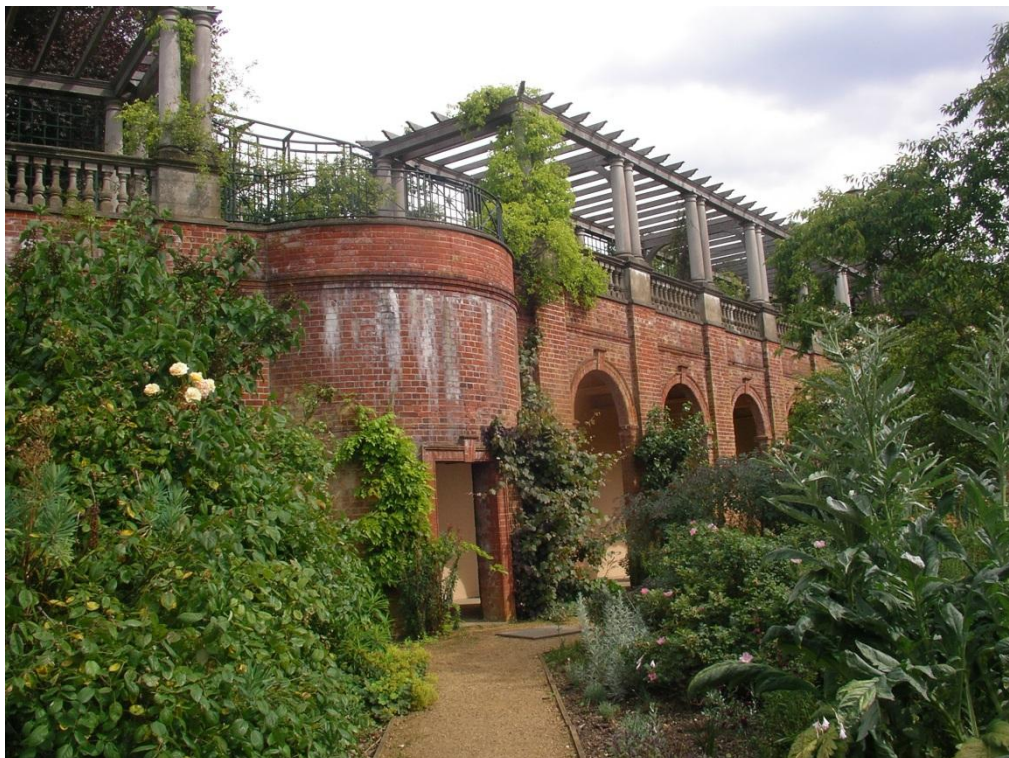
The rotunda is the brick drum shaped structure that is located at the change of direction in the south length of the Pergola. The rotunda has suffered structural damage evident as cracking at high level and movement away from the main walls. An attempt to remedy this is also evident in the form of a steel beam.

Recent structural investigations conclude that the movement is likely to be the result of thermal expansion and contraction over the length of the Pergola but it is not regarded as significant and the cracks have actually introduced expansion joints. They have recommended that any attempt to tie the rotunda back should be avoided. The cracks and movement will be monitored. The openings will be filled with non-structural weatherproofing jointing material.

Section 1: The rotunda feature showing unsightly efflorescence.

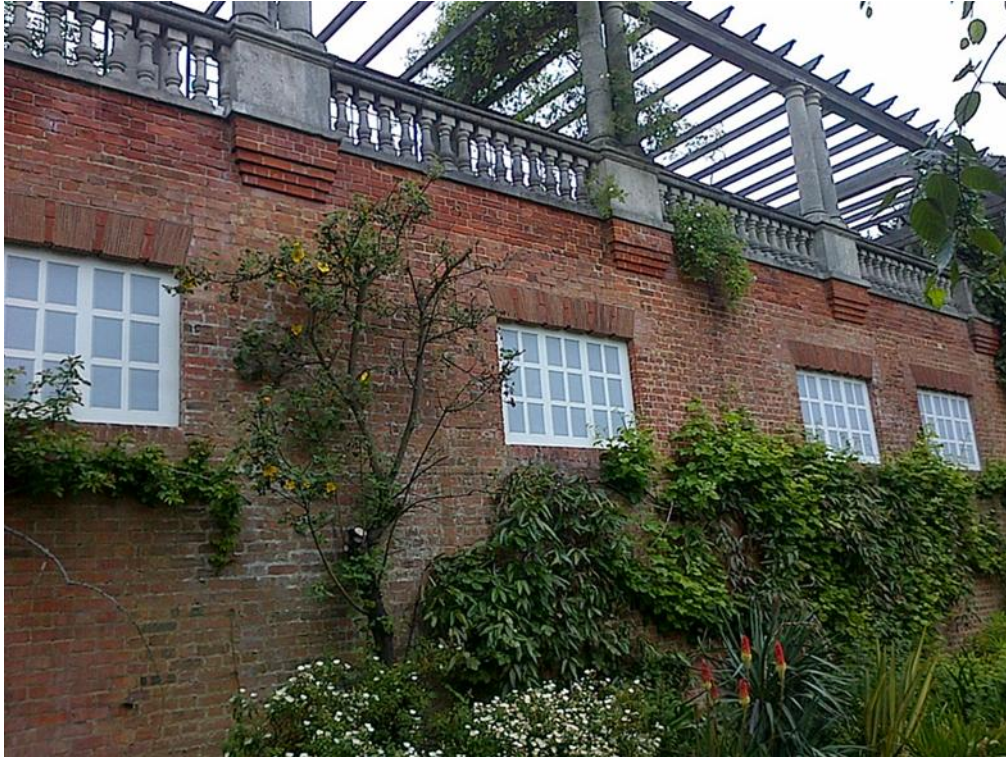
Several of the false windows were re-rendered and repainted in April 2013 and are in good condition. The remainder are now in need of similar treatment.

Section 2: The false windows after renovation in 2013.

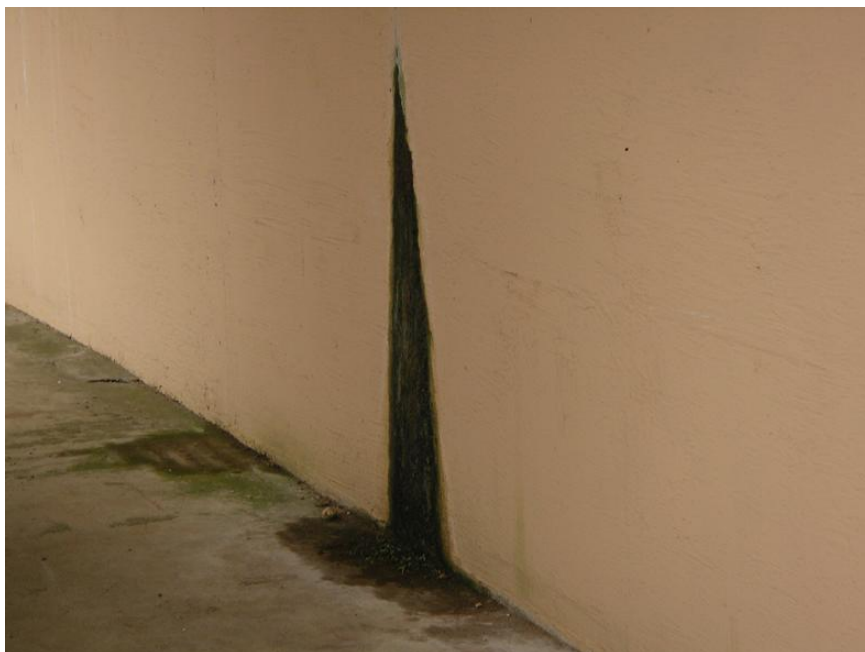
There is minor cracking in the inner face of the retaining wall and water pressure has formed seepage routes which are unsightly but are not of cause for concern in respect of the structural stability of the wall. There are no simple solutions to alleviate the water seepage problem and as this is of relatively minor concern to visitors it is not intended to undertake any remedial works however the situation will be monitored.

Section 2: water seepage through the retaining wall.

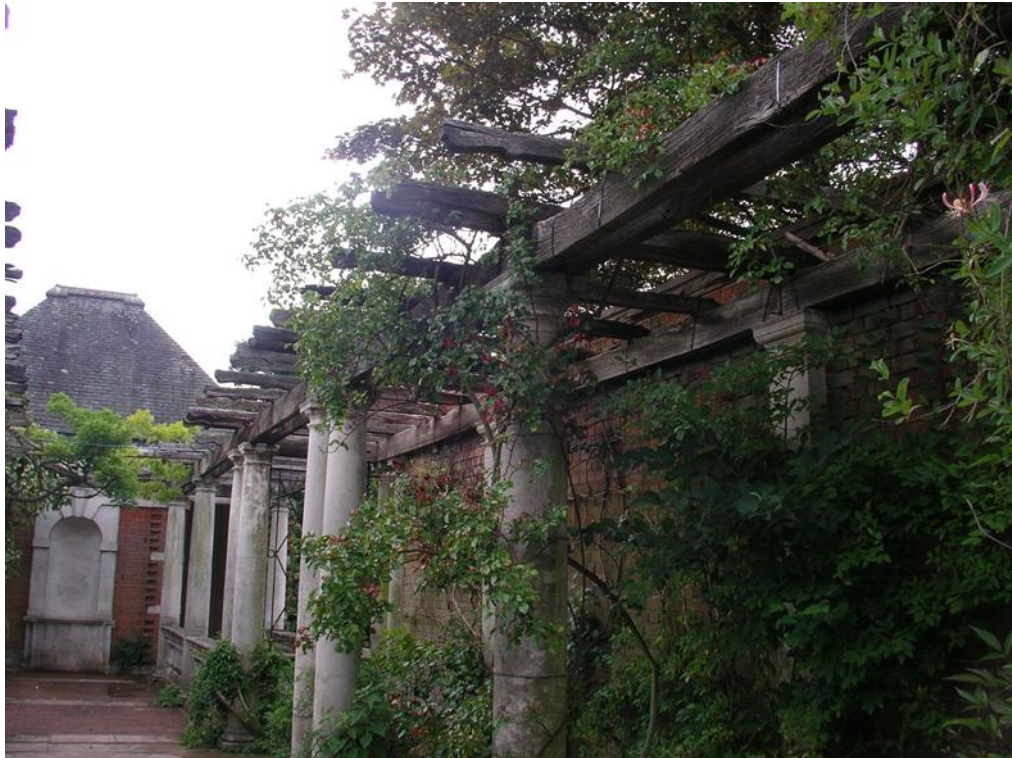
The pergola timber superstructure comprises oak horizontal beams and cross beams. This is the original timberwork, now almost 100 years old. It is of a more elegant, less decorative, design than the replacement timberwork in section 1. The timbers are very decayed with some of the original timber details lost with age. Many of the beams are now missing. The remaining beams have been secured with plastic straps as a temporary measure. The timberwork forms an integral part of the structure of the colonnade; connecting the tops of the columns. The weakness in the timberwork therefore has an adverse effect of the structural integrity of the colonnade.

Section 2: showing timber superstructure with decayed and missing sections.

Although the timberwork is regularly monitored the colonnade area is closed to visitors during high wind conditions because of concerns with the safety (as noted in the Superintendent's 2013 report). Overall the timberwork is overdue for replacement with new oak timber to match the original design. The timberwork should be replaced conjunction with repairs to the columns as part of any restoration project.

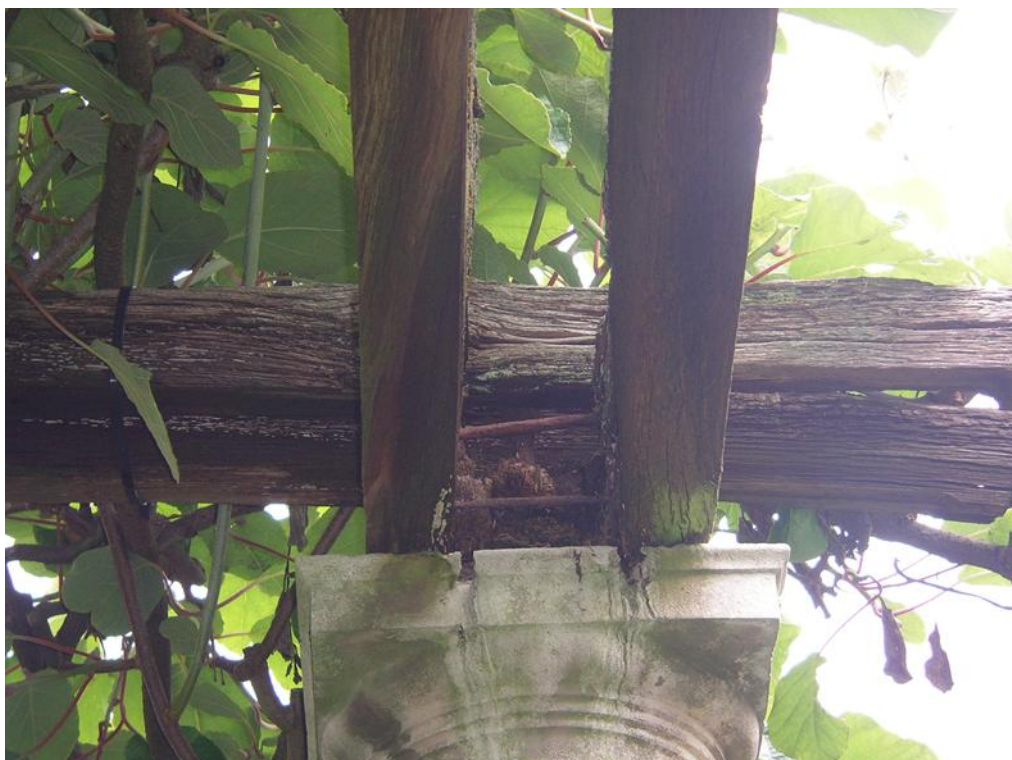
Portland stone columns form a colonnade walkway supporting a timber superstructure. The structural integrity of the stone columns has been affected by the decay of the timber superstructure which should fix into the columns to provide lateral support. The stonework itself is in generally reasonable condition but has been affected by acid attack to the capitols and fixing dowels due to lack of separation with the oak timbers.

Section 2: showing decayed timbers and acid attack to Portland stone column from oak timbers.

The timberwork should be replaced as noted already in this report. At that time the decay to the stonework due to acid attack should be addressed. It is likely that this will require replacement sections of stone with new non-ferrous dowels. The lead separating detail, used in section 1, should be replicated when this work is undertaken in section 2.

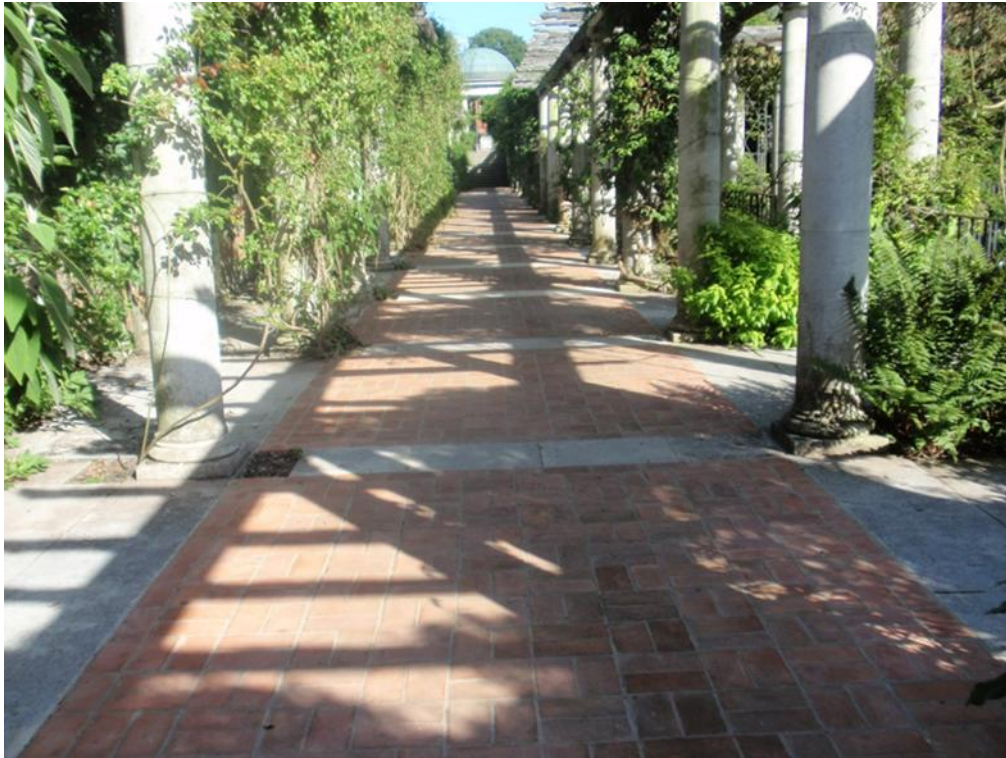
Section 2: showing renewed brick pavements and planting beds set into the structure.

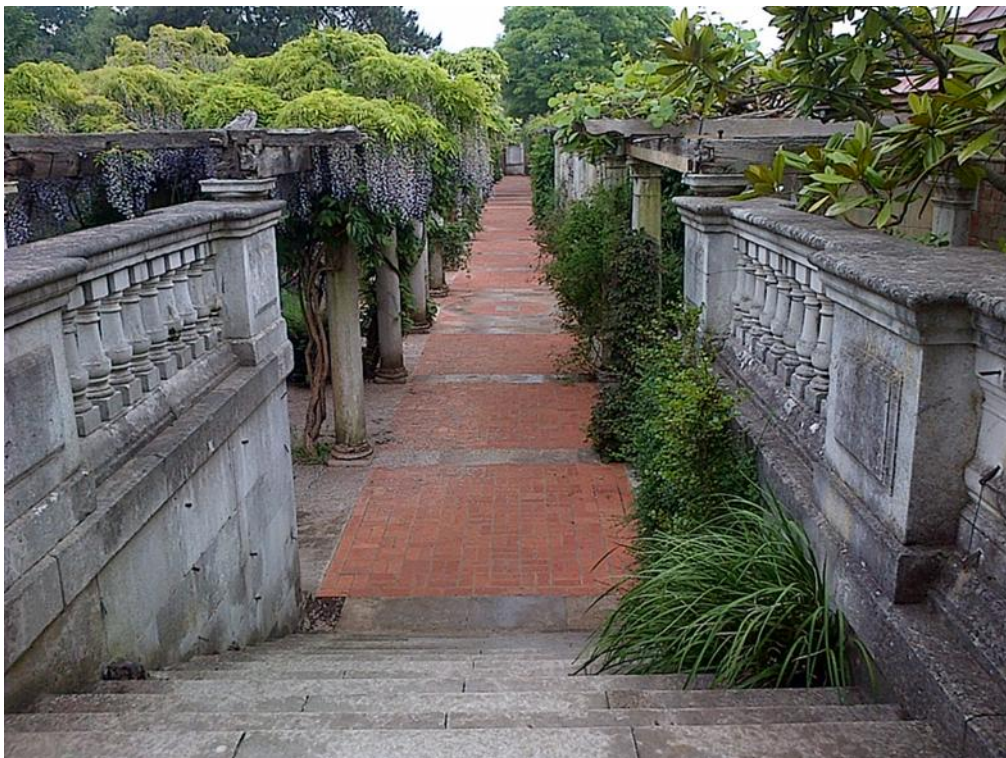
The colonnade walkway is an attractive design of brick paviours and stone slabs. The central part of the walkway, mainly consisting of brick paviours, had suffered settlement probably due to root damage over the years resulting in ponding and, in winter, icy conditions that made the Pergola unsafe for visitors. The brick paviours were re-laid in 2013 as part of the cyclical maintenance programme.

Section 2: general view showing renewed brick pavements.

The condition of the paved surfaces will be monitored and local repairs undertaken as necessary. The stone slabs will be taken up and re-laid to alleviate possible future damage due to root growth as part of the overall restoration of the section 2 Pergola.

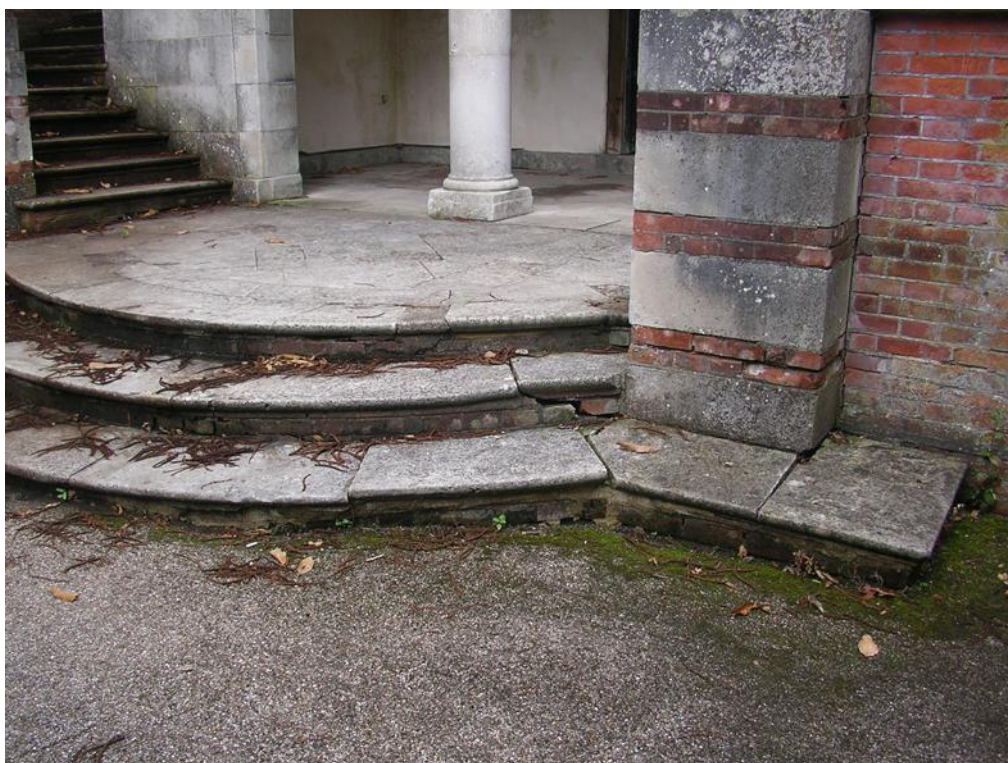
The condition of the planting beds and walkway surfaces are satisfactory but the absence of effective waterproofing is causing deterioration of the structure below. The staircases are in a poor condition. The stonework has been affected by damp and vegetation growth with cracked risers and treads and poor quality previous repairs. There are also signs of structural movement. Some of the timber doors are decayed.

Section 2: cracked staircase at the Belvedere structure which will be repaired as part of the 2015/16 cyclical maintenance programme.

Remedial works to the staircases including replacement of stonework or realignment of treads and risers, together with replacement of decayed timber doors would enable these to be put back in to use and reopened to visitors.

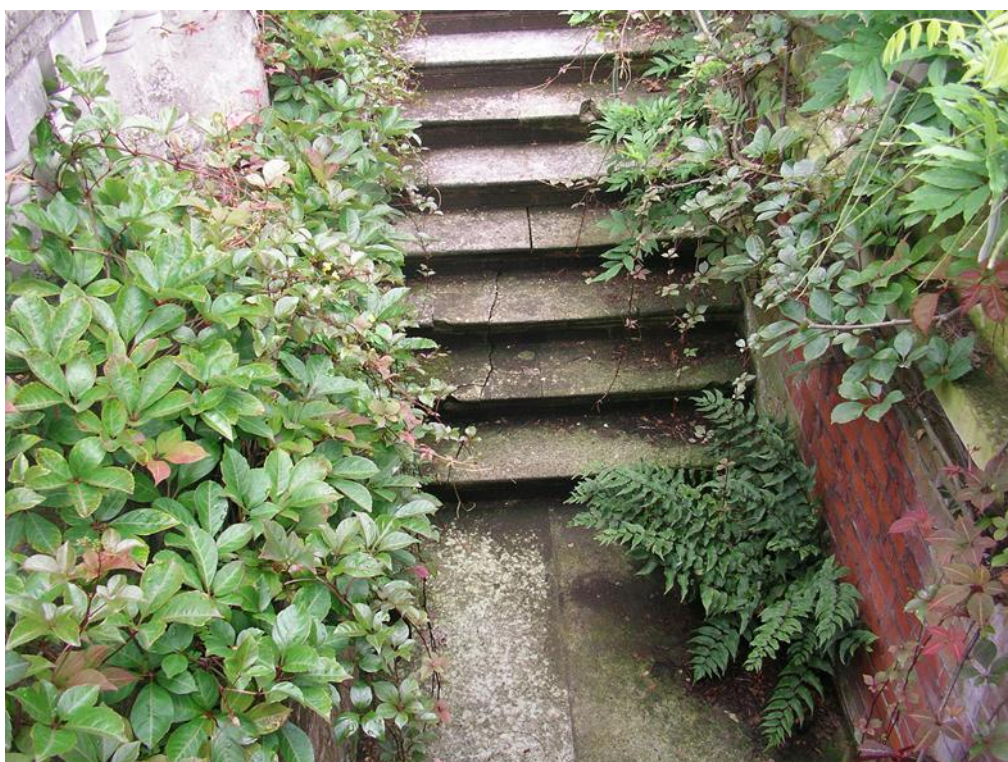
Section 2: one of the minor staircases showing cracked treads.

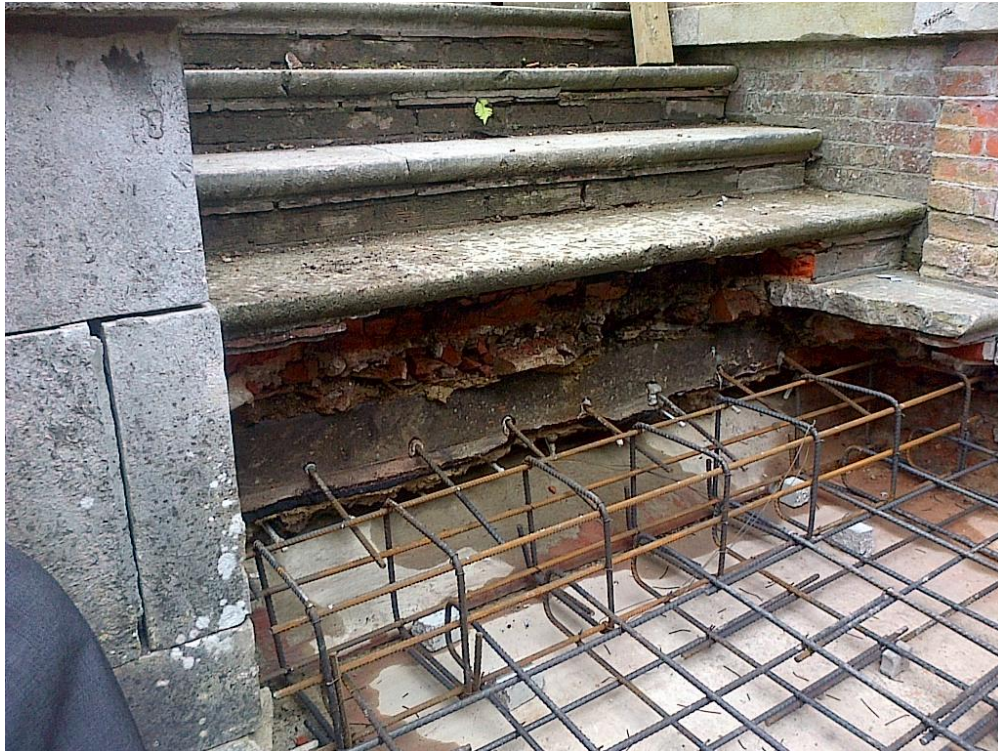
Waterproofing works were carried out in March 2014 to an area forming part of the staircase up to the Belvedere Structure. The structural slab and severely corroded reinforcement was replaced with waterproof tanking. Remedial works to the main staircase between the Belvedere and the Hill Garden are planned for later this year (2015/16) as part of the cyclical maintenance programme. The entrance to the Belvedere structure store room requires re-rendering once the dampness problem has been resolved and allowed to dry out.

Section 2: repairs to Belvedere stair platform undertaken in 2014.

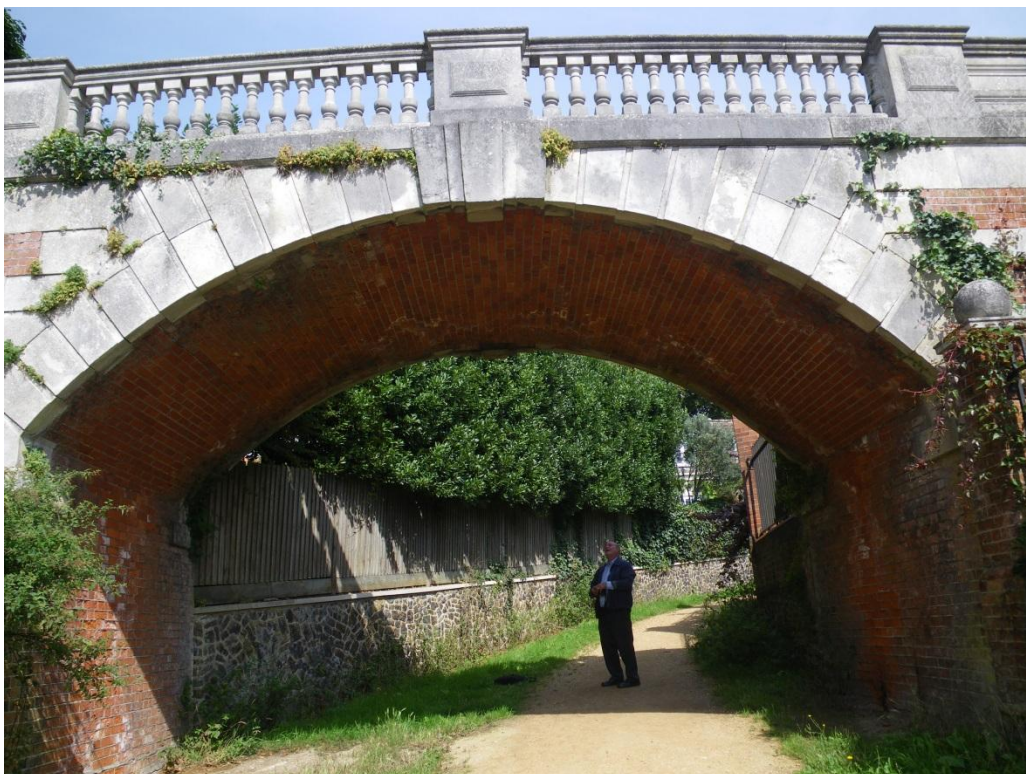
Section 2: The Bridge

Heath area. It is formed by a brick masonry arch faced in stonework bonded back to the arch. Minor repairs, such as repairs to cracked stonework keystones, brickwork replacement and repointing to open joints, were carried out in 2011. At this time it was found that water ingress had caused corrosion in the steel dowels in the key stones.

The structural condition of the bridge is monitored regularly, it is considered to be stable, however some of the conditions affecting other parts of the Pergola, such as water ingress from the walkway, the condition of brickwork and balustrades also affect the bridge.
