| Hampstead Heath Consultative Committee Hampstead Heath, Highgate Wood & Queen's Park | 09/03/2015 23/03/2015 |
| Subject: Hill Garden Pergola | Public |
| Report of: The City Surveyor (CS 044/15) | For Information |

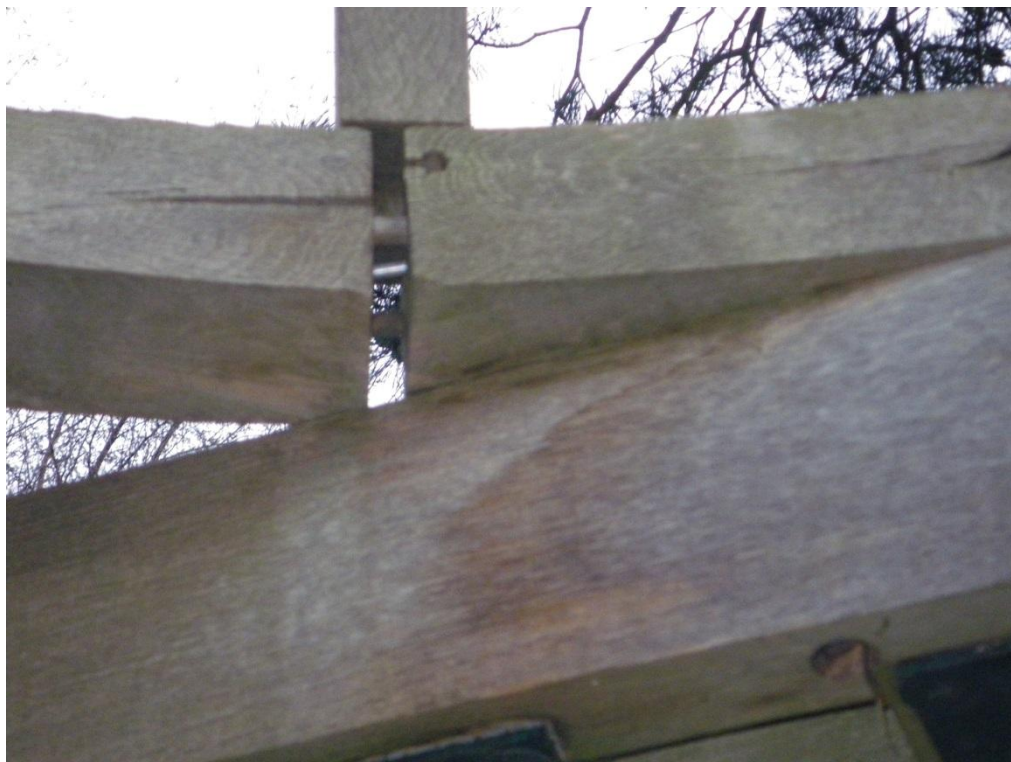
rotted. A series of repairs were carried out in 2012 including replacing rotten parts, checking and tightening all open joints, and fitting steel straps across weak joints.

Section 1: showing opening of joints in the timber superstructure

The condition of the pergola timber superstructure will be regularly monitored. The entire superstructure is planned to be refurbished or replaced in about 10 years' time although its condition will be monitored to try to maximise its life whilst it is in a safe condition.

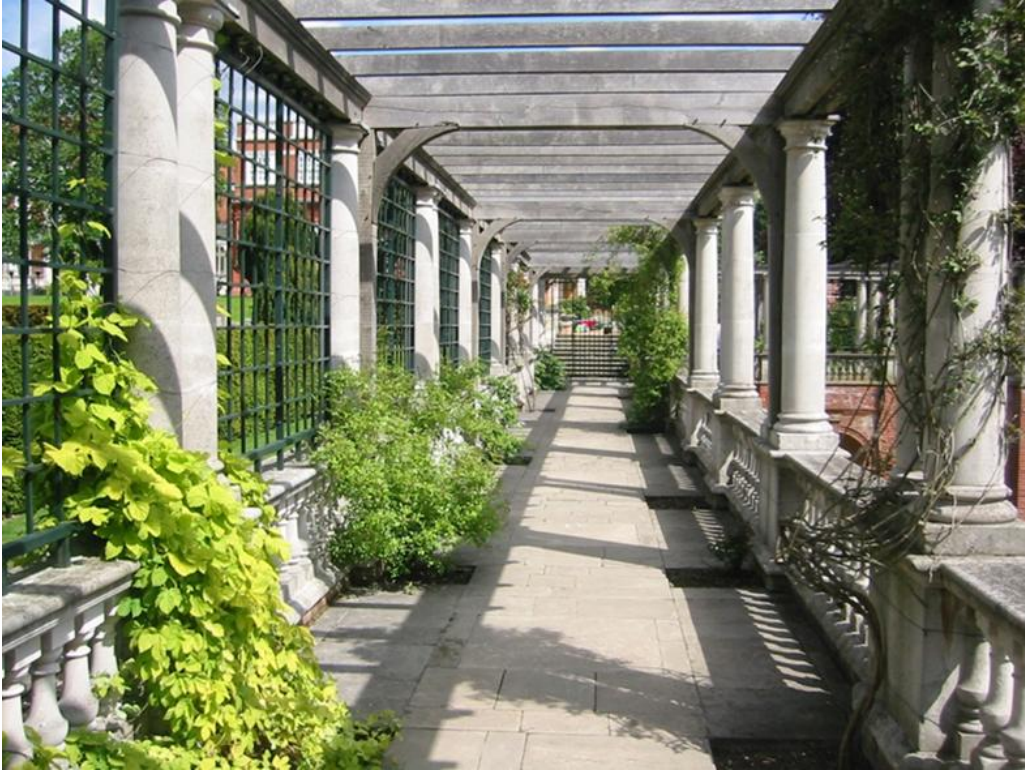
The condition of the planting beds and walkway surfaces are satisfactory but the absence of effective waterproofing is causing deterioration of the structure below particularly to the brickwork and steel beams.

Section 1: showing upper level walkway with stone balusters and columns and planting beds which extend into the void between the paved surface and the structural slab.

A tanking system should be introduced within the planters to contain the root systems and water from the irrigation systems, together with an effective method of draining excess water from the void area. The existing planting will need to be removed to enable these works. These works should be undertaken in advance of any full scale renovation projects.

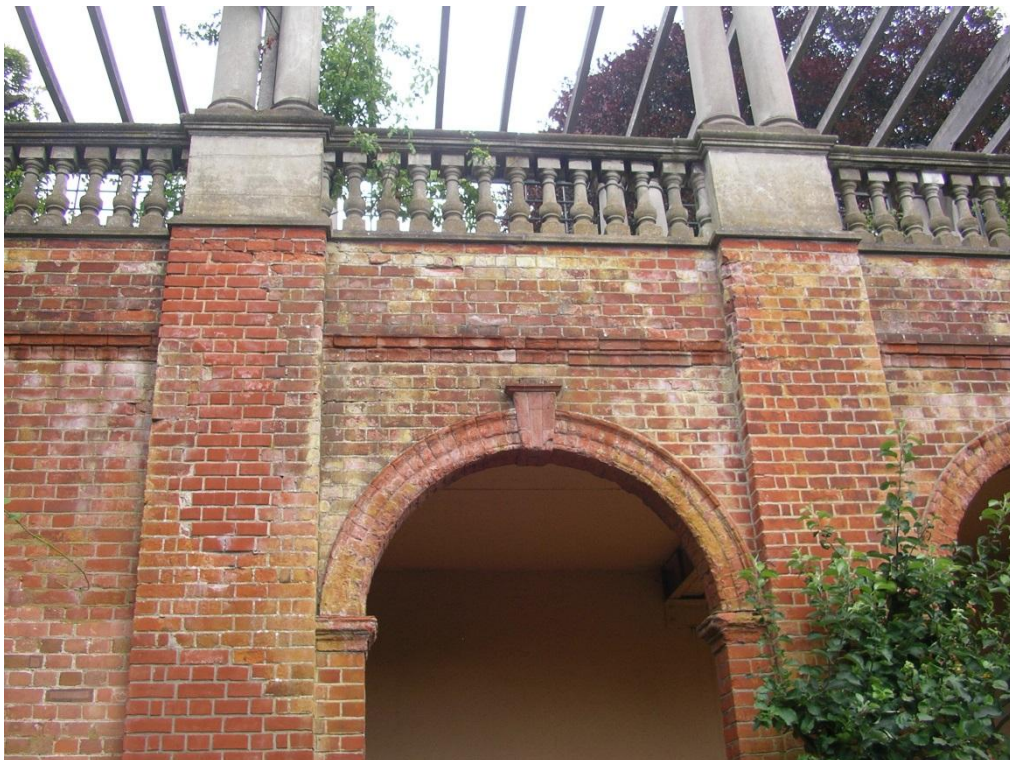
The lower level walkway of section 1 has an arcaded brick wall adjoining the lower garden area with arches supporting the upper level walkway. In section 2 brickwork wall support the walkway where this rises above ground level. The bridge is also faced with brickwork. Large areas of brickwork are heavily weathered and have been affected by efflorescence. The most significant areas of damage are the brick arches, circular windows in section 1. Some of the previous repairs are of poor quality, e.g. the use of hard cement mortar and facing where the surface of the bricks has laminated. The brickwork generally needs repointing.

The defects present are generally associated with water ingress from the upper walkways, the age of the brickwork and the exposed location of the Pergola. A consequential result of this damage could eventually lead to structural defects. The water ingress should be remedied. Damaged areas of brickwork should be rebuilt, particularly features that have structural properties such as the arches and circular windows.

Section 1: Brickwork arcade to lower level walkway showing deterioration due to dampness.

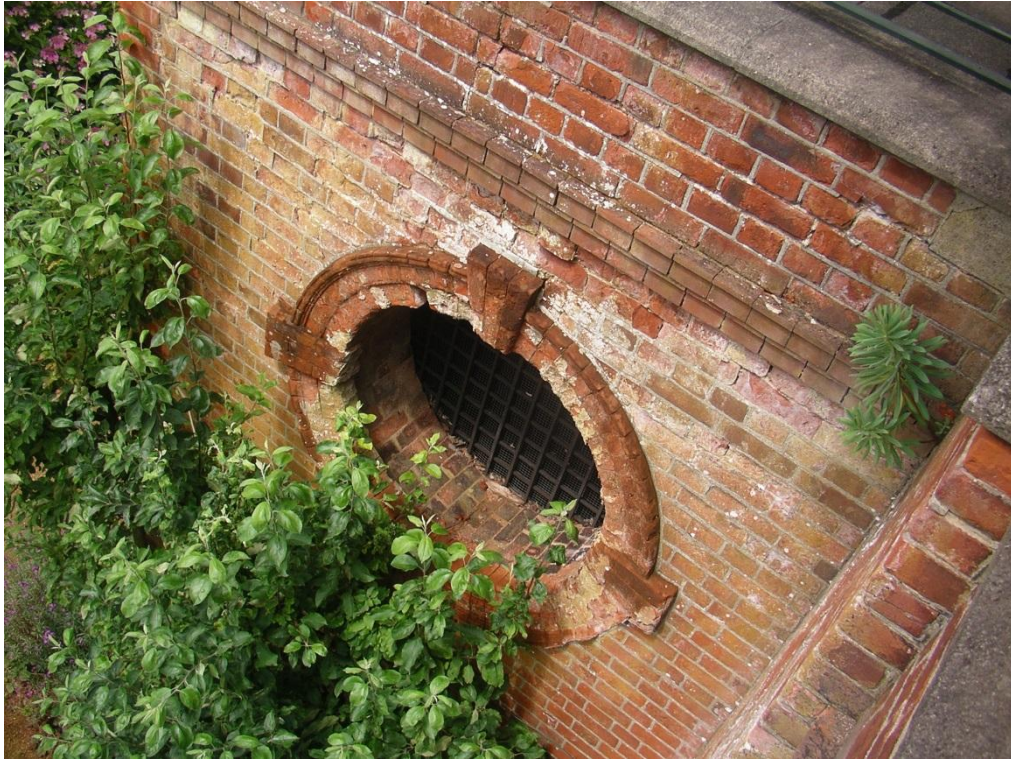
Section 1: brickwork deterioration around a circular window feature and efflorescence below the level of the structural slab to the walkway.

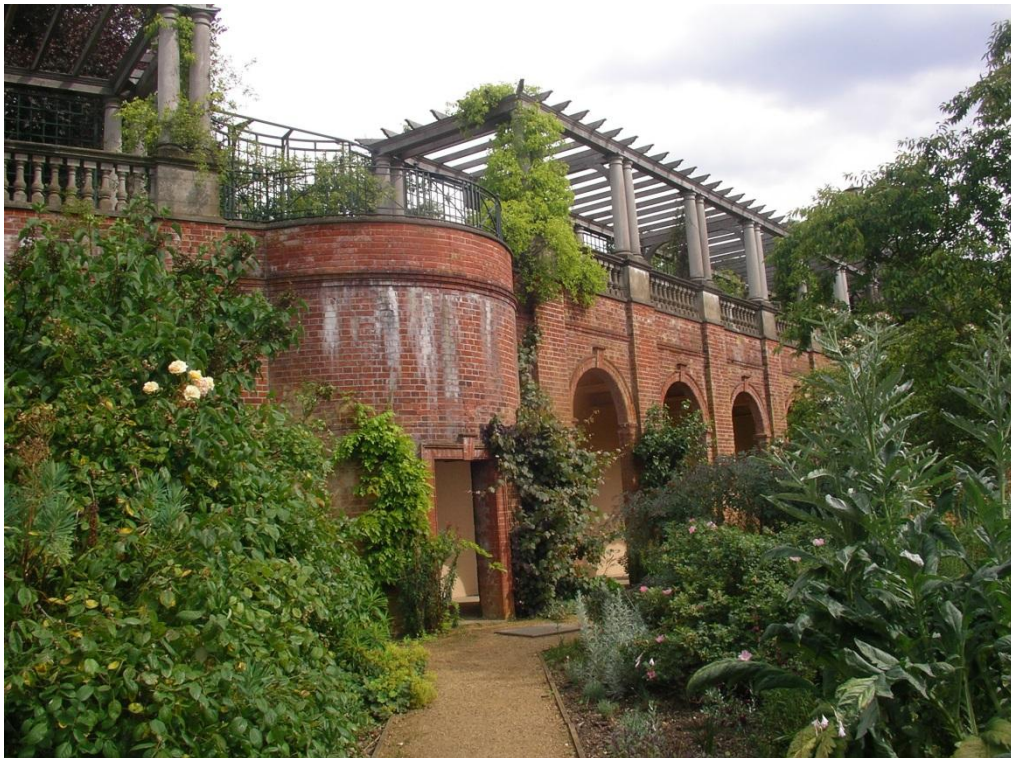
The rotunda is the brick drum shaped structure that is located at the change of direction in the south length of the Pergola. The rotunda has suffered structural damage evident as cracking at high level and movement away from the main walls. An attempt to remedy this is also evident in the form of a steel beam.

Recent structural investigations conclude that the movement is likely to be the result of thermal expansion and contraction over the length of the Pergola but it is not regarded as significant and the cracks have actually introduced expansion joints. They have recommended that any attempt to tie the rotunda back should be avoided. The cracks and movement will be monitored. The openings will be filled with non-structural weatherproofing jointing material.

Section 1: The rotunda feature showing unsightly efflorescence.

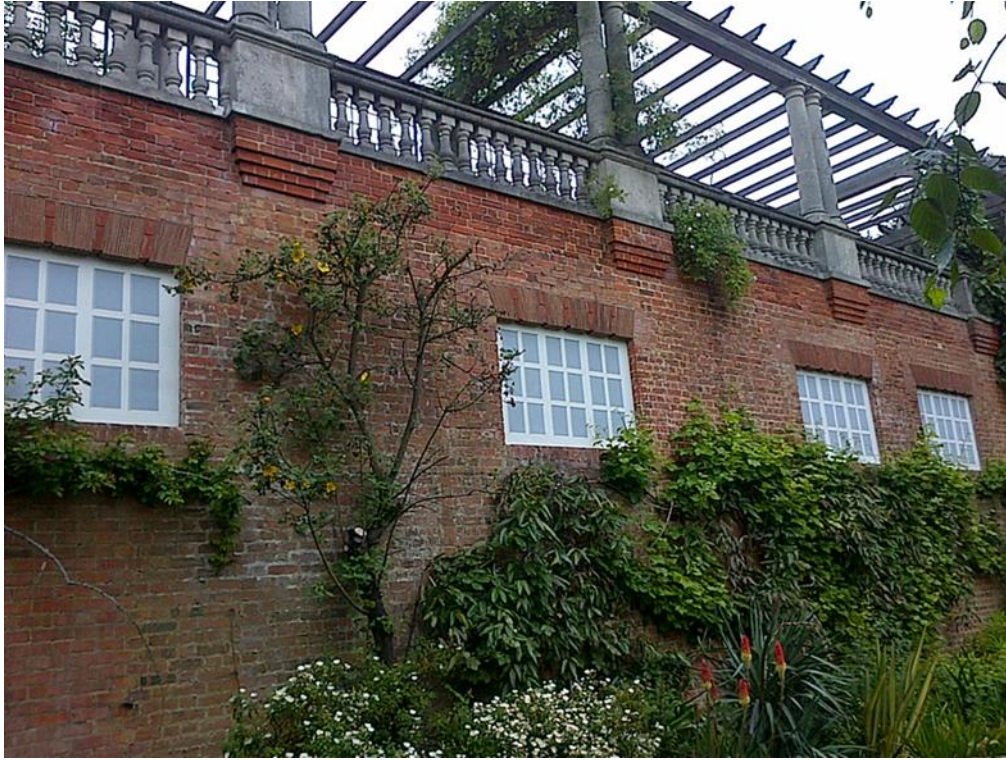
Several of the false windows were re-rendered and repainted in April 2013 and are in good condition. The remainder are now in need of similar treatment.

Section 2: The false windows after renovation in 2013.

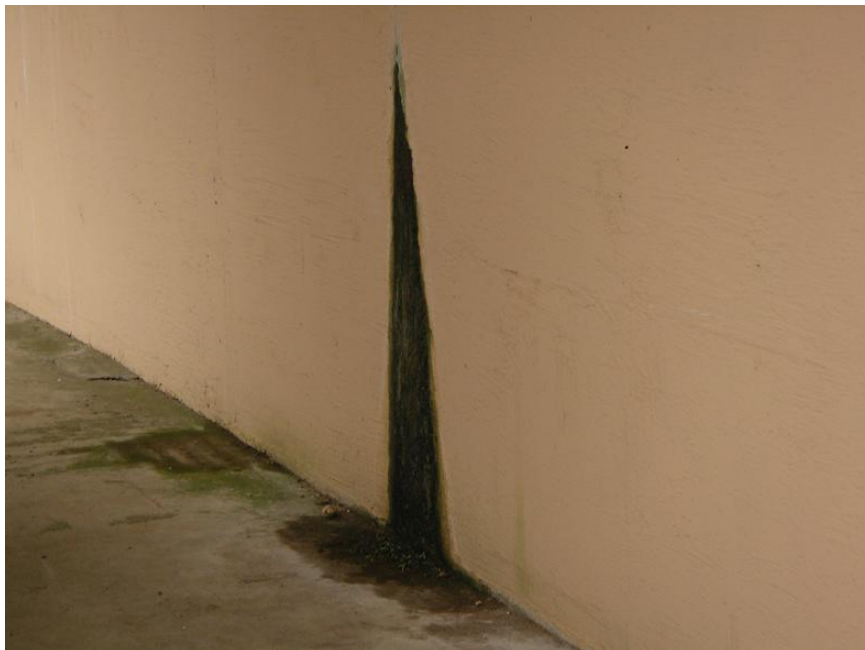
There is minor cracking in the inner face of the retaining wall and water pressure has formed seepage routes which are unsightly but are not of cause for concern in respect of the structural stability of the wall. There are no simple solutions to alleviate the water seepage problem and as this is of relatively minor concern to visitors it is not intended to undertake any remedial works however the situation will be monitored.

Section 2: water seepage through the retaining wall.

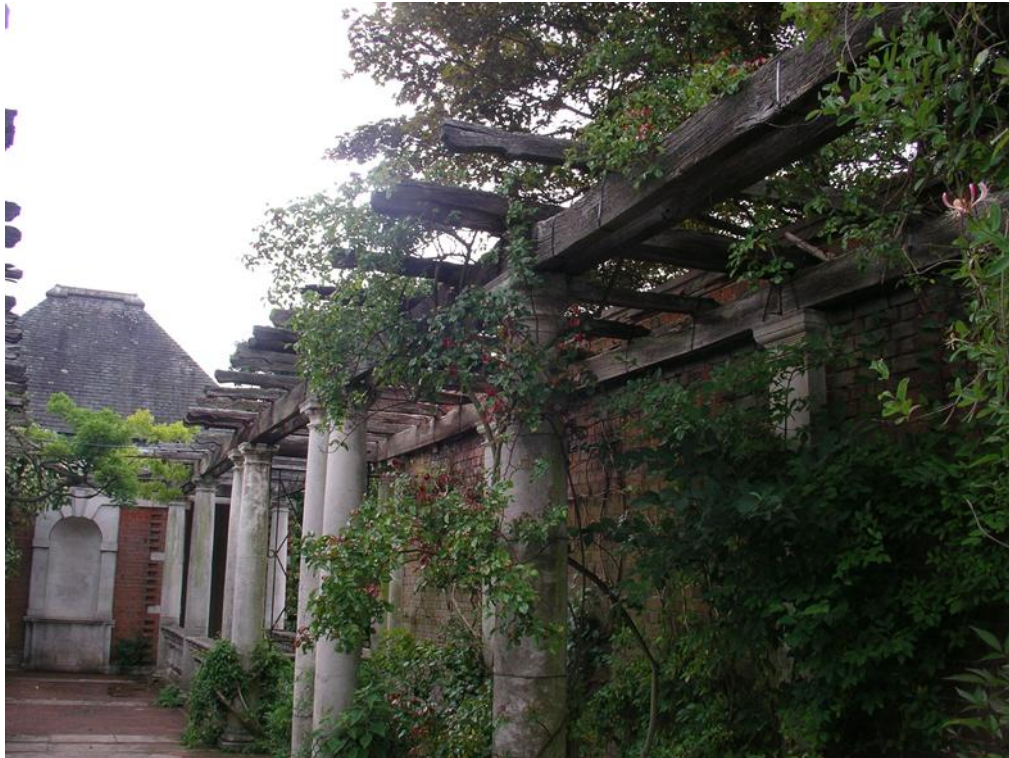
The pergola timber superstructure comprises oak horizontal beams and cross beams. This is the original timberwork, now almost 100 years old. It is of a more elegant, less decorative, design than the replacement timberwork in section 1. The timbers are very decayed with some of the original timber details lost with age. Many of the beams are now missing. The remaining beams have been secured with plastic straps as a temporary measure. The timberwork forms an integral part of the structure of the colonnade; connecting the tops of the columns. The weakness in the timberwork therefore has an adverse effect of the structural integrity of the colonnade.

Although the timberwork is regularly monitored the colonnade area is closed to visitors during high wind conditions because of concerns with the safety (as noted in the Superintendent's 2013 report). Overall the timberwork is overdue for replacement with new oak timber to match the original design. The timberwork should be replaced conjunction with repairs to the columns as part of any restoration project.

Section 2: showing timber superstructure with decayed and missing sections.

37. The provisions totalling £200,000, in years 2015/16 & 2016/17, for major repairs have been assigned for the renewal of the timber superstructure and stone columns in section 2. This will address the current safety concerns and the need to have to close parts of the Pergola at times.

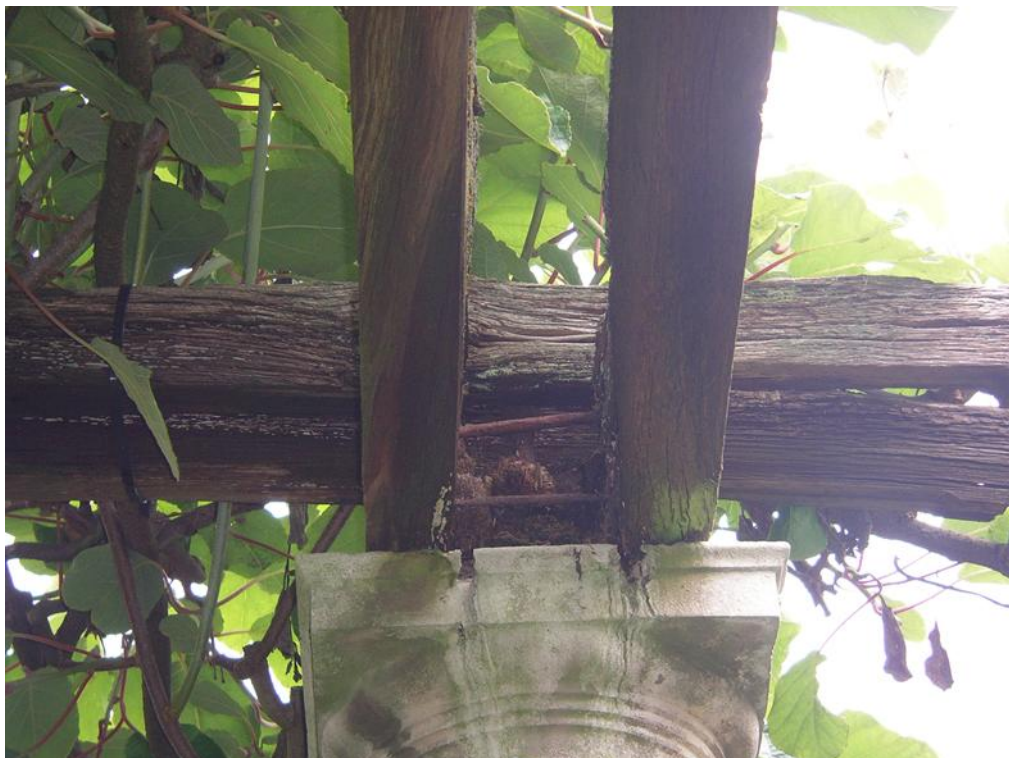
Portland stone columns form a colonnade walkway supporting a timber superstructure. The structural integrity of the stone columns has been affected by the decay of the timber superstructure which should fix into the columns to provide lateral support. The stonework itself is in generally reasonable condition but has been affected by acid attack to the capitols and fixing dowels due to lack of separation with the oak timbers.

Section 2: showing decayed timbers and acid attack to Portland stone column from oak timbers.

The timberwork should be replaced as noted already in this report. At that time the decay to the stonework due to acid attack should be addressed. It is likely that this will require replacement sections of stone with new non-ferrous dowels. The lead separating detail, used in section 1, should be replicated when this work is undertaken in section 2.

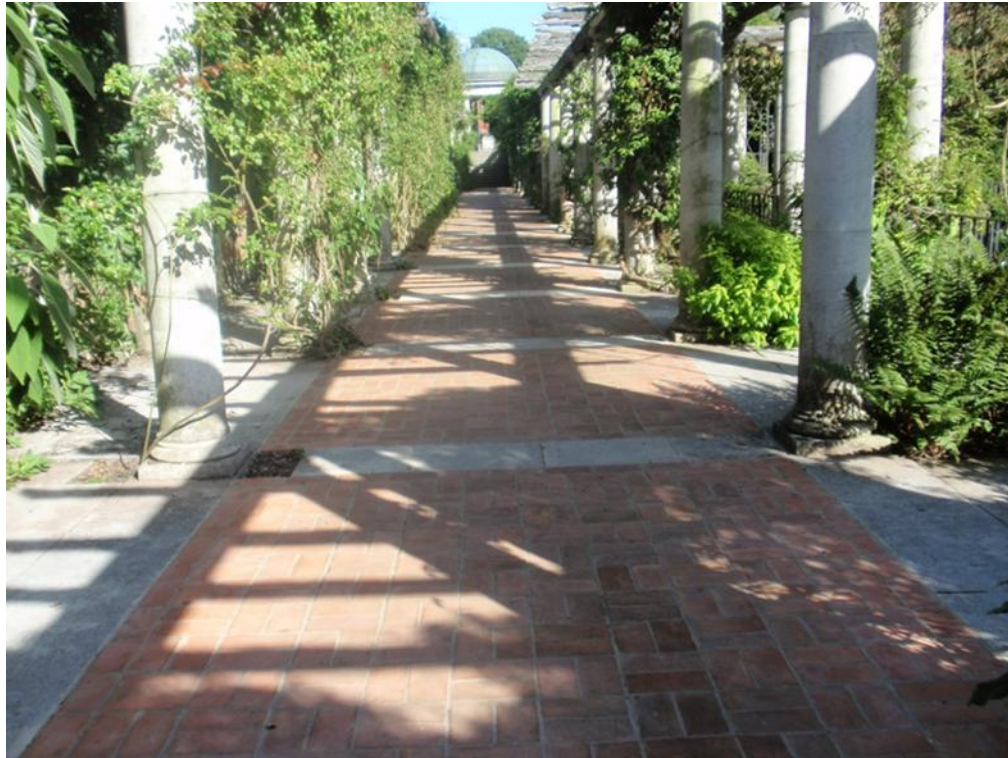
The colonnade walkway is an attractive design of brick paviours and stone slabs. The central part of the walkway, mainly consisting of brick paviours, had suffered settlement probably due to root damage over the years resulting in ponding and, in winter, icy conditions that made the Pergola unsafe for visitors. The brick paviours were re-laid in 2013 as part of the cyclical maintenance programme.

Section 2: showing renewed brick pavements and planting beds set into the structure.

The condition of the paved surfaces will be monitored and local repairs undertaken as necessary. The stone slabs will be taken up and re-laid to alleviate possible future damage due to root growth as part of the overall restoration of the section 2 Pergola.

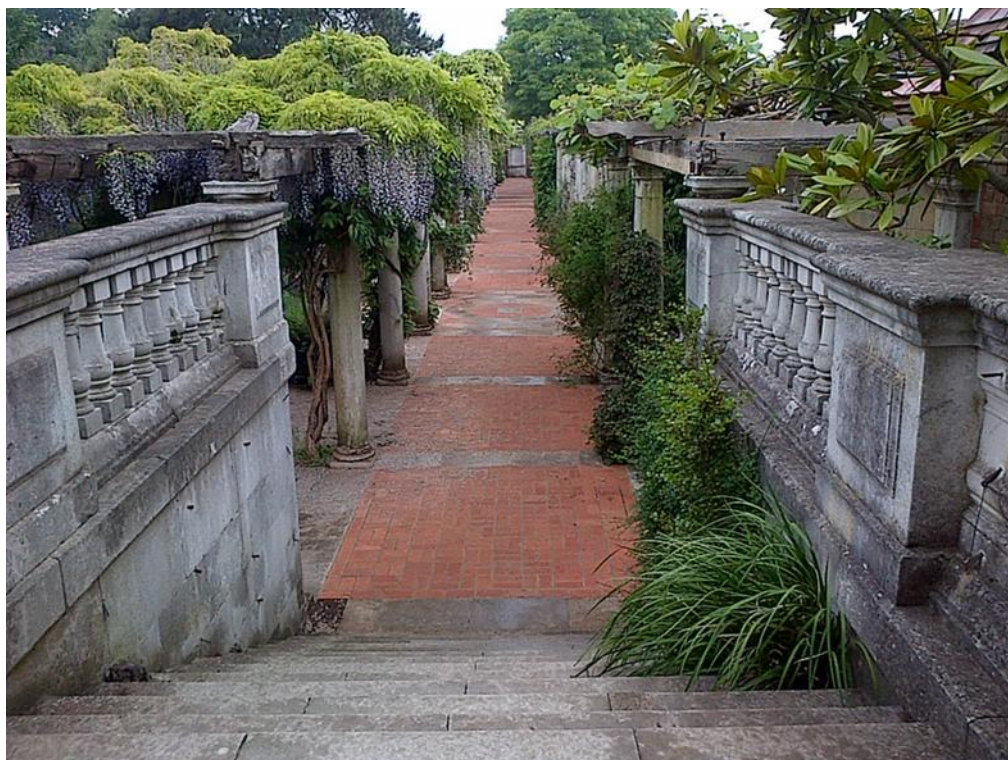
Section 2: general view showing renewed brick pavements.

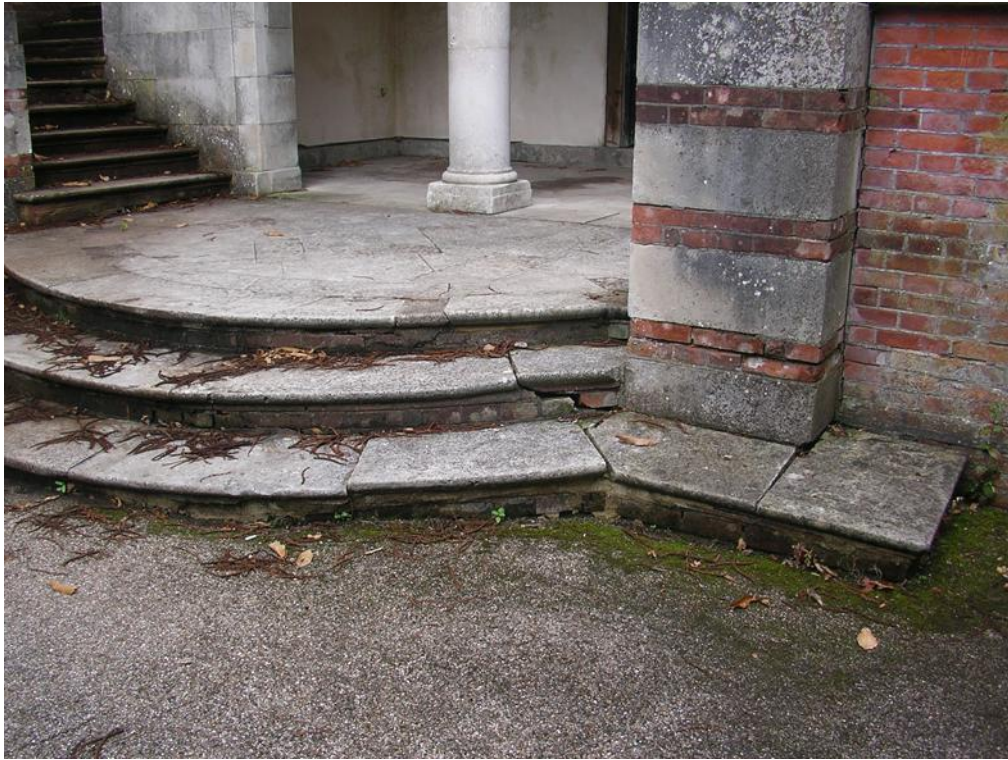
The condition of the planting beds and walkway surfaces are satisfactory but the absence of effective waterproofing is causing deterioration of the structure below. The staircases are in a poor condition. The stonework has been affected by damp and vegetation growth with cracked risers and treads and poor quality previous repairs. There are also signs of structural movement. Some of the timber doors are decayed.

Section 2: cracked staircase at the Belvedere structure which will be repaired as part of the 2015/16 cyclical maintenance programme.

Remedial works to the staircases including replacement of stonework or realignment of treads and risers, together with replacement of decayed timber doors would enable these to be put back in to use and reopened to visitors.

36. Remedial works to the staircase and waterproof tanking to the slabs in the Belvedere structure are being planned to be carried out later this year (2015/16), as noted previously, from the £150,000 provision in the 2014/2015 Additional Work Programme budget provision.

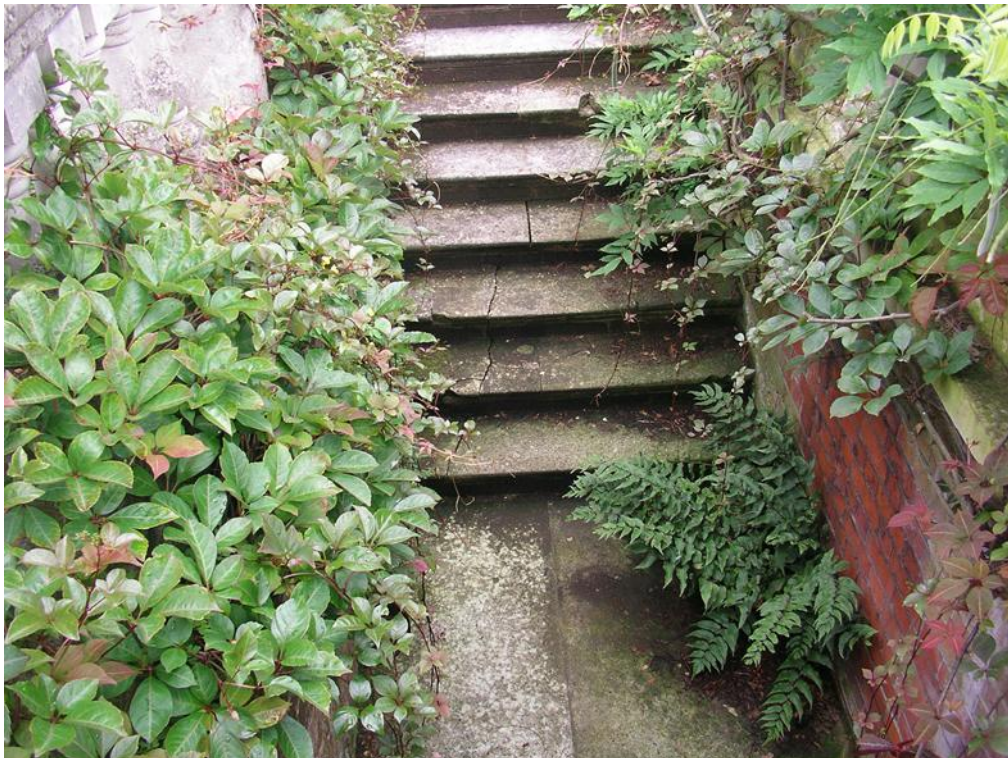
Section 2: one of the minor staircases showing cracked treads.

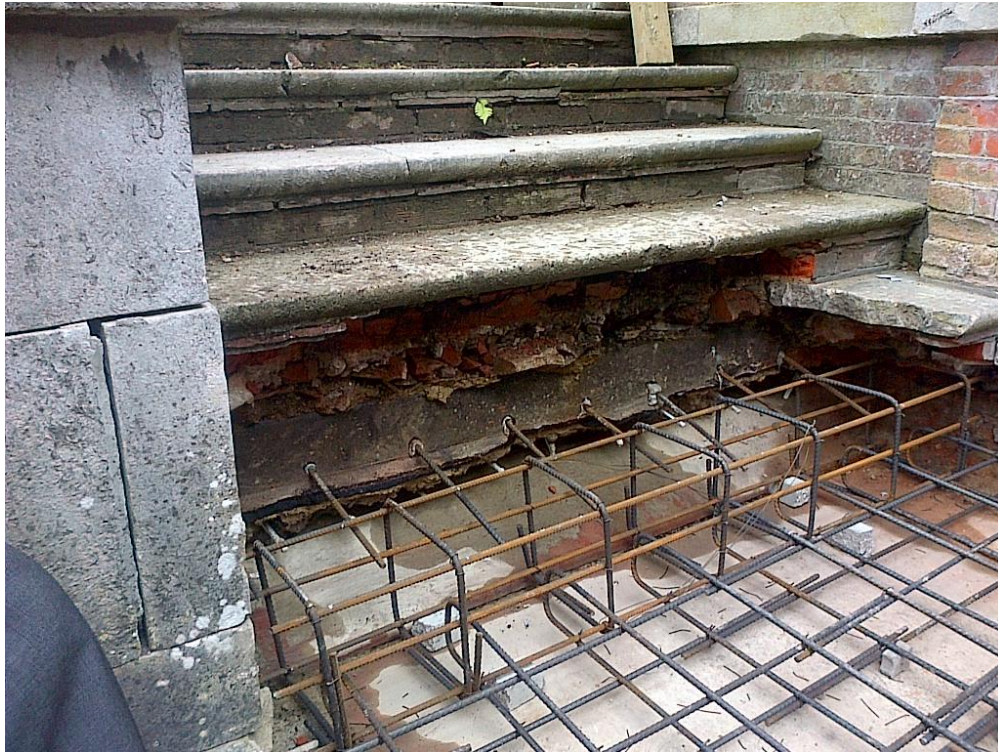
Waterproofing works were carried out in March 2014 to an area forming part of the staircase up to the Belvedere Structure. The structural slab and severely corroded reinforcement was replaced with waterproof tanking. Remedial works to the main staircase between the Belvedere and the Hill Garden are planned for later this year (2015/16) as part of the cyclical maintenance programme. The entrance to the Belvedere structure store room requires re-rendering once the dampness problem has been resolved and allowed to dry out.

Section 2: repairs to Belvedere stair platform undertaken in 2014.

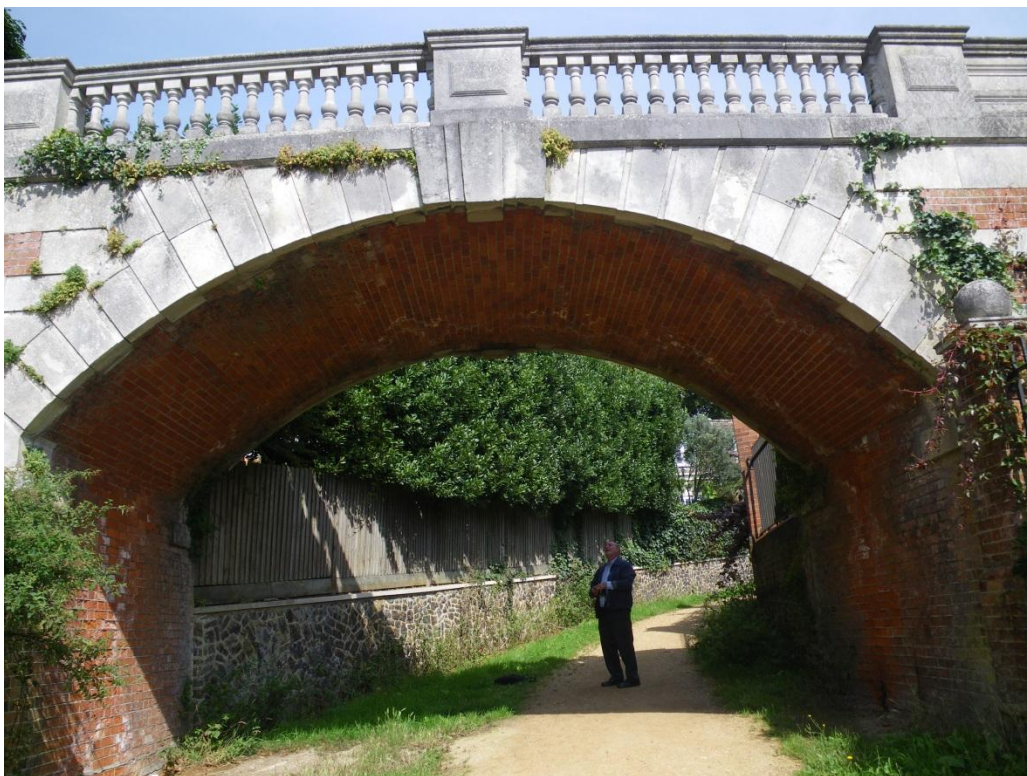
Section 2: The Bridge

brickwork replacement and repointing to open joints, were carried out in 2011. At this time it was found that water ingress had caused corrosion in the steel dowels in the key stones.

The structural condition of the bridge is monitored regularly, it is considered to be stable, however some of the conditions affecting other parts of the Pergola, such as water ingress from the walkway, the condition of brickwork and balustrades also affect the bridge.
