Report Document

Project: – Barbican Estate
Non-Langley Roof Areas

Barbican Estate
City of London
EC2Y

Roof Survey Report & Recommendations

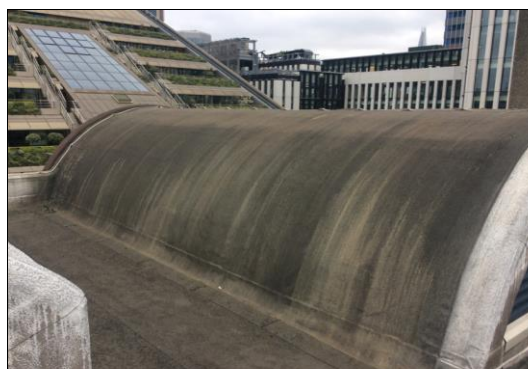
1. General condition of all barrel roofs that would benefit from being cleaned.

We recommend that drainage is be maintained and kept unblocked, all lightning strips are to be re-fixed were needed. All barrel roof areas could be prepared, primed and coated with 2 additional re-enforced layers of liquid offering a 20-year guarantee.

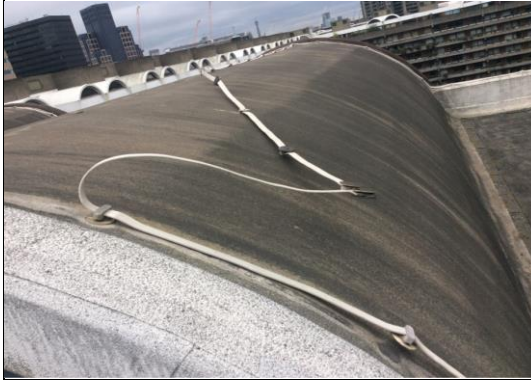
2.
In many areas, lightning strips need to be re-fixed. This is evident on many of the Barrel roof areas.

Barrel roof areas are generally in average condition and have been waterproofed with a liquid material. Some barrel roofs have been re-painted/coated with others being dirty and dark in appearance. In areas, lightning strips have broken and lightning strip pads have de-bonded from the existing liquid material. Drainage is through an internal outlet or through an internal lead gutter that drains onto the main roof area.

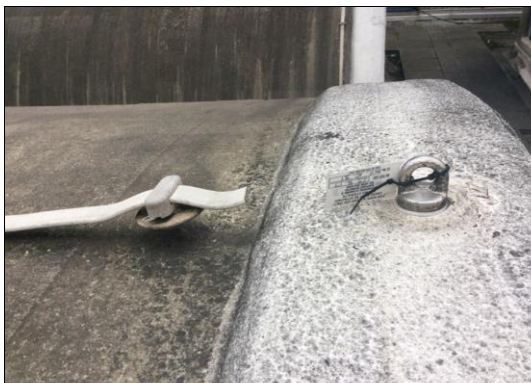
3.
As above.

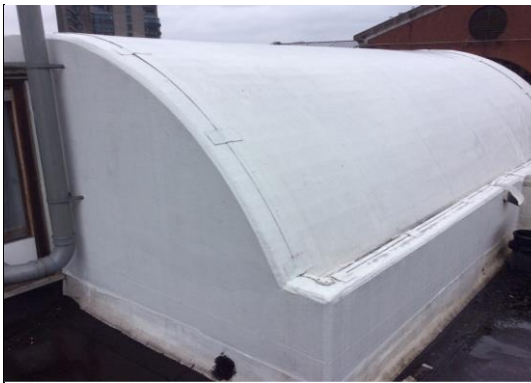
4.
Barrel roof area that has been painted/coated.

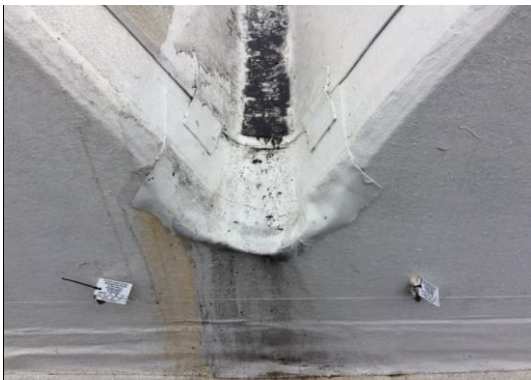
5.
Close up of the existing lead and gutter that has been painted/coated.

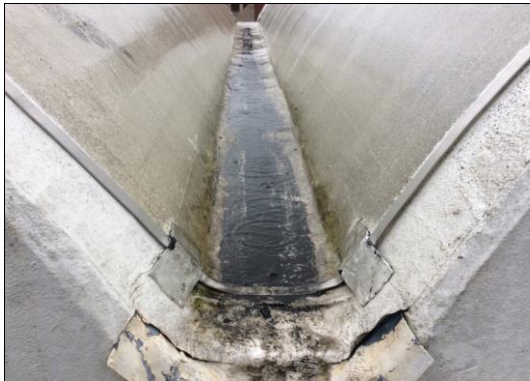
6. Barrel roof drainage needs to be maintained and unblocked in places.

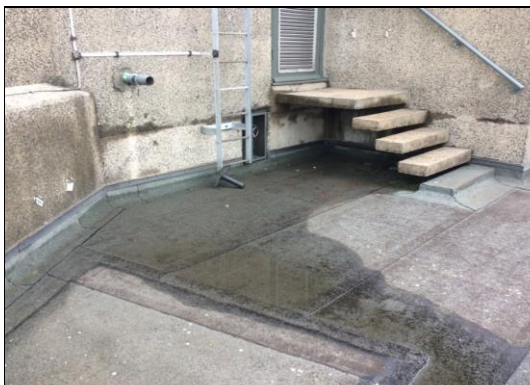
7. Main roof for Cromwell and Shakespeare Tower; BUR felt in average condition and no signs of repairs or failure.

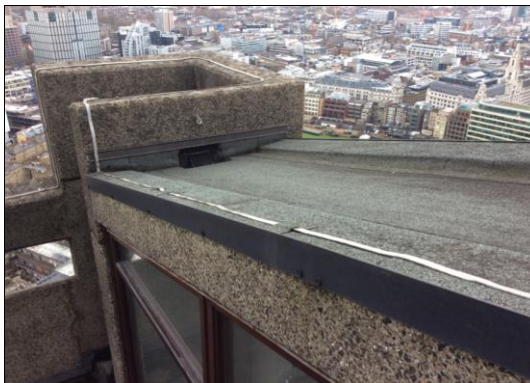
8. Overview of Cromwell and Shakespeare Tower link roofs that are in average condition.

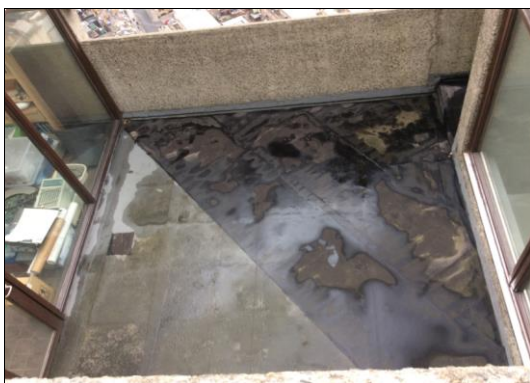
8. Cromwell Tower balcony roof
Overview of Cromwell Tower balcony roof; in poor condition and has previous repairs.

The existing roof area has been repaired with various materials such as BUR felt and liquid in different areas indicating previous water ingress issues; in places the repairs have started to fail becoming ruckled, blistered and worn. The existing asphalt has started to slump underneath the wooden door threshold.

We recommend that the repairs are to be stripped back and the existing asphalt is to be overlaid with 2 layers of bituminous elastomeric felt with counting flashing protection to the concrete upstand and door threshold.

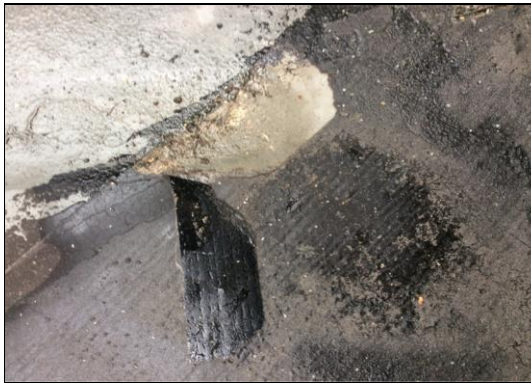
9. Cromwell Tower balcony roof

Felt repair has started to fail leaving an aperture for potential water ingress.

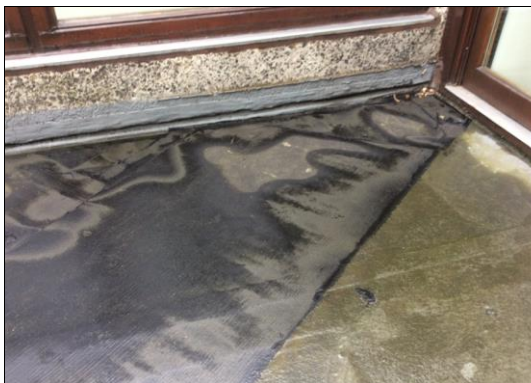
10. Cromwell Tower balcony roof

Felt repair has become ruckled and blistered and liquid repairs have taken place to the concrete upstand.

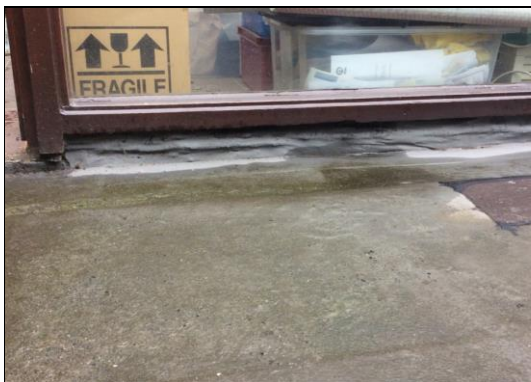
11. Cromwell Tower balcony roof

Existing asphalt underneath the door threshold has started to slump.

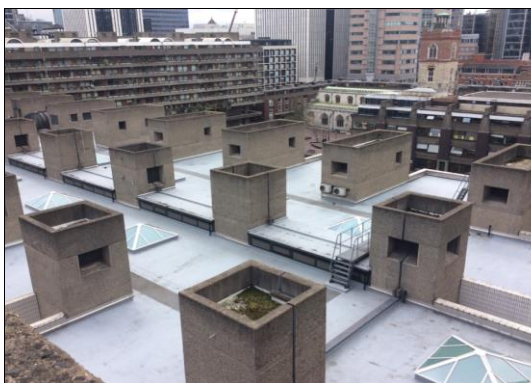
12. Barbican Centre roof

Overview of the Barbican Centre roof.

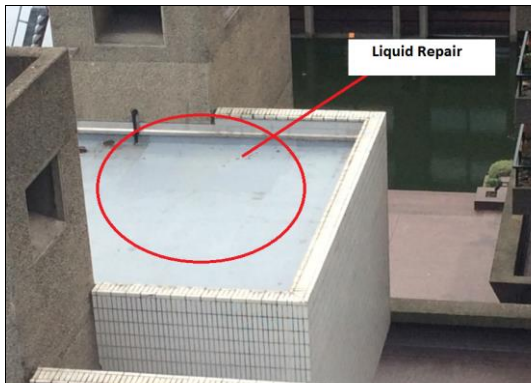
13. Barbican Centre roof

Liquid repair indicating previous water ingress issues.

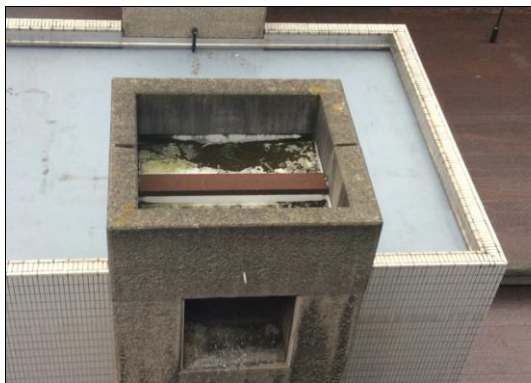
14. Barbican Centre roof

Vegetation growth on existing asphalt stairwell roof.

It is recommended that standard routine maintenance continue to include the clearing of all rainwater outlets, gutters and other drainage outlets, as well as removing any vegetation, loose debris and repair of any paving slabs as required.

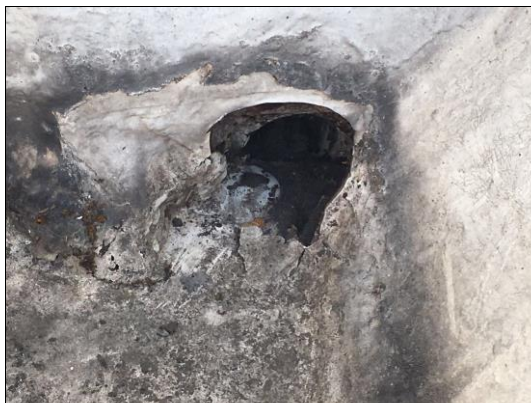
15. Andrewes House Barrel Roof Areas

Liquid has de-bonded from the concrete upstand with cracking also evident causing water ingress.

One valley of the existing barrel roof area is leaking with reported water ingress from failed 2 no. scupper outlets through an expansion joint and down to the bottom of the building. The existing liquid waterproofing has de-bonded from the concrete upstand causing repeated leaking, with cracking of the existing liquid waterproofing also evident around both the failing scupper outlets with the metal guards currently loose and unfixed. This area will need to be repaired with a reinforced liquid system, and may require some substrate repairs also. Please note that a repair only would not carry any guarantee, and consideration should be made to upgrade the complete roofing area, depending on guarantee period remaining.

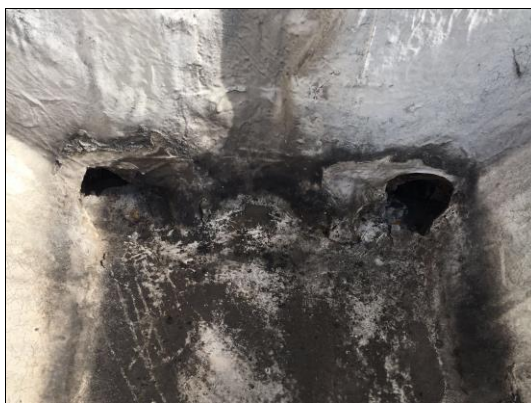
16.

As Above.

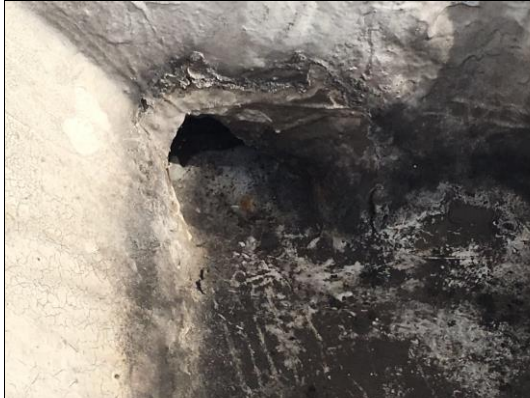
17.
As Above.
