Small scale fire test utilising the heating and pressure conditions given in BS EN 1363-1: 2012 on a section of timber based door leaf, taken from 5 Eric Wilkins House, London.

396019 – Draft Copy

TSG Building Services Plc
Carnborne Road,
Potter Bar,
London,
United Kingdom.

Indicative Fire Resistance Test Letter Report

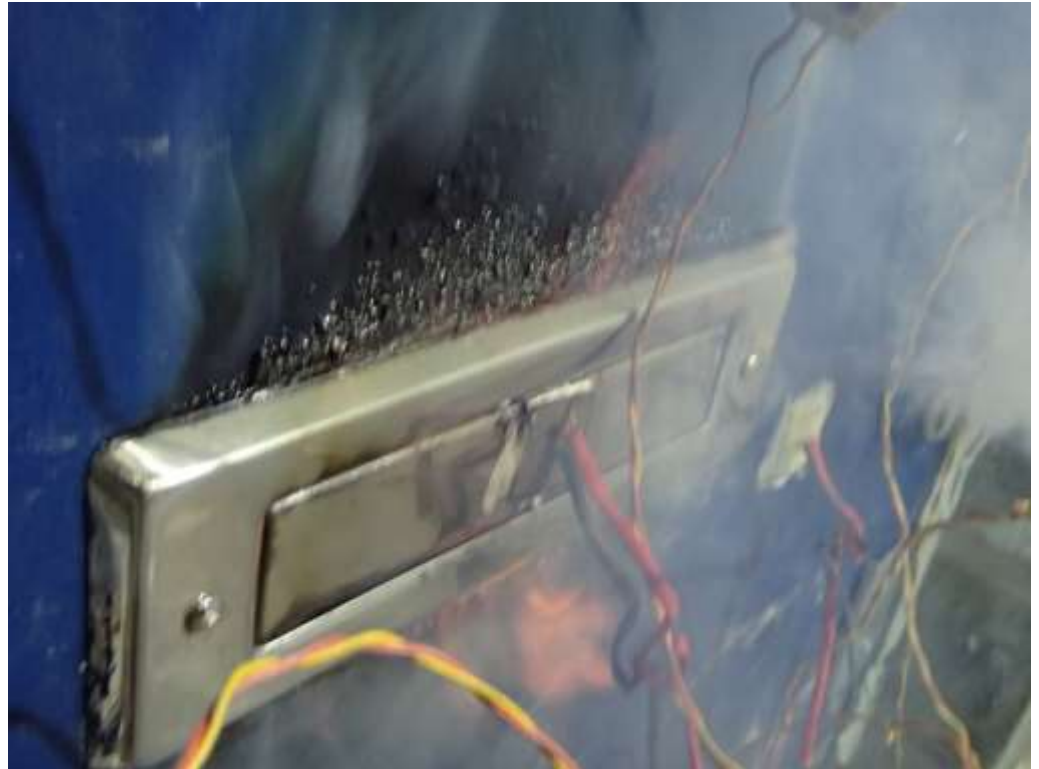
Flaming observed from around the letter plate on the unexposed face of the doorset after a test duration of 14 minutes

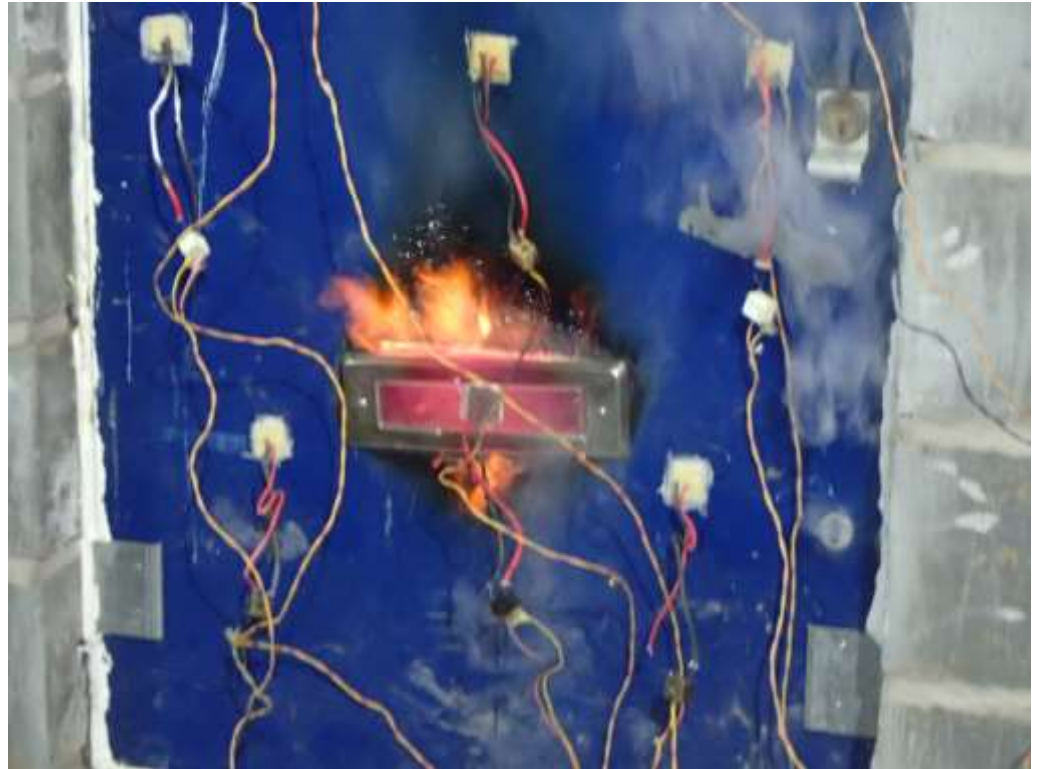
16	30	Cotton wool pad integrity test is performed above the letter plate. The cotton wool pad ignites.
17	00	Flickers of flame around letter plate continue to glow in size and frequency.
18	00	Flickers of flame around the letter plate have now turned in to a sustained flame as the letter plate begins to fall away from the door leaf.
20	00	Sustained flames continue to issue from the letter plate and begin to spread up the door leaf's face.
23	00	Large sustained flames issue through the letter plate. The area is blanked off with ceramic based wool to the test to continue.
24	00	Steam/smoke release continues from around the door viewer, latch and deadlock key hole.
27	00	Flickers of flame are observed around door viewer.
30	00	Flickers of flame are observed around door viewer have now formed a sustained flame.

Sustained flames issue around the latter plate on the unexposed face of the doorset after a test duration of 18 minutes

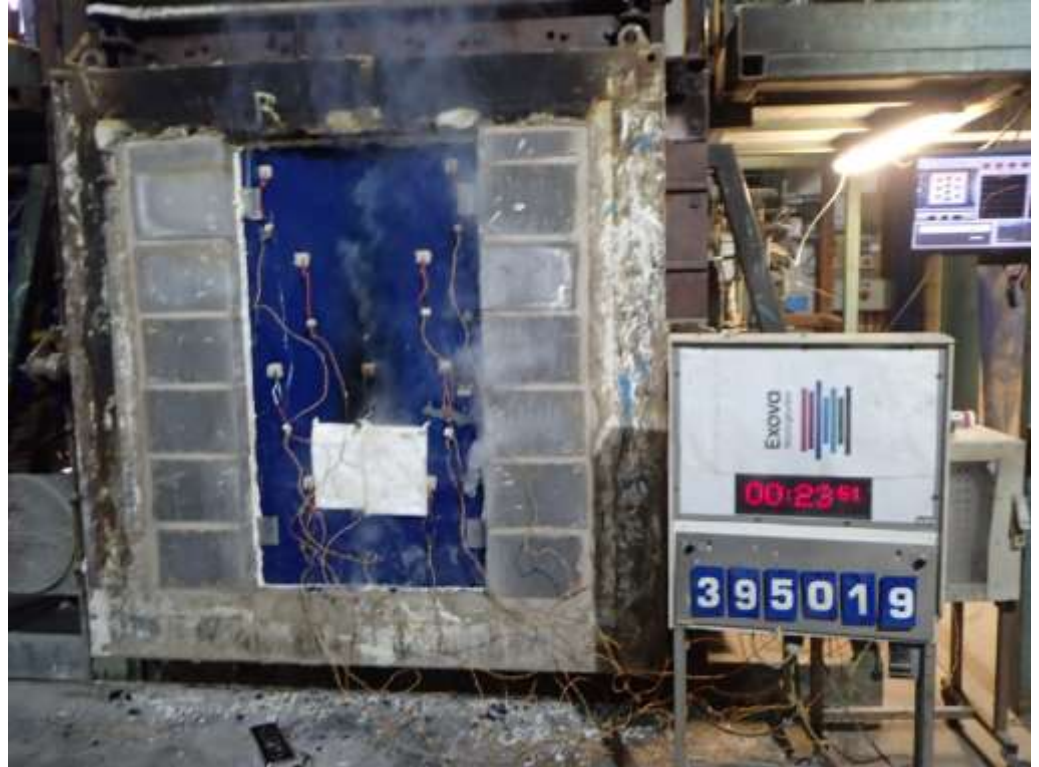
The letter plate on the unexposed face of the doorset is blanked off after a test duration of 23 minutes

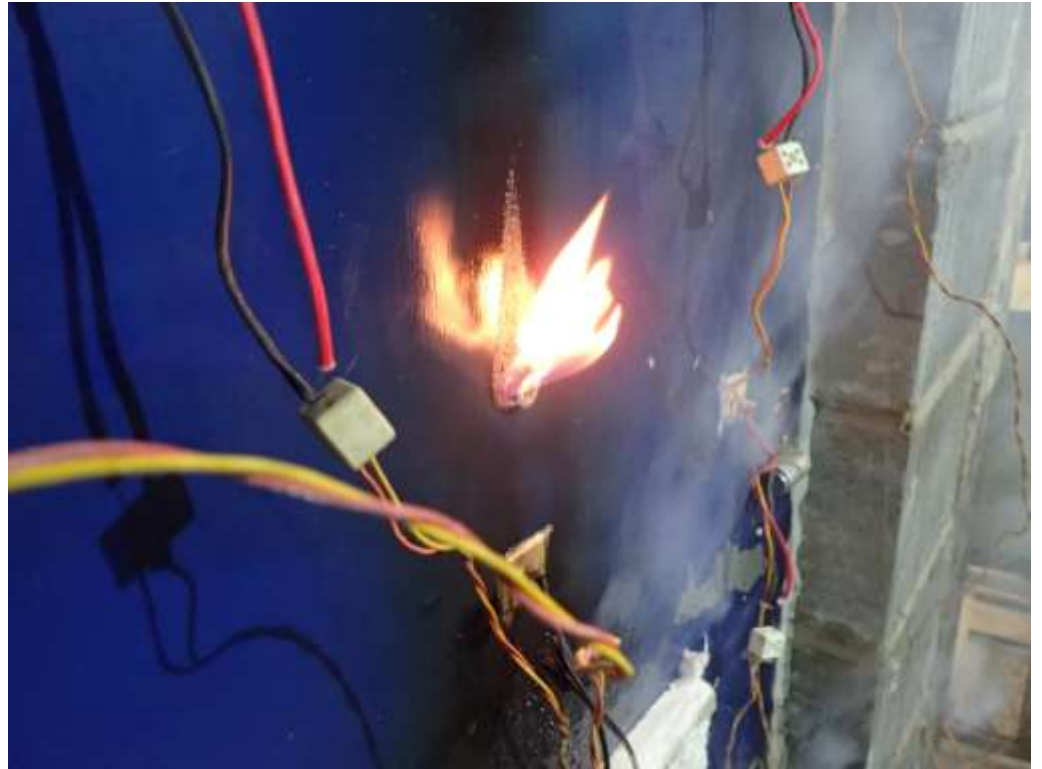
**Sustained flames
issue from
around the door
viewer on the
unexposed face
of the doorset
after a test
duration of 30
minutes**

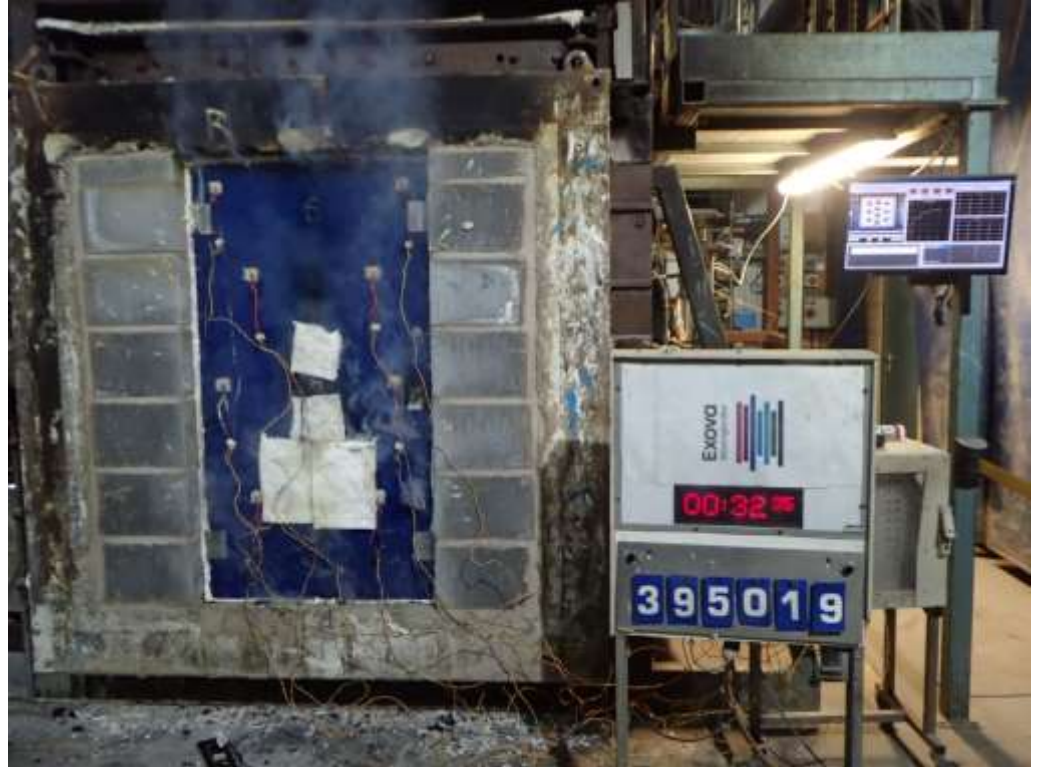
| 31 | 50 | Sustained flames continue to issue around the door viewer.

The area blanked off with ceramic based wool to the test to continue. |

The door viewer on the unexposed face of the doorset is blanked off after a test duration of 32 minutes

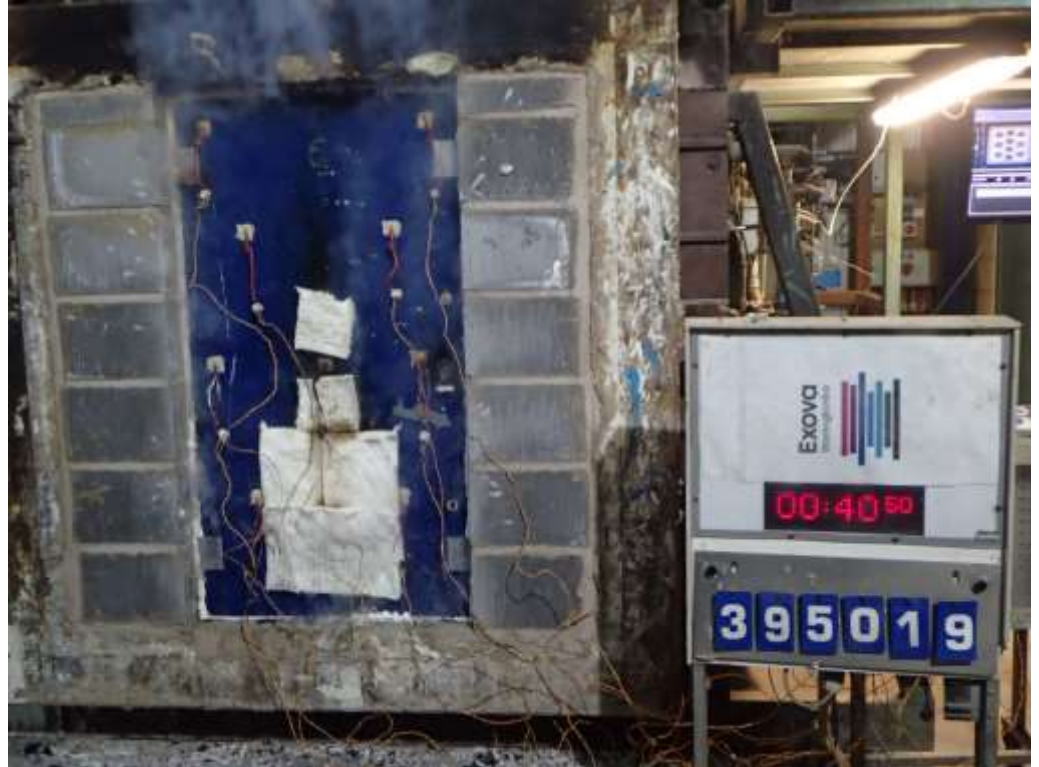
| 39 | 00 | The paint on the unexposed face of the door leaf is now showing signs of bubbling. |

The unexposed face of the doorset after a test duration of 40 minutes

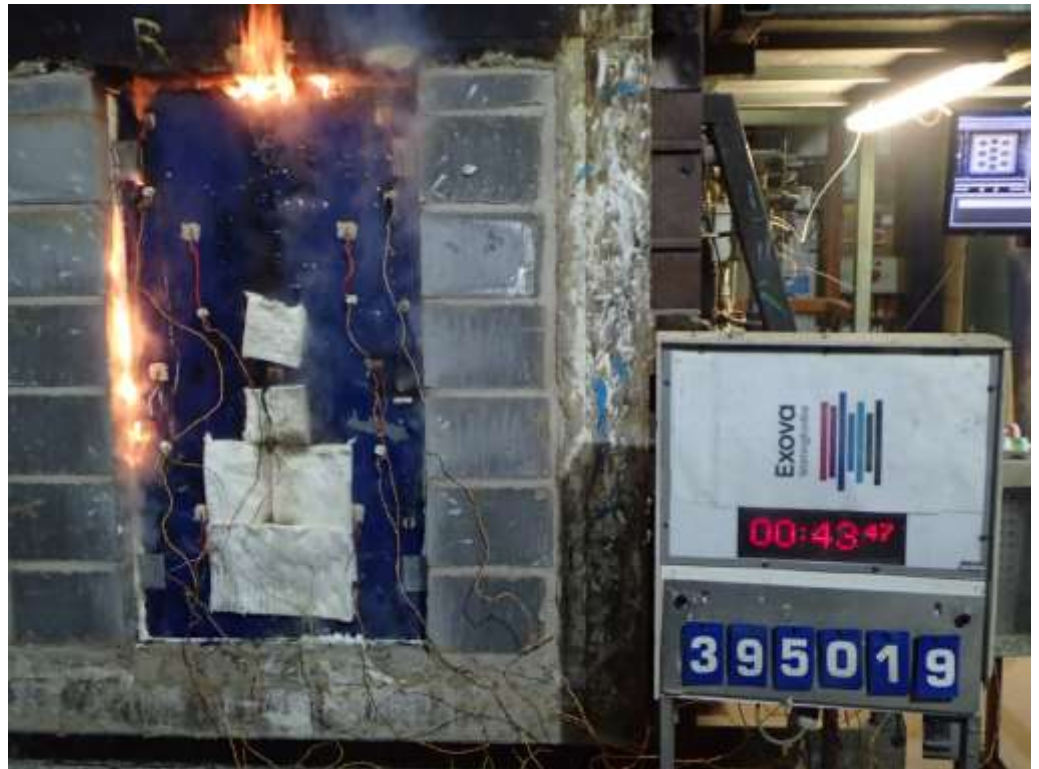
| 43 | 00 | Flames continue to issue from the hinge side as the bowing of the leaf continues. Sustained flames are now also issuing at the head |

The unexposed face of the doorset after a test duration of 43 minutes

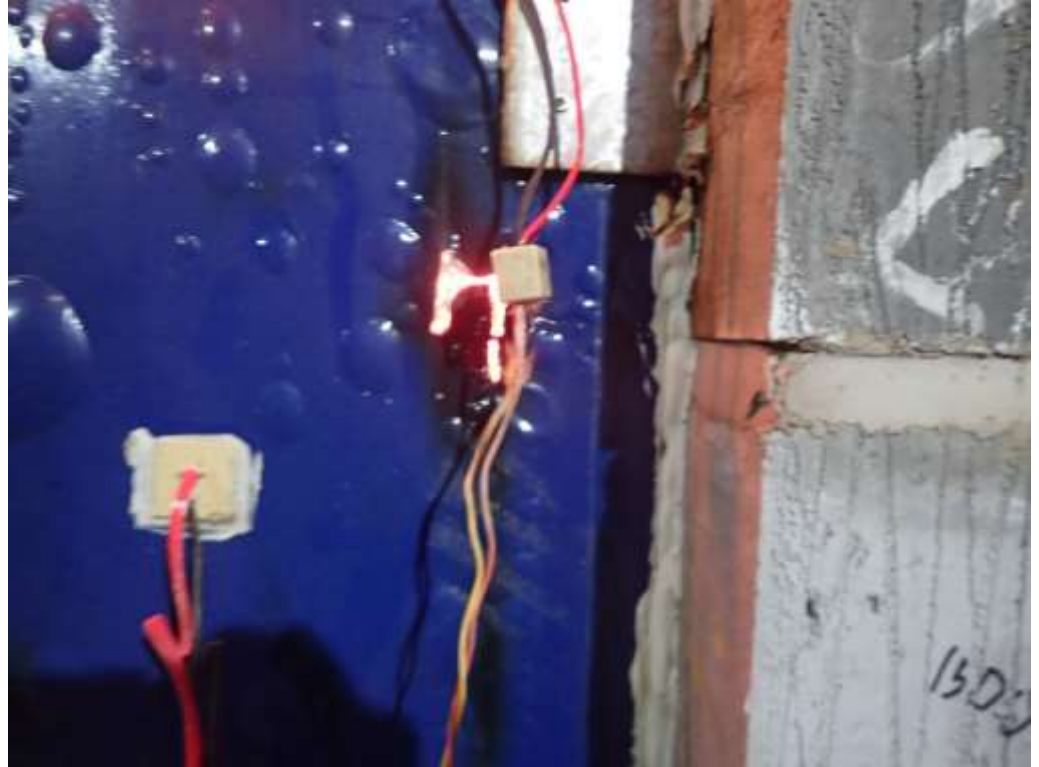
| 43 | 20 | Holes begin to form on the unexposed face of the leaf and begin to form small sustained flames. |

Holes beginning to form on the unexposed face of the doorset after a test duration of 43 minutes
