### 8. THE MONUMENT CONSERVATION MANAGEMENT PLAN - APPENDICES

THE MONUMENT TO THE GREAT FIRE OF LONDON

VOLUME I: CONSERVATION PLAN

MARCH 2025

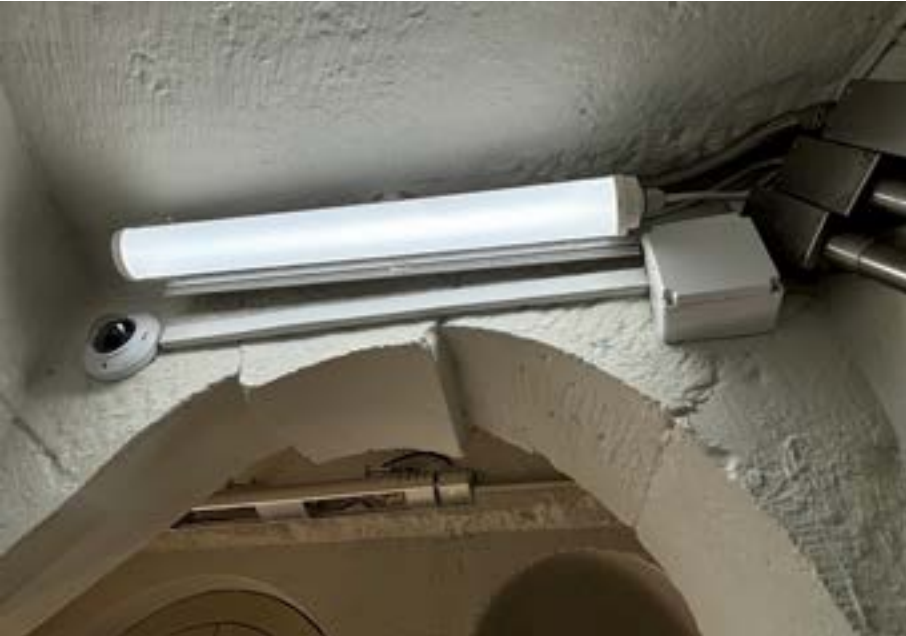
Lighting: Wall Light located at the base of the Spiral Stair		
CCTV Cameras	NEUTRAL: CCTV camera DETRIMENTAL: Plastic junction boxes & plastic conduit	Both cameras are fairly unobtrusive, but conduits and junction boxes serving them are white plastic, whereas all other designed junction boxes & conduit are stainless steel.
Electrical Services in Attendants' Recess	DETRACTS	The extent of electrical services has outgrown the small cupboard designed in 2007 to accommodate them.

Fig. 98 Attendants recess strip light, CCTV plastic junction box & plastic conduit, 2024

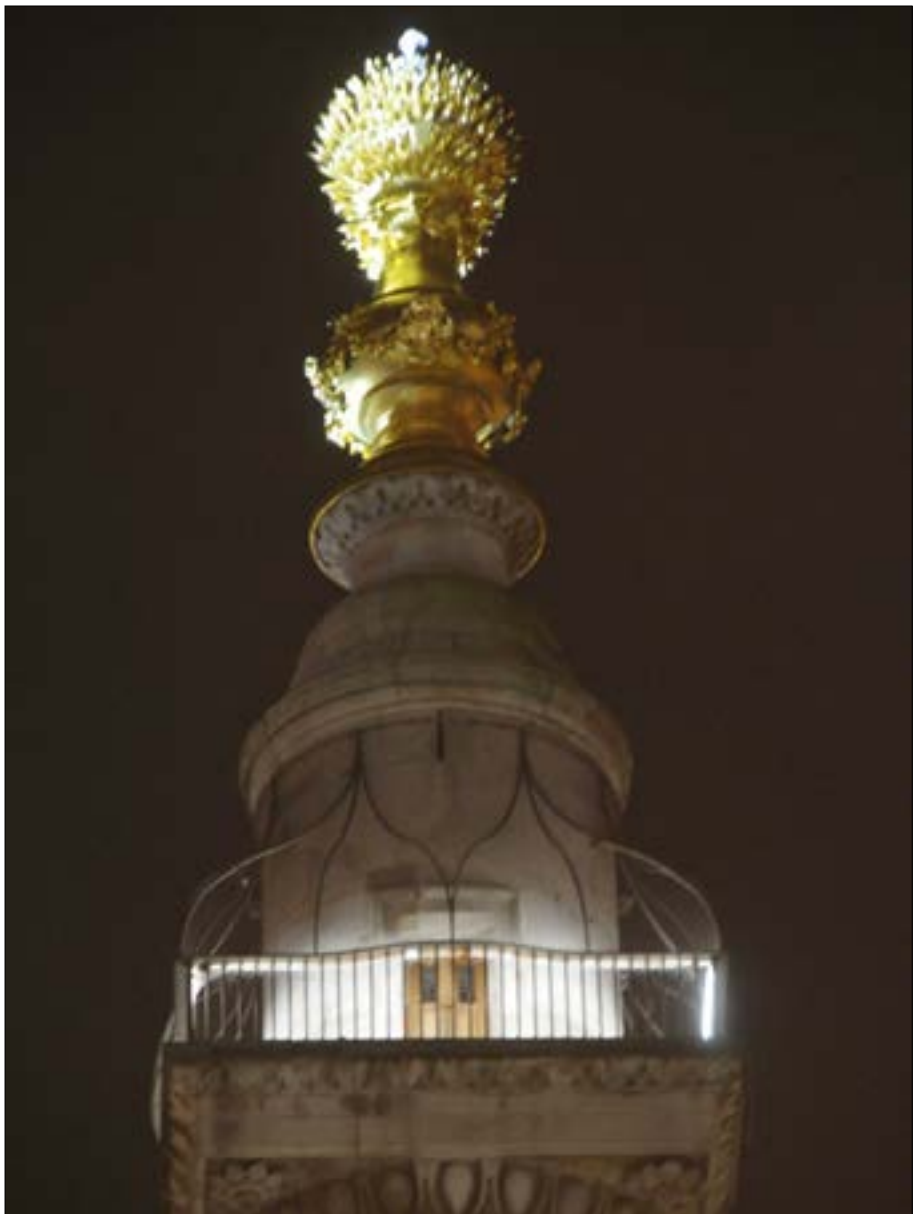
Fig. 3 Night photo balustrade glare, 2018

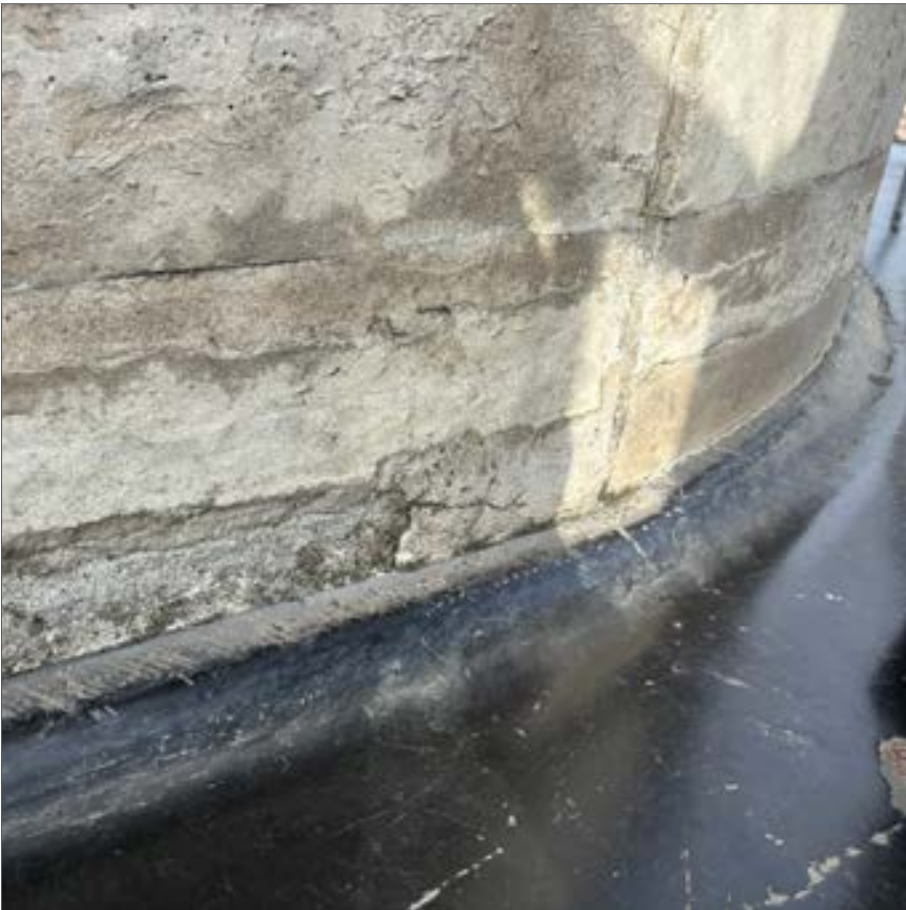
Fig. 9 & 10 Wide joint at the base of the Drum, 2024

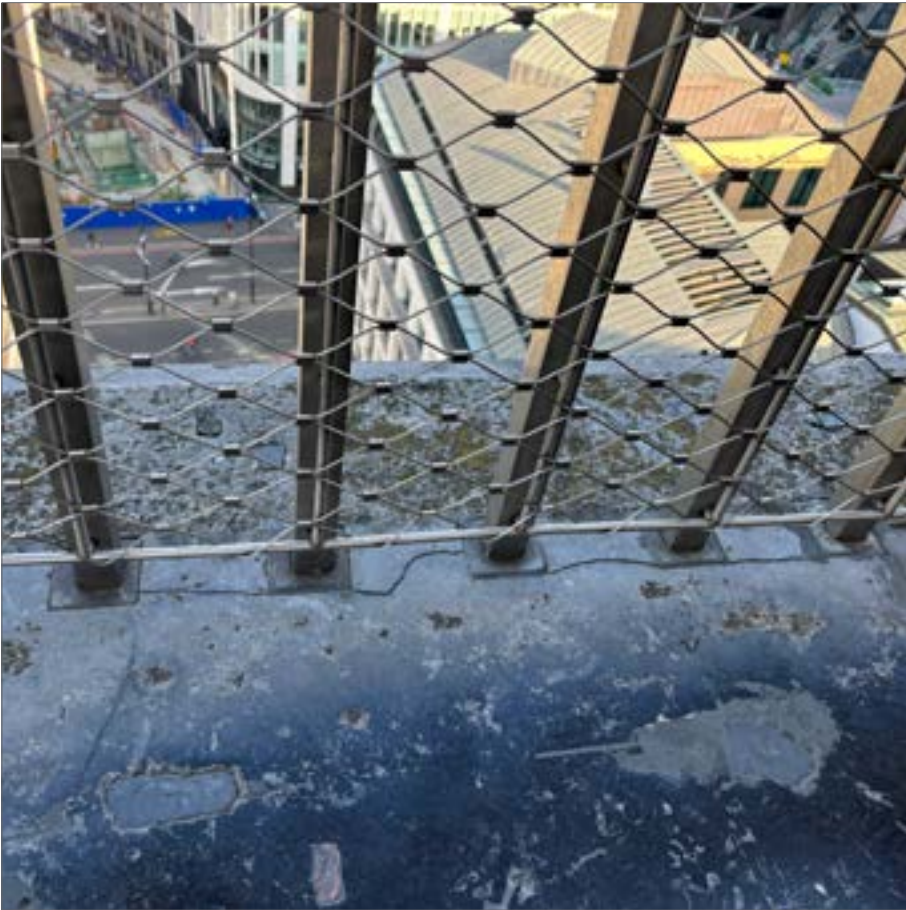
5.2B EXTERIOR STONEWORK: VIEWING PLATFORM OR ABACUS				
DESCRIPTION	CONDITION	RECOMMENDATION	PRIORITY	COSTS
<p>The Viewing Platform is constructed from particularly large slabs of black limestone. Archaeological remains of earlier balustrades and support posts remain set into the stone.</p>	<p>The black limestone platform: Grey resin repairs undertaken in the 2007-2009 contract are well adhered to the stonework but the finish appears duller and dirtier than at the end of the 2007-2009 contract, which makes the repairs more visible against the shiny stonework. Condition of stone platform as Structural Engineer's Condition Survey report, which notes significant cracking observed along the railing line, particularly to the west and east sides. These cracks had not been noted on previous inspections and did not form part of the previous set of monitoring. This would suggest that whilst they may have been present, they would have been less severe. It is therefore assumed that the cracking has worsened since the last set of structural inspections.</p>	<p>i) As structural engineer's condition survey Detailed inspections of the cracking around the base of the railings; the position of the cracks makes stud monitoring difficult due to the proximity to the railings. Repair and stabilisation scheme to be developed once the causes are better understood.</p>	<b>WITHIN 6 MONTHS</b>	See St.Eng. Fees

Fig. 12 Crack line along the base of balusters, 2024

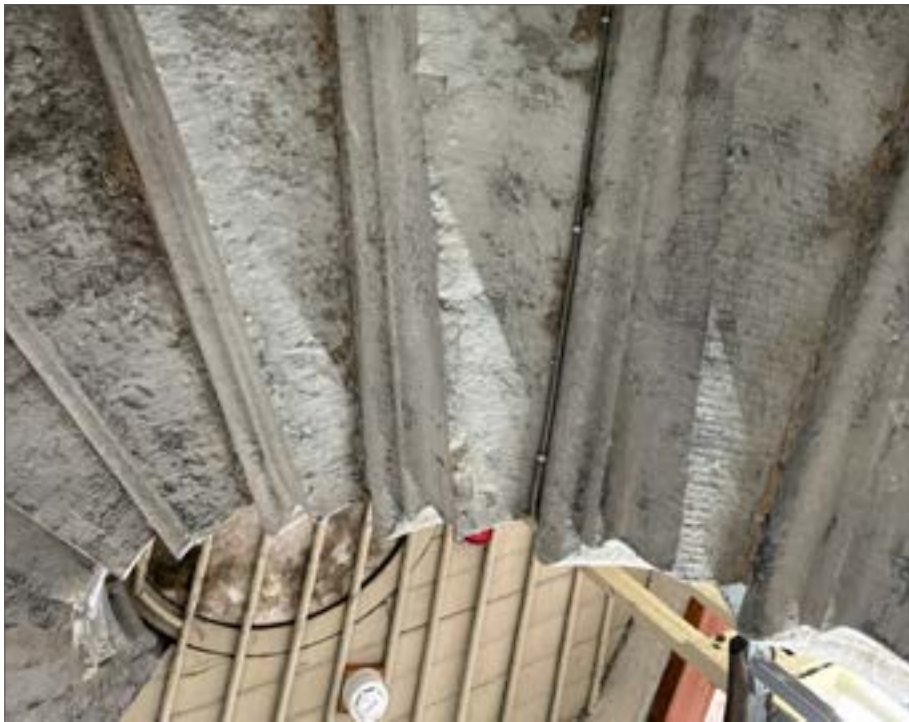
Fig. 35 Stair soffit showing local damage (next to emergency light), 2024

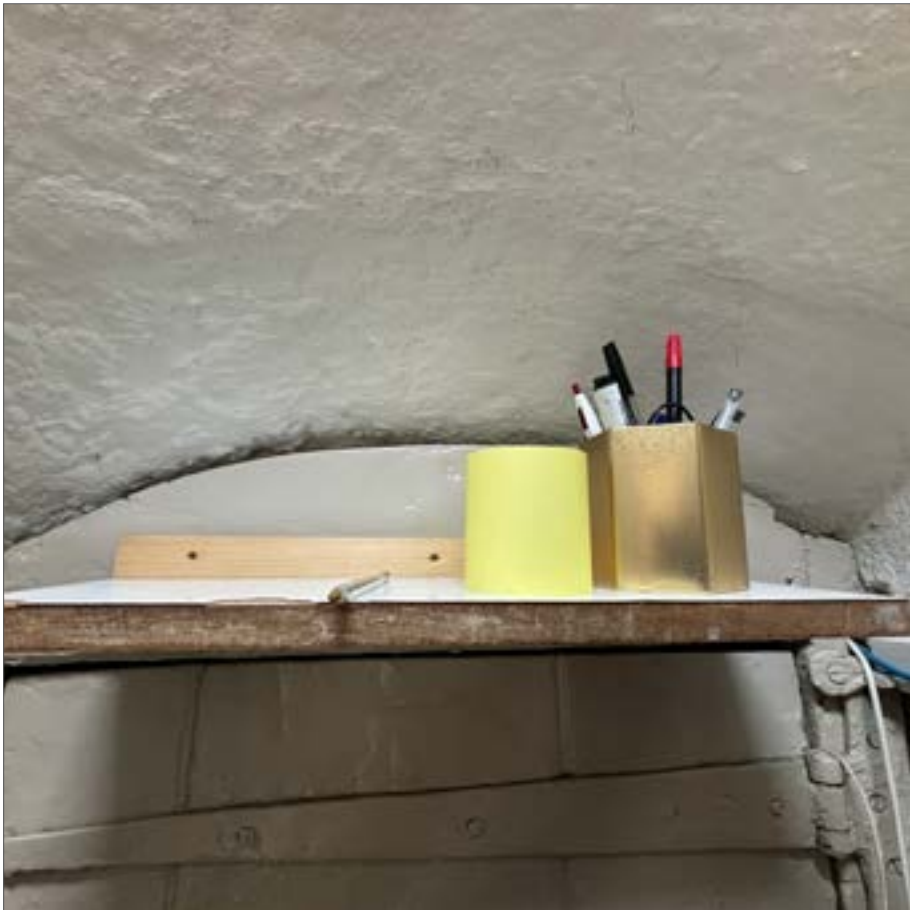
Fig. 63 Recent chipboard shelf, 2024

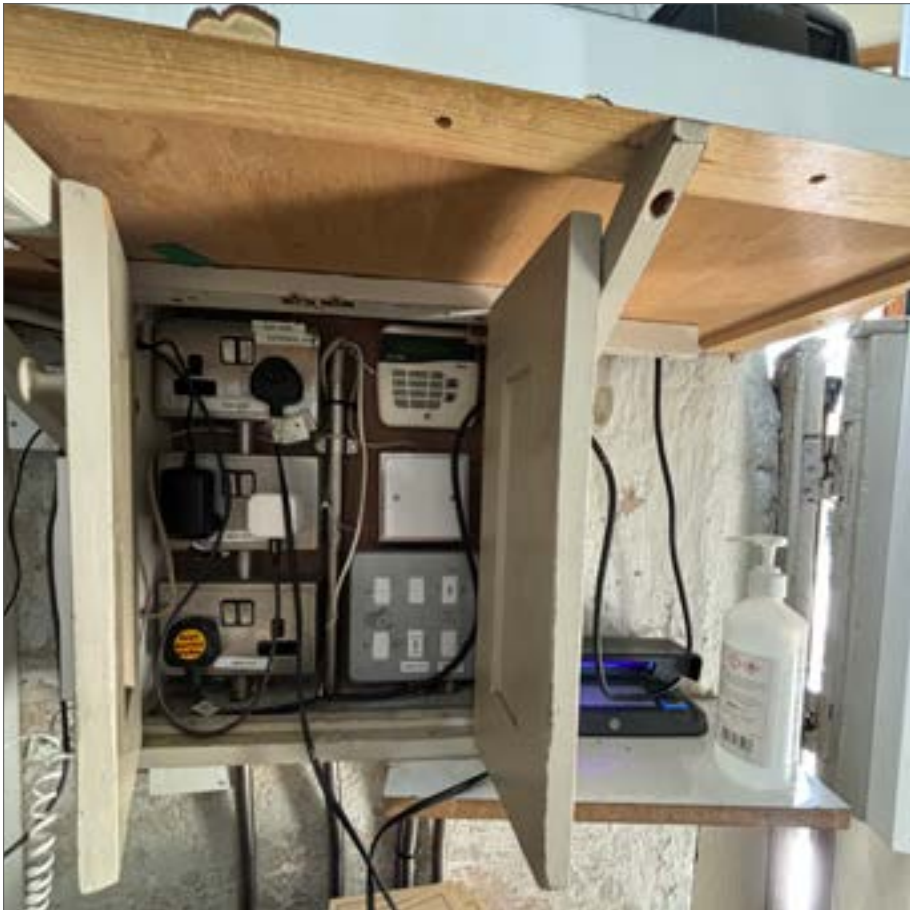
Fig. 65 The electrics' cupboard c.2009 can no longer contain all electrical services, 2024

Fig. 66 Inside the electrics' cupboard, 2024

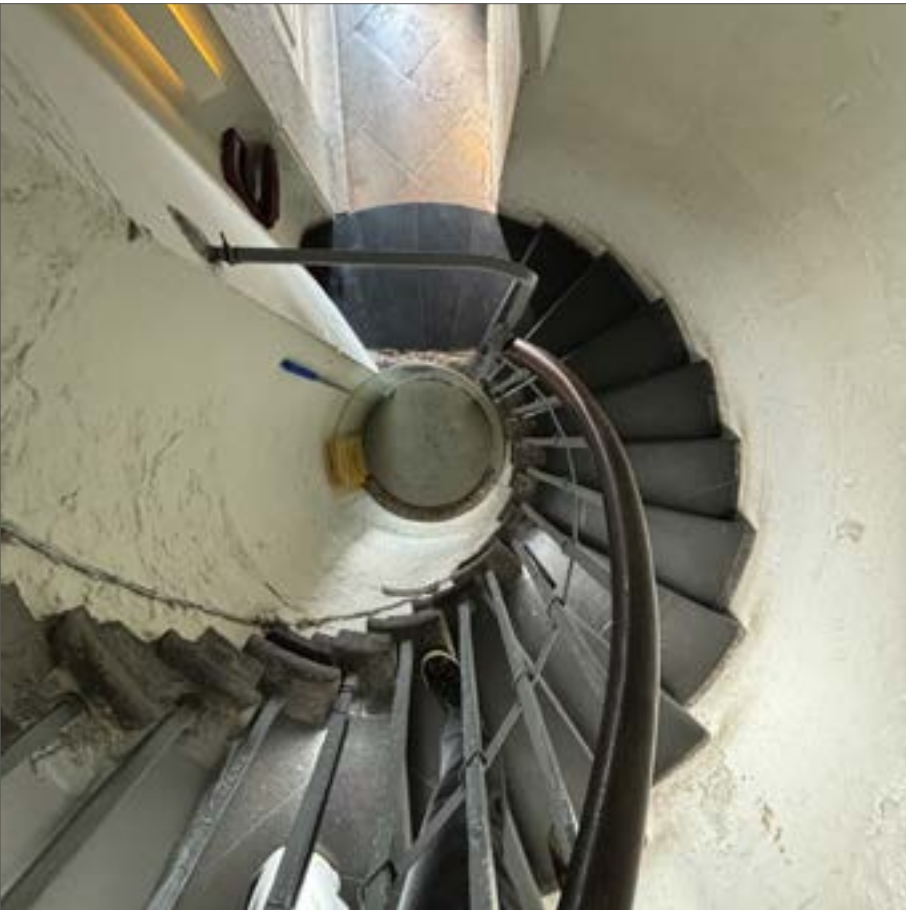
Fig. 74 Looking down the spiral staircase, mop and yellow sign stored in public view, 2024

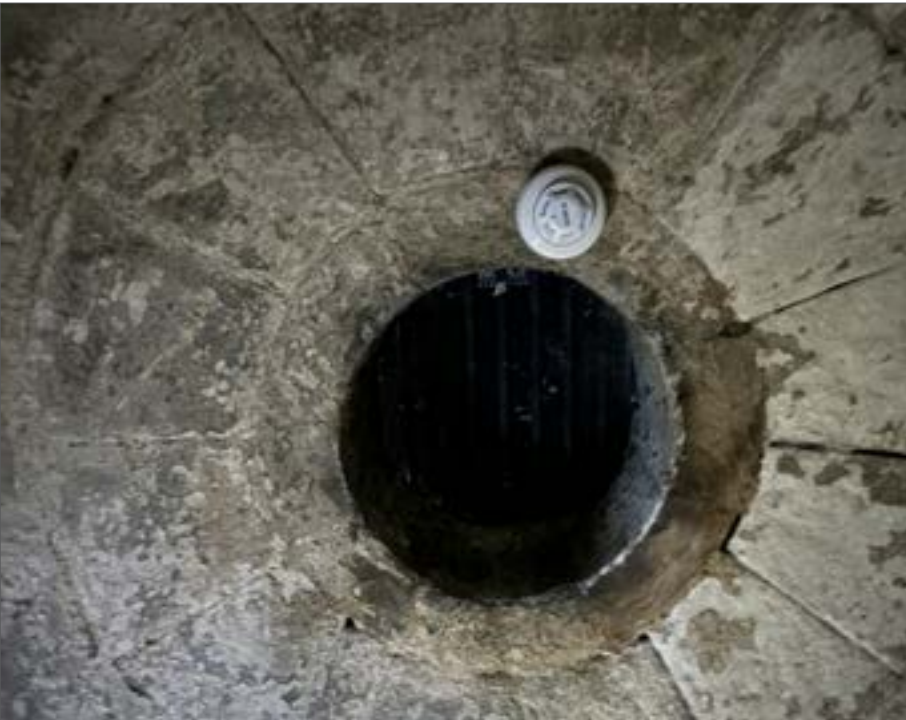
Fig. 81 Blocked-up oculus opening at the apex of the basement vaulted soffit, 2024

ii) Sweep all floors and ledges.	A	Incl. Staff Budget
		iii) Computer & electrical equipment in connection with former temporary panoramic camera system (now disused), to be removed together with all the associated equipment and cabling in the Monument.	C	£1,600
		iv) Re. the steel angle fixed across the circular basement just above floor level used for verticality testing of the Monument, it is important that this steel bar is not damaged in any way.	NOTE	-

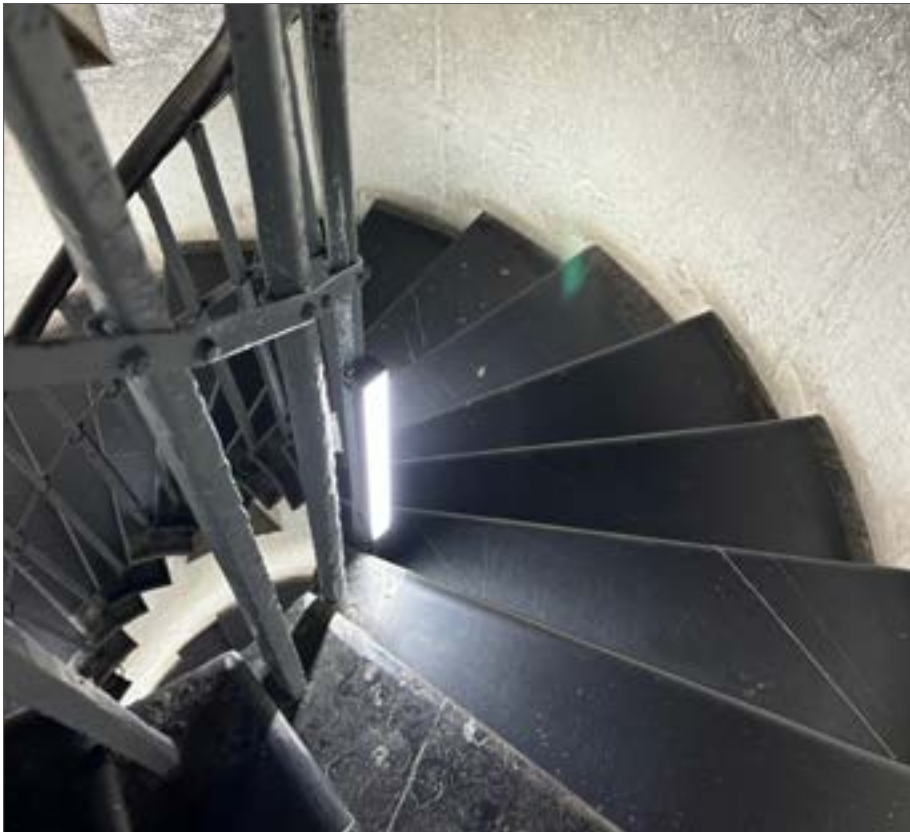
At the 2024 inspection, it was noted that all the 2009 baluster light fittings have been replaced except for those above viewing platform level, where the original bespoke light fittings remain.

Fig. 98 2024 glare

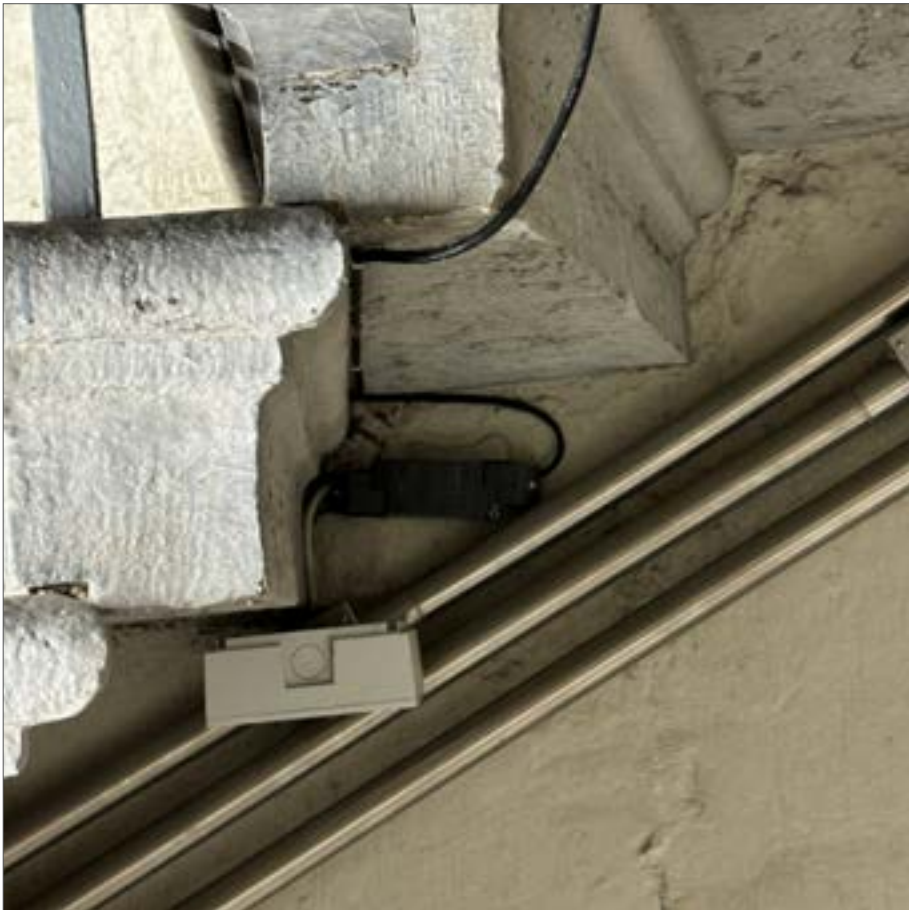
Fig. 99 Black cabling connecting a transformer to the replacement baluster lights, 2024

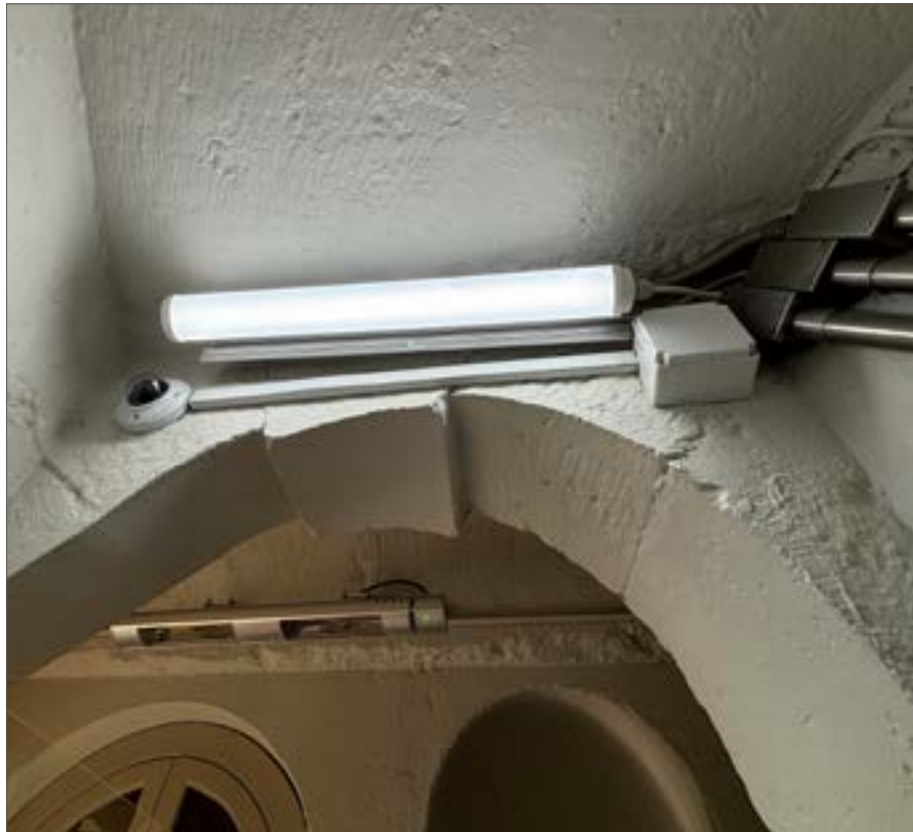
Fig. 104 Replacement light fitting, plastic conduit and junction box, 2024

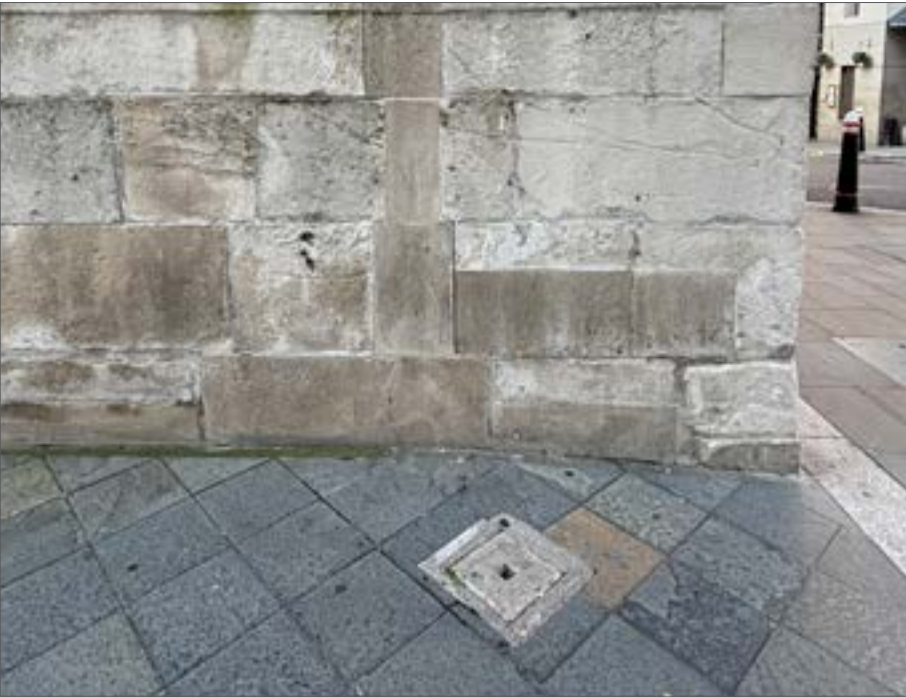
Fig. 108 North elevation down conductor, partly concealed, and test pit, 2024

DESCRIPTION	CONDITION	RECOMMENDATION	PRIORITY	COSTS
<p>Date of installation: 2009.</p> <p>Lightning protection down-conductors are UPVC coated copper tape and upvc copper rod, with the appropriate high-quality fixings, which connect the copper flaming orb, the stainless-steel cage and the internal wrought iron balustrade to the ground earthing points.</p> <p>Conducting tapes are connected at high level to the inside of the copper urn, iron ladder and iron support cradle. From here, two tapes to go out to the exterior of the column and connect to the top of the 2008 viewing platform cage on east and west elevations. The stainless steel of the balustrade and cage is part of the conductor system. Conductor tape is connected to the bottom of the cage railings, on the east and west elevations; it goes down to the top of the shaft of the column, to the base, from where the tapes go horizontally: 1 no. to the north elevation and 1 no. to the east elevation, then down the plinth to the 2no. earthing points. The east down conductor is labelled: ‘System maintained by Omega Red Group Ltd 0871 540 666’</p>	<p>Visual inspection: the lightning conductors look to be secure and in good condition.</p> <p>The lightning protection system was inspected and tested by Omega Red Group Ltd on 20.06.2024, who reported the following: The lightning protection system for this structure has been inspected in accordance with BS 6651:1999. The structure has a system designed in accordance with the requirements of BS 6651:1999, or an earlier British standard. The lightning protection system for this structure does not comply with the standard to which it has been inspected (see statement above). Please contact us if you require further explanation. The lightning protection system has an overall resistance value to earth of 8.42 ohms. The lightning protection system requires repair works to bring it into a serviceable condition. Please refer to the attached quotation. The lightning protection system will not comply with the standard to which it has been inspected if the identified repair works are completed. However, it will be returned to a serviceable state of repair.</p>	<p>i) Undertake repair work as quotation provided to CoL by Omega Red Ltd</p> <p>(Quotation for repair work not provided to JHA)</p>	<p>A</p>	<p>Client to Provide Quote</p>

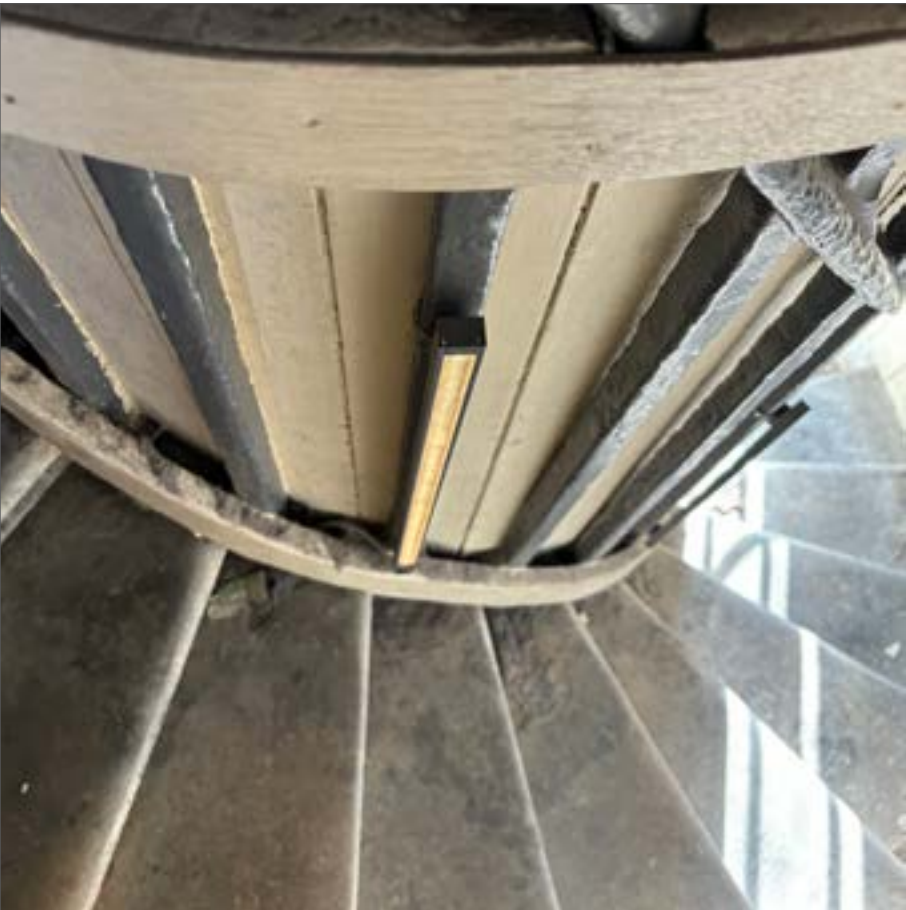
Fig. 111 Dust build-up in flame area, 2024

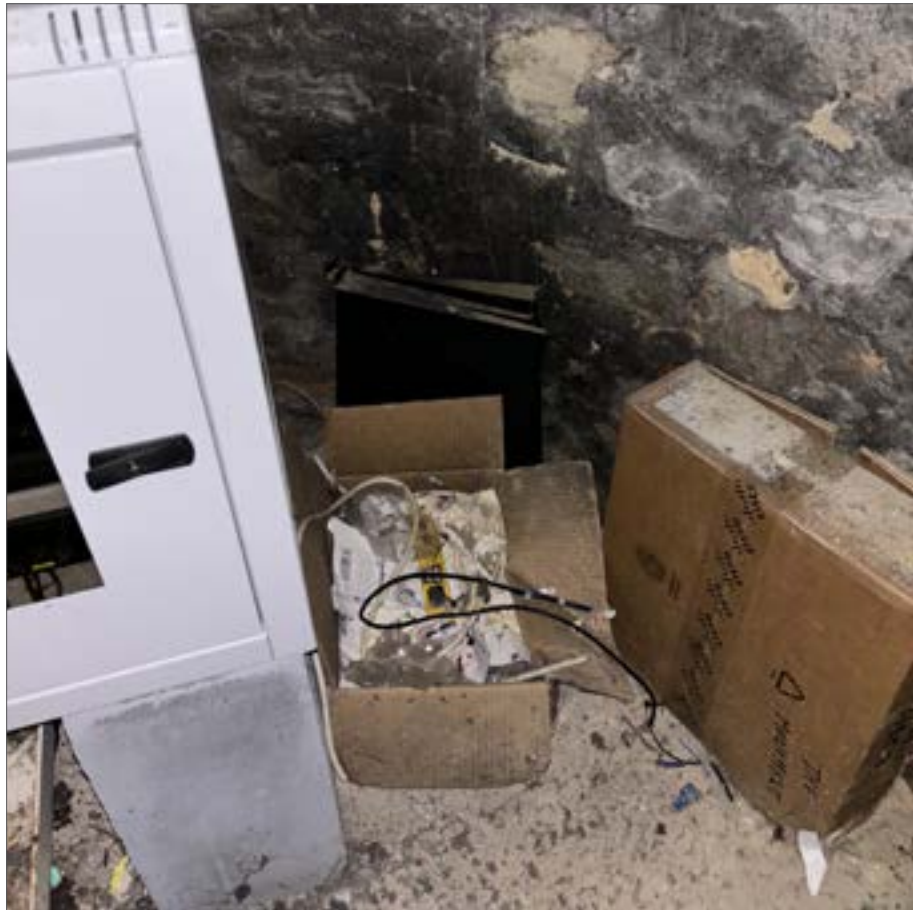
Fig. 113 Rubbish? & cardboard boxes in cellar, 2024
