Barbican Residential Committee

Date: FRIDAY, 17 JUNE 2022
Time: 1.45 pm
Venue: COMMITTEE ROOMS, 2ND FLOOR, WEST WING, GUILDHALL

Barbican Estate
Barbican Residential Blocks
Andrewes House - Fire Strategy
Report

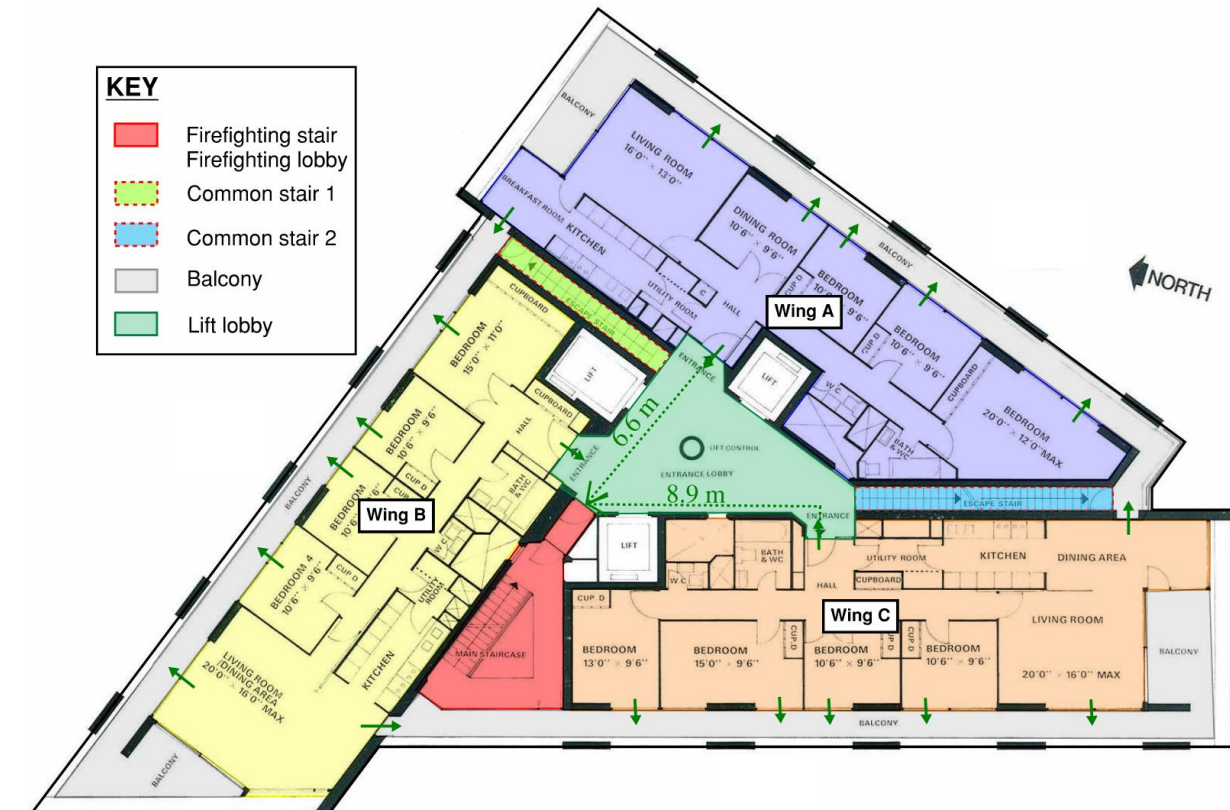
Figure 6: Travel distance in the unvented lift lobby to the firefighting stair

As shown in the travel distance within the unventilated lobby is greater than 7.5 m and exceeds the recommended travel distance.

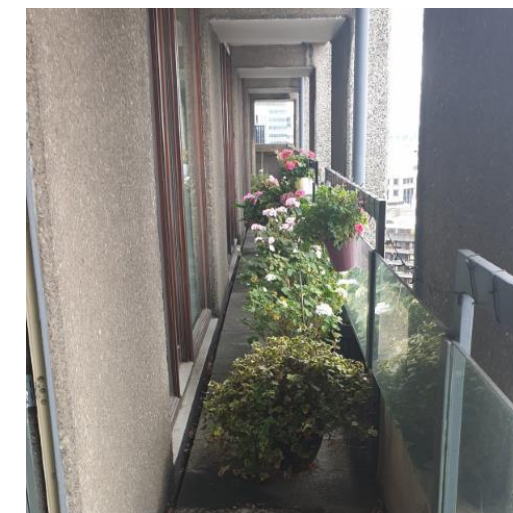
Figure 7: Furniture along the balcony

The width of the balconies is 830 mm. It was identified during the site visit, that furniture is located along the balcony in certain levels of the tower as shown in . These should be removed so that the escape route remains unobstructed.

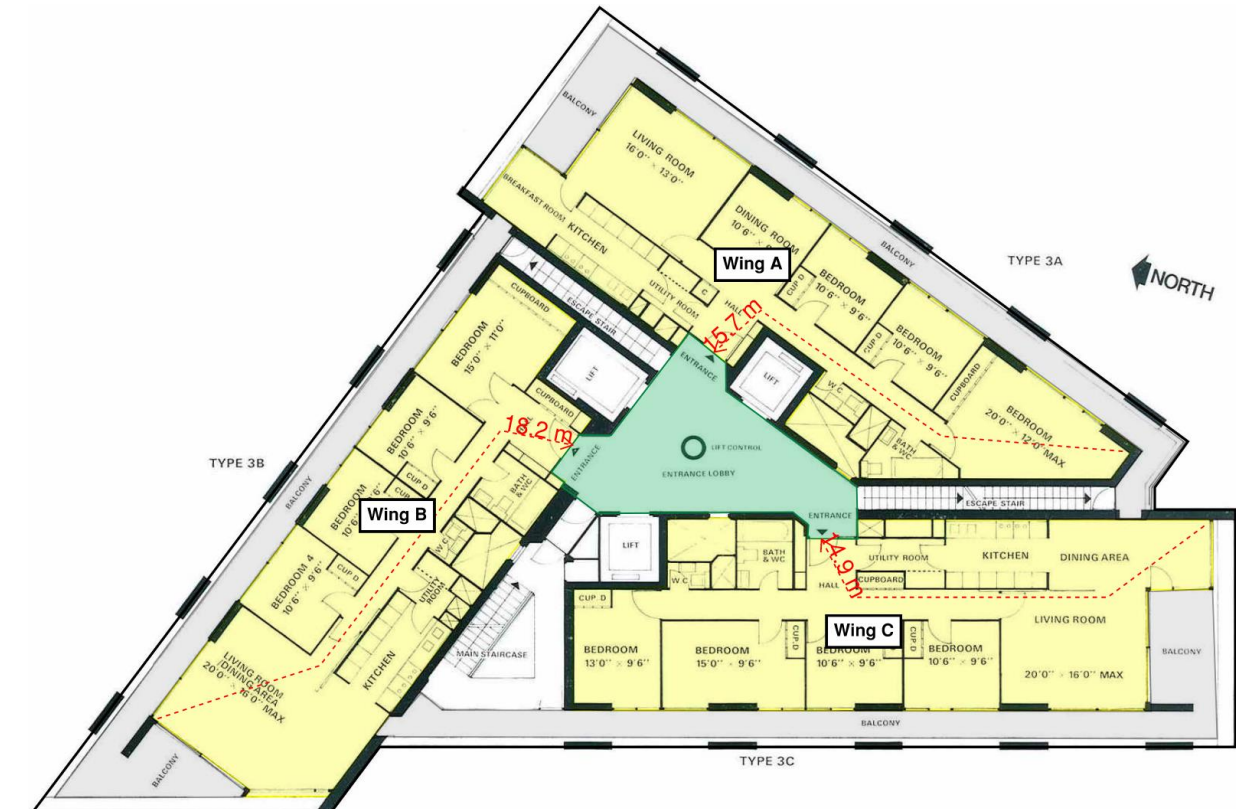
Figure 11: Extended travel distance for single means of escape for PRMs

As there is only a single means of escape for PRMs, the travel distances within the flat should be limited to 9 m from the furthest point in the flat. As the flats do not have a common internal corridor serving all rooms, the current travel distance within the flats to the entrance door ranges between 14.9 m to 18.2 m which exceeds the recommendations of BS 999, as shown in Figure 11 below.

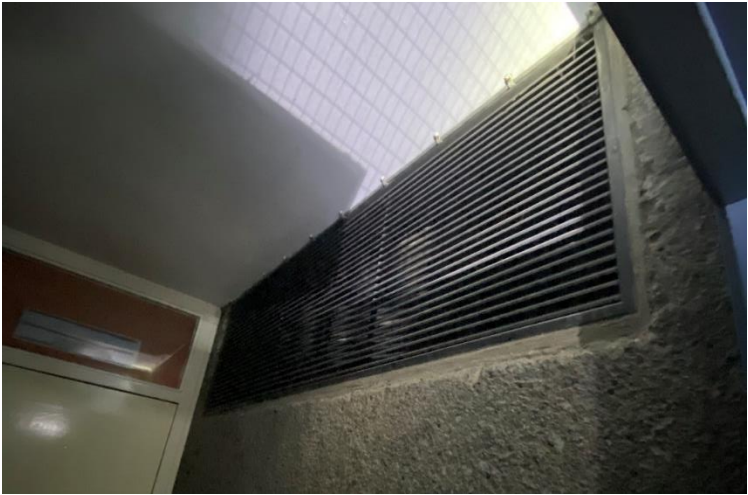
Figure 12: Louvre connecting the small lobby and the electrical riser

- Electrical riser: There is a concrete floor on each level of the riser from L37 and below. Fire stopping around cables penetrating the concrete floor appear to be missing. Above L37, the electrical riser is connected to the ventilation shaft, which is opened to the small lobby.

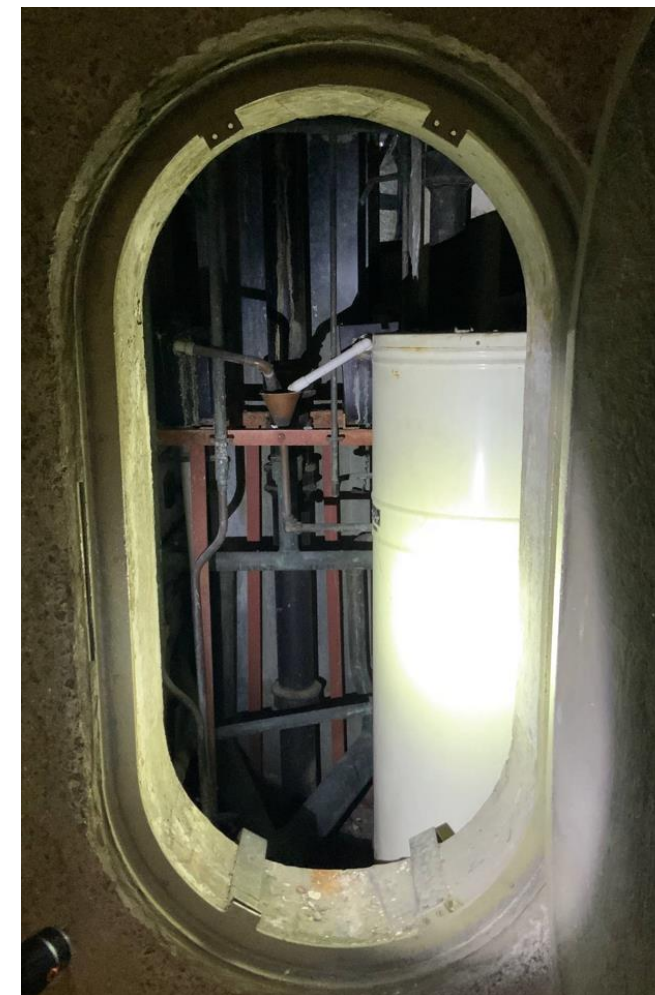
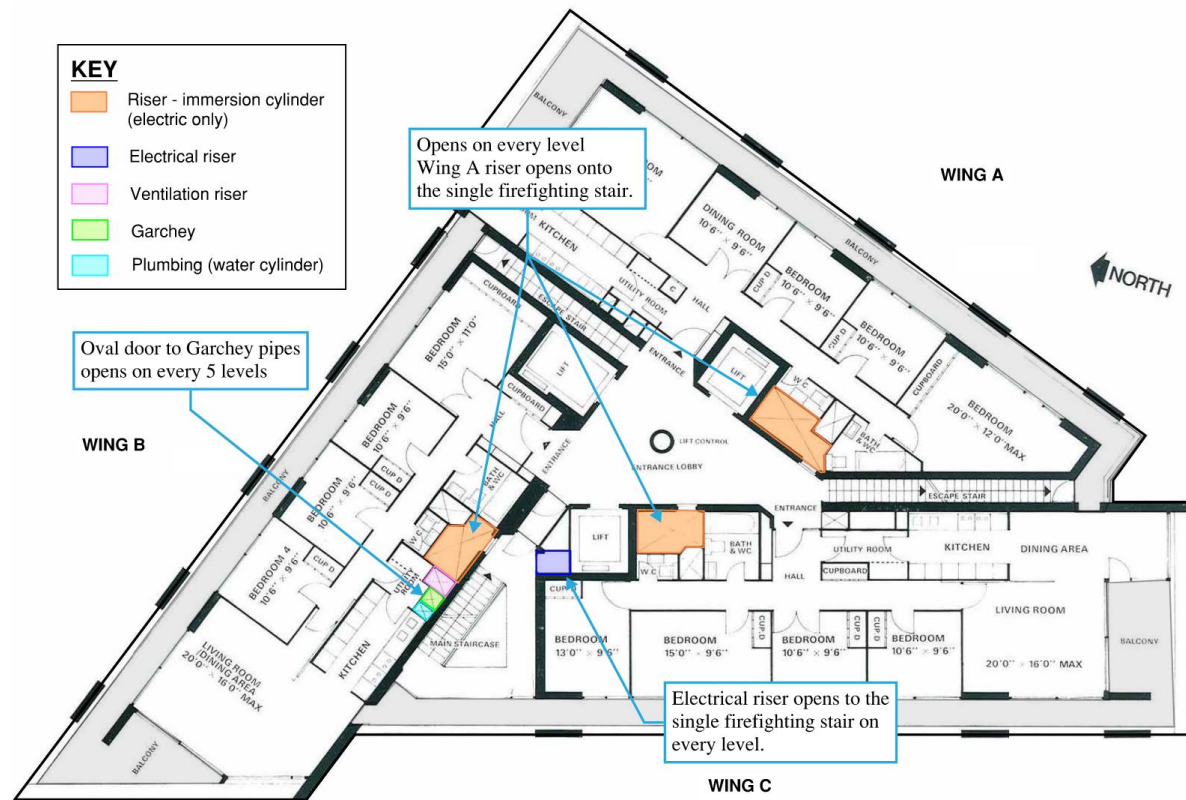
Figure 15: Risers within the lift lobbies

Figure 16: Risers opening onto the firefighting stair and lift lobby

As Cromwell tower is provided with a single stair, it is recommended to ensure adequate compartmentation is provided to the stair. This is to ensure occupants can evacuate via the stair as well as fire service to use the stairs to enter the building.

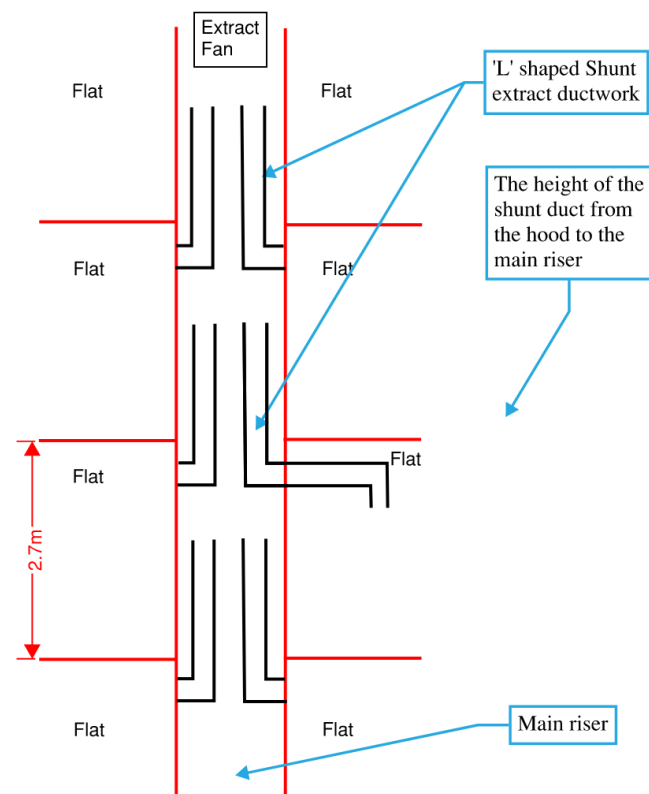
Figure 18: Existing layout of shunt duct system in Cromwell Tower

In the Barbican Residential Development, it is understood that a common approach to maintain fire separation between flats is to use shunt duct arrangement for the kitchen and toilet extract ventilation ducts. The purpose of shunt duct is to avoid the need for fire protection using the Methods described above. A shunt duct arrangement comprises of branch ductwork ('s' or inverted 's' shaped) that are connected to the main extract ductwork as shown as Figure 17. In addition to the downward bend of the shunt duct, a fan at the top of the main extract ductwork maintains a negative pressure that stops smoke from spreading out of the ductwork.

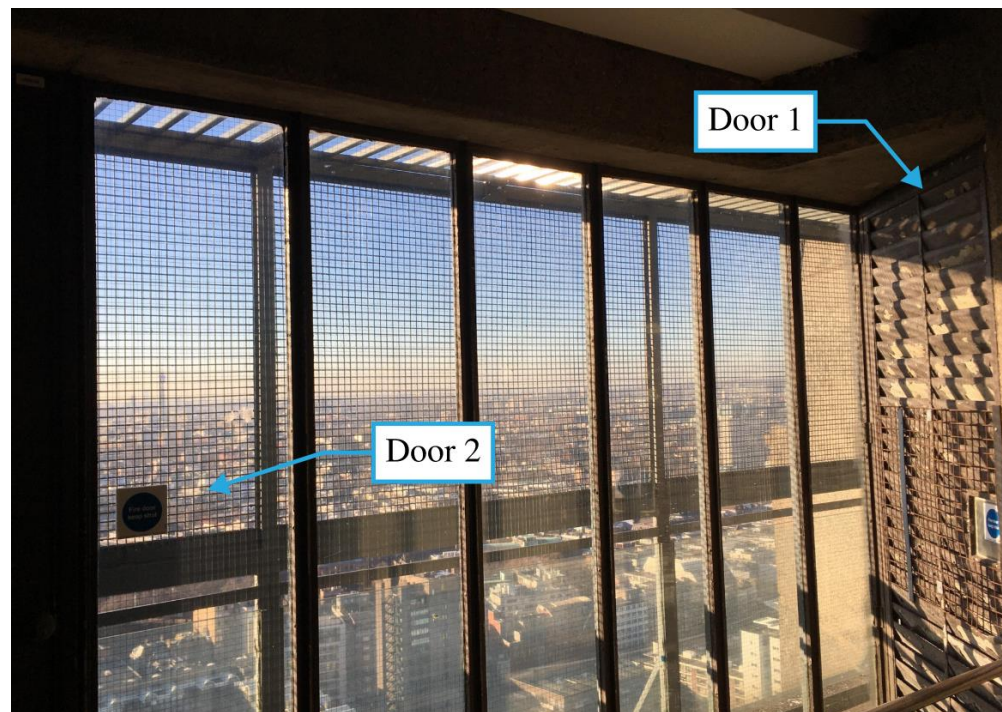
Figure 24: Louvred door at the top of the firefighting stair on L39

The firefighting stair has two louvred doors (approximate total area of louvres are 3.52 m²) on L39 as indicated as Door 1 and Door 2 in Figure 24. It was not possible to determine the free area of the louvre from visual inspection. The firefighting stair leads to an open helical stair to the Roof level.

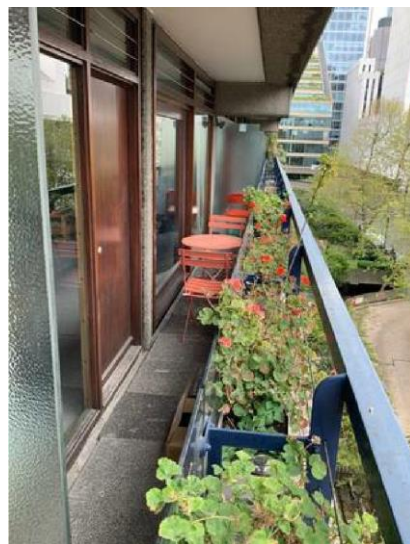
Figure 5: Furniture along the South balcony

In addition to the above, it was identified during the site visit, that furniture is located along the South balcony as shown in Figure 5 below. These should be removed so that the escape route remains unobstructed.

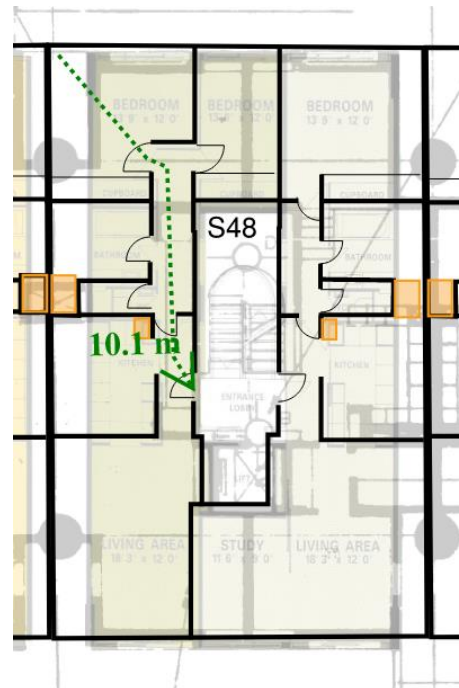
Figure 11: Extended travel distance for single means of escape for PRMs

The current travel distance within the flat to the entrance door is approximately 10.1 m which exceeds the recommendations of BS 9991 (maximum travel distance of 9 m for single means of escape within flats), as shown in Figure 11 below.

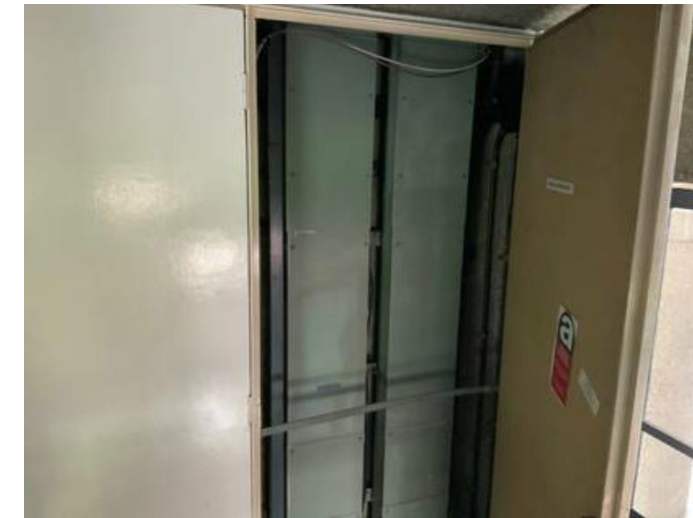
Figure 15: Service shaft door within one of the common stairs

During the site visit, the doors to services risers within the stairs were not labelled fire doors and were not being maintained properly to provide separation between the riser and the stairs. Figure 15 shows one of the doors for service risers.

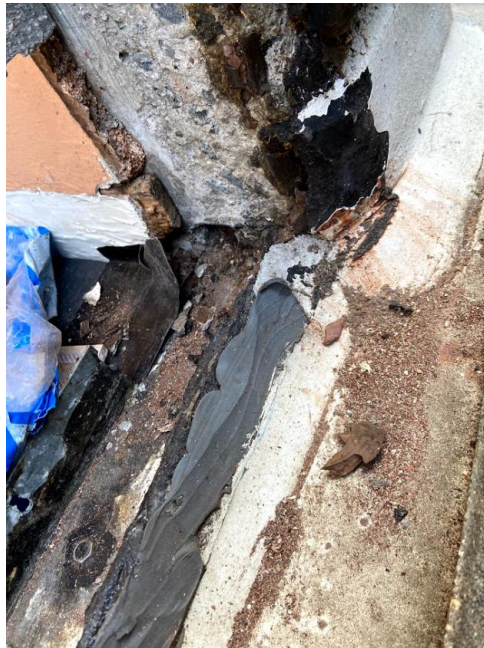
Figure 16: Aperture of a balcony door frame showing no cavity

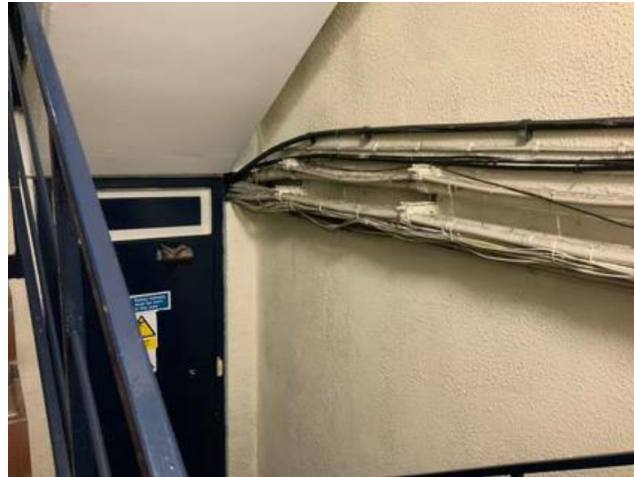
Figure 20: Service not related to firefighting shaft passing through the firefighting stair

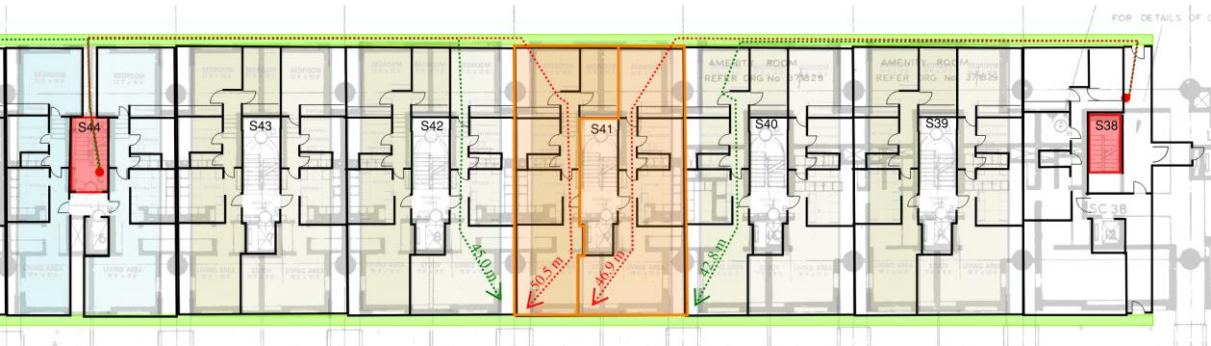
Figure 23: Hose coverage shortfall area shown in orange
