**Project: – Barbican Estate**  
**Non-Langley Roof Areas**

Barbican Estate  
City of London  
EC2Y

## Roof Survey Report & Recommendations

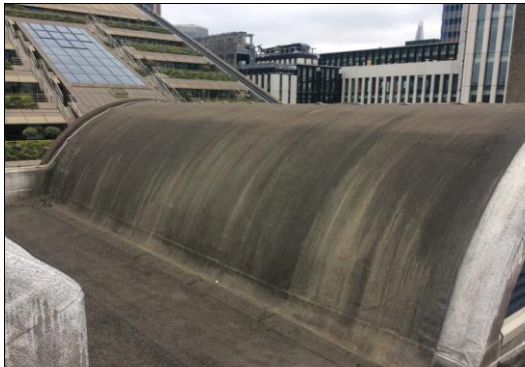
1.  
General condition of all barrel roofs that would benefit from being cleaned.

We recommend that drainage is be maintained and kept unblocked, all lightning strips are to be re-fixed were needed. All barrel roof areas could be prepared, primed and coated with 2 additional re-enforced layers of liquid offering a 20-year guarantee.

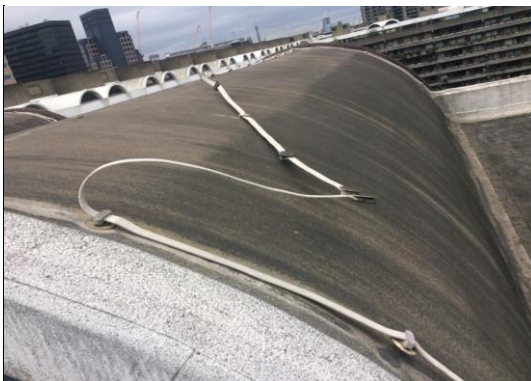
2.  
In many areas, lightning strips need to be re-fixed. This is evident on many of the Barrel roof areas.

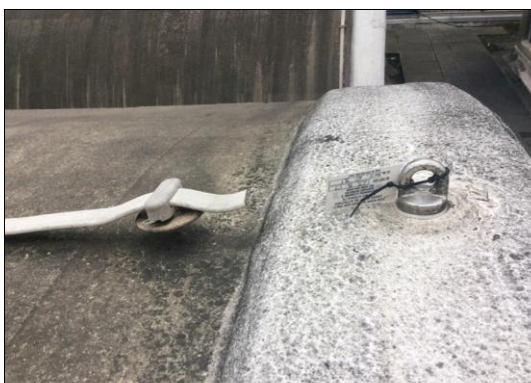
3.  
As above.

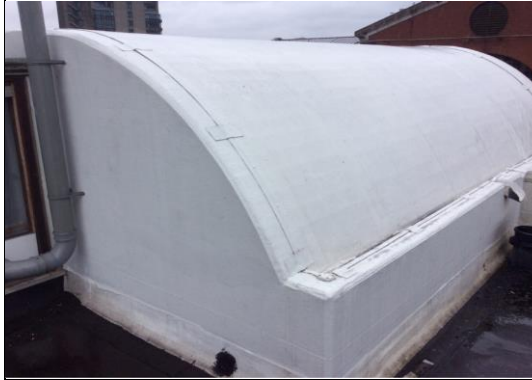
4.  
Barrel roof area that has been painted/coated.

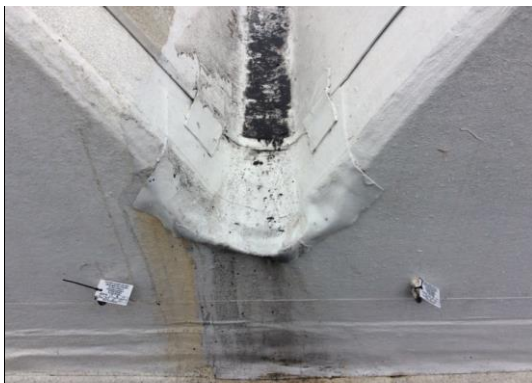
5.  
Close up of the existing lead and gutter that has been painted/coated.

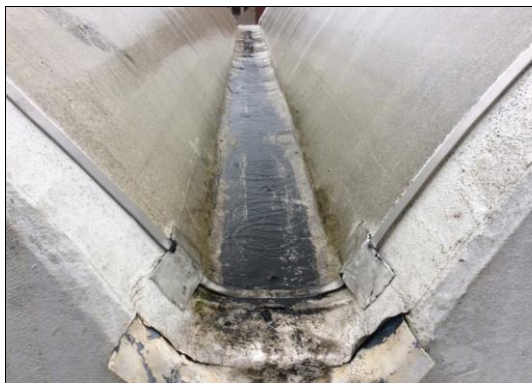
6.  
Barrel roof drainage needs to be maintained and unblocked in places.

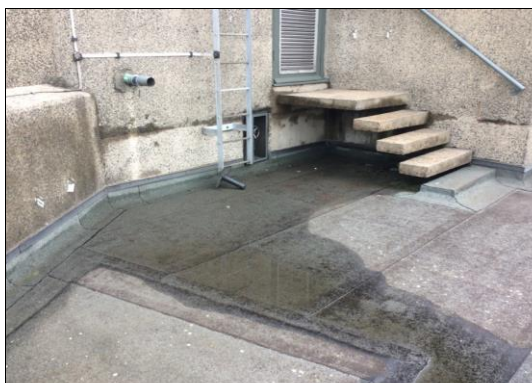
7.  
Main roof for Cromwell and Shakespeare Tower; BUR felt in average condition and no signs of repairs or failure.

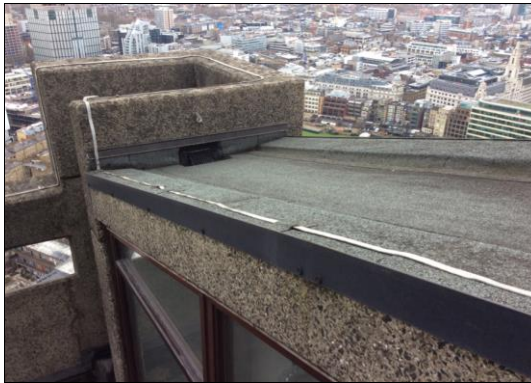
8. Overview of Cromwell and Shakespeare Tower link roofs that are in average condition.

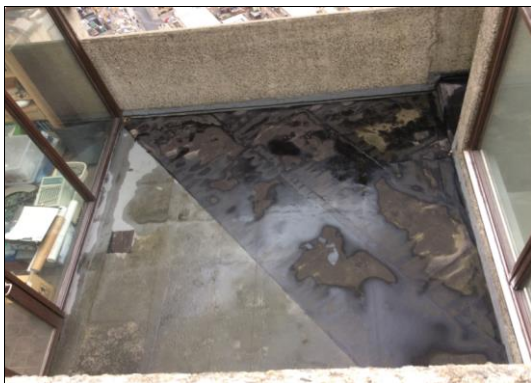
8. Cromwell Tower balcony roof  
Overview of Cromwell Tower balcony roof; in poor condition and has previous repairs.

The existing roof area has been repaired with various materials such as BUR felt and liquid in different areas indicating previous water ingress issues; in places the repairs have started to fail becoming ruckled, blistered and worn. The existing asphalt has started to slump underneath the wooden door threshold.

We recommend that the repairs are to be stripped back and the existing asphalt is to be overlaid with 2 layers of bituminous elastomeric felt with counting flashing protection to the concrete upstand and door threshold.

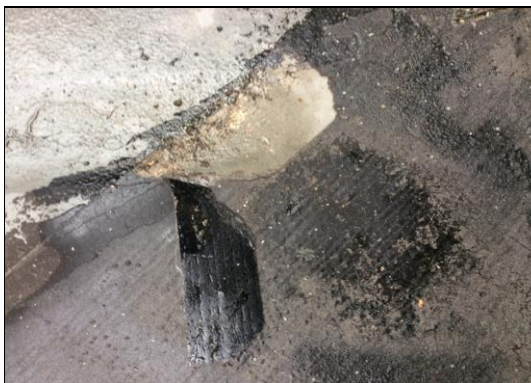
9. Cromwell Tower balcony roof  
Felt repair has started to fail leaving an aperture for potential water ingress.

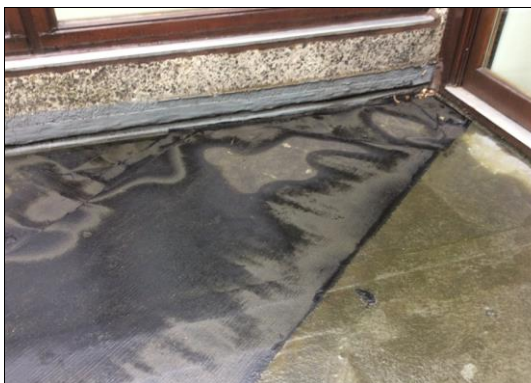
10. Cromwell Tower balcony roof  
Felt repair has become ruckled and blistered and liquid repairs have taken place to the concrete upstand.

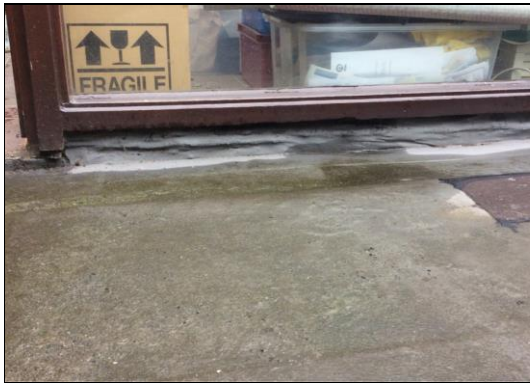
**11. Cromwell Tower balcony roof**

Existing asphalt underneath the door threshold has started to slump.

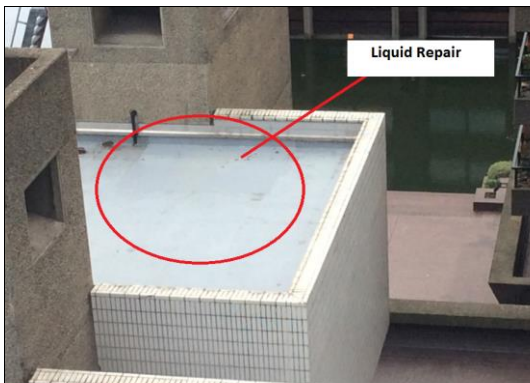
**13. Barbican Centre roof**

Liquid repair indicating previous water ingress issues.

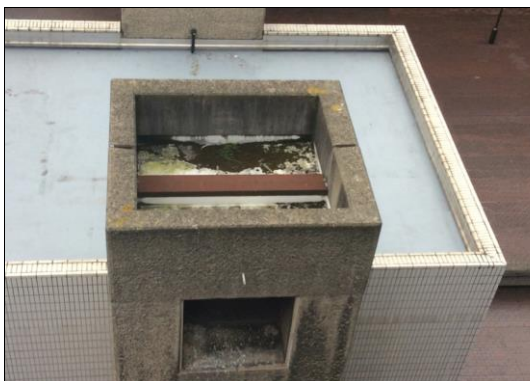
**14. Barbican Centre roof**

Vegetation growth on existing asphalt stairwell roof.

It is recommended that standard routine maintenance continue to include the clearing of all rainwater outlets, gutters and other drainage outlets, as well as removing any vegetation, loose debris and repair of any paving slabs as required.

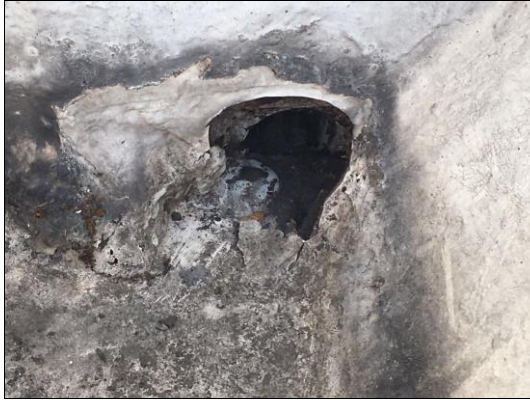
**15. Andrewes House Barrel Roof Areas**

Liquid has de-bonded from the concrete upstand with cracking also evident causing water ingress.

One valley of the existing barrel roof area is leaking with reported water ingress from failed 2 no. scupper outlets through an expansion joint and down to the bottom of the building. The existing liquid waterproofing has de-bonded from the concrete upstand causing repeated leaking, with cracking of the existing liquid waterproofing also evident around both the failing scupper outlets with the metal guards currently loose and unfixd. This area will need to be repaired with a reinforced liquid system, and may require some substrate repairs also. Please note that a repair only would not carry any guarantee, and consideration should be made to upgrade the complete roofing area, depending on guarantee period remaining.

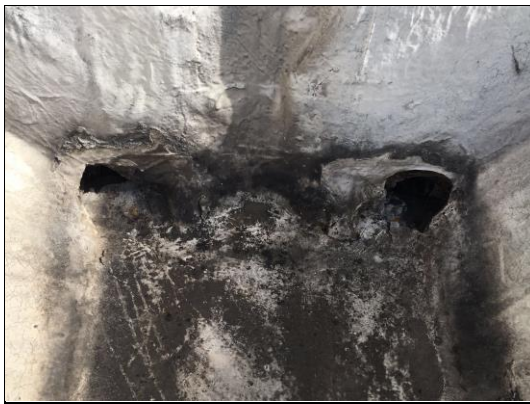
**16.**

As Above.

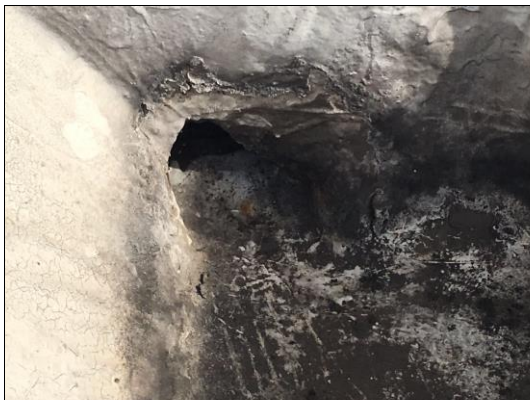
**17.**

As Above.
