**Review report on Concrete Testing  
Shakespeare, Cromwell & Lauderdale Towers  
The Barbican, London**

**16 March 2012**

**Prepared for: City of London Corporation**

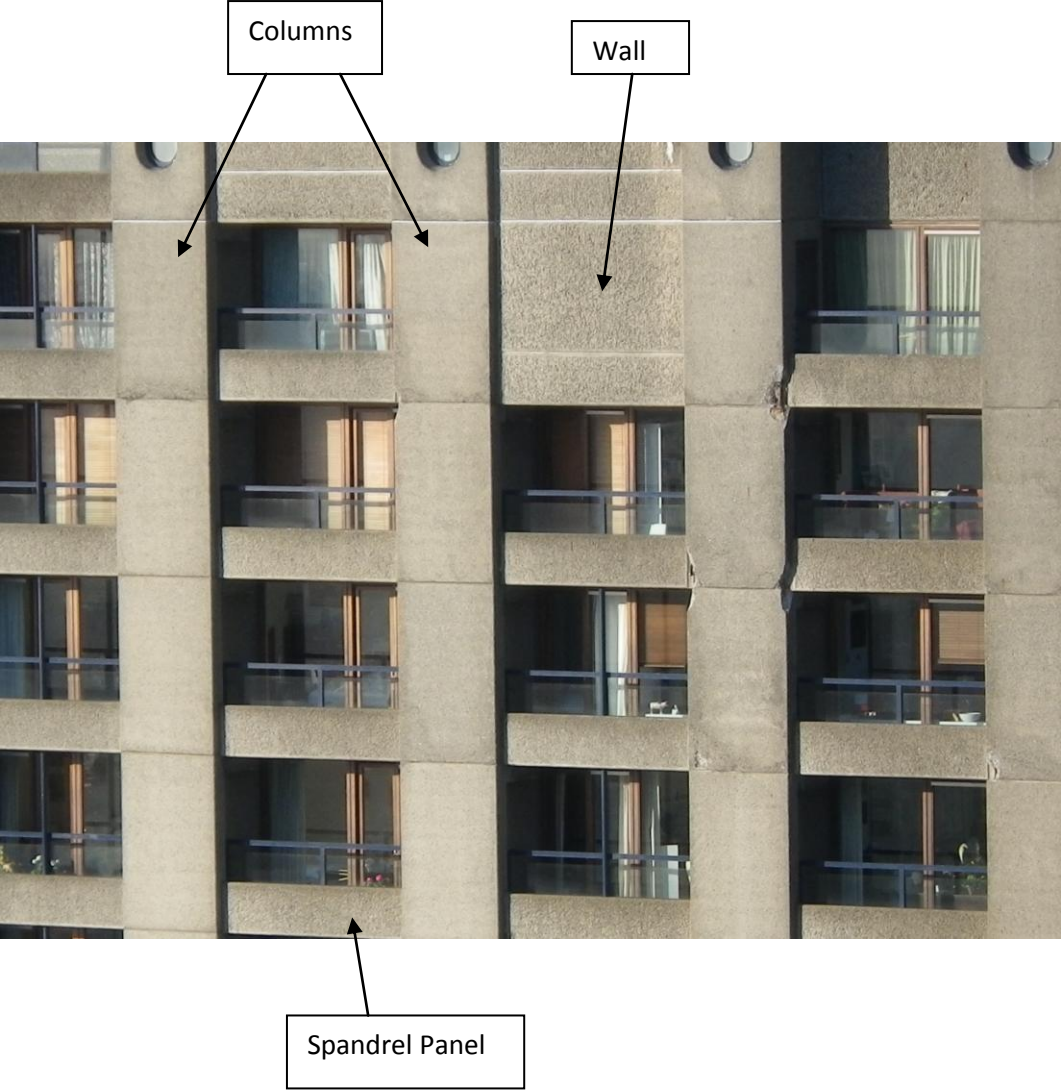
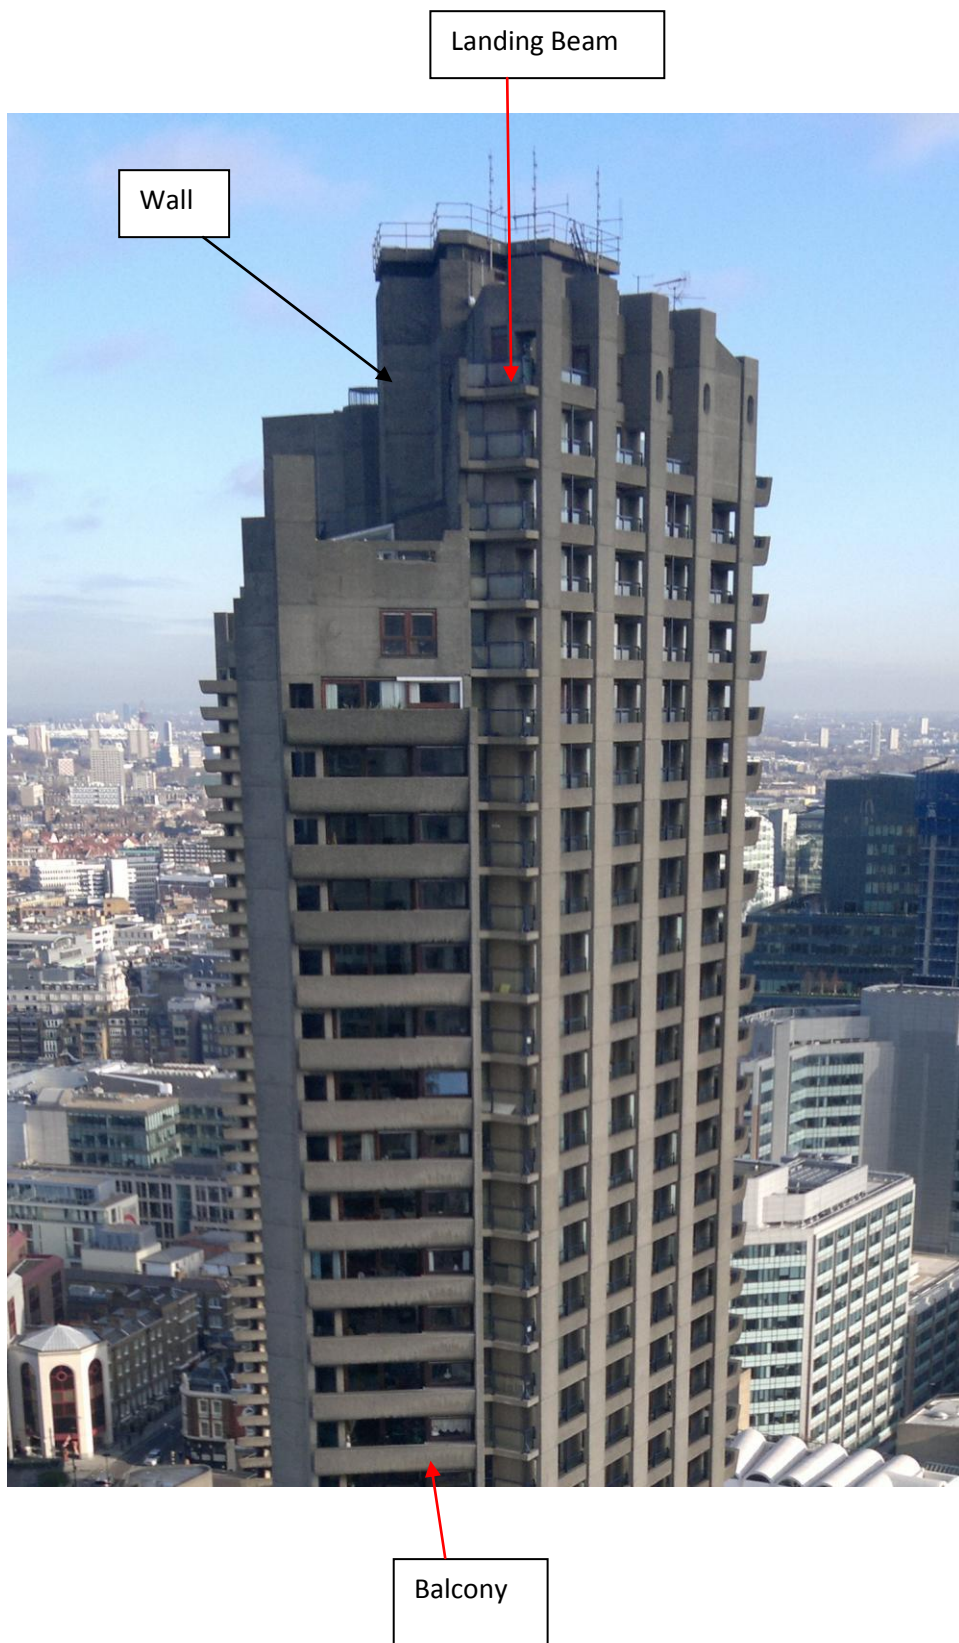
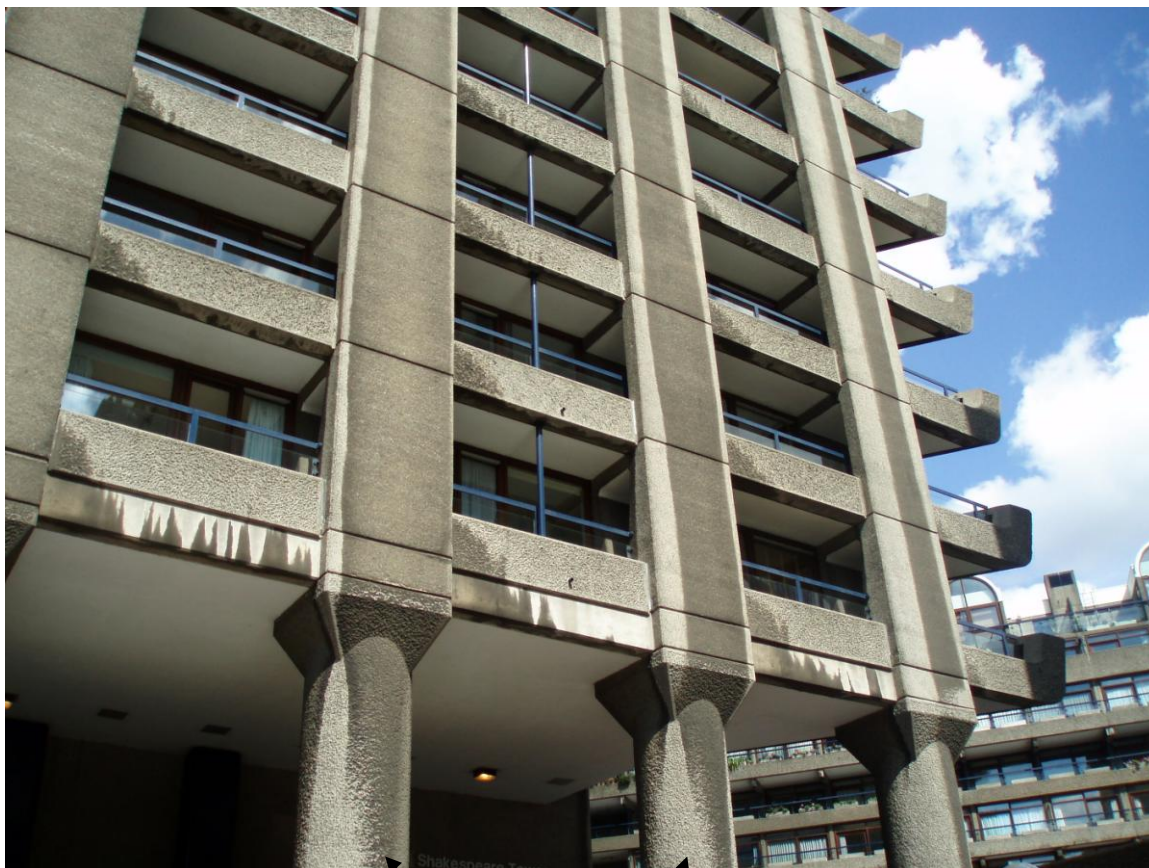
Figure 1  
Elements of the buildings

Shakespeare Tower									
Element	Depth of Cover			Depth of Carbonation			Chloride Content		
	(mm)			(mm)			(%)*		
	Min	Max	Mean	Min	Max	Mean	Min	Max	Mean
Landing Beam	3	67	43	<5	15	7	0.08	0.29	0.18
Wall	0	>80	53	<5	>50#	13	0.17	0.33	0.23
Spandrel Panel	29	>100	60	<5	20	8	0.10	0.73	0.20
Balcony	7	>100	42	<5	15	7	0.13	0.26	0.17
Column	0	>100	55	<5	>70#	10	0.08	0.33	0.20
Round Column	45	>80	61	<5	10	4	0.14	0.26	0.19
Cromwell Tower									
Element	Depth of Cover			Depth of Carbonation			Chloride Content		
	(mm)			(mm)			(%)*		
	Min	Max	Mean	Min	Max	Mean	Min	Max	Mean
Landing Beam	8	80	47	<5	40	11	0.08	0.93	0.39
Wall	13	89	54	<5	25	13	0.09	0.36	0.19
Spandrel Panel	22	99	53	<5	10	5	0.08	0.59	0.26
Balcony	0	88	41	<5	20	8	0.10	0.25	0.15
Column	28	95	62	<5	70	11	0.09	0.30	0.18
Round Column	3	81	67	5	10	8	0.22	0.29	0.25
Lauderdale Tower									
Element	Depth of Cover			Depth of Carbonation			Chloride Content		
	(mm)			(mm)			(%)*

Min	Max	Mean	Min	Max	Mean	Min	Max	Mean
Landing Beam	6	83	38	<5	40	9	0.16	0.42	0.26
Wall	6	>100	56	<5	15	6	0.13	0.30	0.22
Spandrel Panel	15	80	54	<5	10	5	0.15	0.41	0.25
Balcony	10	82	43	<5	25	7	0.10	0.45	0.18
Column	17	84	60	<5	35	5	0.14	0.34	0.23
Round Column	78	90	84	<5	10	6	0.23	0.35	0.30
