Report Reference: N&V-R2707

# NOISE & VIBRATION INVESTIGATION BRANDON MEWS BARBICAN

Issue Date: 16<sup>th</sup> November 2019

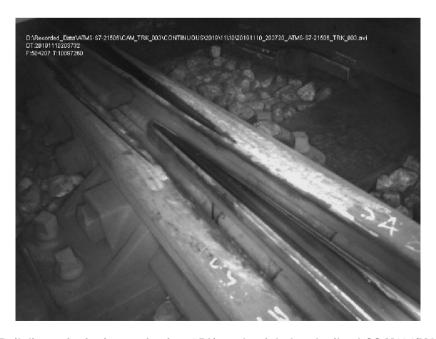
The figure below shows the discontinuity on the right hand rail located at LCS M134/MORLO 466m.

Figure 2 – Rail discontinuity (nose of points 35A) on the right hand rail at LCS M134/MORLO 466m

The open gap at a fixed V-crossing forms a point on the track where the heavily loaded wheel must bump across the resulting gap of about 10 cm, supported only by the portion of the wheel tread which is on the wing rail.

This pounds the rail so heavily, that often the steel deforms and/or wears out. This damage may easily spread to other components including the wheels, and as a consequence, the noise becomes an issue for neighbouring properties.

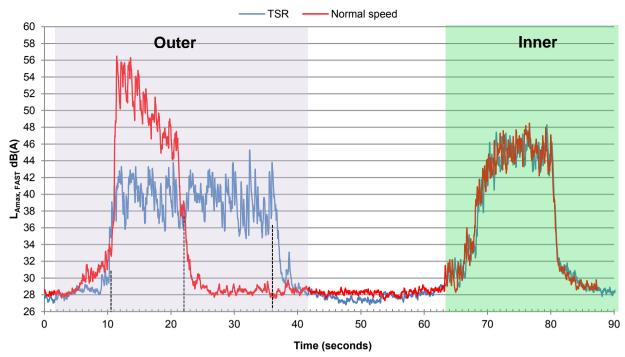
The results during the current TSR show that within the property, outer train noise levels were reduced by 7dB, on average.

Figure 3 - Noise plots of trains on the outer and inner road

From the plot above, outer trains had their average speed reduced by roughly 55%, from approximately 35mph down to 15mph. The train pass by time increased as a consequence, correlating with the reduction in speed; ~11 seconds to ~24 seconds.

With the speed reduction, every bogie traversed the gap on the right hand rail at LCS M134/MORLO 466m, at a constant speed as observed in the plot above.
