The fire resistance performance of a single leaf single acting doorset with side screen and overpanel, when tested in accordance with BS 476: Part 20/22: 1987

399929

Housing Property
Services

2nd June 2018

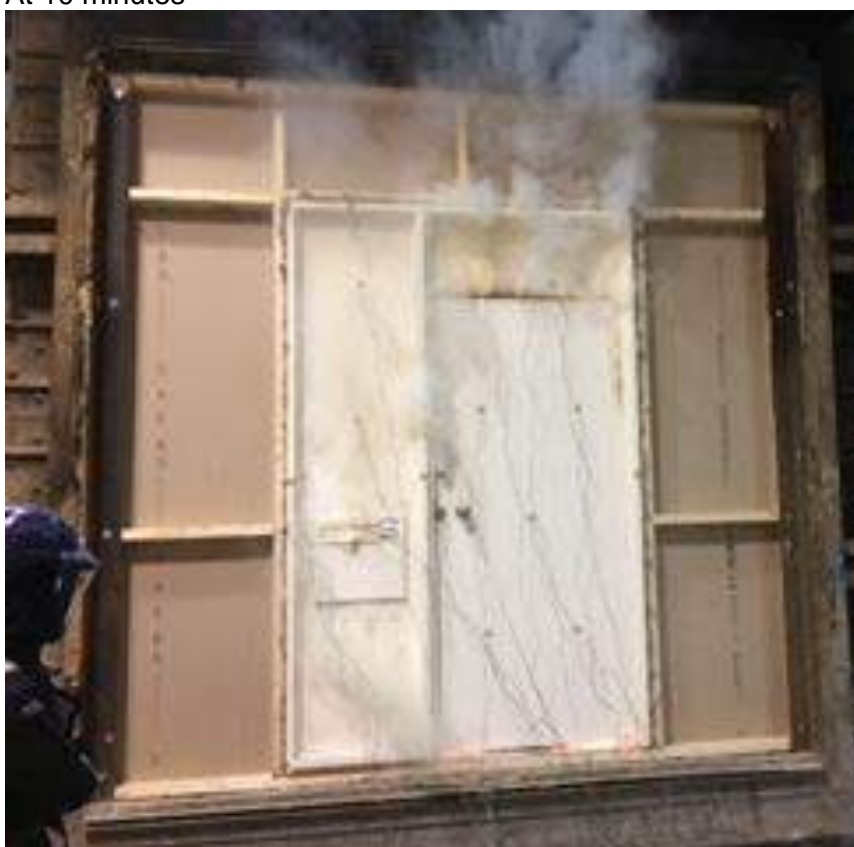
At 10 minutes

09:00	There is an increase in smoke issuing at the upper keyhole.
10:50	The paint on the letter plate bubbling.
11:20	There is an increase in smoke issuing at all of the previous locations.

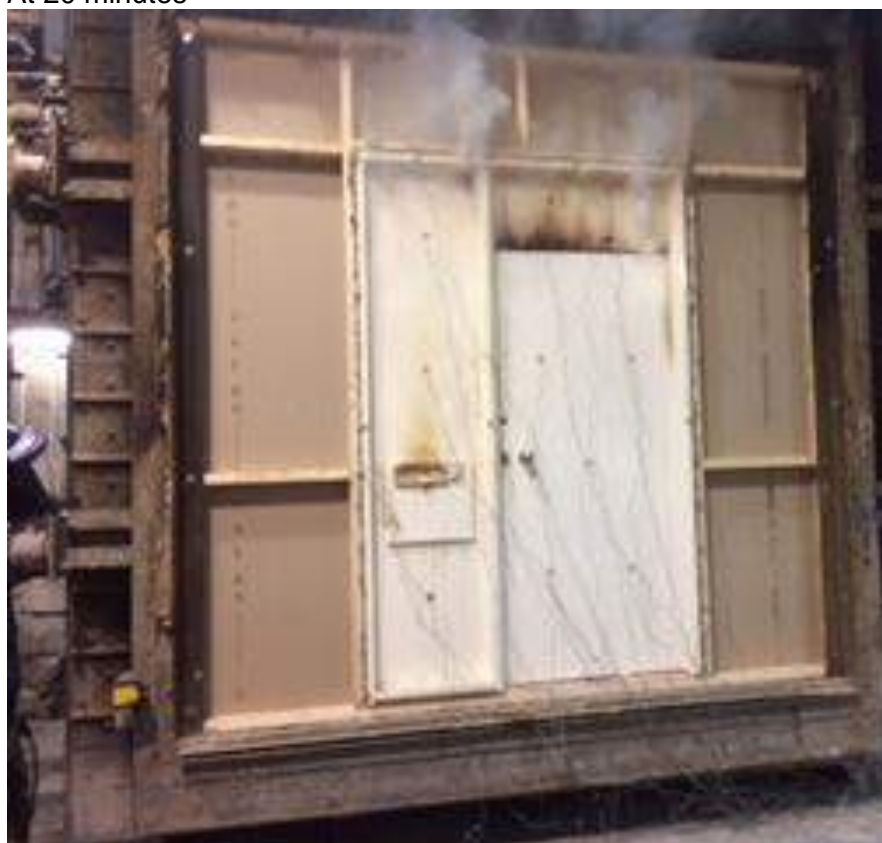
At 20 minutes

18:40	There is discolouration at the top right corner of the side panel.
21:00	There is discolouration at the right edge of the side panel.

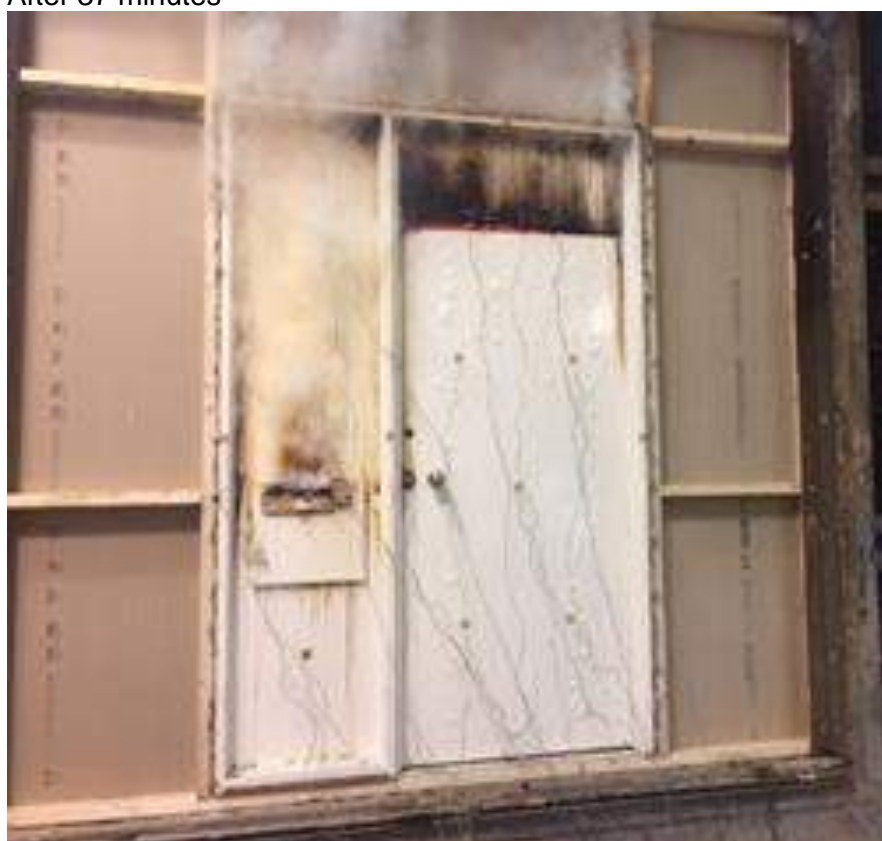
After 37 minutes

- 35:15 A cotton pad integrity test was performed at top closing corner which resulted in the ignition of the cotton pad thereby constituting **integrity failure**.

- 35:28 There is continuous flaming at the leaf head thereby constituting **further integrity failure**.
- 37:40 There is continuous flaming at the top of the over panel thereby constituting **further integrity failure**.
