Barbican Estate
Barbican Residential Blocks
Mountjoy House – Fire Strategy
Report

Rev A | 7 September 2022

Job number 279095-01

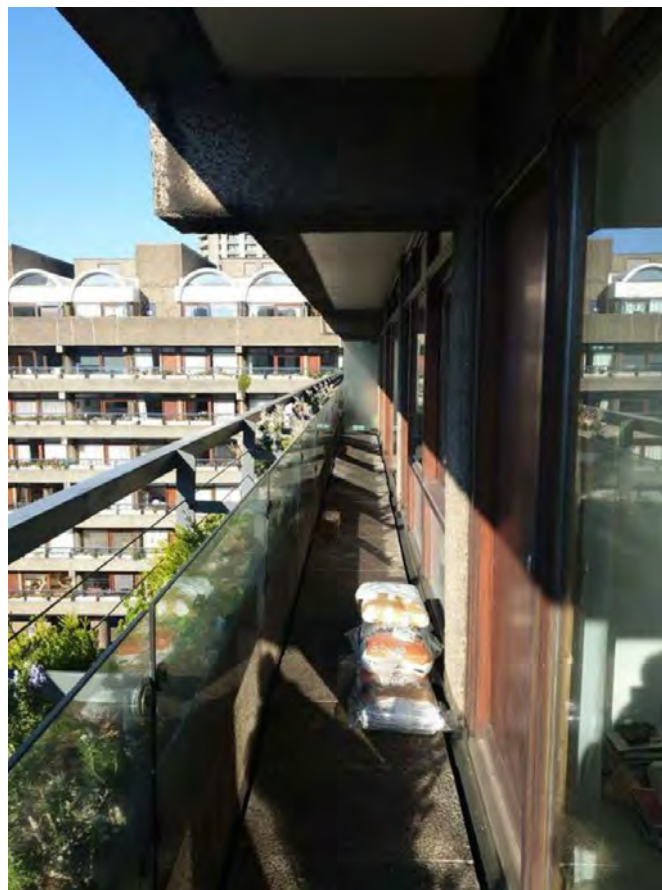
Figure 5: Stored goods in balconies

The width of the balcony is 560 mm at pinch point with privacy screens fully open. It was identified during the site visit that stored goods are located along the balcony in certain levels of the building as shown in Figure 5. These should be removed so that the escape route remains unblocked.

- It is recommended to maintain the management procedure in place to keep the balconies clear of any obstacles at all times. This is to provide a clear escape route for occupants to evacuate in an emergency.

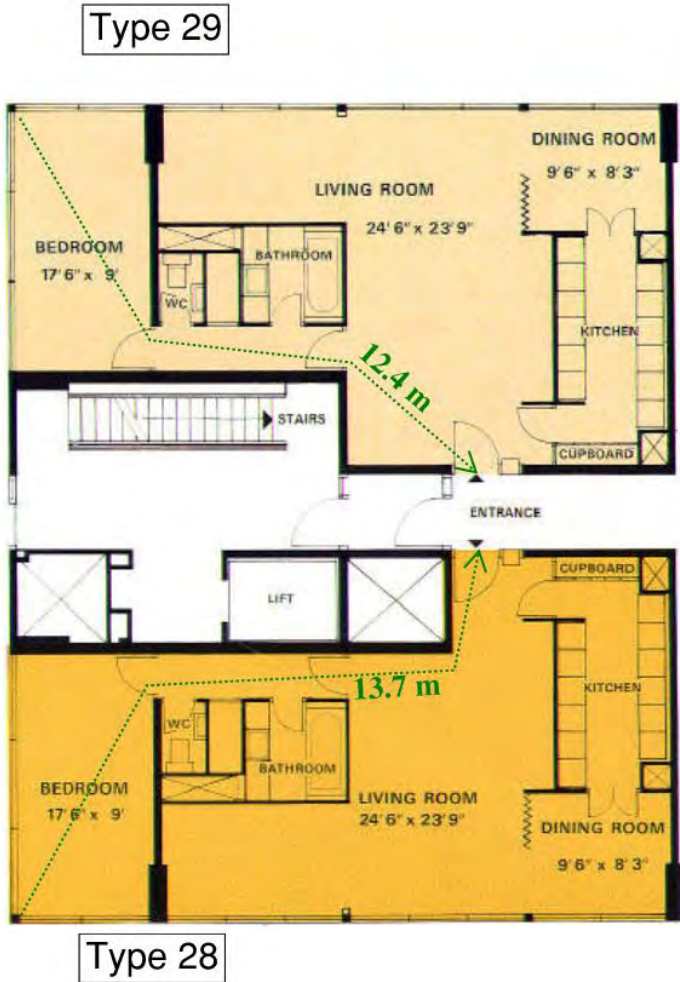
Figure 9: Flat type 28 with greatest travel distance within the flat

As there is only a single means of escape for PRMs, the travel distances within the flat should be limited to 9 m from the furthest point in the flat. It is Arup's understanding that there are different internal layouts throughout the building. The flat with the greatest internal travel distance is Flat type 28 with 13.7 m which exceeds the recommendations of BS 9991, as shown in Figure 9 below.

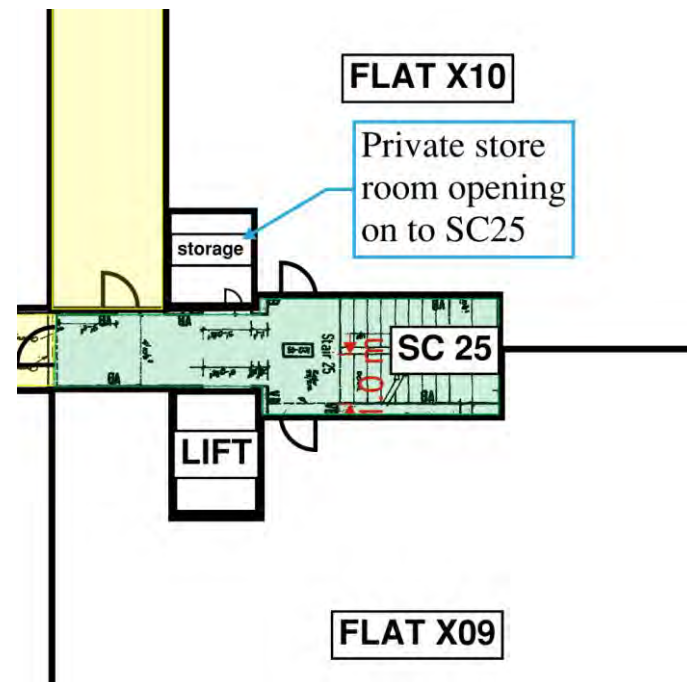
Figure 10: Current layout of storeroom opening on to Staircase 25

- **Plant/storeroom in stairs:** There is a storeroom within Staircase 25 (common stair) and a plant room within Staircase 26 (firefighting stair) on every level. The rooms are separated from the stairs by masonry/concrete walls but it is not possible to establish the fire rating of the door. This is a risk as a fire within these rooms may affect the use of Staircase 26 for means of escape, or cause smoke to spread to all levels via Staircase 25.

Refer to Section 4.3.3 for recommendation on fire door.

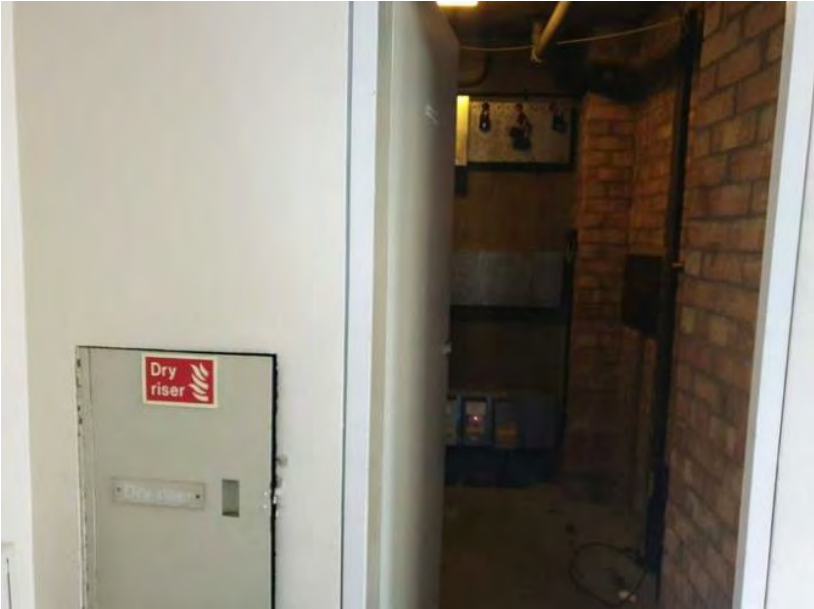
Figure 16: Plant room within Staircase 26

There is a plant room within the firefighting stair landing areas as shown in Figure 16 below. The door should be inspected to determine the fire rating and to maintain fire separation from the firefighting stair.

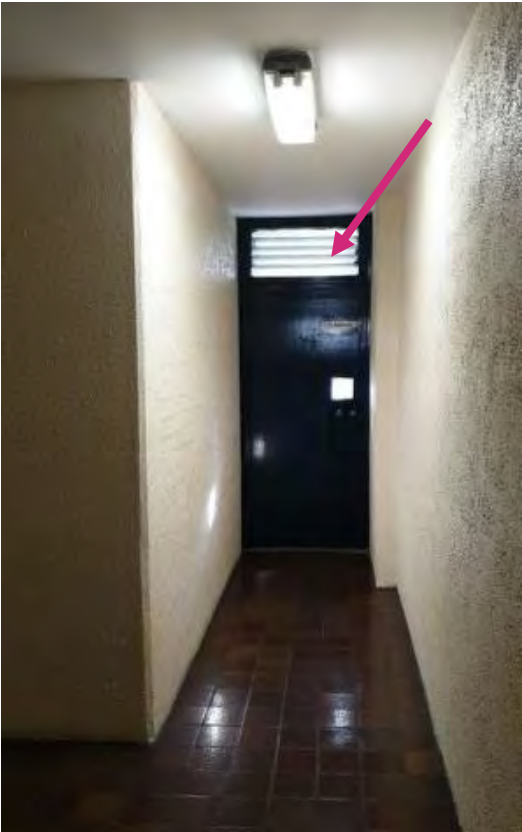
Figure 17: Stair/lift lobby vent (red arrow) for Staircase 24

Staircase 24 has a vent at the top of the stair (dimensions not available) that is manually activated from a switch at the fire service access level (Level 03). At each level, the stair lobby (also the lift lobby) has a vent that opens onto the external balcony. Refer to the Figure 17 below.

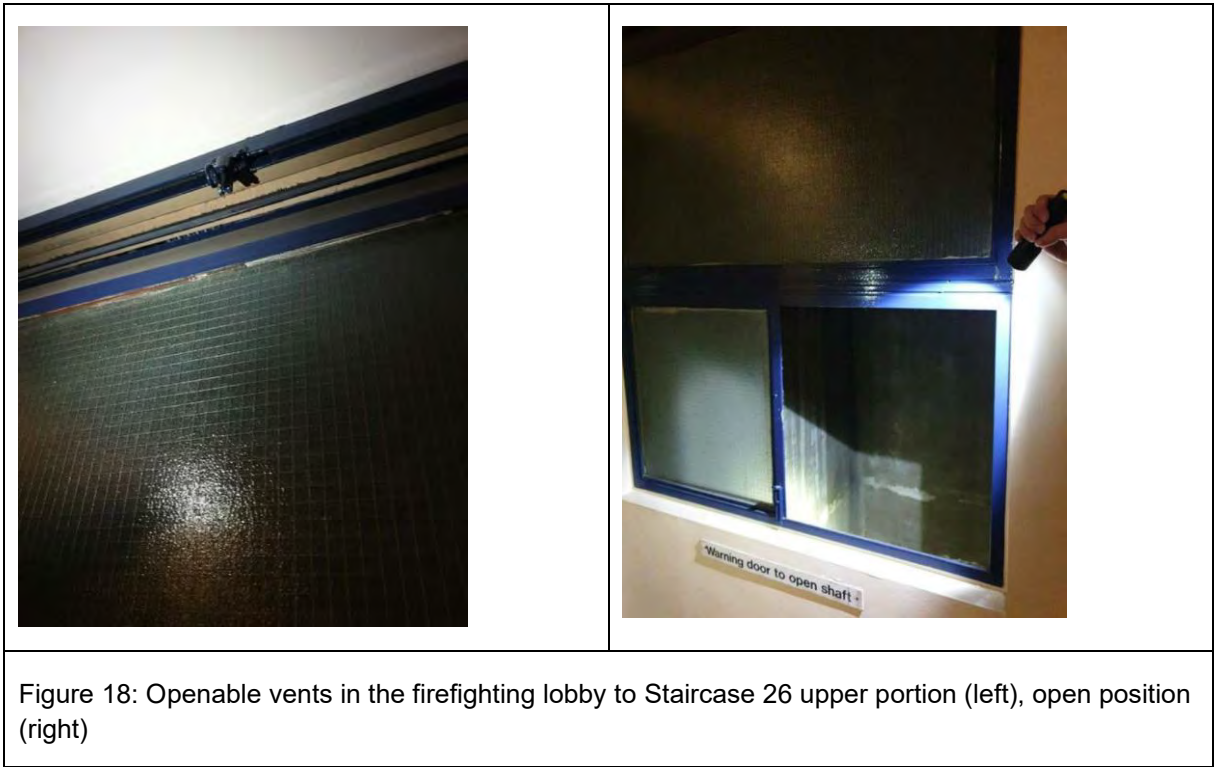
Figure 18: Openable vents in the firefighting lobby to Staircase 26 upper portion (left), open position (right)

Staircase 26 has a louvred door (louvre area is 1.5m x 0.55 m – unlikely to achieve 1m² free area) at the top of the stair that opens onto the external balcony. The lift is within the stair enclosure. A lobby separates the stair from the common corridor at each level. The lobby opens into a vent shaft at every level via an openable window as shown in Figure 18 (with Georgian-wired glass). Some of these windows were in the open position and will cause smoke to spread between the floors if smoke were to enter the lobby.
