Kenley Revival

Evaluation Addendum 2

Thaumasia Sulphate Attack

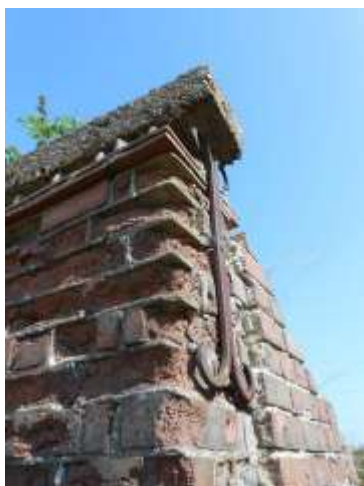
This picture of Fighter Pen KC44 taken in 2014 shows the extent to which Kenley Airfield's structures had deteriorated. The mortar remained reasonably intact, but the brickwork was badly eroded and spalled. The structures were not expected to survive much longer without intervention.

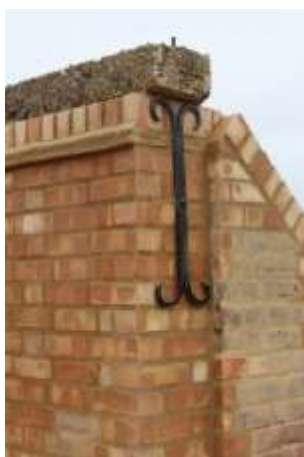
KC44 following conservation work in 2017.

Shortly afterwards it was observed that some of the mortar in newly conserved sections of brick wall had failed. Mortar joints had expanded, ejecting material to create spoil heaps of extruded paste laying at the foot of the walls. The mortar itself appeared to be soft and saturated. In places it was possible to push a finger into the mortar joints. This phenomenon had not affected all the 2017 conservation work, and where it had not to the same degree, but it was quite widespread across the site.

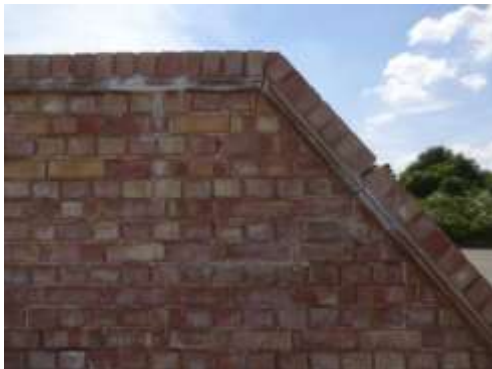
Example of TSA damage affecting the end wall of the new central spine in Fighter Pen KC12. Salt staining is also visible.

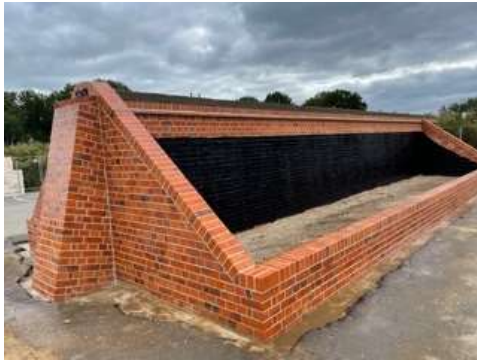
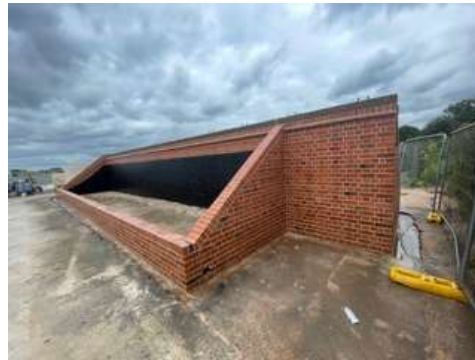
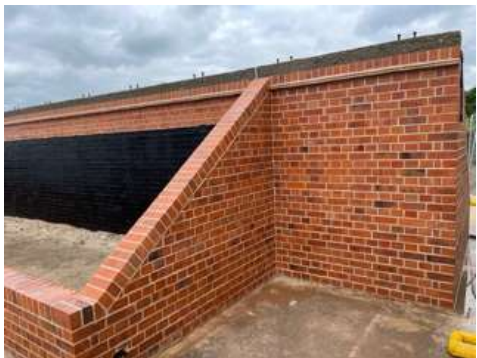
The pictures above also illustrate several design changes for the new central spine. The 2017 structure utilised high-density polystyrene blocks as a core for the tall central wall. The top courses of brickwork and the concrete coping sat on this polystyrene core, separated by a geotextile membrane. In their 2021 assessment of this structure the architect and structural engineer found that the brick and concrete ridge had expanded and contracted, slipping over the geotextile and pushing on the end walls, which were already weakened by thaumasite. This caused the end walls to bow out.

The 2021 structure has a full-length wall and expansion joints at both ends. Unlike the 1939 and 2017 structures, all the walls now sit on their own foundations. Interestingly, when digging the foundations, it was discovered that the concrete apron upon which the 1939 and 2017 structures sat varied greatly in thickness front to back; a fact that possibly further exacerbated rotation and cracking as the apron probably yielded inconsistently under their weight.

In February 2021 architects and structural engineers working for the project's conservation contractor produced a condition survey and schedule of work for rectifying the 2017 defects. This aimed to replace failed sections of the 2017 work using the most resilient material combination from the trials – Northcot Nine Elms bricks and Aarlborg White cement. Additional waterproofing and drainage were prescribed for many of the replaced sections.

2021 reconstruction of the central spine wall in KC12. The structure now includes waterproofing applied to soil facing areas of brickwork, drainage and a waterproof membrane.
