Site Visit Report

Barbican Estates, London EC2Y 8EN

Specification Dulux Pyroshield Matt

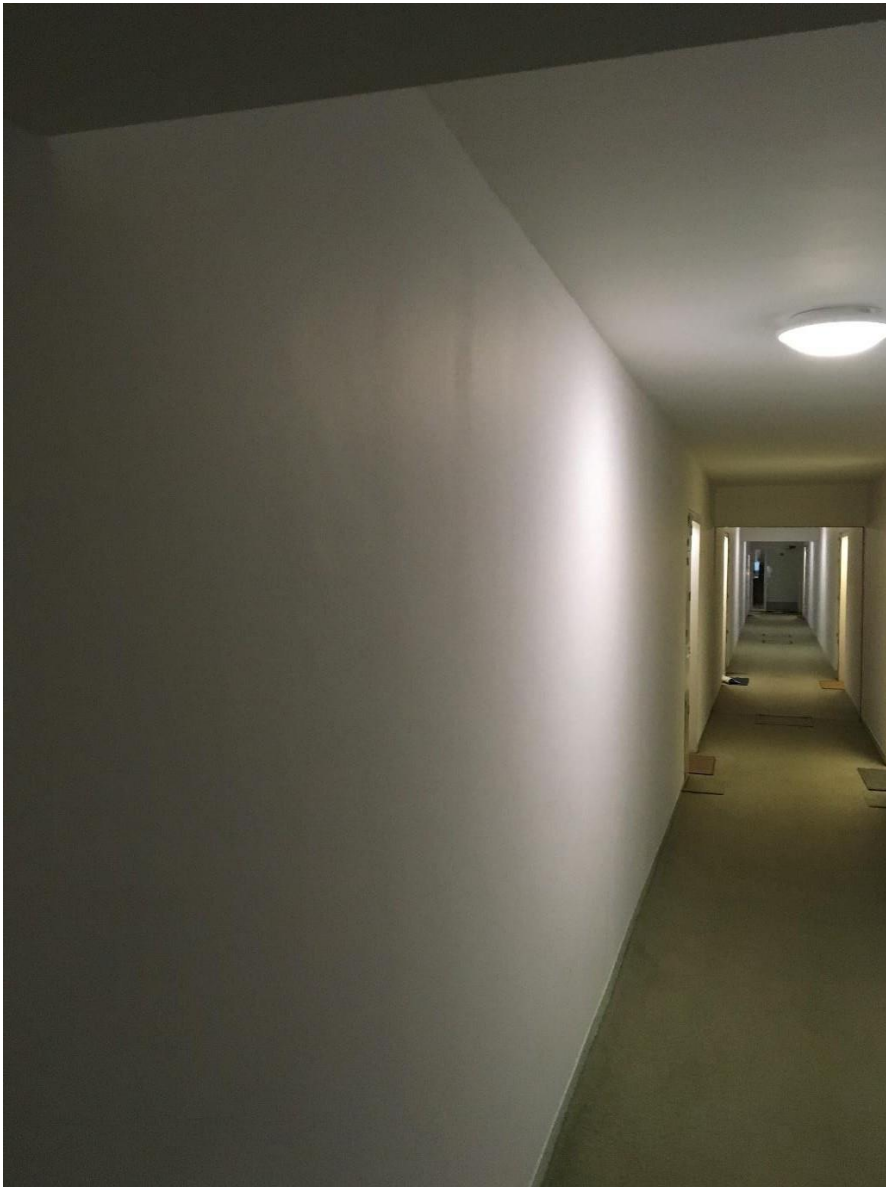
- Critical lighting occurs when sunlight or another source of light strikes a wall surface at an angle of 15 degrees or less. At this angle, any irregularity in a wall surface may cast a slight shadow, causing the wall to look patchy, or uneven.

Fig 1, Walls & ceiling affected by critical lighting

We discussed on site a way forward and I have advised a trial/benchmarking with our Pyroshield Eggshell to help minimise the patchy effect.

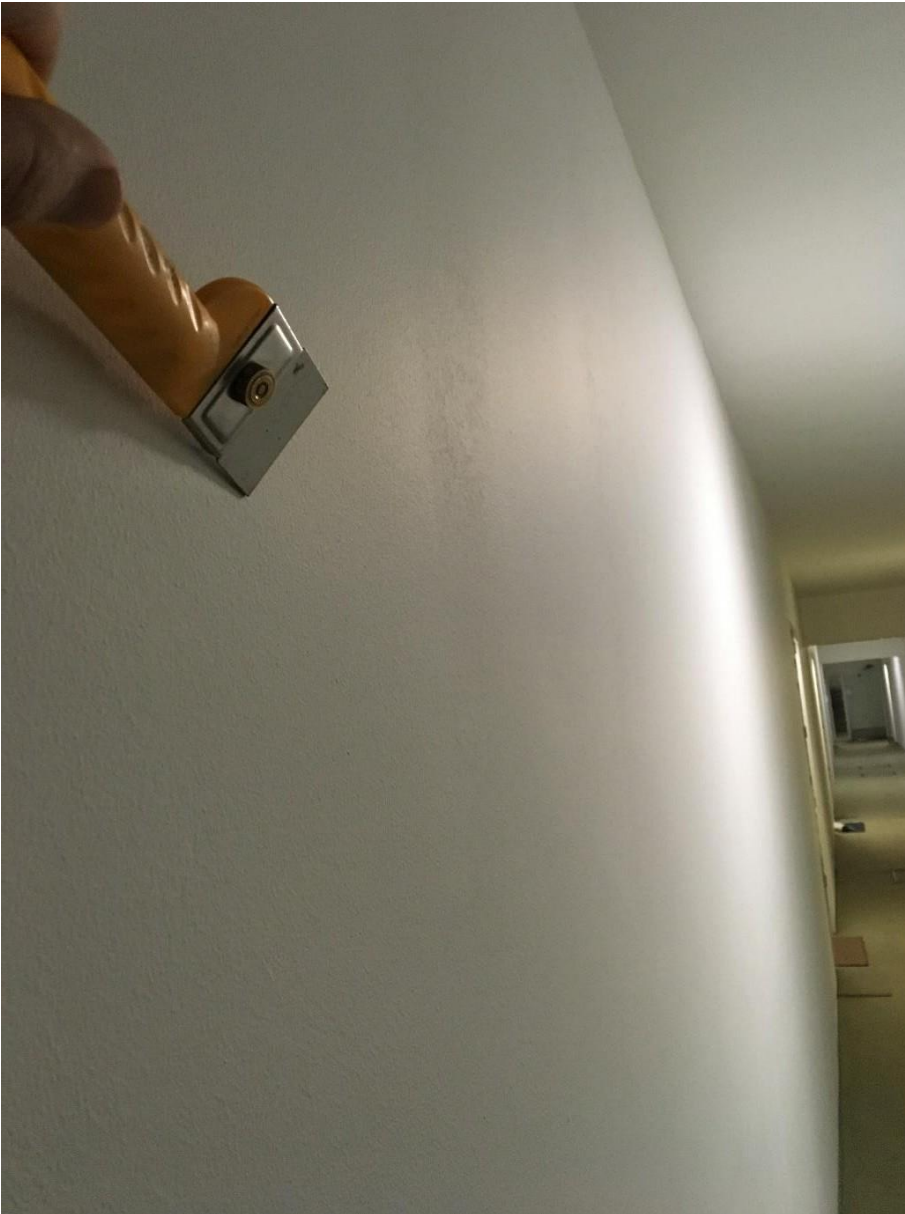
Fig 2, Walls affected by critical lighting, where the light is not hitting the wall sections this appears to be smooth with an even finish

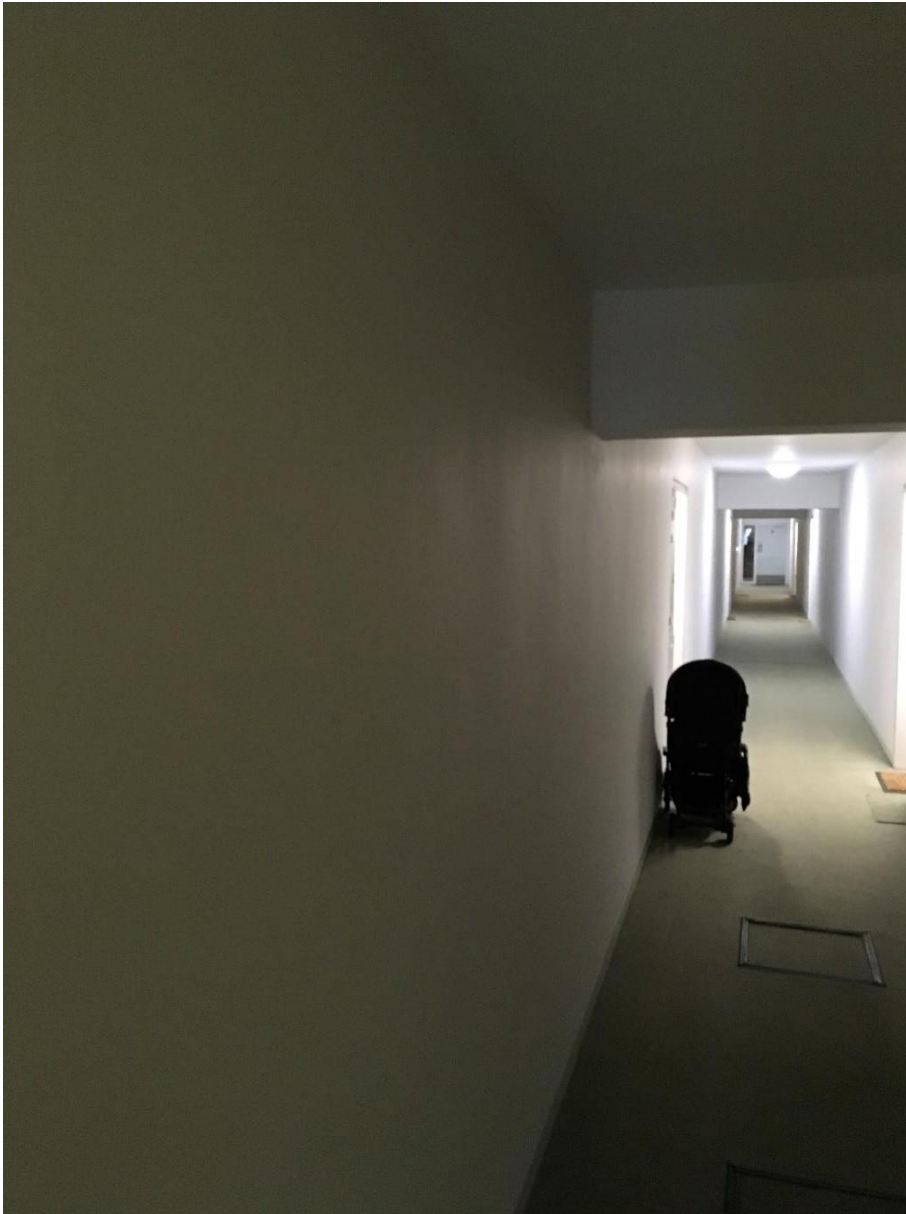
- The sections completed in the resident's corridors using the Matt finish appear to be streaky and patchy (when viewed at an angle) however when we inspected the same areas following the BS recommendations for inspections (10.1, 10.2, 10.3, 10.4) the pacy streaky finish was not visible.

Fig 3, another example of walls affected by critical lighting, when views head on the finish is acceptable and no flashing can be observed

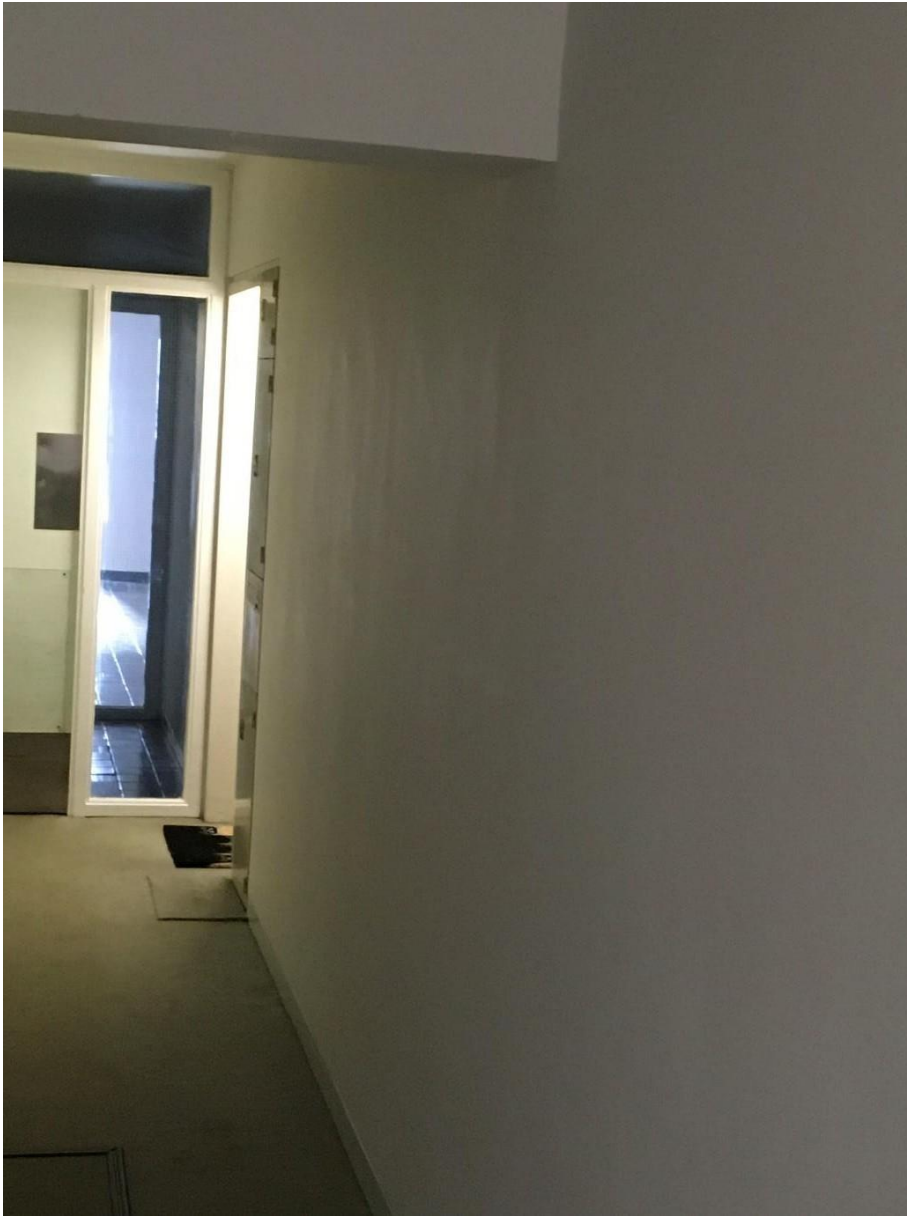
- The walls are not smooth and even there was multiple areas which have been made good over time and these are not flat/flush with the existing wall.

Fig 4, walls not smooth and even

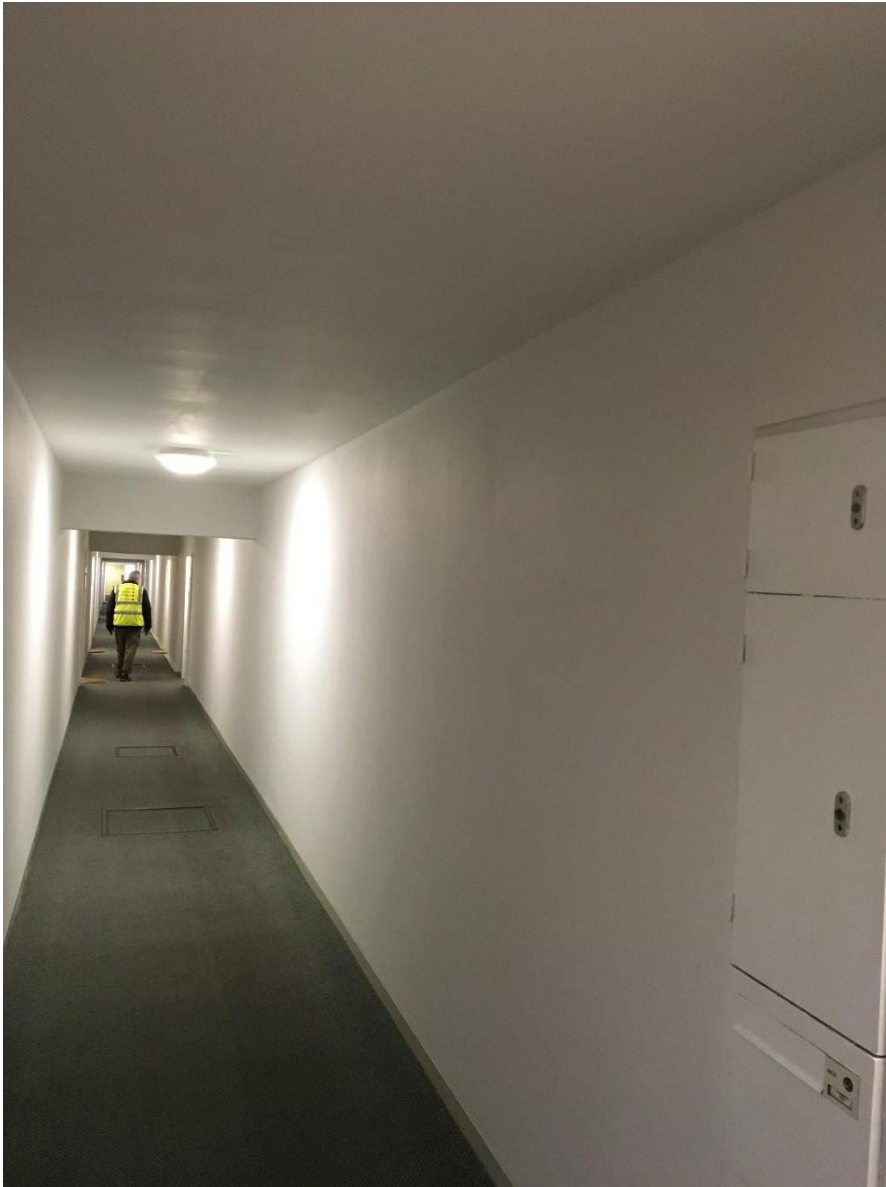
- The design of the walls in Willoughby House are round/semicircle we inspected the painted walls and there was no flashing present. The ceiling did show some patchy areas however when viewed directly face on the patchy appearance was not visible.
- The ceiling also has multiple areas which have been made good and were not flat/flush to the ceiling

Fig 5, streaky finish on ceiling when viewed from angle however when viewed face on no patchy/streaky effect was observed

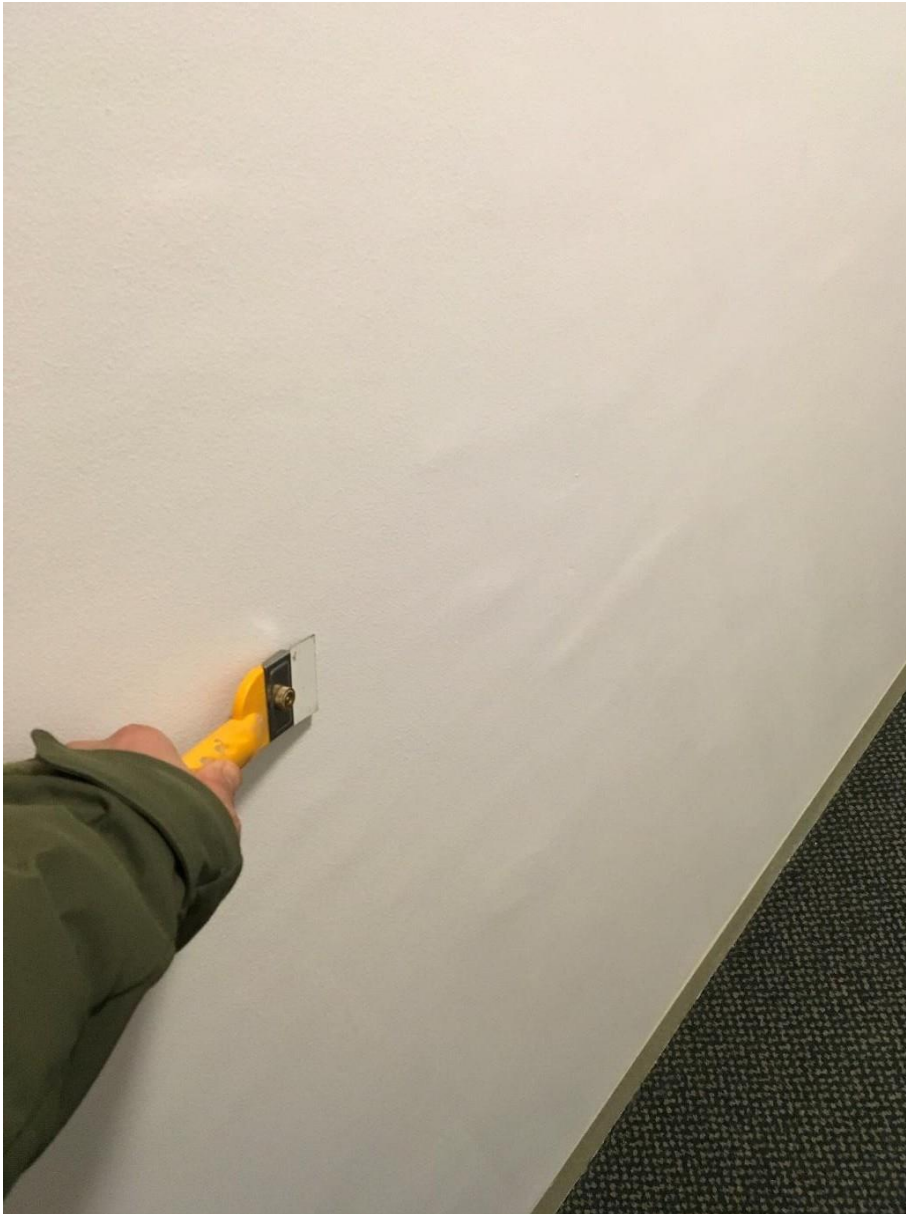
Fig 6, Walls are not smooth and even

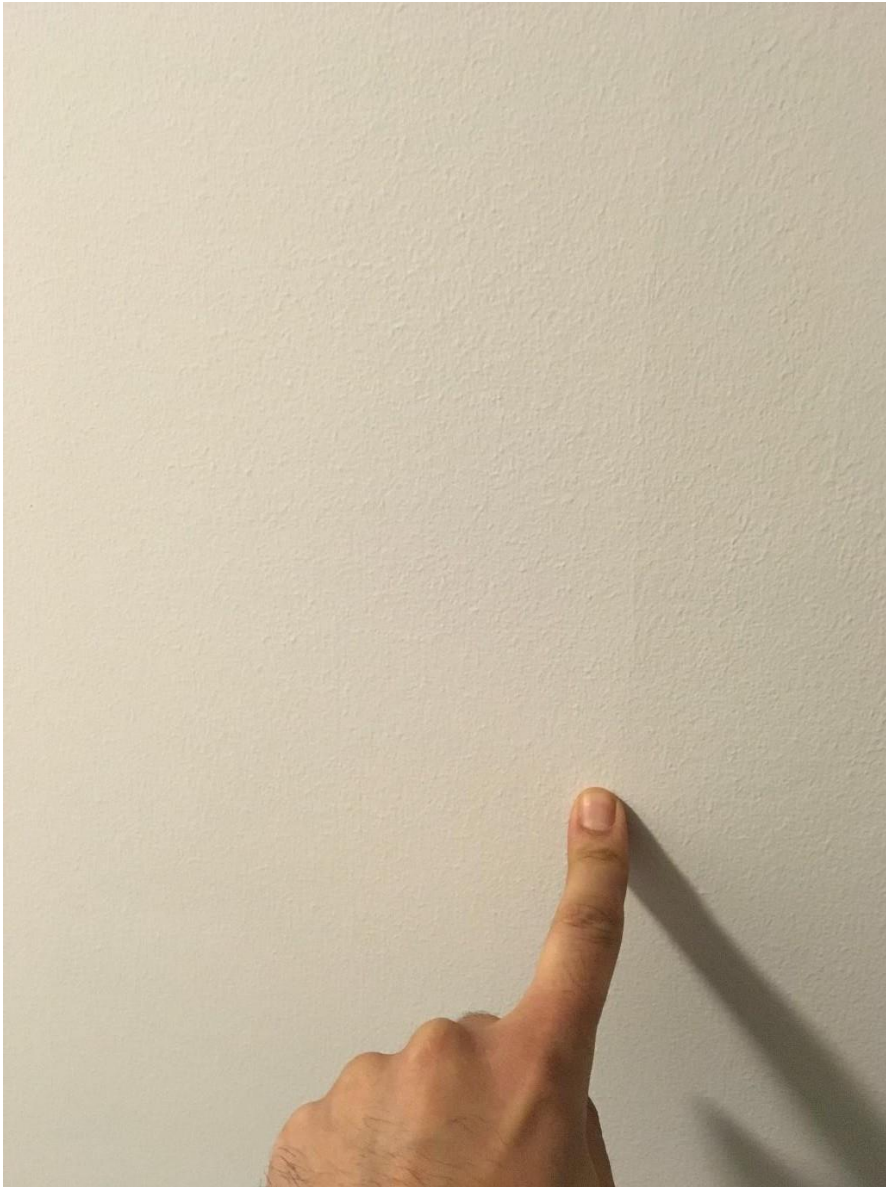
Fig 7, Walls are not smooth and even due to repairs

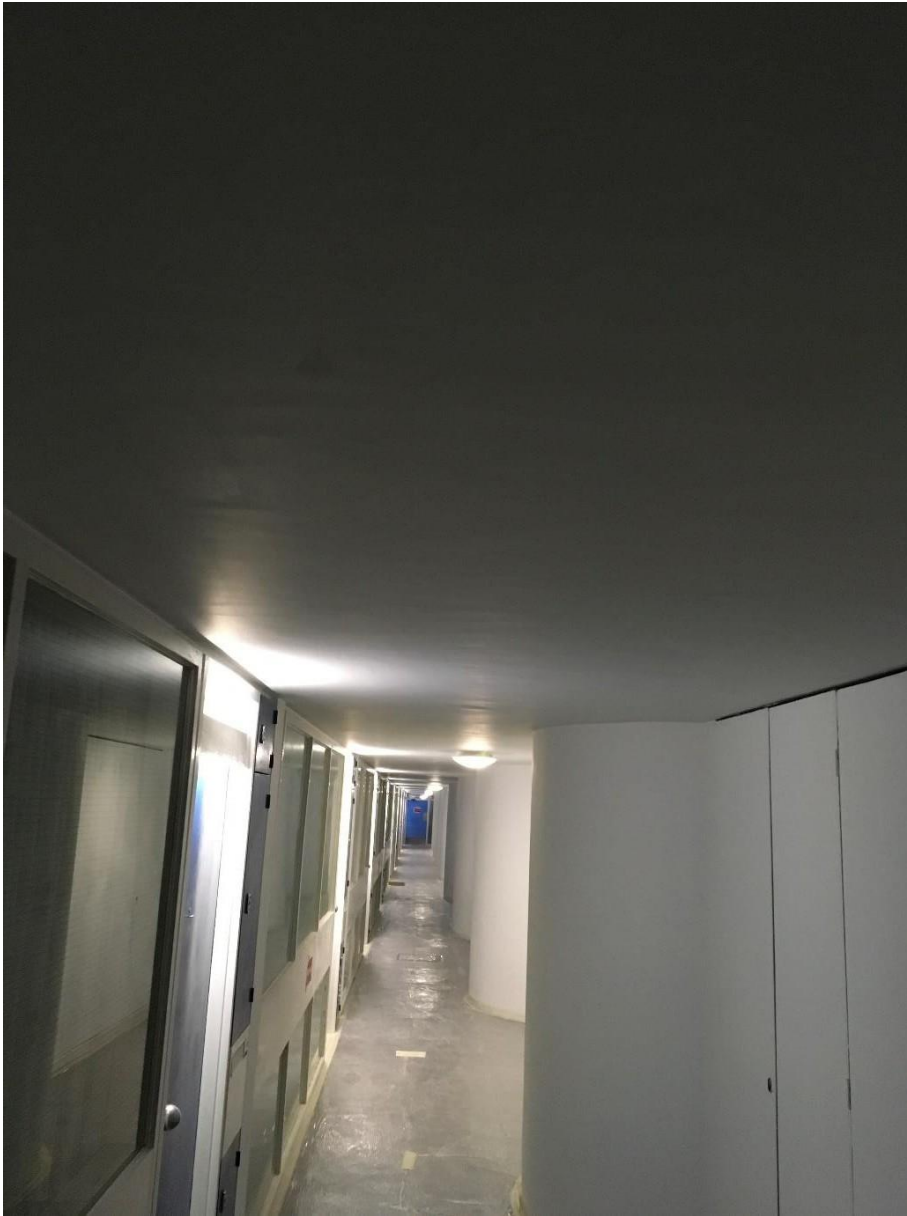
Fig 8, no flashing observed on walls which were curved
