Access Audit

Common parts of Petticoat Square
Artizan Street
London

Prepared on Behalf of
City of London

Date: 26th January 2022

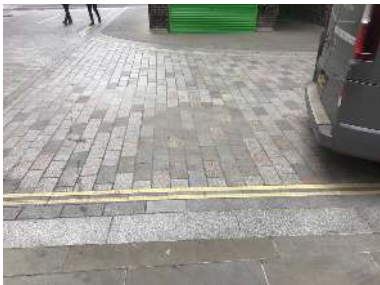
1.2	The temporary hoarding serving what we assume is temporary plant is not particularly well contrasted against the paving posing a risk of collision to some visually impaired users.	Apply contrasting markings at base and head level to hoarding	2	A

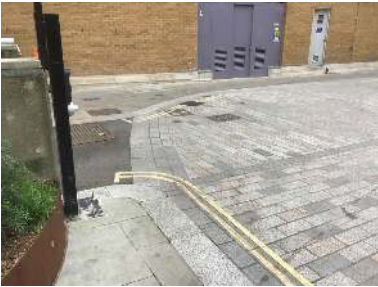
1.3	The dropped kerb points to the service entrance and car park ramp has no tactile blister paving fitted and thus there is a risk that visually impaired users will walk into the carriageway unawares.	Fit tactile 'blister' profile paving to crossing points	2	B

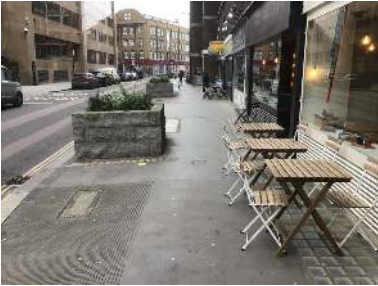
1.4	<p>The dropped kerb point across Artizan Street has no tactile blister paving fitted and thus there is a risk that visually impaired users will walk into the carriageway unawares.</p>	<p>Fit tactile 'blister' profile paving to crossing point</p>	2	A

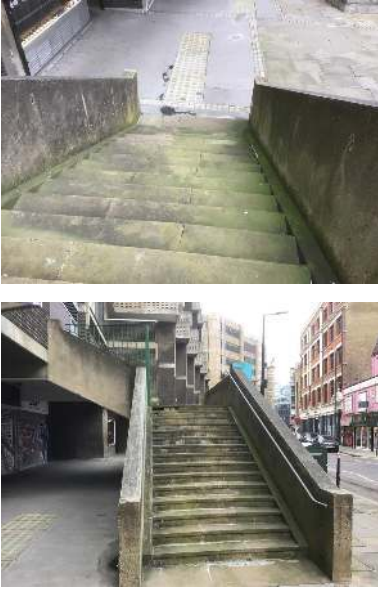
1.10	<p>The former entrance steps now serve no purpose but the lack of contrasting nosings does pose a trip hazard to a visually impaired user.</p> <p>The lack of handrails will also make the steps more difficult to use by a mobility impaired person.</p> <p>We suggest these steps are blocked off at each end to prevent access.</p>	Block off former entrance steps	2	B

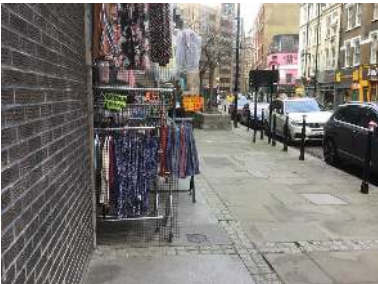
1.11	<p>Where goods are displayed on street these present a similar hazard to seating as set out previously.</p> <p>In this instance well contrasted barriers to either end would help to mitigate the risk of collision.</p>	Require tenants to use well contrasted cordons to highlight on street trading areas	2	Zero

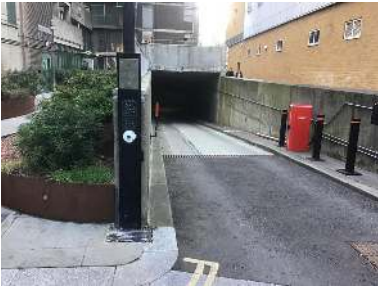
1.12	<p>The intercom points at the car park entrances are set around 1400mm above ground level and are not positioned so as to be within reach of a car.</p> <p>As a result a wheelchair user would have to transfer twice to access the intercoms if indeed he or she could reach them.</p>	<p>Lower and move intercoms and fit signs at car park entrances</p>	3R	B

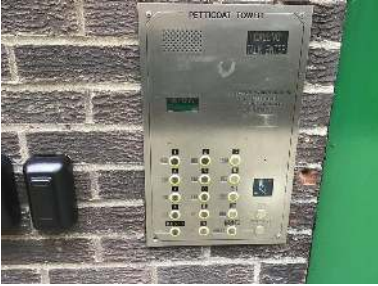
2.1	<p>Entrance intercom units are not particularly well contrasted against wall surfaces but call buttons are well highlighted against the faceplate with highly contrasted surrounds.</p> <p>This contrast is supplemented with embossed numbering and braille.</p> <p>The intercom units are generally set with buttons no higher than 1275mm above ground level. This is slightly above the comfortable reach range for the average wheelchair user of 1200mm but are within the upper extended reach range of 1400mm.</p>	<p>Improve contrast of intercom units with contrasted frames or faceplates</p>	3R	B

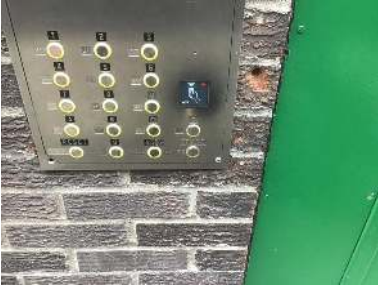
2.2	<p>The buttons which are most frequently used are losing the contrasted surround.</p>	<p>Replace damaged contrasted rings to call buttons</p>	3M	A

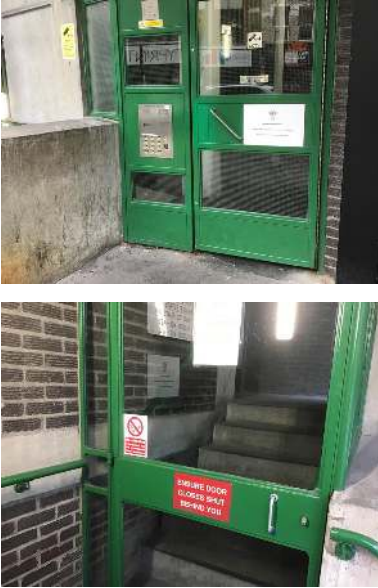
2.4	<p>The older entrance doors require excessive force to pull open of more than 50Newtons, as a result it will prove difficult for a user with impaired upper body strength to open these doors.</p> <p>Best practice recommends a maximum opening force of 30Newtons for the first 30 degrees of the door swing and 22.5Newtons thereafter.</p> <p>Closers to these doorsets are likely to prove difficult to adjust for what are old and heavy steel doors. It may be necessary to fit new closers.</p> <p>Whilst you have fitted power assistance to no.1, which will be of benefit to all, many disabled users will be able to pull open a well adjusted manual side hung door.</p>	<p>Adjust door closers to achieve maximum 30Newtons opening force</p>	3M	A

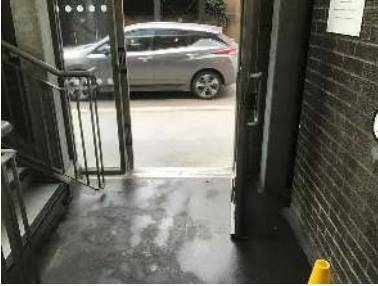
2.6	<p>The powered door to the no.1 entrance does not open to the full 90 degrees thus there is a limited risk of collision with the door edge for a visually impaired person.</p>	Adjust closer to open 90 degrees	3M	A

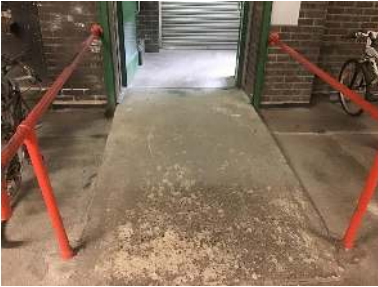
2.12	<p>This door is exceptionally heavy to open requiring up to 80N of force.</p> <p>The ramp to the tower car park entrance is set at a relatively shallow gradient but we do suggest kerbs are installed to either edge to mitigate the risk of a wheelchair user falling off of the opening edge.</p> <p>Whilst handrails are in place there is no guarding at low level.</p>	Install 100mm kerbs to either edge of ramp	3R	A

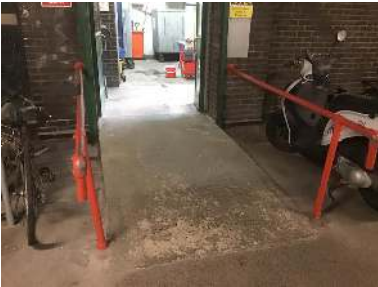
2.13	<p>Lighting to the ramp surface is poor with lux levels as low as 30 at the surface making it more difficult for a visually impaired user to identify key features such as the start and finish of the ramp and handrails etc. In this location best practice recommends that a lux level of 100lux is achieved at the ramp surface.</p>	Upgrade lighting to ramp surface to achieve 100lux at ramp surface	3R	A

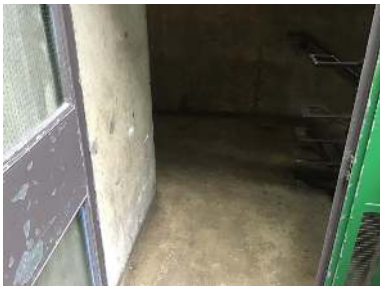
2.16 Transitional lighting is poor as one enters the building from the ground floor car park with lux levels as low as 70lux noted in the stairwell.

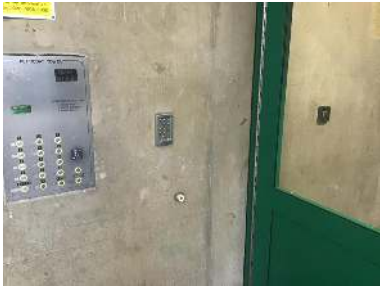
2.17	<p>The keypad to the tower stair entrance is poorly contrasted making it difficult to locate by all but particularly a user with a visual or mental impairment.</p> <p>This could be improved by forming a well contrasted frame or surround to the intercom unit or fitting a new well contrasted faceplate.</p>	Improve contrast of keypad	3R	A

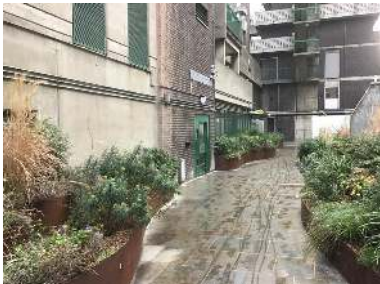
2.19	Best practice recommends that canopies are fitted over entrances to provide shelter when using the intercom units and door controls.	Fit canopy over tower entrance	3R	B

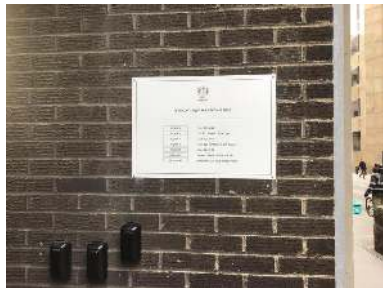
3.1	Entrance signs generally achieve good contrast against wall surfaces and do give clear indication of flat locations using a simple font. However some capital text is used thus removing the shape of the word making them more difficult to read by all but particularly someone with a visual or mental impairment.	Fit new signs with sentence case text only and larger number	3R	Info
	They would also benefit from a larger number to make it clearer which entrance one has arrived at.			
3.2	The entrance signs tend to be mounted between 1650 and 1780mm above ground level which is set above average eye level making them more difficult to read by all.	Re-mount entrance signs at 1500mm above ground level to centreline	3R	A

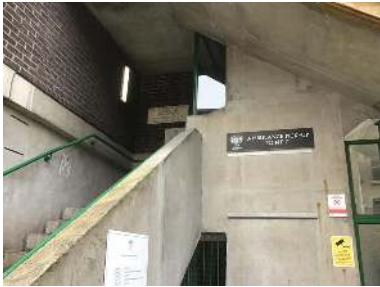
3.3	<p>Older signage tends to use capital text only thus removing the shape of the word making them more difficult to read by all but particularly someone with a visual or mental impairment.</p> <p>These signs often convey information which is likely of little use to a visually impaired user but should still be replaced in the longer term.</p>	Fit new signs with sentence case text	3R	Info

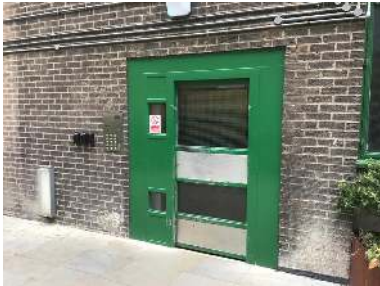
3.4	There is no signage to the tower entrance consistent with entrances to the podium units which would be helpful for visitors in particular.	Fit signage to tower entrance	3R	A

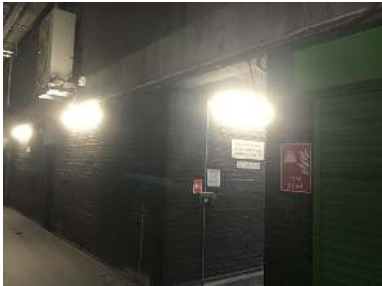
3.8	Lift cores are poorly signed from the basement and ground floor car parks and whilst residents will likely be familiar with the layout a simple sign over each exit point would be of benefit to all but particularly someone with learning difficulties or a mental impairment.	Install signs over car park exits	3R	B

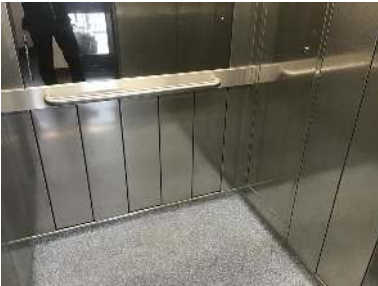
4.2.1	<p>Lift call points could be better contrasted against wall surfaces when mounted direct or into stainless steel plate making them difficult to locate by a visually impaired person.</p> <p>Where they are mounted against directory signs they are well contrasted.</p>	<p>Install signage or apply contrasting markings to call points to highlight their position</p>	3R	A

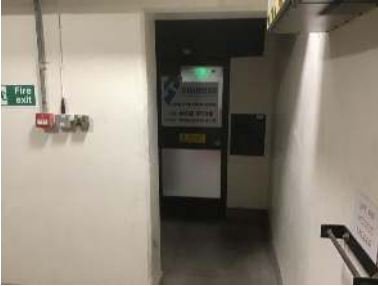
4.6	<p>Lighting is poor to the tower lift lobbies with many dark spots and lux levels as low as around 70lux noted at floor level generally.</p> <p>This will make it more difficult for visually impaired users to navigate the space and avoid obstacles, obstructions and other users.</p>	<p>Upgrade light levels to achieve 100lux at floor level</p>	3R	C

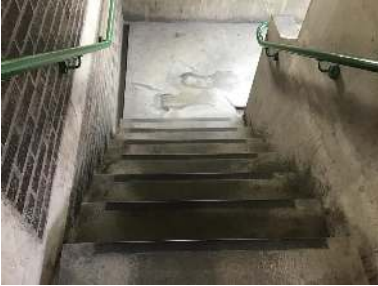
5.1	<p>The stair nosings achieve adequate contrast where the stairs are clean and well lit but where soiled, in shade or poorly lit they lose their efficacy making it very difficult for a visually impaired person to identify the step edges thus posing a significant trip hazard.</p> <p>Nosings should achieve a 30 point difference in light reflectance value to the treads and risers.</p>	Fit lighter nosings	3R	D

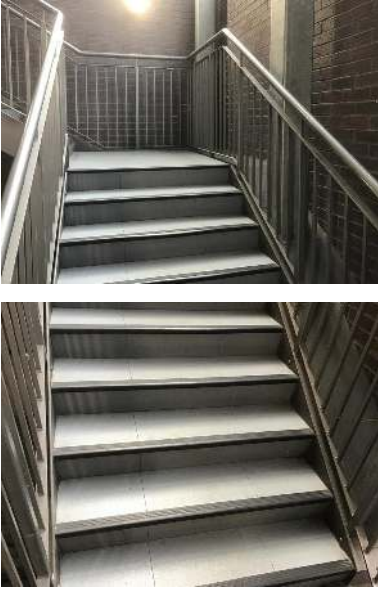
5.5	<p>The handrails to the base of no. 1 stairs are poorly contrasted to their background making them difficult to identify by a visually impaired person but this lower section does have well contrasted nosings.</p>

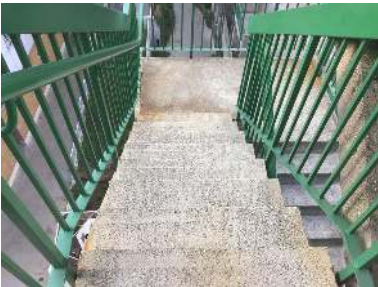
5.6	<p>The external fire escape stairs are not fitted with contrasting nosings making it very difficult for a visually impaired person to identify the step edges thus posing a significant trip hazard.</p> <p>Nosings should achieve a 30 point difference in light reflectance value to the treads and risers.</p>	<p>Fit contrasting nosings to step edges</p>	1	A

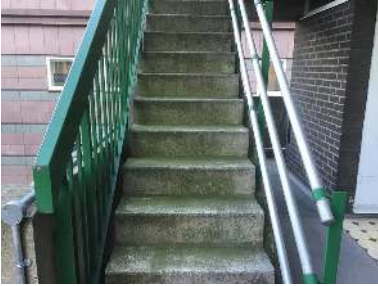
5.7	<p>A small number of stairs have deep section rails only to one side.</p> <p>Ideally these would be supplemented with a tubular rail to match the existing which will be far easier to grip.</p>	Fit additional tubular rails to deep sections	3R	B

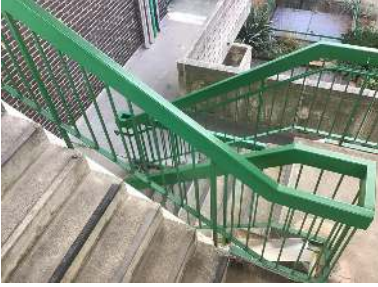
5.8	<p>The open bulkhead to the stairs in the podium cycle park area poses a risk of collision to a visually impaired user who may scan the ground for obstacles so be unaware of obstructions at high level.</p>	Guard bulkhead up to head level	3R	A

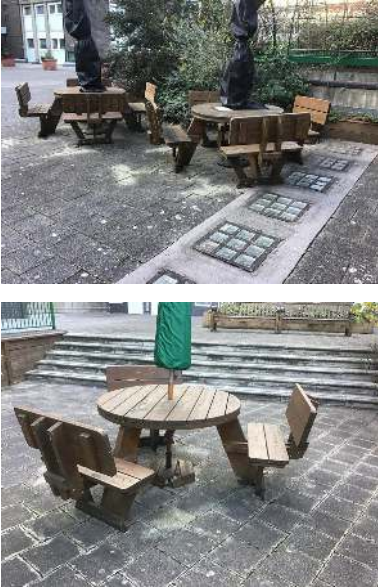
6.2	<p>The picnic benches to the podium level have insufficient kneespace under the table surface to allow their use by most wheelchair users.</p> <p>Wheelchair accessible picnic benches are available.</p> <p>The bench to the lower level does have sufficient space.</p>	Purchase wheelchair accessible picnic bench	3R	A
	6.3	<p>A range of seating opportunities is available with arm and back rests available to a reasonable proportion which will provide a useful means of leverage to an elderly or mobility impaired user.</p>

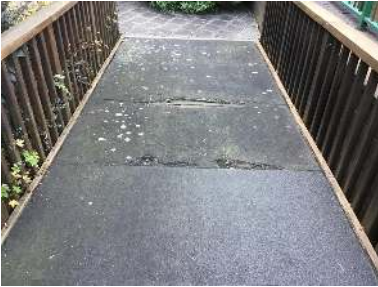
6.6	<p>contrasted to give a further clue of the flights to a visually impaired user.</p> <p>The ramp serving this lower level achieves a gradient of around 1:16 which should be suitable for most users but the worn felt covering poses a trip hazard to all.</p>	Repair felt covering to ramp	3M	A

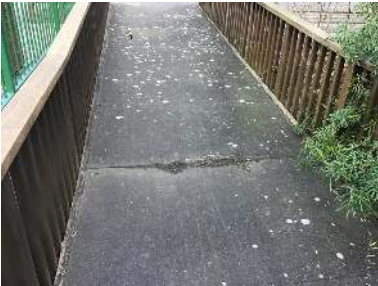
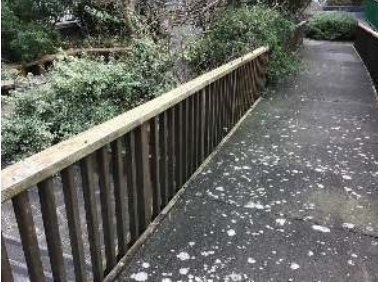
6.7	<p>The handrails to this ramp are over 100mm wide making them difficult to grip by a user with impaired dexterity to the hands such as an elderly person with arthritis.</p> <p>New rails should ideally be tubular and between 40-50mm in diameter so that they are easy to grip.</p>	Fit ergonomic handrails to ramp	3R	B

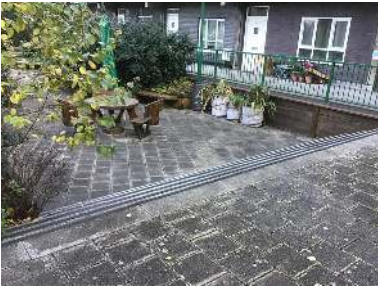
6.9	<p>Lighting to the external steps and ramp is likely to be poor given the type, number and location of light fittings, making it more difficult for a visually impaired user to identify key features such as step edges, level changes and handrails.</p> <p>In this location best practice recommends that a lux level of 30lux is achieved at step level.</p>	Install lighting to ramp and steps	3R	B

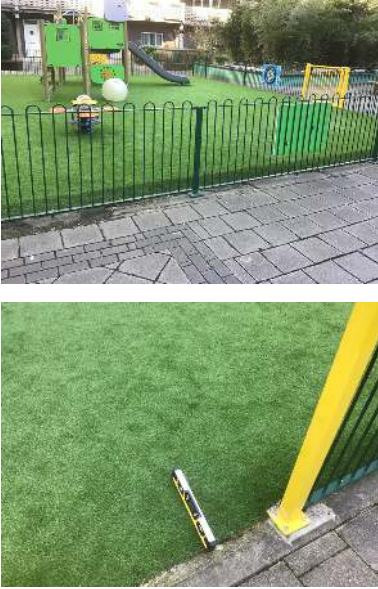
6.10	<p>The play surface would prove difficult to mount by a wheelchair user but clearly a flush surface would be difficult to achieve given the deck construction.</p> <p>The ramp at the entrance is however set far too steep for safe wheelchair access at around 1:5 posing a risk of tipping to most chair users.</p>	Extend ramp to achieve min 1:12	3R	A

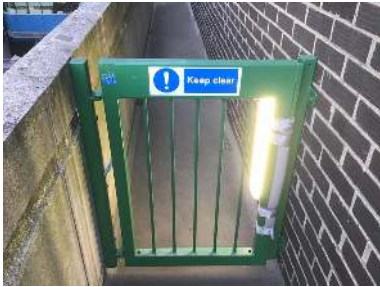
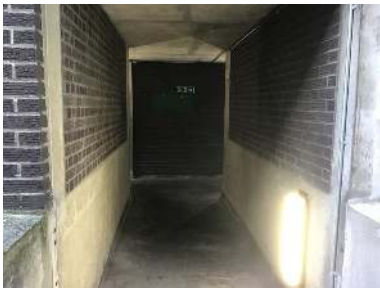
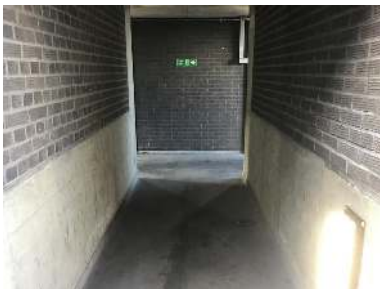
7.2		Light levels are poor in and around the lift lobbies with lux levels as low as 20 noted in daylight hours.	Upgrade lighting to lift lobby areas to achieve 100lux	3R	C
-----	--	--	--	----	---

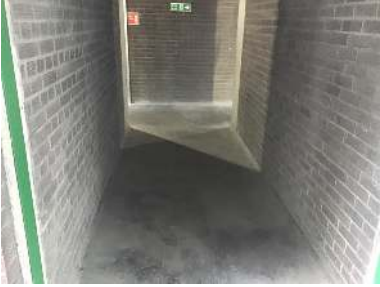
7.5	<p>socket to these recesses would allow buggies to be charged in these areas.</p> <p>The contrast between wall and floor is poor to lift/stair lobby areas. This will make it difficult for a visually impaired person to navigate these areas as walls will blend in to floors.</p> <p>This is exacerbated by the poor lighting to these areas.</p>

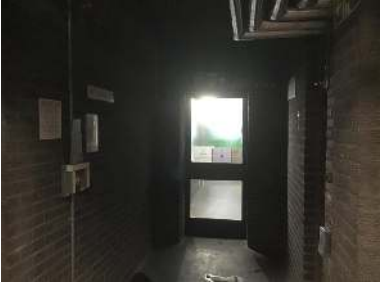
7.7	<p>Lighting is poor to the lobby and corridor linking core 4 to the ground floor car park with lux levels as low as around 25lux noted at floor level.</p> <p>Lighting is also poor to the core 2 entrance point.</p> <p>This will make it more difficult for visually impaired users to navigate the space and</p>	Upgrade light levels to achieve 100lux at floor level	3R	B

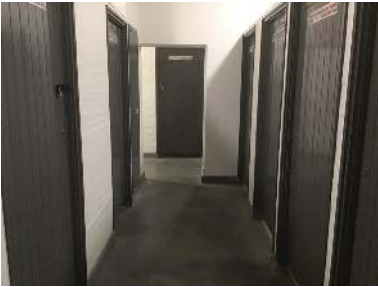
7.9	<p>Access to the refuse chutes in the tower will likely prove difficult for a wheelchair, crutch or frame user due to the restricted door widths on route and lack of manoeuvring space around the chute.</p> <p>To improve access it would be necessary to replace the double lobby doors, which achieve a clear width of only 515mm to one leaf with a single doorset but access to the chute is still likely to prove problematic unless the lobby to the chute can be removed.</p> <p>We assume the lobby is there for fire compartmentation but suggest this is investigated.</p> <p>If this cannot be altered it may be appropriate to provide a collection/ assistance service for disabled residents.</p>	<p>Review access to refuse chutes in tower</p>	<p>3R / EXP</p>	<p>E</p>

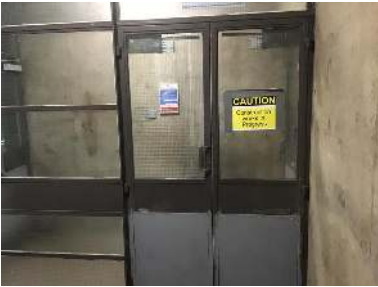
9.4	<p>We tested a sample of the internal steel doors and found that, where fitted with self-closing devices, they generally require excessive force to pull open of more than 50Newtons making them difficult to open by a user with impaired upper body strength.</p> <p>Best practice recommends a maximum opening force of 30Newtons for the first 30 degrees of the door swing and 22.5Newtons thereafter.</p> <p>Where they are not fitted with closers, such as to the shed areas they require minimal force so the closers are the issue.</p>	<p>Adjust self-closing devices to achieve maximum 30 Newtons opening force to internal doors</p>	3M	A

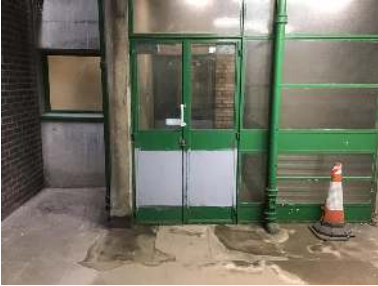
9.5	<p>The double doorsets on route from the basement car park to tower core achieve a clear width of as little as 515mm through a single leaf.</p> <p>This will make them very difficult to operate by many wheelchair users, thus in the longer term we recommend that these double door sets are replaced with door and a half sets to achieve a minimum 800mm clear width through a single leaf.</p> <p>Alternatively, they could be held open on</p>	<p>Replace basement lobby doors with door and a half sets</p>	3R / 3M	C
