THE TEMPLE, WANSTEAD PARK
VOLUME 03: CONDITION, MECHANICAL AND ELECTRICAL, AND STRUCTURAL SURVEYS
FINAL ISSUE
MARCH 2024

THE TEMPLE, WANSTEAD PARK: CONDITION, MECHANICAL AND ELECTRICAL, AND STRUCTURAL SURVEYS

CONDITION SURVEY 04

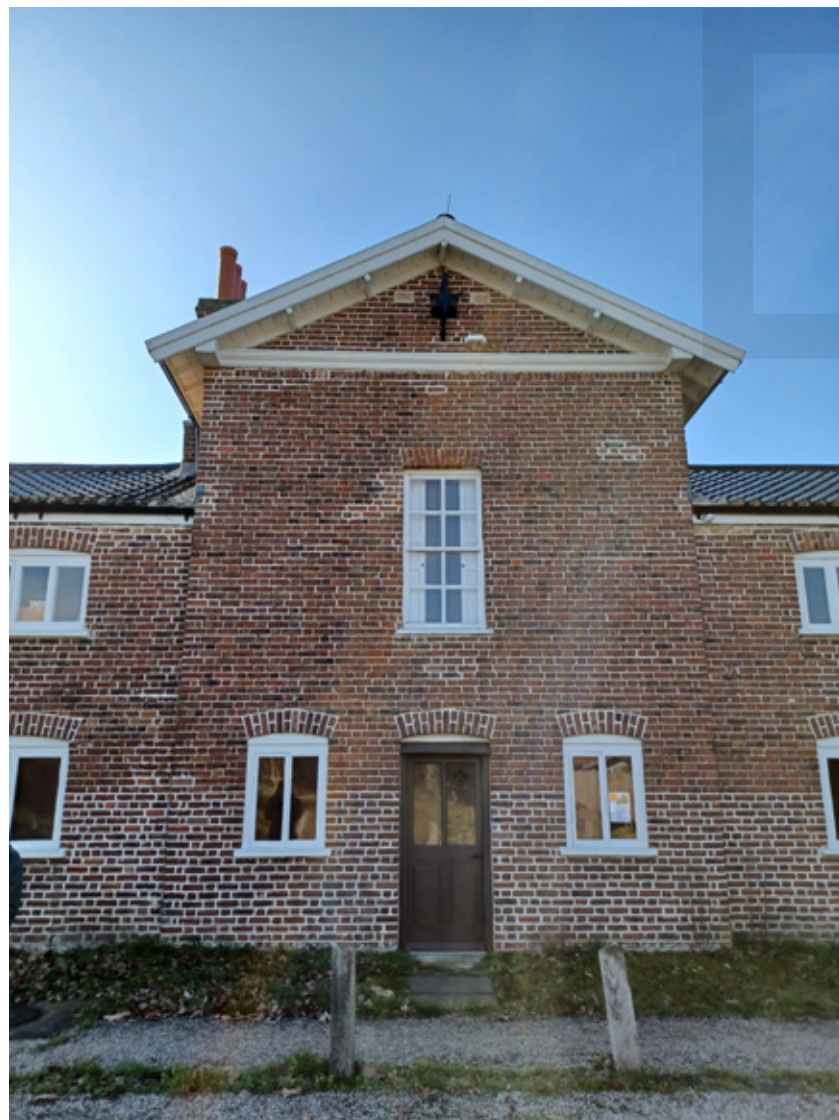
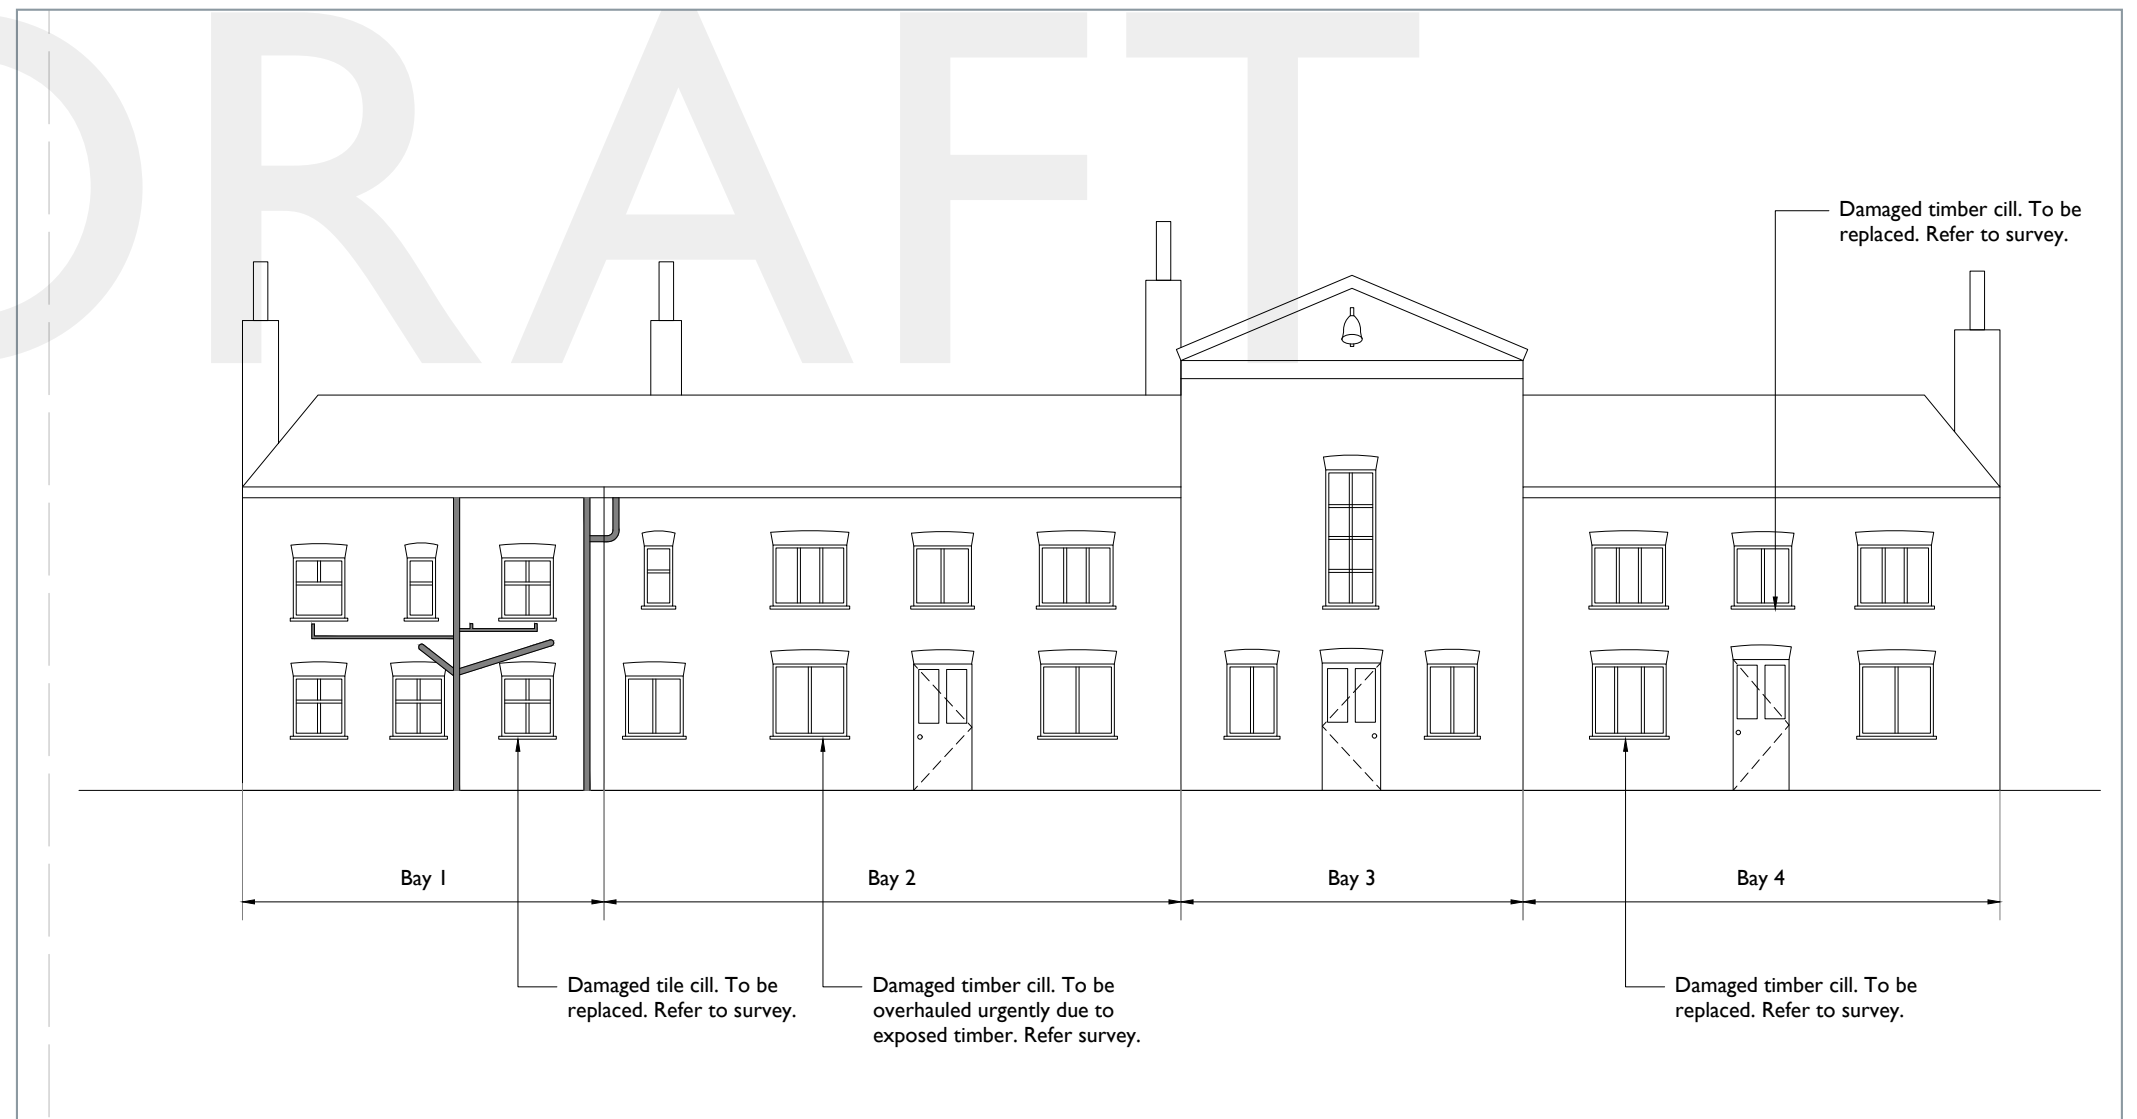
Overall, the brickwork is in fair condition with isolated instances of receding mortar and brick. On the east elevation specifically, it was noted that there were around 5 holes where previous fixing had been removed and approximately 20 bricks needing consolidation due to weathering.

The condition of the mortar is fair but previously there has been numerous external works packages to the brickwork and the different approaches are visible on the elevations with large patches of repointing in various techniques. In many areas the brickwork is starting to recede due to age and exposure and in certain places receding mortar and brickwork is due to previous repairs using too hard a mortar. We have split the repointing work into low and high level due to access needs. This elevation needs around 5.5m² repointing at low level and 4m² at high level. Mortar to the roof tile verge is in good condition along this elevation with only approximately 4 instances where repointing is needed. The roof returns either side of bay 3 are in bad condition. Mortar to the roof verge tile is missing or damaged along both lengths and needs to be wholly repointed.

The external windows and doors are in a fair condition. However, to prevent damage to the fabric of the building in the future, all external windows and doors should be overhauled. Specifically on this elevation there is one damaged tile cill that will need replacing, one timber cill where flaking paint has exposed the timber beneath and will need repainting urgently to protect the timber, as well as 2 timber cills damaged beyond repair that will need to be replaced.

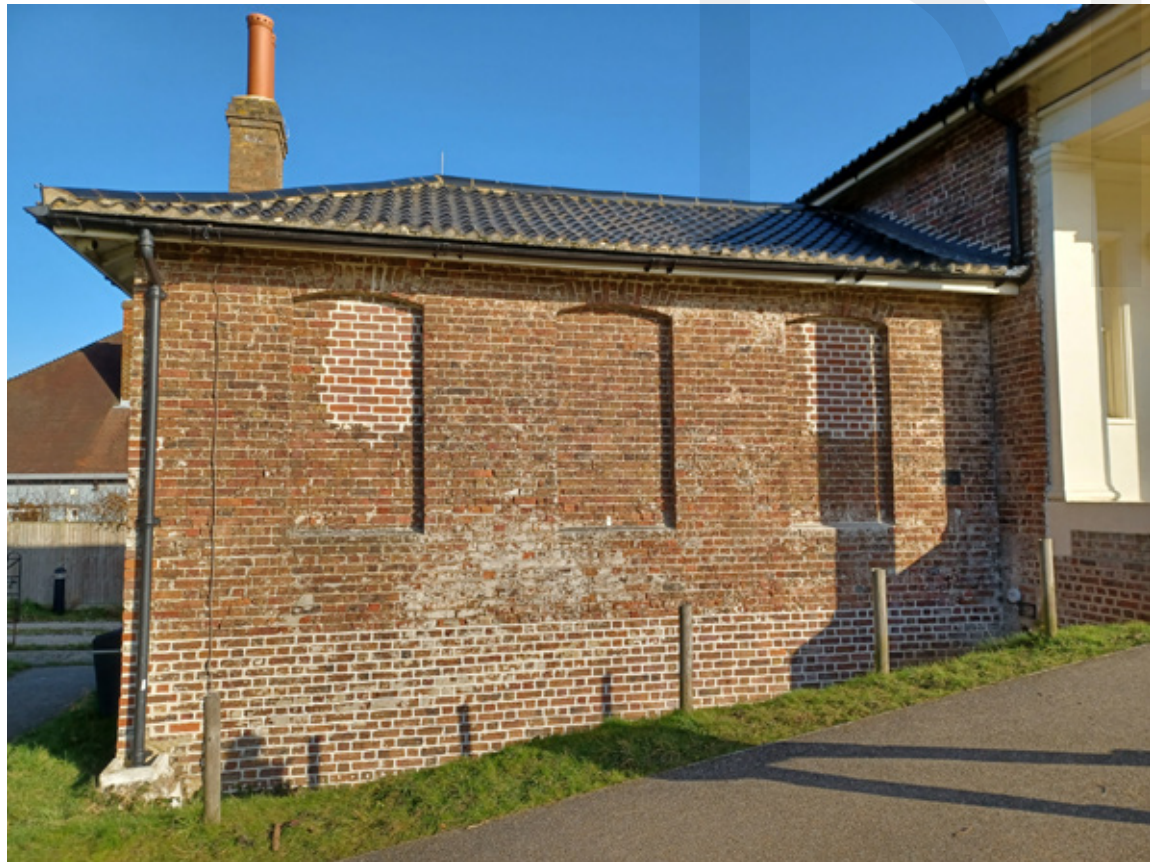
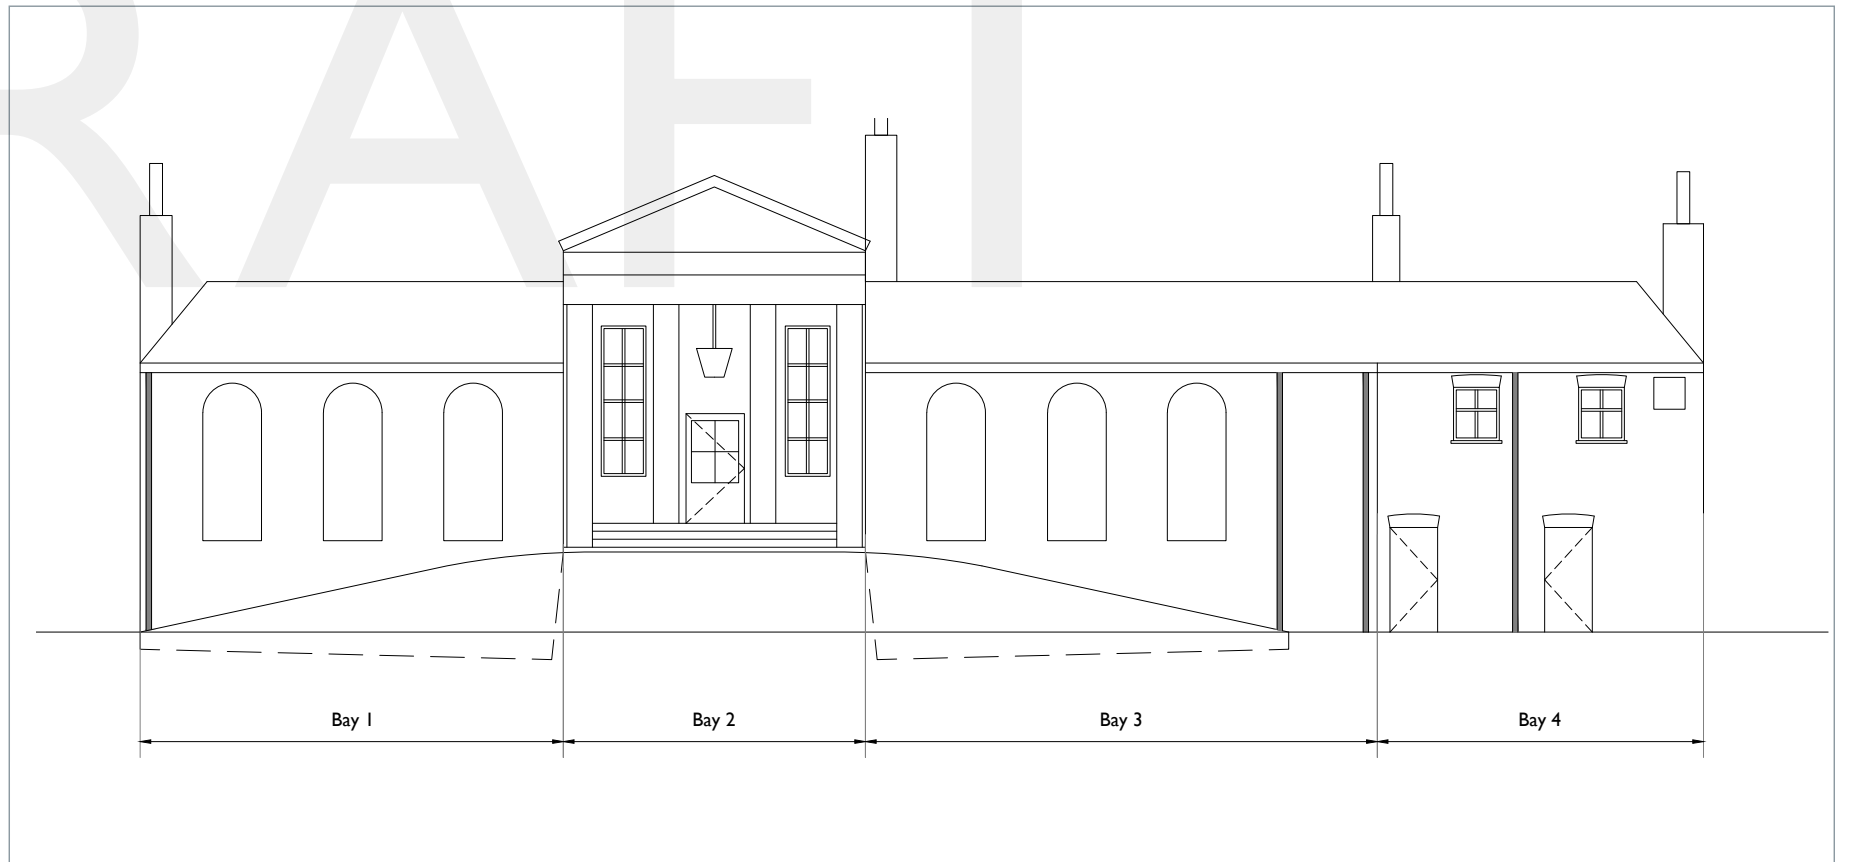
The fascia boards, rainwater pipes and gutters are in good condition. The left hand side rain water pipe on bay 1 is noticeably loose at the lower section and needs to be refixed.

Overall, the brickwork is in fair condition with isolated instances of receding mortar and brick. On the west elevation specifically, approximately 30no. bricks needing consolidation due to weathering and approximately 10 bricks are in poor condition and will need to be cut out and replaced. The condition of the mortar is fair but the various repointing techniques are evident as on the other elevations. This elevation needs around 5m² repointing at low level and 0.5m² at high level. Mortar to the roof tile verge is in good condition along this elevation with only approximately 17 instances where repointing is needed.

The external windows and doors are in a fair condition, however, as on the east elevation, to prevent damage to the fabric of the building in the future, all external windows and doors should be overhauled.

This elevation contains the Doric portico, painted white and accessed by a shallow flight of stone steps. Access to the upper-ground floor of the central cell is provided by a timber panelled and glazed door with a timber hood over and 8-light sash window, timber framed sash windows on either side. The high level render on the outside of the portico is in good condition. However, the finish to the interior of the Portico is flaking and cracking. This needs to be removed, prepared and repainted to prevent exposed timber. It is assumed that the finish to the 4 columns is inappropriate as the paint has blown and cracked in multiple places. The columns need to be striped back to bare stone, prepared, and repainted with an appropriate finish.

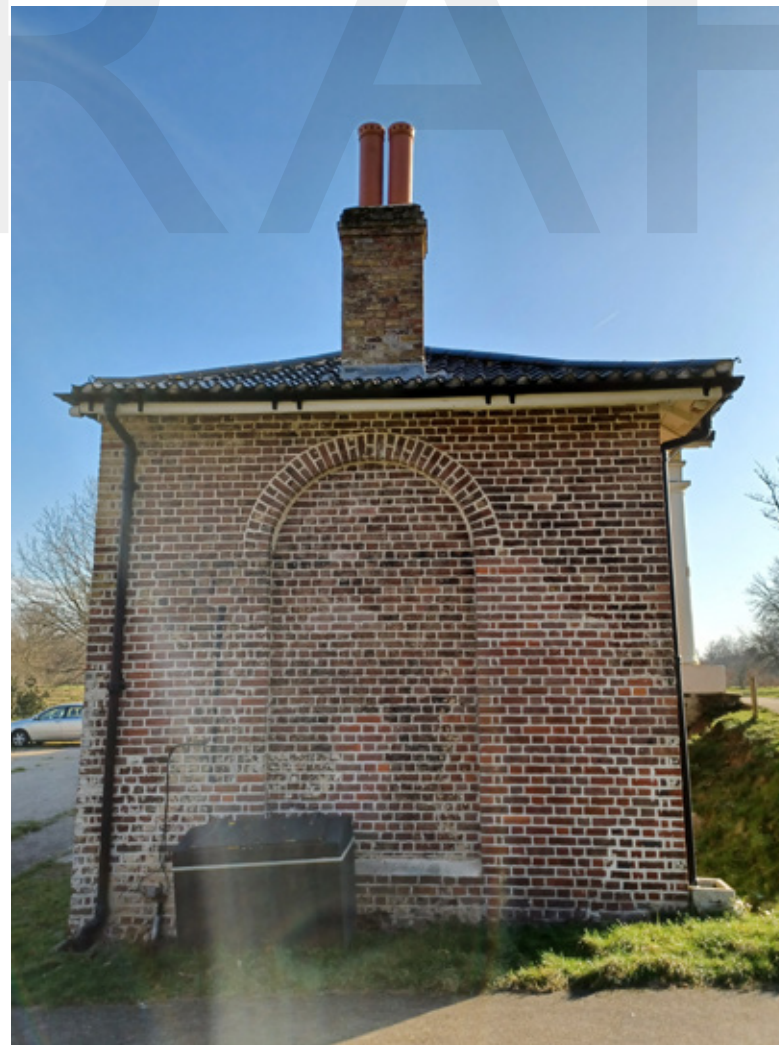
Figure 5 North Elevation

This elevation contains a recessed brick arch. The brickwork and mortar on this façade is in good condition with only 1m² of brick consolidated needed.

Mortar to the roof tile verge is in good condition as is the fascia board, gutter and rainwater pipe.

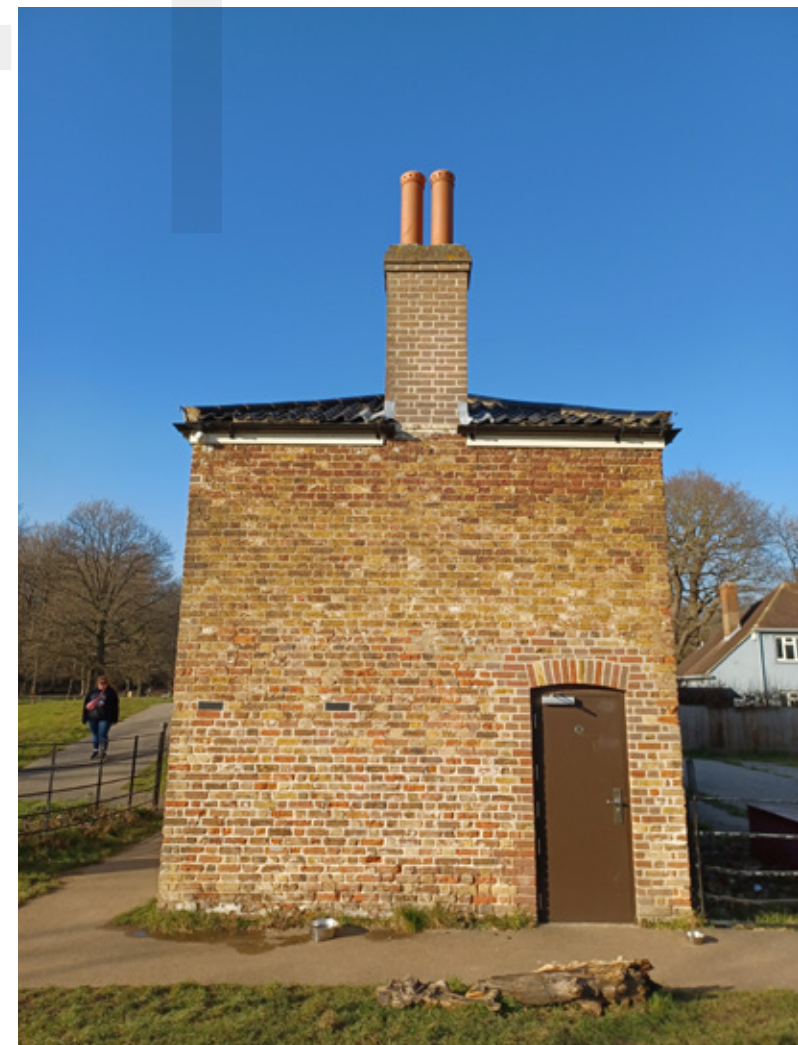
Figure 6 South Elevation

This elevation contains a single metal door that leads to the public men's WC. The brickwork and mortar on this façade is in good condition with only 0.5m² of low level repointing, 5 bricks consolidated and 5 bricks replaced.

Mortar to the roof tile verge is in bad condition along this whole elevation. The length is around 5m in total. In addition to the high level work at the roof verge, the flaunching to the chimney is flaking away. This needs to be removed and replaced to match existing

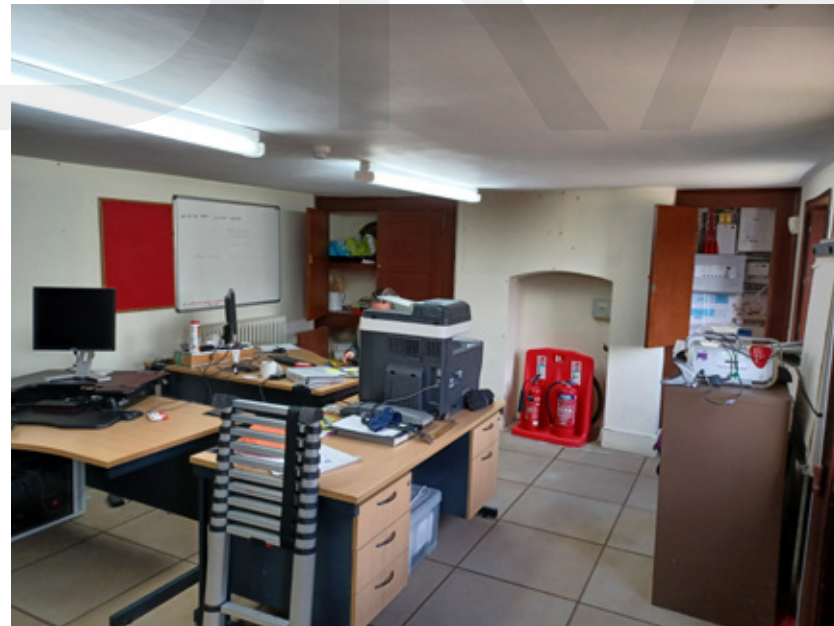
Figure 8 LG01 (Office)

- In LG01 (office) the left cupboard on the north wall has evidence internally of damp and salt damage. Ventilation to this cupboard should be provided to allow the interior of the cupboard to dry out.
- In LG03 (stair) there is one loose winder which should be refixed or replaced.

LG01 is the staff office accessed via the east elevation. The ceiling is lath and plaster repainted lining paper in a generally fair condition. There is evidence of previous moisture adjacent to the east elevation (external wall) but appears to be dry. The 2 strip light fixings are causing cracks to the ceiling. These need to be removed, plaster made good, redecorated and refixed.

The walls are painted plaster in generally good condition. There is localised cracking and evidence of salt damage to the north end of the east and west walls (this continues into the left hand side cupboard on the north wall). The cupboards on the north wall are in generally good condition. The right-hand side cupboard contains the alarm system and the door is damaged. The interior decoration is flaking and the plaster is failing. The chimney between the cupboards is missing a grill but is otherwise in good condition.

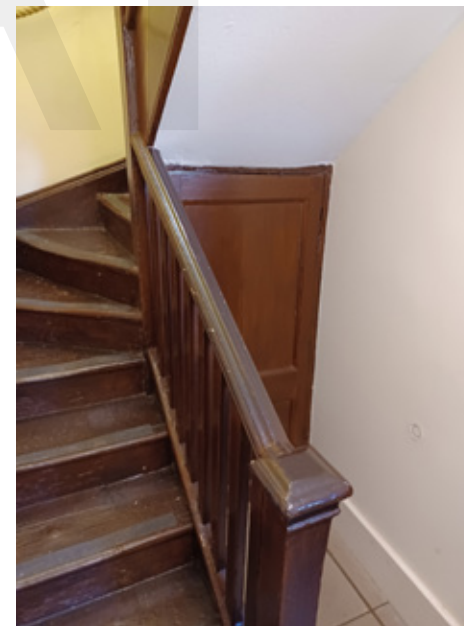
Figure 10 LG03 (Stairs)

LG03 is the staircase to the upper ground floor level. The walls are in good condition other than a large crack to the plaster to the top of the door as well as damage to the plaster where the under-stair cupboard door has hit the wall. Cracking to the decorative finish is evident on the upper level, specifically to the corners of the walls.

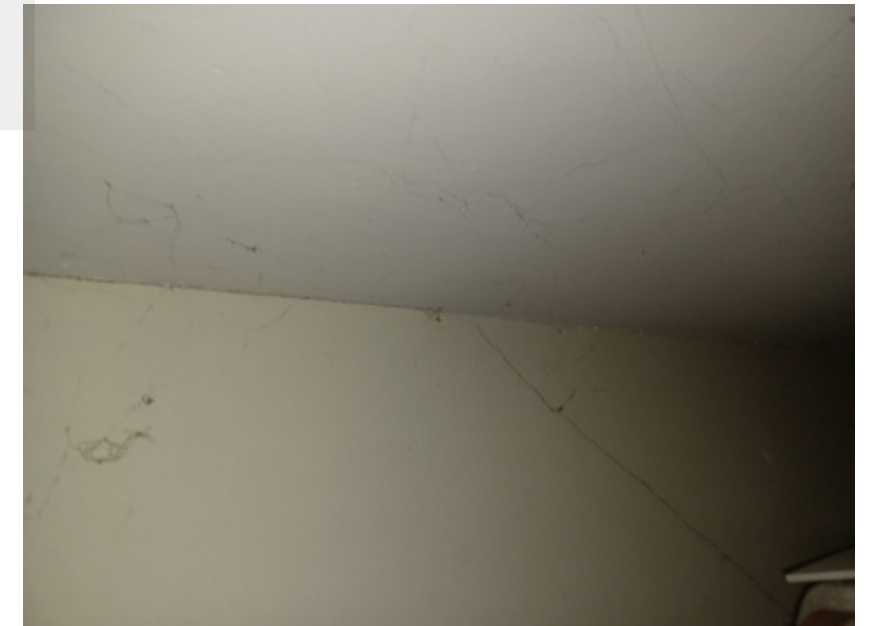
Figure 9 LG02 (Store)

LG02 is a cleaning store in generally good condition with localised cracking to the walls.

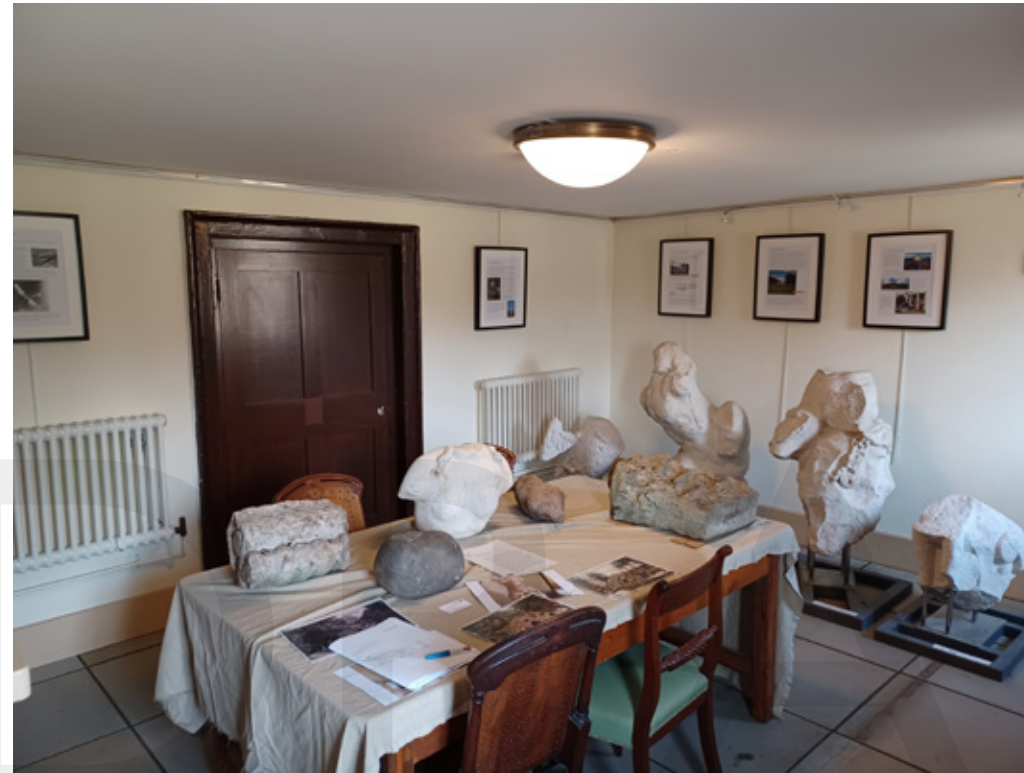
Figure 12 LG04 (Display Room)

LG04 is one of The Temples display rooms. The ceiling is lath and lime plaster with painted lining paper, however the plaster is cracking in places. The cupboard to the south wall is damaged and cannot lock or close properly. The stone tile floor is in good condition throughout.

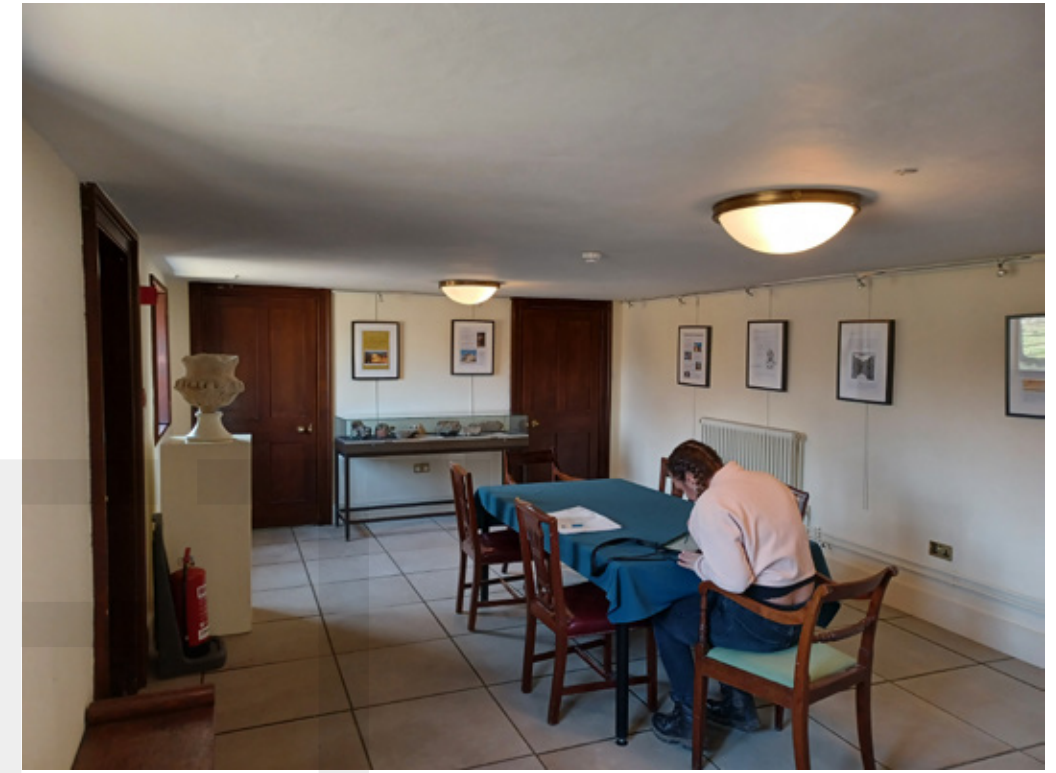
Figure 13 LG06 (Display Room)

LG06 is another display room and compared to LG04 is in good condition overall. The chimney was noted to be blocked with no vent.

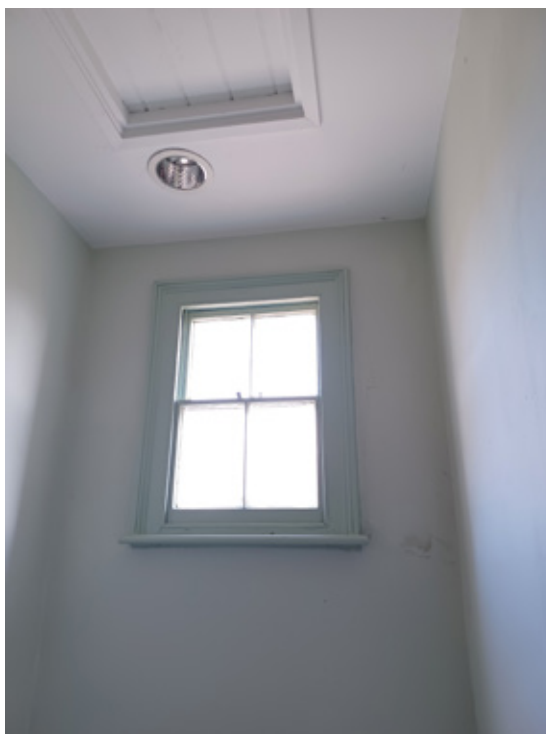
Figure 14 LG07 (Stairs)

LG07 is the southern staircase and is in good condition with minor issues of flaking to the upper landing walls and around the window on the west elevation. The stairs themselves are sound and the ceiling finishes appear in good condition.

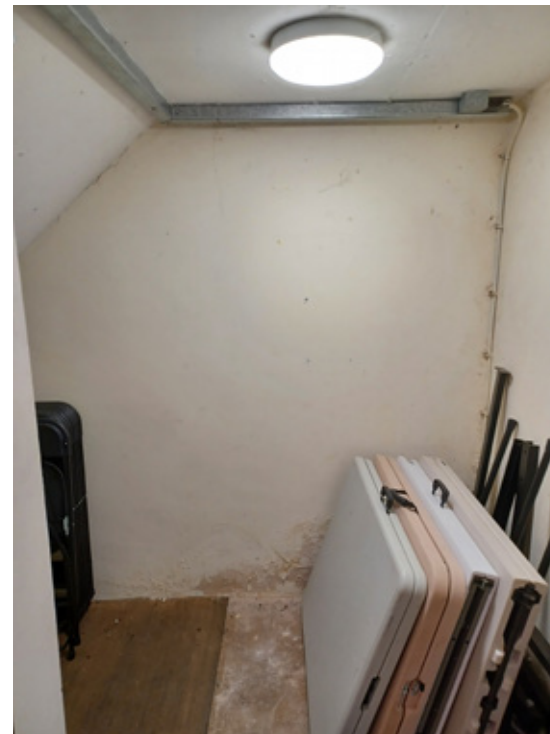
Figure 15 LG08 (Store)

This electrical storeroom has evidence of salt damage at the bottom of the south wall. The floor is concrete but is in good condition.

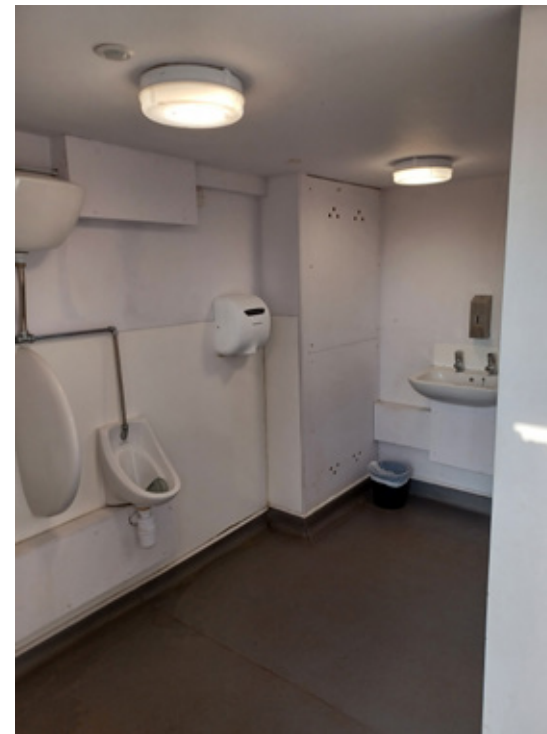
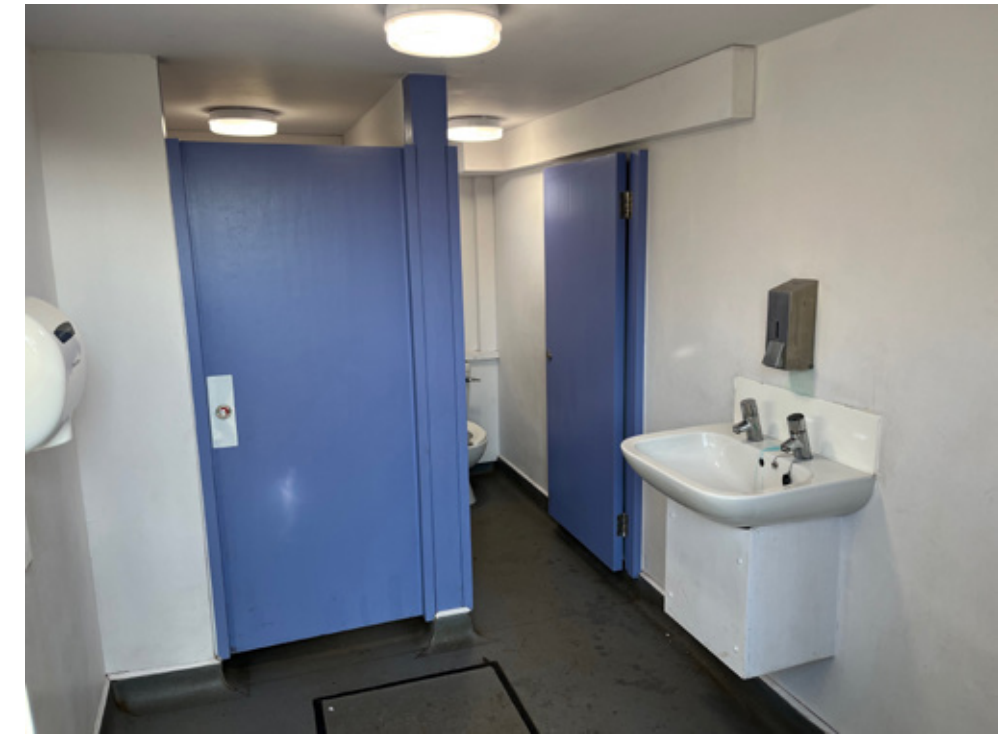
The public WCs are in fair condition with worn finishes and visually would benefit from a deep clean to bring the floors back to a good visual condition.

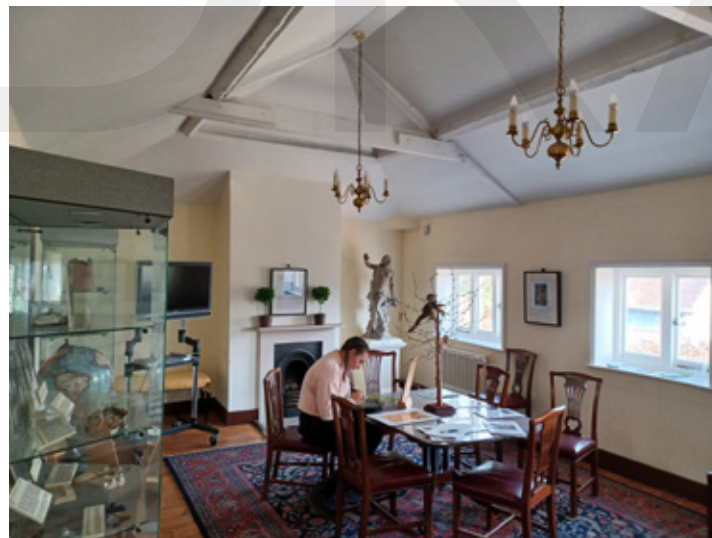
Figure 18 UG01 (Meeting Room)

UG01 is the meeting room on the upper ground floor that is not always accessible to the public but is sometimes used for events. This room is in good condition with a couple of loose floor boards that need refixing. However, they are not a hazard. There is evidence of cracking where the new partition meets the existing wall on the south side of the room. This could be due to the difference in materials and their structural movement. The crack should be filled to match existing (refer to schedule) and then monitored for further cracking.

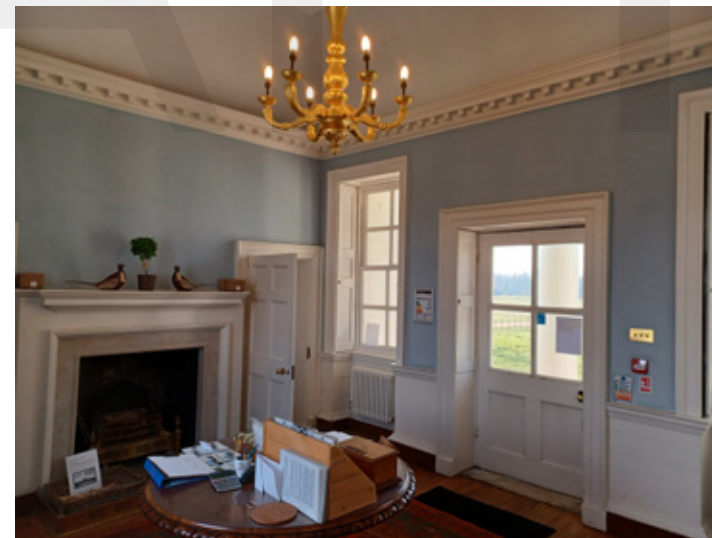
Figure 19 UG02 (Shop)

This room is the main entrance for the public with doors that lead out into the portico on the west wall. There are issues in this room with movement; a large gap between the window surround and panelling on the east wall suggests movement and should be investigated. However, this cracking is not replicated on the exterior façade.

The walls are showing cracking and flaking to finishes in multiple locations. There are also small 3mm cracks on the north and east walls. Joints are opening up around the fireplace on the south wall as well as on the west wall panelling. The finish to this timber panelling is in bad condition and needs to be overhauled. There are 4 timber, 6 panel doors into this room, all of which have evidence of movement at the panel joints.

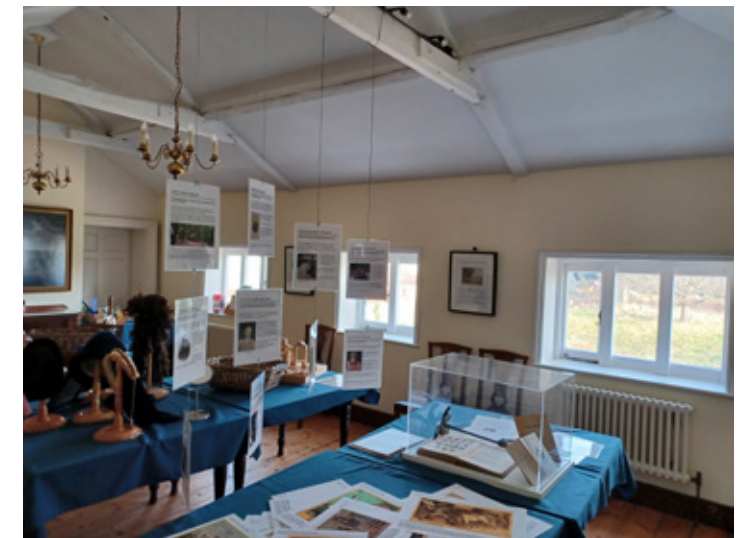
Figure 20 UG03 (Children's Room)

This is another display room that focuses on children's interaction with the building's history. This room is in good condition with timber floorboards, painted plaster walls and painted plaster ceilings. There is a hole in the west wall assumed to be a previous redundant fixing.

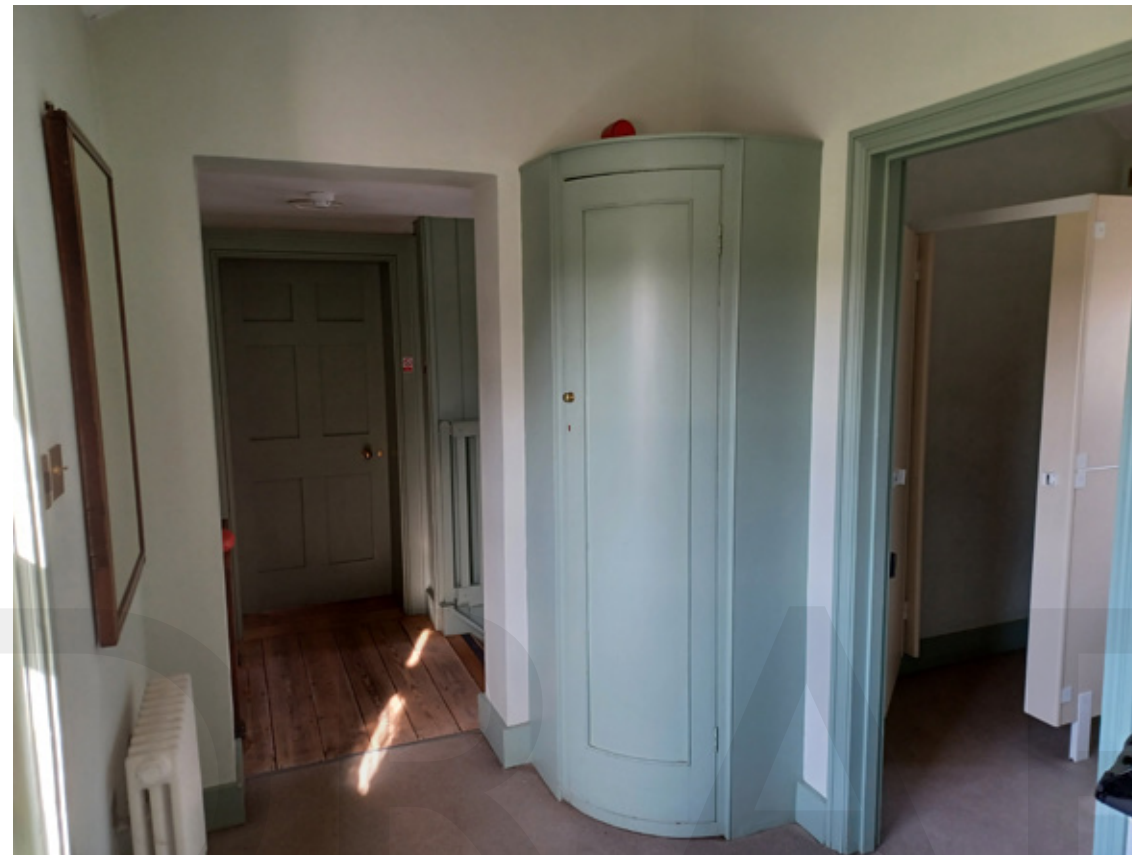
Figure 22 UG04 (Lobby)

This lobby has localised cracking to painted wall finishes. The curved timber cupboard in the corner is used as a cleaning store and is in good condition. The vinyl floor is coming away at the edges and welded joints. It is not yet a trip hazard, though it needs to be addressed before more damage is done.

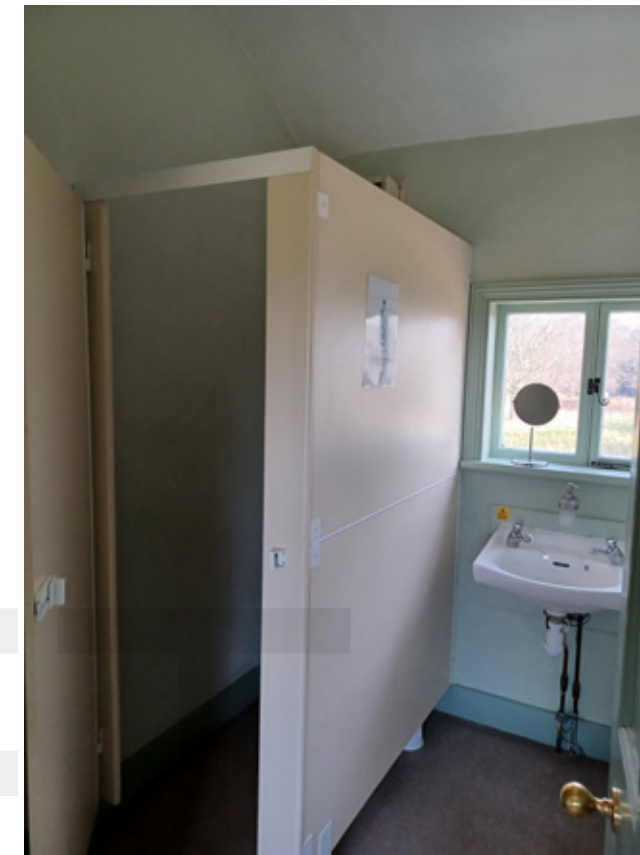
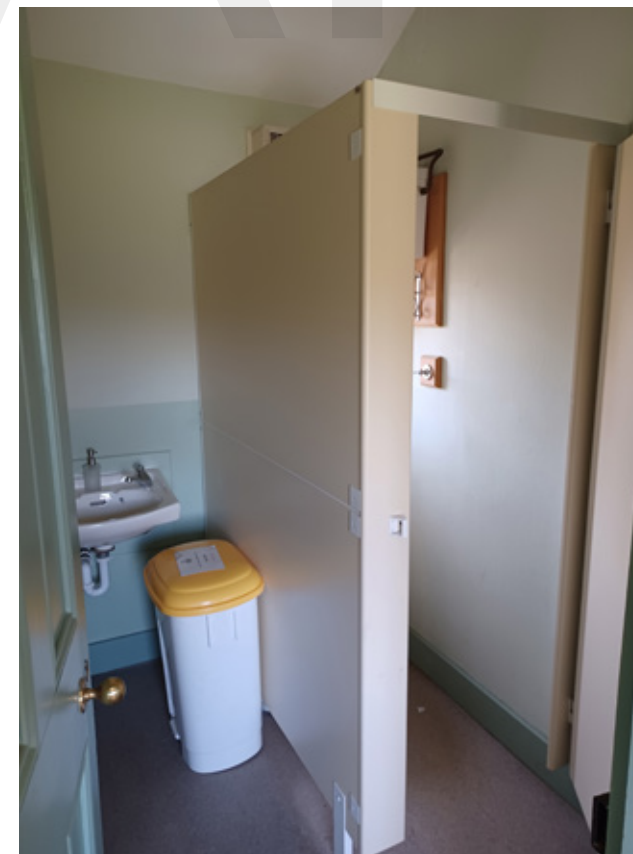
These are the staff toilets and are in a similar condition to UG04. The painted plaster wall finishes are marked with slight finish cracking in areas of traffic. The vinyl floor is coming away at the edges and welded joints. It is not yet a trip hazard, though it needs to be addressed before more damage is done or it becomes a health hazard due to increased cleaning difficulty.

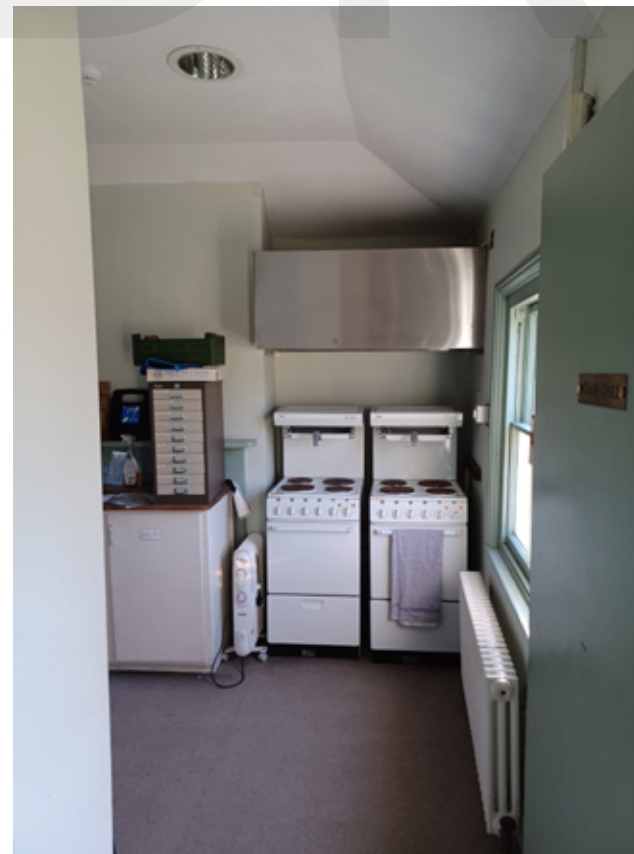
Figure 25 UG07 (Kitchen)

- The kitchen extract is not functioning and should be repaired or replaced.

The staff kitchen has localised cracking to the painted plaster finishes, though the ceiling is in good condition. As with UG04 the vinyl floor is coming away at the edges and welded joints. It is not yet a trip hazard, though it needs to be addressed before more damage is done or it becomes a health hazard due to increased cleaning difficulty. A staff member present noted the ovens have been isolated and need removing and replacing.

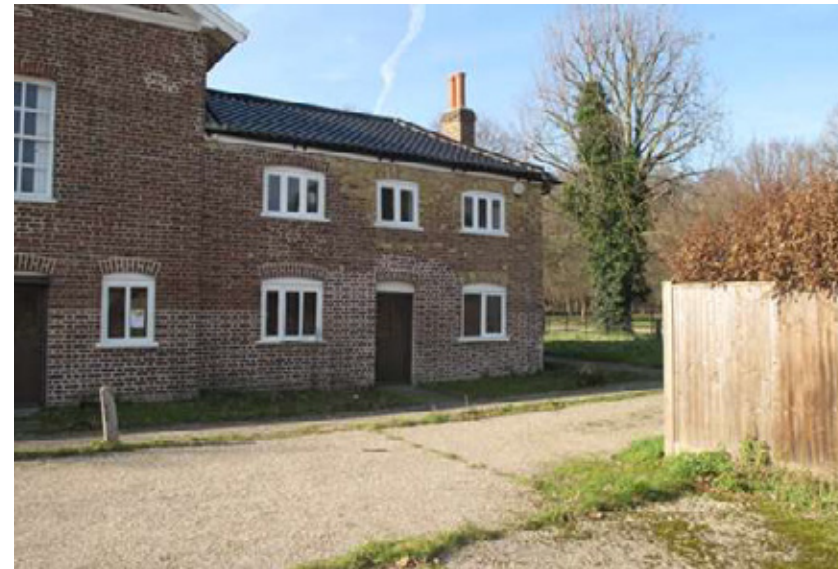
4. East elevation showing areas of previous work to the brickwork

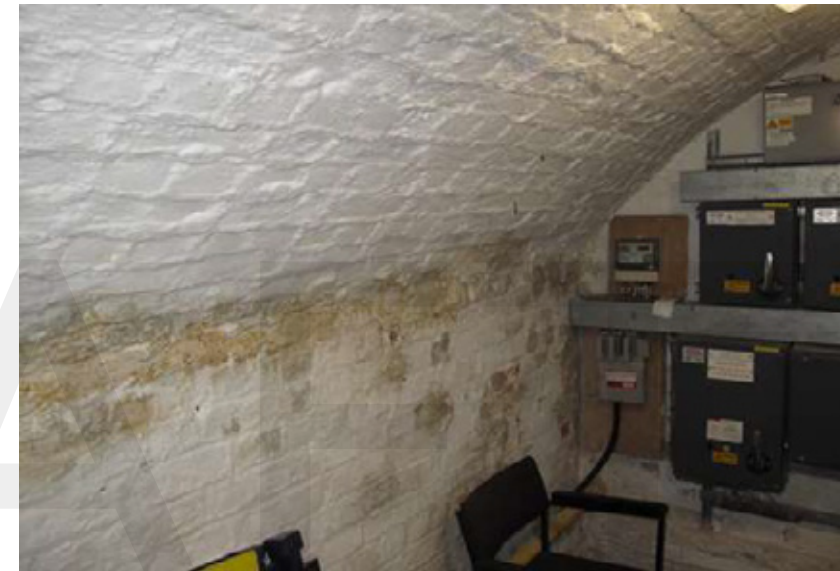
7. Vault below entrance portico showing areas of water ingress

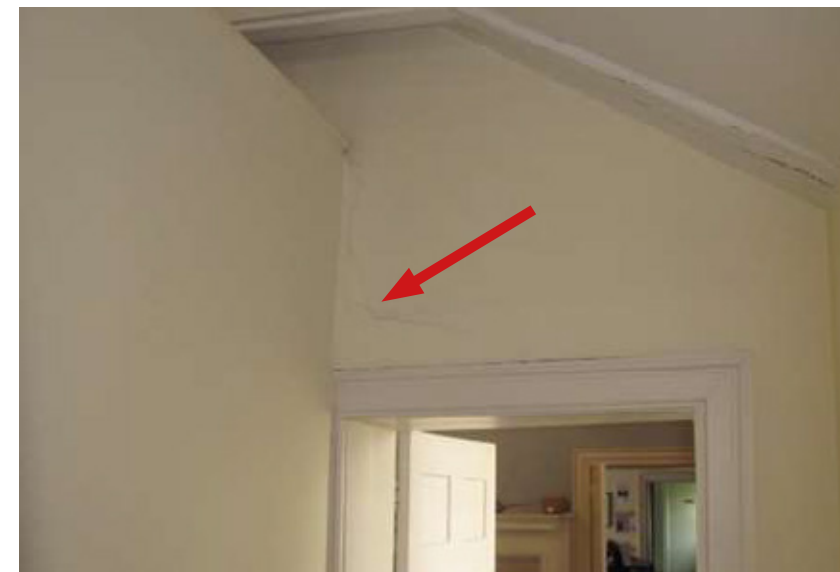
8. Upper ground floor; crack to finishes

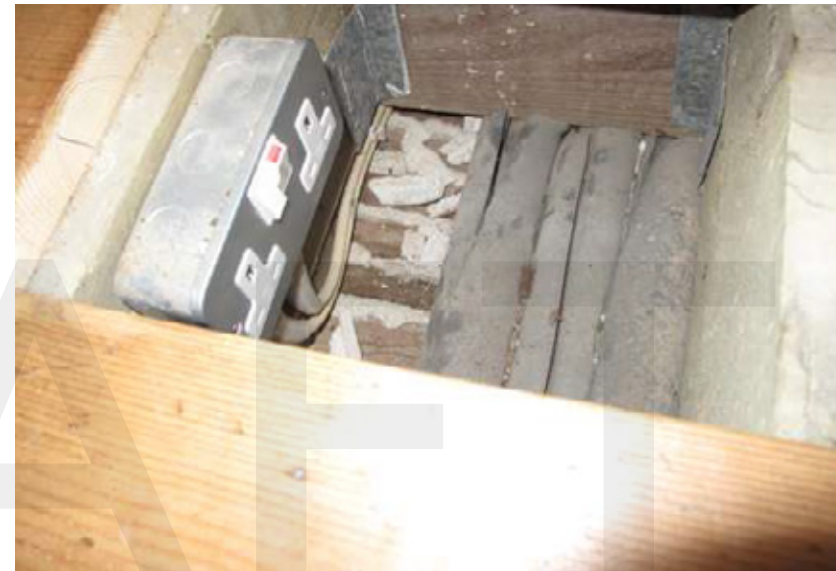
10. View into access point showing plaster debris from damaged key to timber
