Appendix 3 - Photos

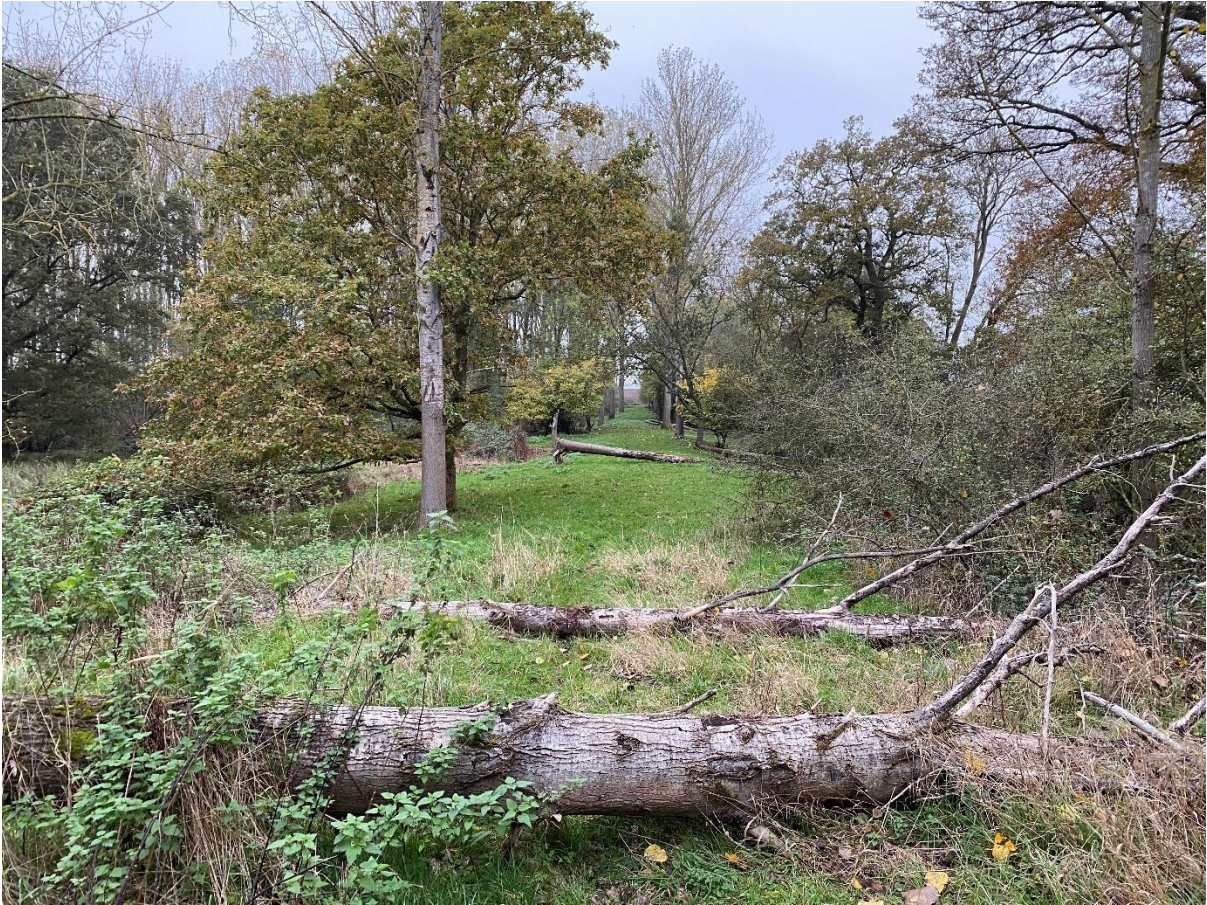
Plate 1 General view along crest of dam, from east end looking northwest, showing trees on dam slopes and in reservoir, which is on left-hand side.

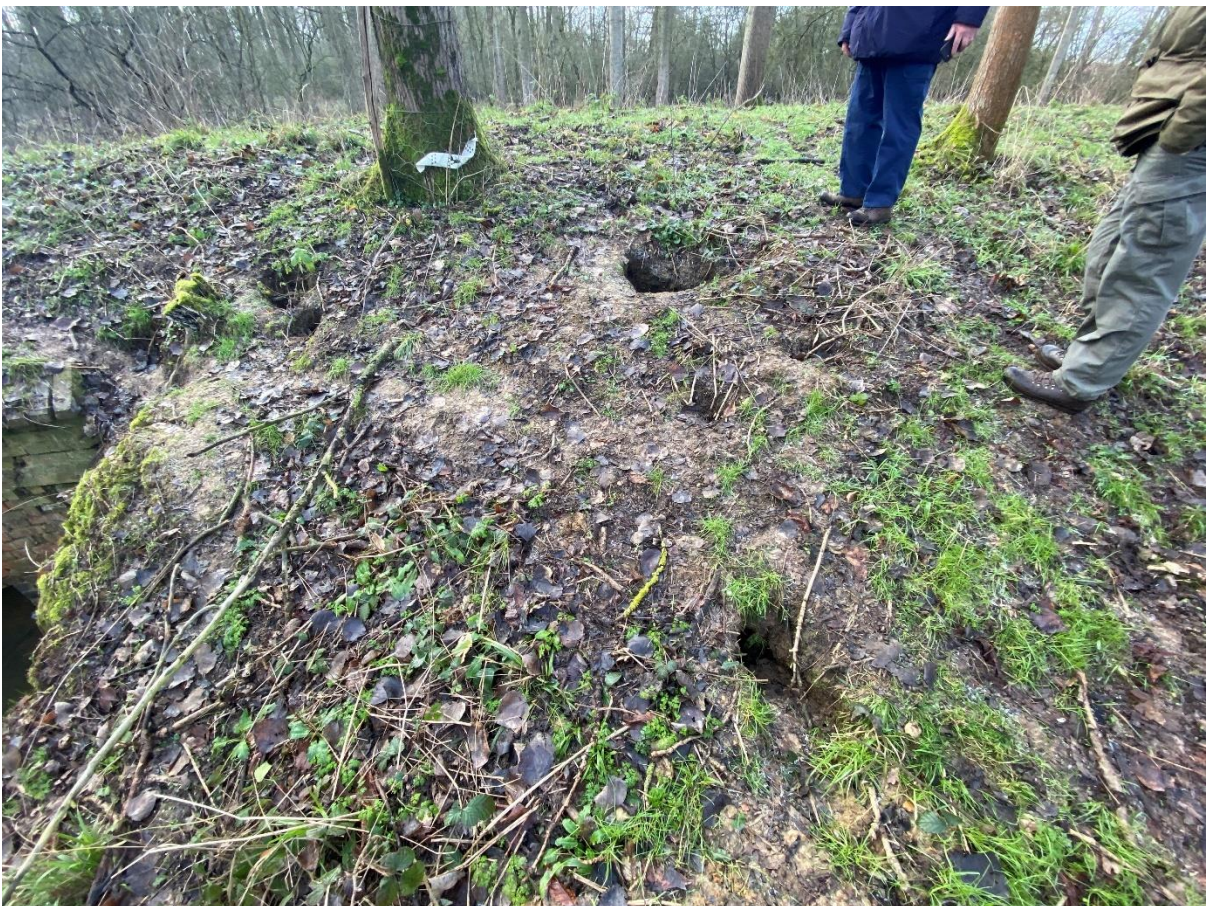
Plate 2 Example of badger burrows in the dam, near to one of the culverts.

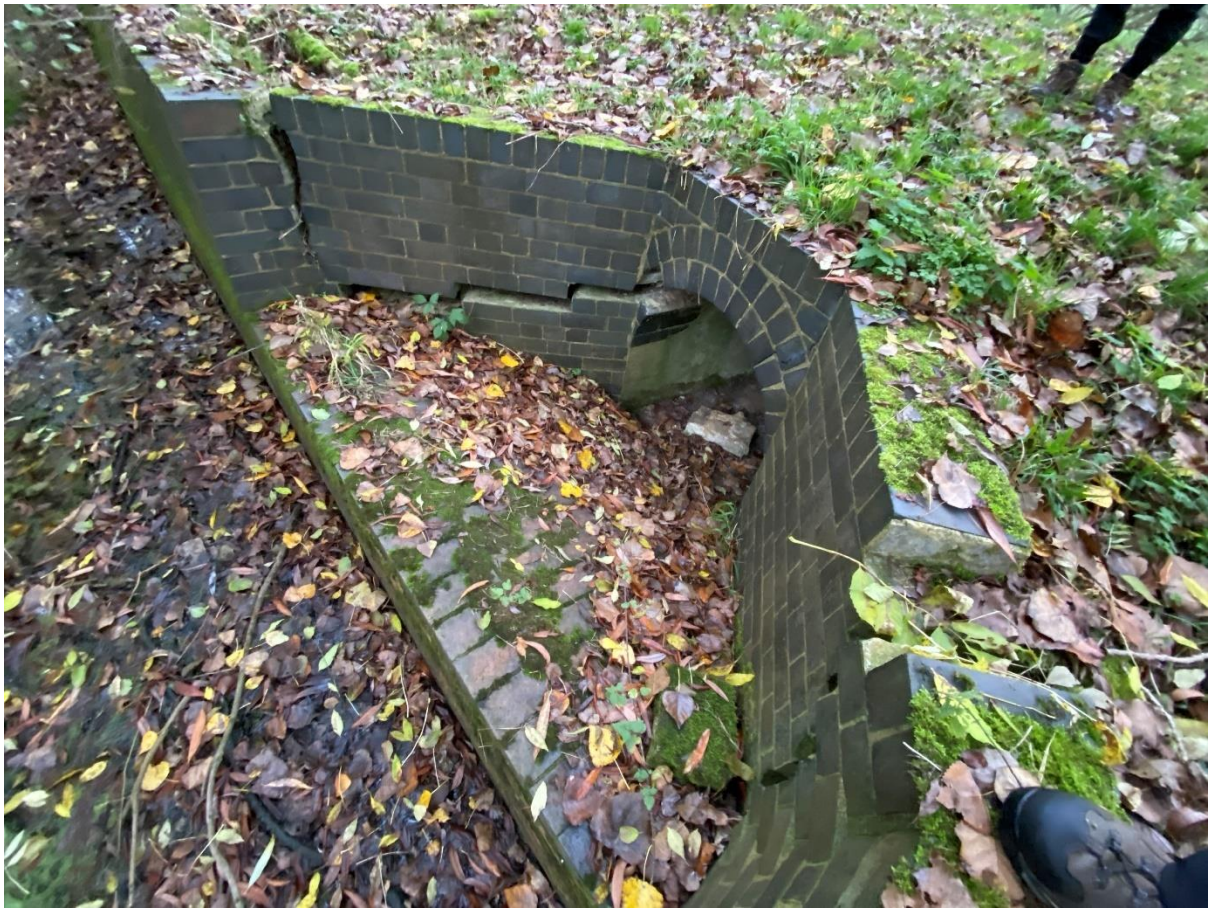
Plate 3 Headwall of one of the culverts shown sunken with broken headwall.

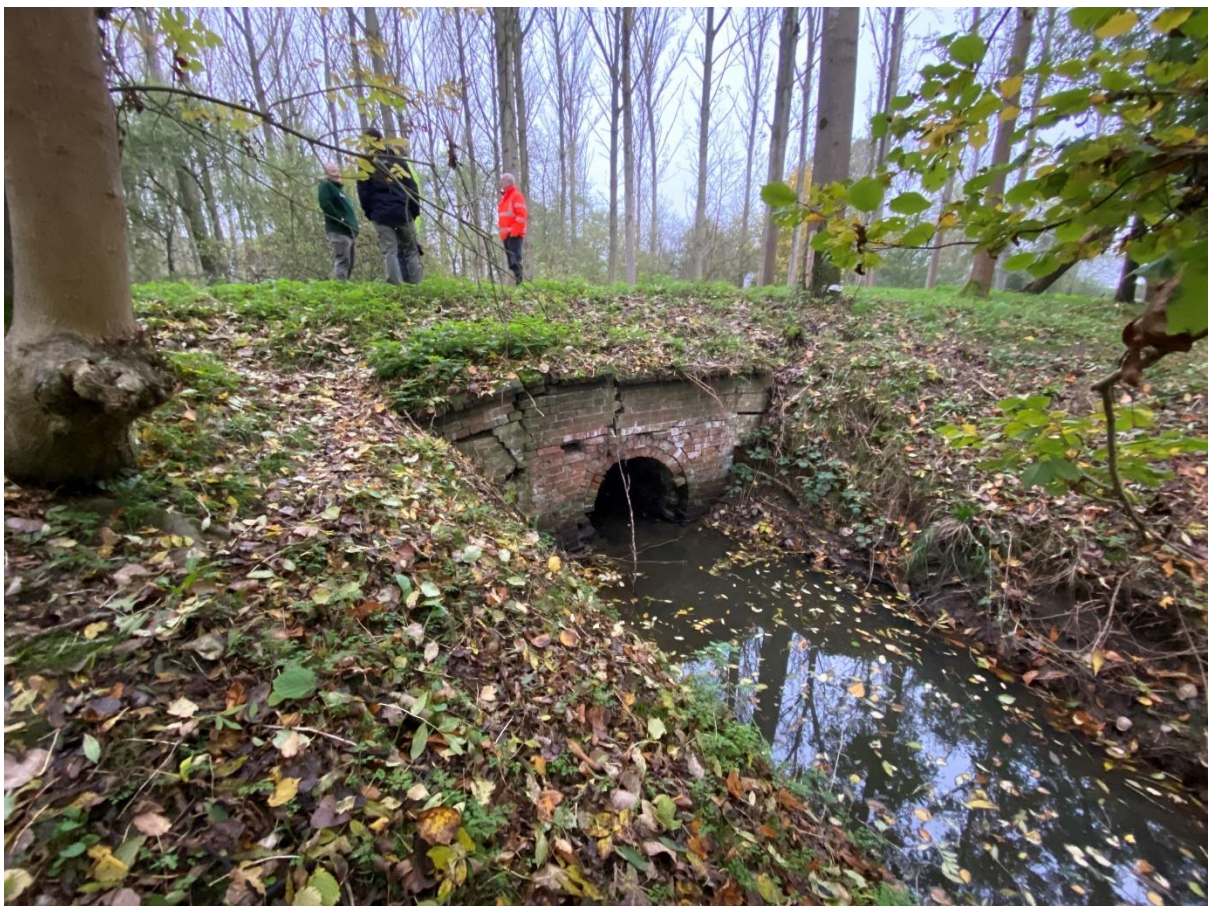
Plate 4 Headwall of second culvert shown broken, Condition of brickwork inside culvert also very poor.
