THE MONUMENT TO THE GREAT FIRE OF LONDON

VOLUME II: QUINQUENNIAL INSPECTION SURVEY

MARCH 2025

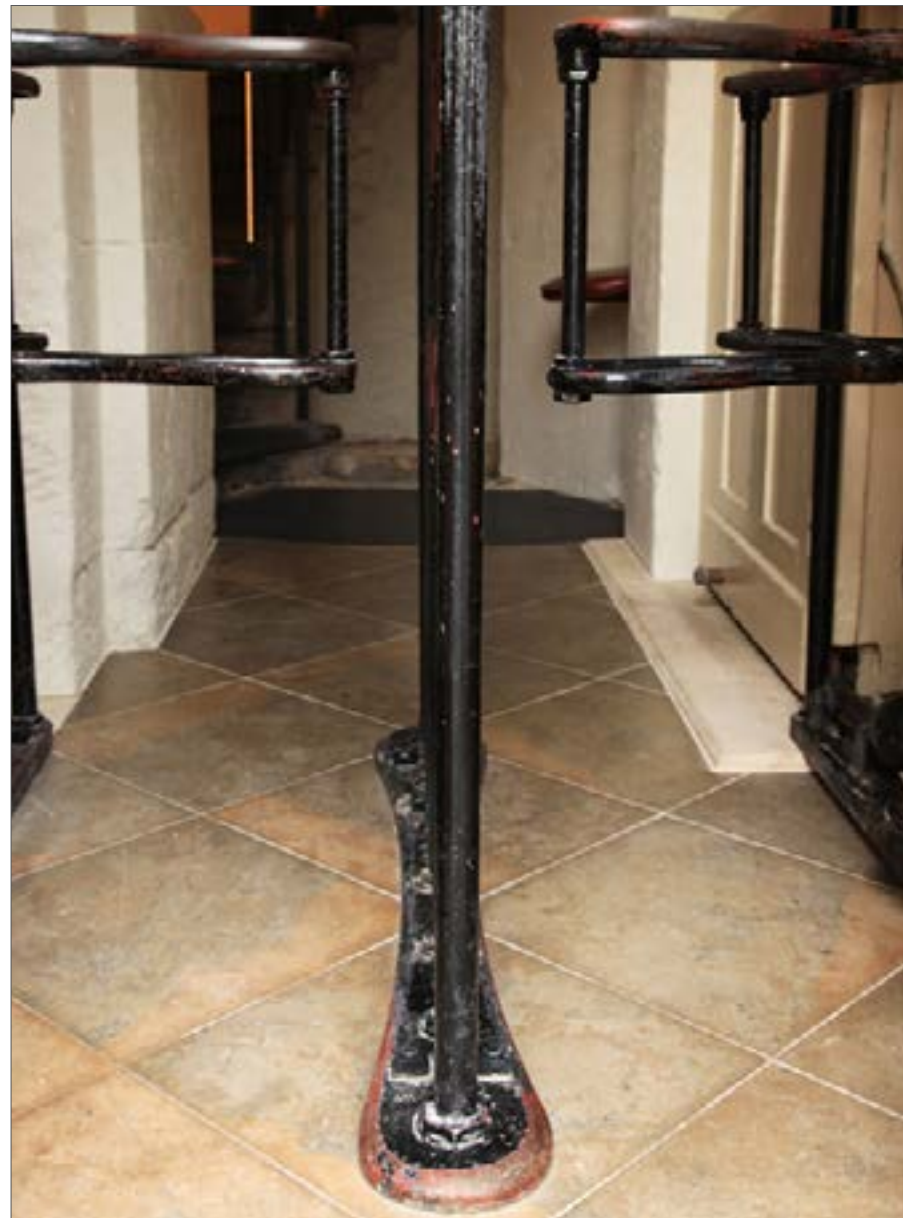
Fig. 1 c.1981 turnstiles reinstated in 2009, now partly removed, 2009

6.6F GROUND FLOOR ENTRANCE LOBBY: TURNSTILES i) Inspect the missing parts of the turnstiles to ensure they are recorded and safely stored.	B	Inc. in Staff Budget

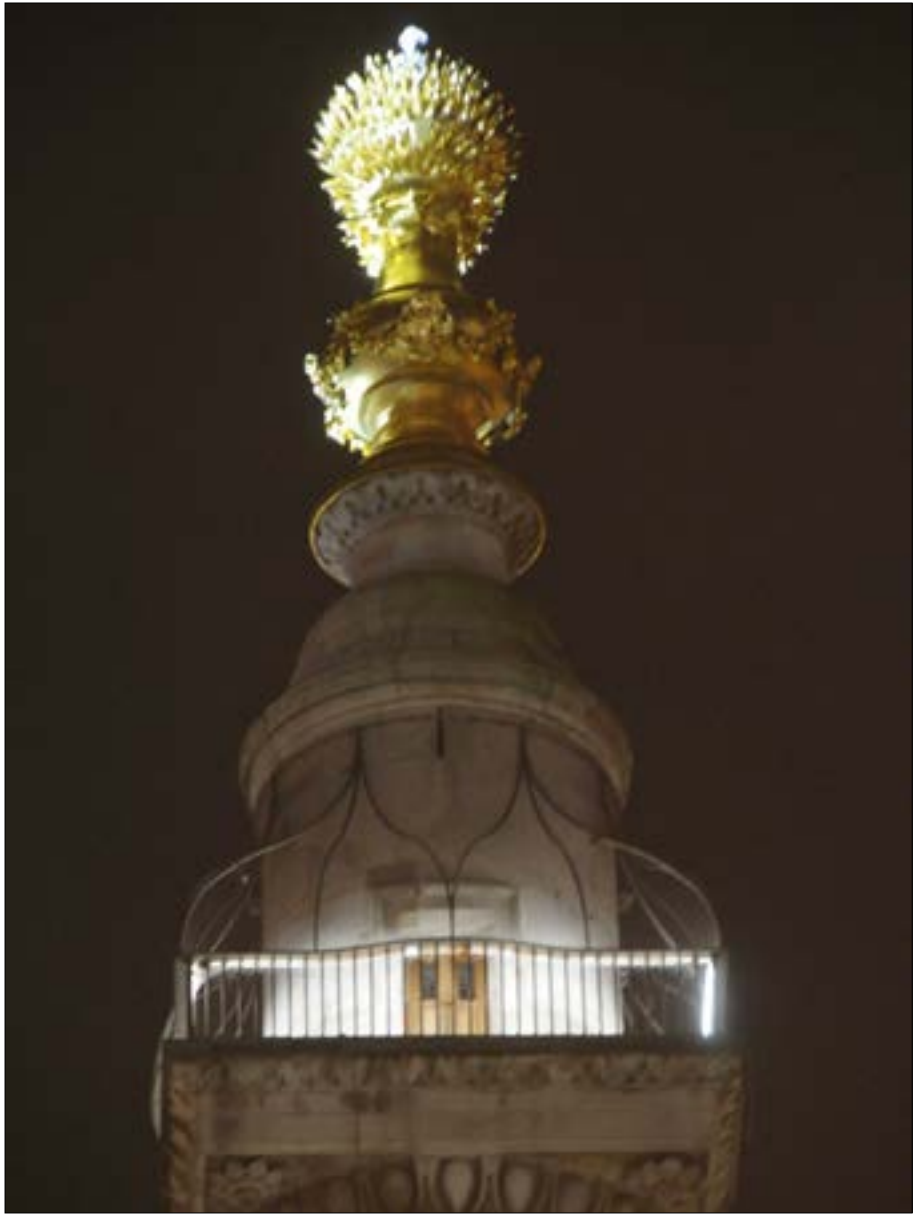
Fig. 3 Night photo balustrade glare, 2018

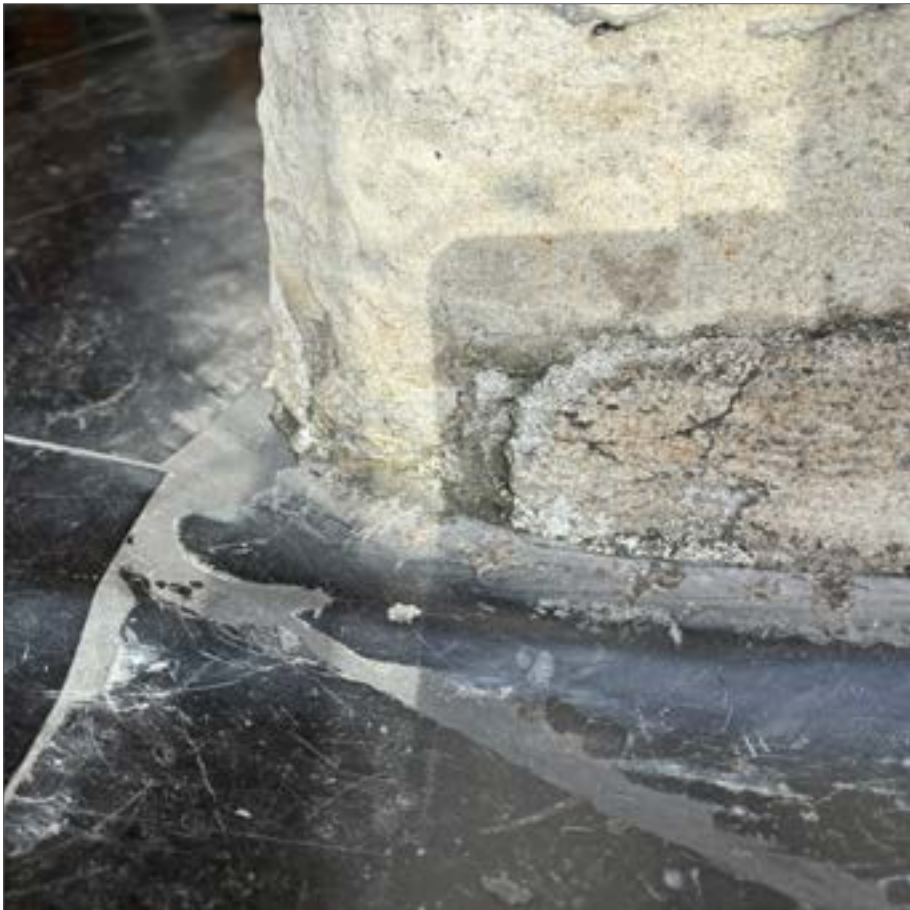
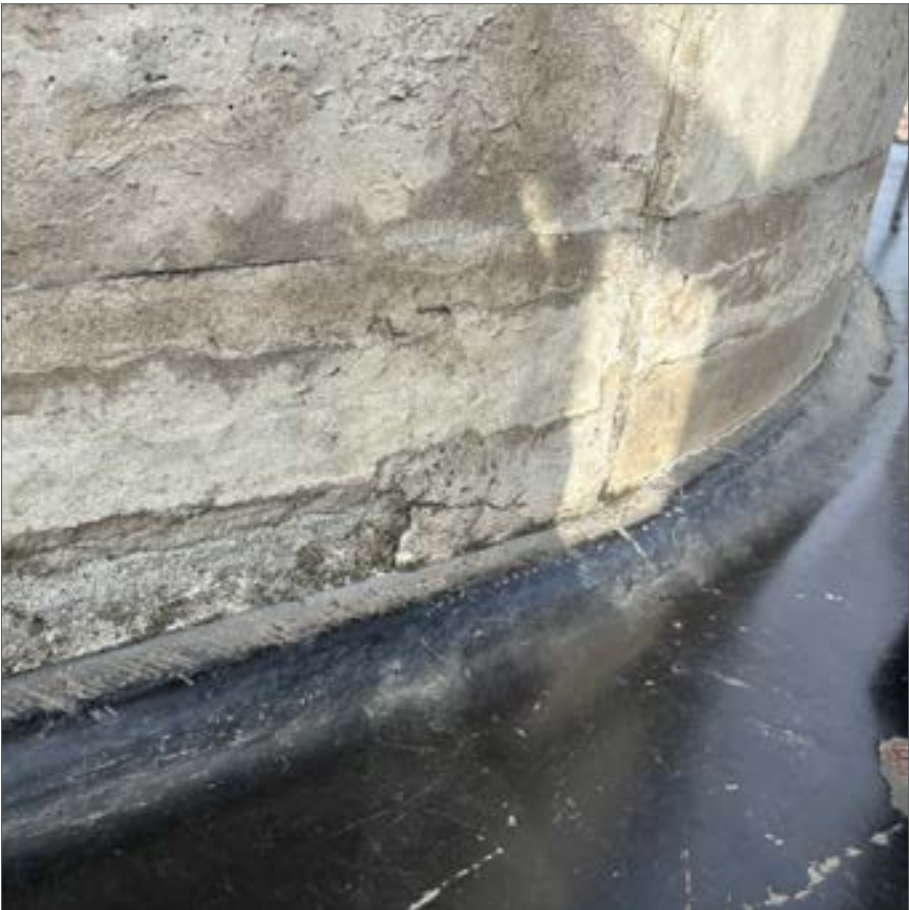
Fig. 9 & 10 Wide joint at the base of the Drum, 2024

<p>ii) Provisional sum for injecting crack repairs and using resin anchors across cracks subject to results from monitoring and inspections (minor structural interventions only)</p>	C	£7,600

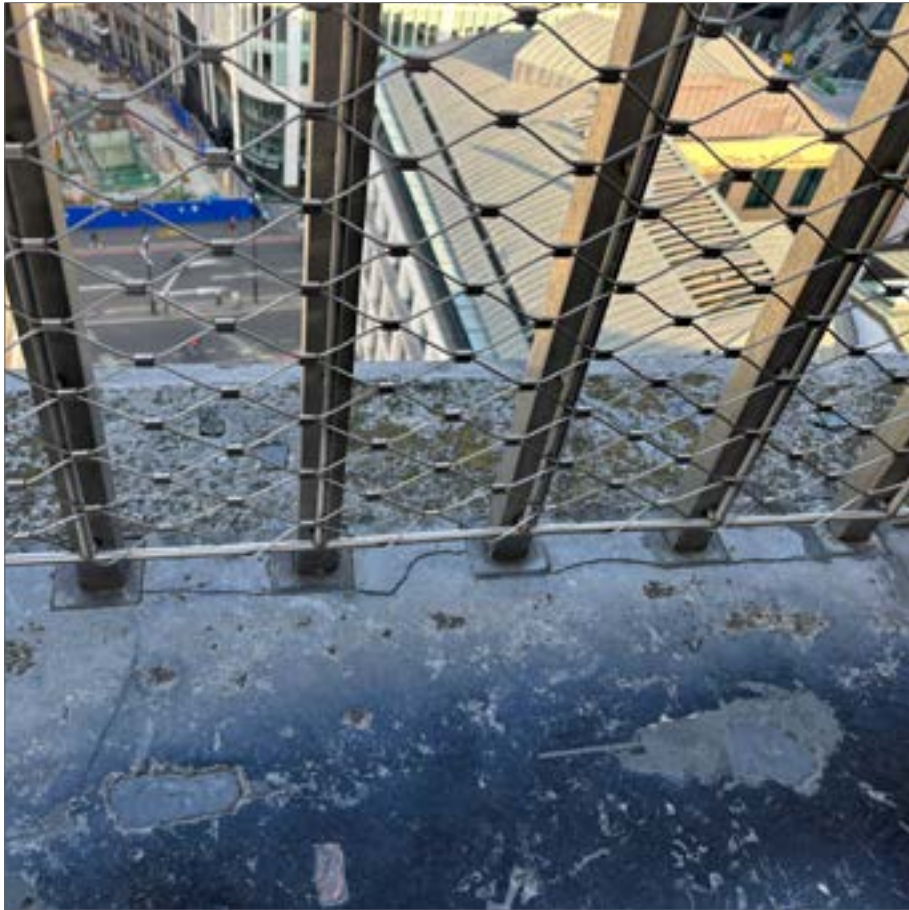
Fig. 12 Crack line along the base of balusters, 2024

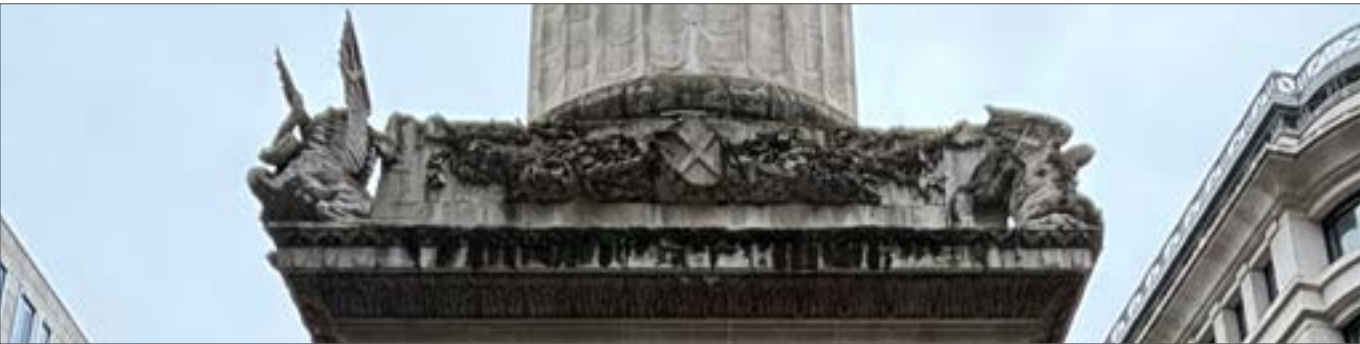
Fig. 14 North elevation Column Base, 2024

ii) Lightly steam (Doff) clean from a Moving Elevated Working Platform (MEWP) to reduce black staining		
		iii) Carefully loosen by hand any loose stonework and remove, inspect condition. Allow for this to be undertaken annually until the drip moulding is repaired.		
		iv) Natural stone indent repairs to roll moulding; consider adding a lead or Belzona protective cover flashing.

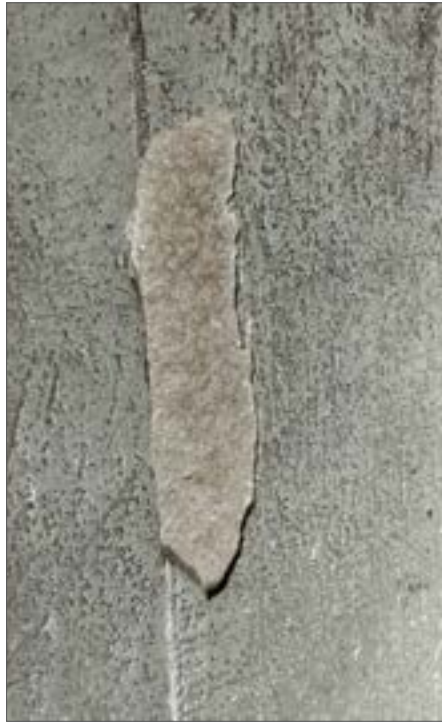
Slight hairline crack observed at window no.4 jamb
Minor areas of surface spalling at low level, likely due to damp
The wall surface has slight wearing to the paint finish where people brush against it.
The paintwork is obviously difficult to clean above a certain level.
The stairwell has been partly repainted at low-level, but paintwork has extensively eroded from the wall at approximately six stair treads up from entrance

Fig. 33 Local spalling of stonework, 2024

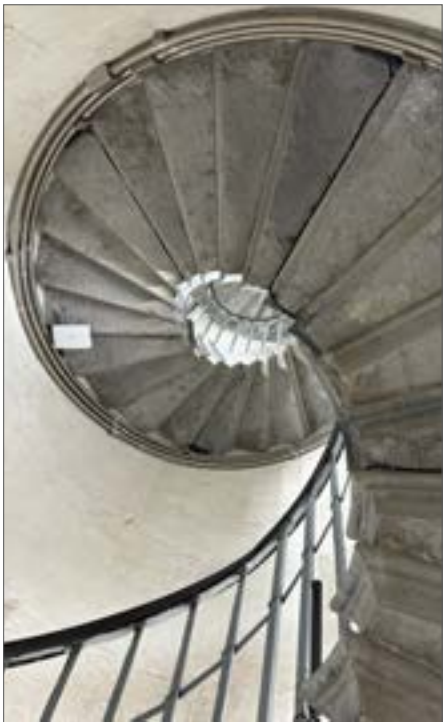
Fig. 36 Underside of stairs with pocket in stonework of central tread, 2024

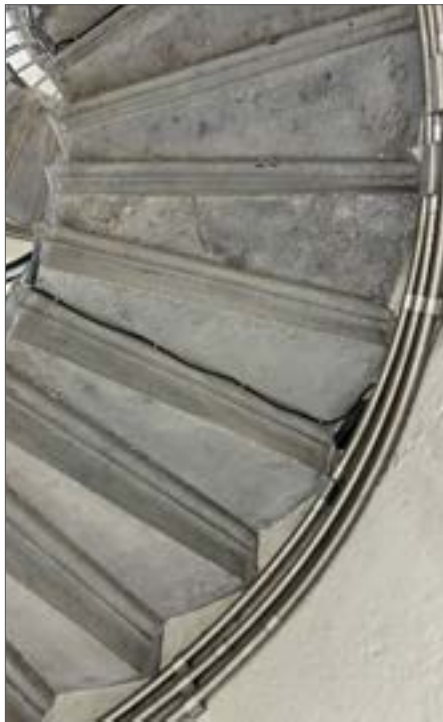
Fig. 37 Underside of one step is in markedly poorer condition, 2024

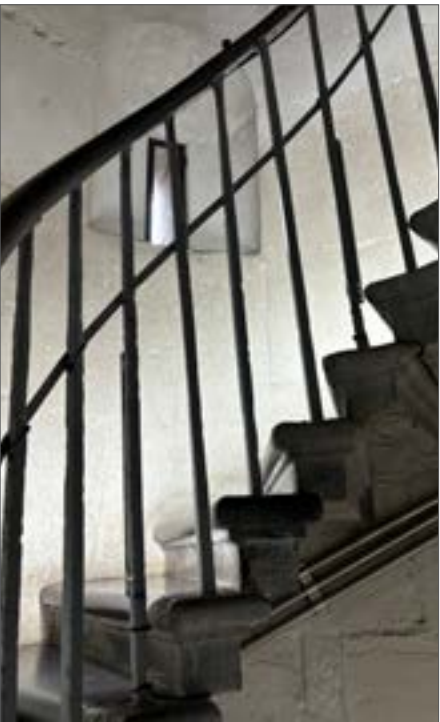
Fig. 38 Balustrade strap detracts from the simplicity of the interior, 2024

ii) Redecoration, locally	C	£1,500
		iii) Redecoration, fully	C	£14,000
		iv) The structural engineers report recommends the balustrade strengthening details are undertaken, as proposed by Hockley & Dawson in 2016	C	£55,000

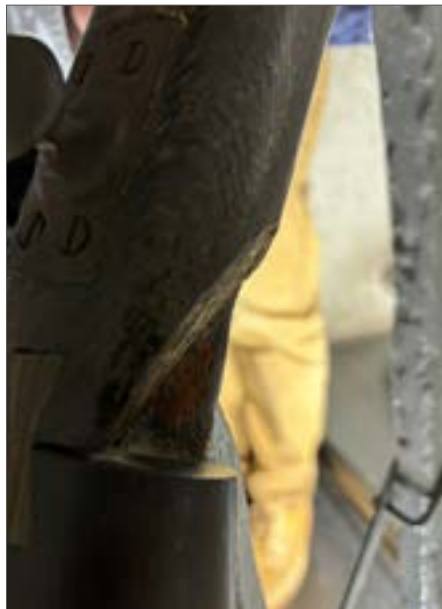
Fig. 45 Damaged section of handrail, 2024

RECOMMENDATION	PRIORITY	COSTS
6.5D STAIRWELL AND SPIRAL STAIRCASE: OAK HANDRAIL i) Detailed inspection of the oak handrail by a suitably qualified carpenter, to check if there is any splintered timber immediately above the iron bar supporting the timber, if so, ensure the splits are sanded to avoid damage to hands.	B	-

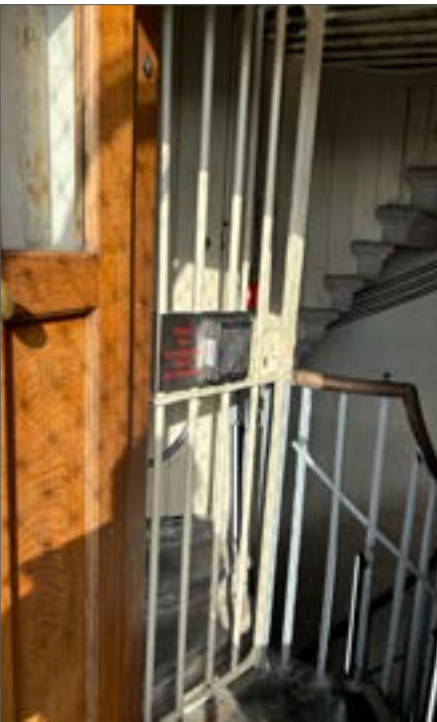
Fig. 48 Balustrade strap detracts from the simplicity of the interior, 2024

ii) Clean and decorate the temporary infill board. Fix onto the top of the board, large clear instructions to say that the board is to be used while operatives are working above, as temporary protection to prevent objects falling down the stairwell; the board is to be removed from the opening after every use.	B	£400
		iii) Ensure there is a place for the board to be kept, adjacent to the opening, but out of sight to the public.	A	Incl. Staff Budget.

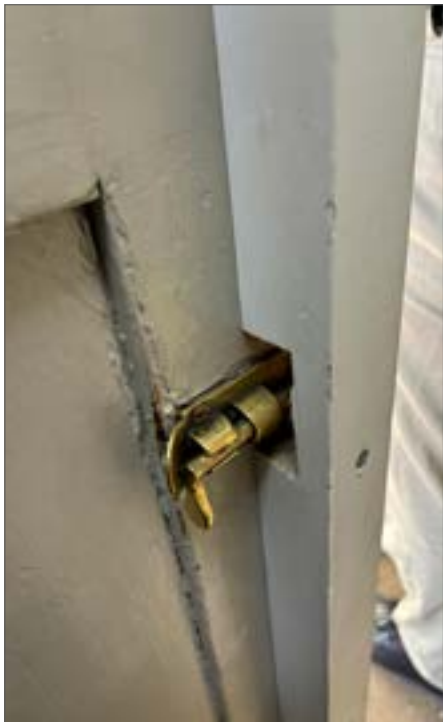
Fig. 58 Detail of the screen support fixed around historic bolt, 2024

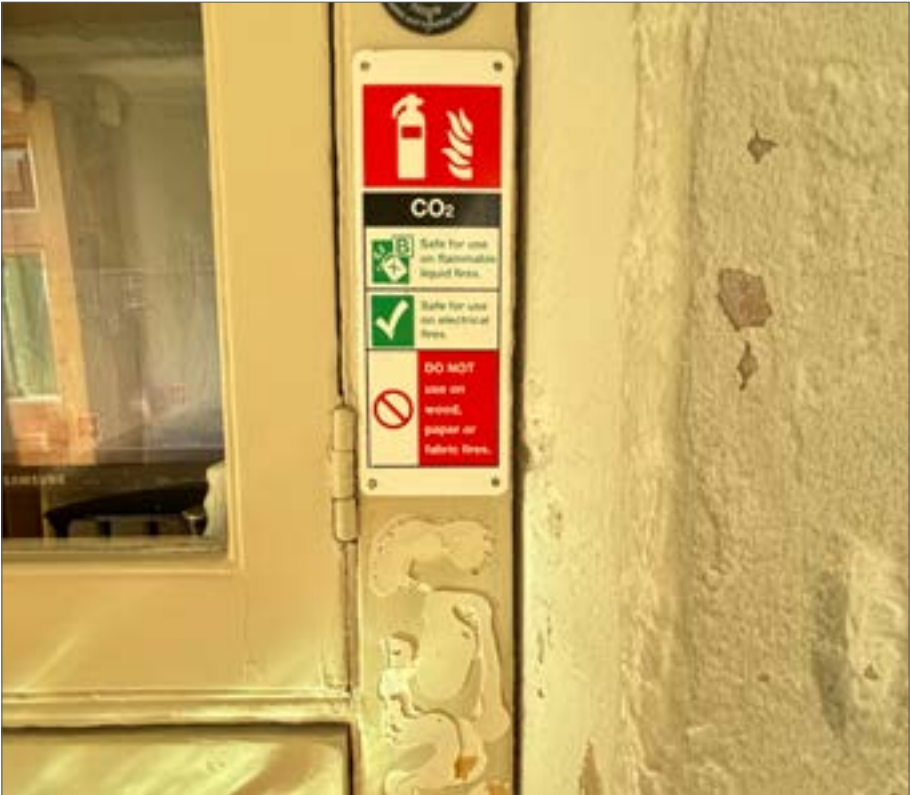
<p>Large CCTV in Operation sign stuck onto the glass of the left hand side glazed door</p> <p>CO2 Fire Extinguisher sign glued to the right hand side timber frame, which appears to duplicate the CO2 Fire Extinguisher sign fixed to the stone wall above the CO2 fire extinguisher.</p> <p>Remains of adhesive from a former sign, now removed, same size as the above sign</p> <p>World Tag disc – possibly used as part of the security system, whereby security officers use a wand/pipe tool and scans the point to prove they made the round.</p>	<p>iii) Avoid duplication of Fire Extinguisher notices. Locating the notices directly above the fire extinguishers is preferable for the presentation of the historic interior.</p>	<p>B</p>	<p>-</p>
		<p>iv) Review the number of CCTV signs displayed at the Monument, reduce the number to the recommended minimum by eliminating those which detract from the visitor experience of the historic building.</p>	<p>B</p>	<p>-</p>

Fig. 60 Detail showing remains of adhesive applied to the joinery, 2024

6.6C GROUND FLOOR ENTRANCE LOBBY: JOINERY - GLASS FRONTED PAINTED SOFTWOOD CUPBOARD iii) Avoid duplication of Fire Extinguisher notices. Locating the notices directly above the fire extinguishers is preferable for the presentation of the historic interior. iv) Review the number of CCTV signs displayed at the Monument, reduce the number to the recommended minimum by eliminating those which detract from the visitor experience of the historic building.	B B	- -

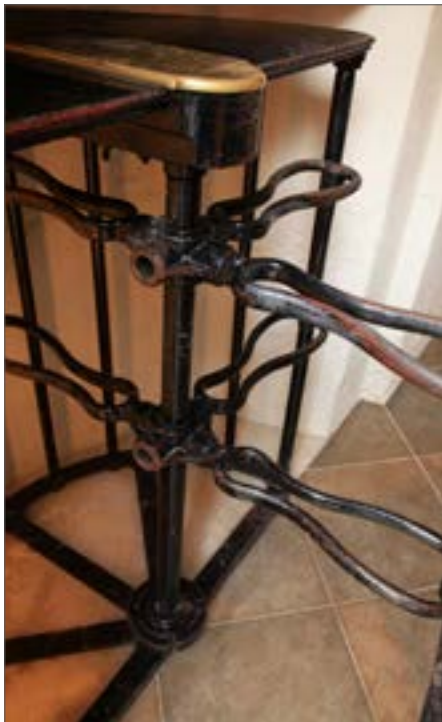
Fig. 68 Turnstile shown open, (one set of arms is missing), 2024

ii) Give consideration to either reinstating the working turnstiles or obtaining the statutory consents required to alter the formerly working turnstiles.	C	£3,200

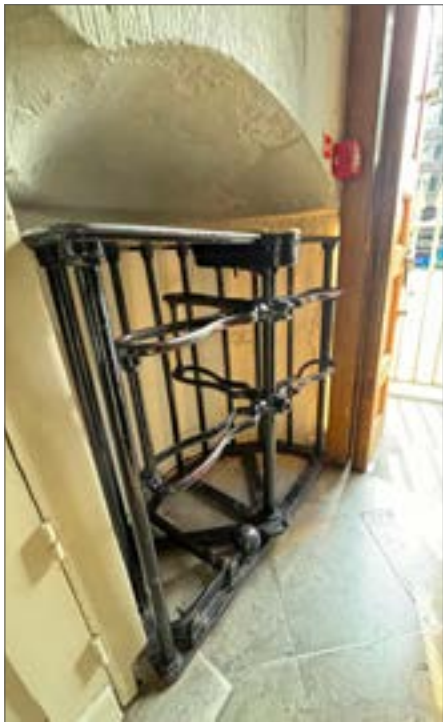
Fig. 69 Turnstile in north recess (arms missing), 2024

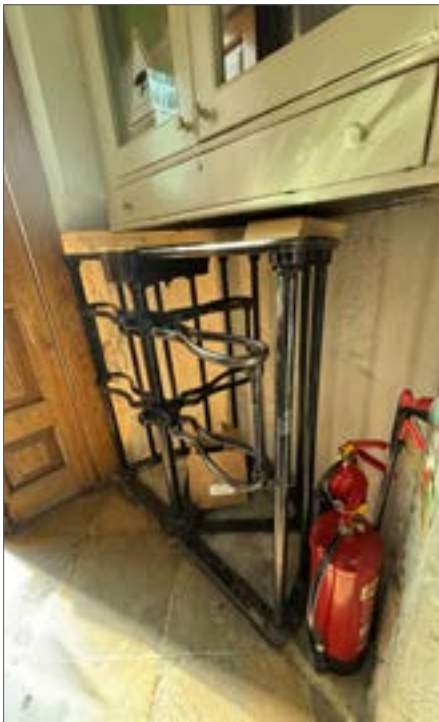
Fig. 70 Turnstile in south recess (arms missing), 2024

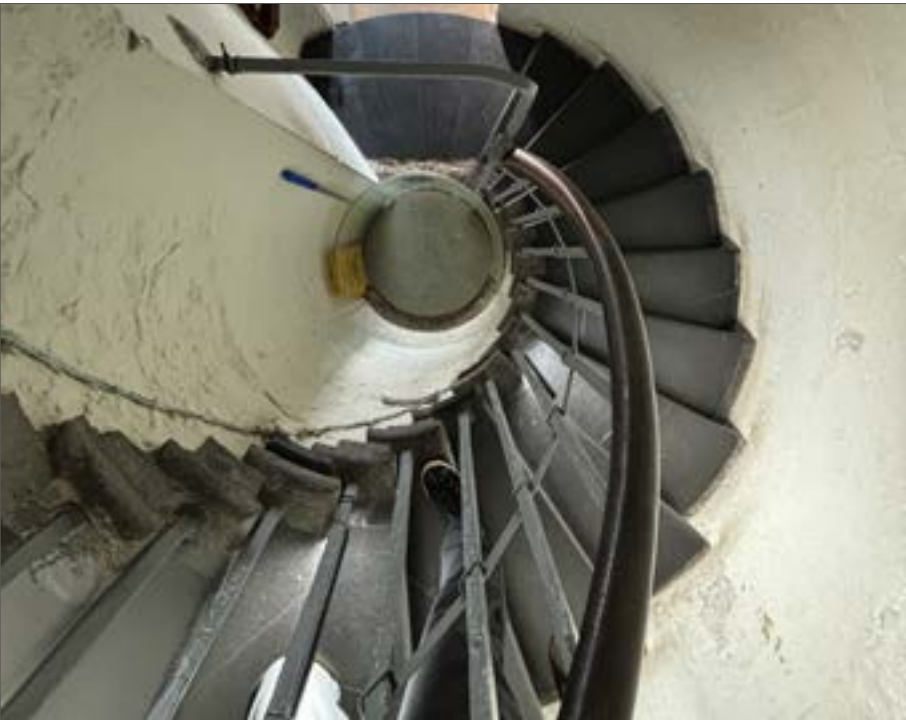
Fig. 71 Looking down the spiral staircase at the boarded-over oculus (circular floor opening), 2024

i) It has been recommended elsewhere that the plywood board is removed for ventilation reasons, and that the iron floor grille remains unobstructed to allow air movement through the currently unventilated and damp basement.	A	Incl. Staff Budget
ii) Ensure the red-tinted basement lighting is working and switched on daily.	B	Incl. Staff Budget

ii) Ensure the red basement lighting is switched on during visiting hours to allow the possibility of visitors understanding the form of the building and obtaining a glimpse of Hooke’s workshop	B	Incl. Staff Budget
		iii) Decorate Ground Floor grill	C	£400

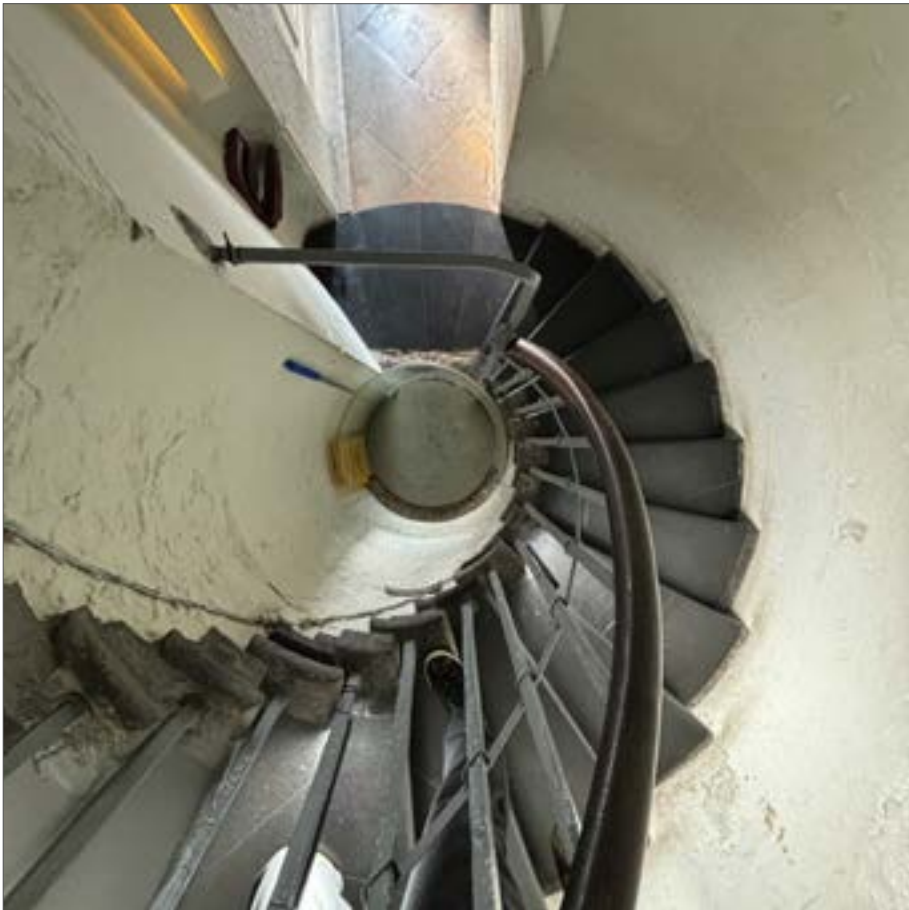
Fig. 74 Looking down the spiral staircase, mop and yellow sign stored in public view, 2024

6.6H GROUND FLOOR ENTRANCE LOBBY: FURNITURE & EQUIPMENT				
DESCRIPTION	CONDITION	RECOMMENDATION	PRIORITY	COSTS
<p>The following have been brought into the ground floor of the Monument:</p> <p>Floor mop and large yellow plastic sign warning about a Wet Floor, prominently stored at the base of the stairwell in full view of the visiting public.</p> <p>Curved Perspex panel with the large, printed instruction: LEAVE BAGS HERE</p>	<p>Comments on Appearance:</p> <p>Storing cleaning equipment at the centre of the helical stair, spoils one of the principal views (and photo opportunities), within the Monument.</p> <p>The curved Perspex panel with the large, printed instruction obscures the historic oculus</p>	i) Do not store cleaning equipment within public view at the base of the helical stair. Store with the other cleaning equipment, in the Pavilion building in Monument Yard.	A	Incl. Staff Budget
		ii) Review the bag store and consider alternative locations to store bags, to allow the grille to the basement to remain unobstructed.	A	CS

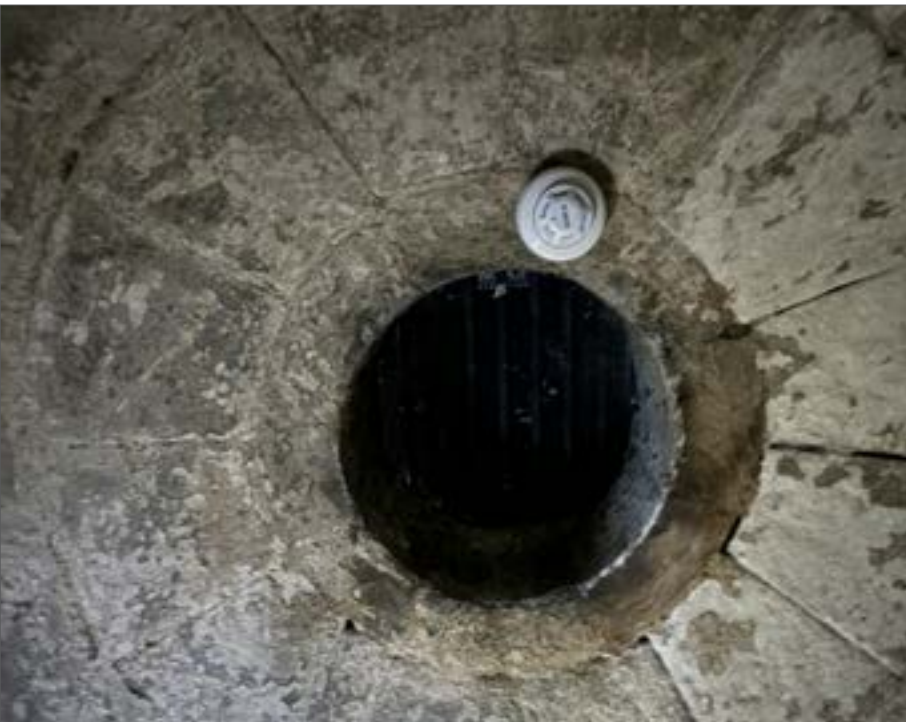
Fig. 81 Blocked-up oculus opening at the apex of the basement vaulted soffit, 2024

ii) Clear away metal platform, if no longer in use (retain at present)	B	No cost
		iii) Reinstate (what is likely to have been) the original basement ventilation system: allowing air to enter the basement via the flue in the north wall recess and for air to be drawn up out of the basement via the large oculus opening in the domed ceiling of the circular basement room. Ventilation to be improved before any redecoration, local stonework repointing or repairs are undertaken	C	£3,500

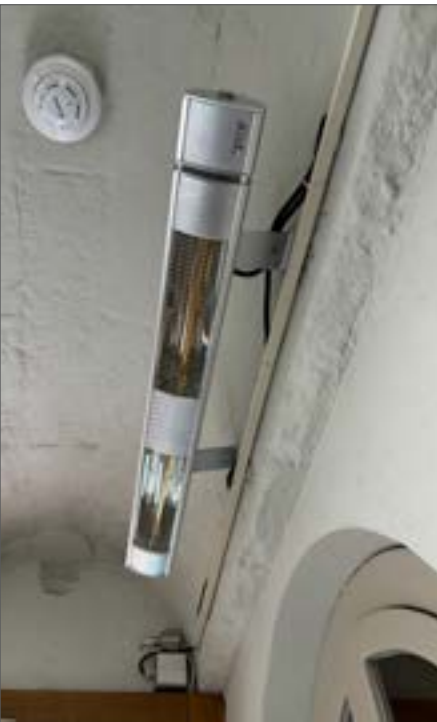
Fig. 84 Radiant electric heater, black cabling is visible, 2024

ii) Consider removing the strip uplighter if the heater is to be permanently located here and installing a slim stainless-steel conduit to take the black cable.	C	£800	
		iii) City Corporation to provide information on heaters, installation dates and testing certification	B	CS

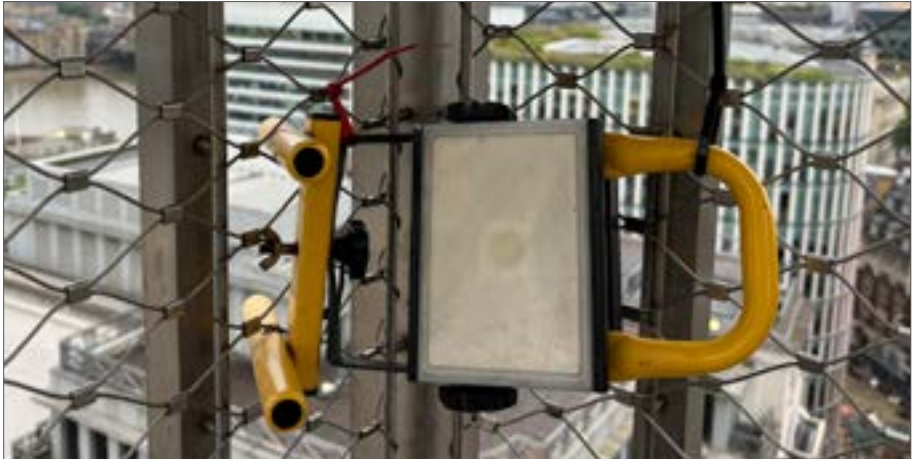
A temporary builder's spotlight is now located in the south-west corner of the viewing platform, fixed to the stainless-steel mesh inside the corner baluster with cable ties.

Fig. 91 A portable LED work-light fixed to the balustrade mesh, 2024

7.3A VIEWING PLATFORM LIGHTING				
DESCRIPTION	CONDITION	RECOMMENDATION	PRIORITY	COSTS
<p><u>2007-2009 Major Repair Contract Lighting Design</u></p> <p>An outline lighting design was prepared during the 2007-2009 repair contract. The intention of the design was to light inside the viewing platform cage, to make the cage netting almost invisible when looking at the exterior of the Monument. The viewing platform luminaires would also light the gilded flaming orb. The light fittings were successfully mocked-up on site by Light Bureau Ltd on completion of the 2007-2009 repair contract. Power supplies have been provided to each of the four corners of the viewing platform for the future installation of bespoke light fittings.</p> <p><u>2024 Viewing Platform Lighting Design</u></p> <p>Viewing Platform lighting is:</p> <p>A rope of LED lights fixed to the underside of the balustrade handrail on the viewing platform.</p> <p>A portable LED work-light fixed with cable ties to the balustrade mesh in the south-west corner of the viewing platform, directed upwards towards the flaming orb</p> <p>Light fittings have not been installed at the corners of the viewing platform. It is not known if the current lighting design has received planning approval</p>	<p><u>2024 Viewing Platform Lighting Design</u></p> <p>The 2024 lighting design is not the subtle lighting proposal discussed with the planners in 2008.</p> <p>The LED rope-light fixed under the balustrade handrail is directly visible from the ground after dark as a series of glaring dots of white light, strongly highlighting the balustrade handrail and harshly lighting only the lowest part of the stone drum. It does not light the dome or the flaming orb.</p> <p>The single portable uplighter has quite a good effect for a temporary light; seen from the ground after dark, it lights the flaming orb well, although perhaps too brightly, and only from one side. It is assumed that this is a temporary installation.</p>	<p>i) Replace the current amateur temporary lighting design with a permanent design by a lighting designer for historic buildings.</p>	C	£26,000

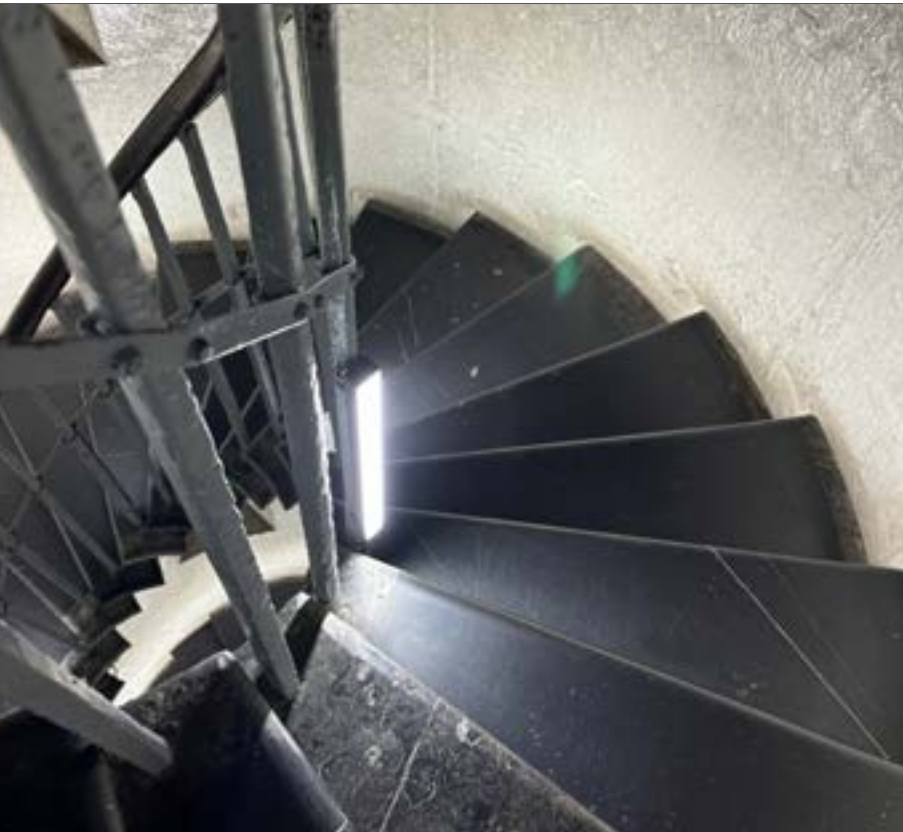
Fig. 98 2024 glare

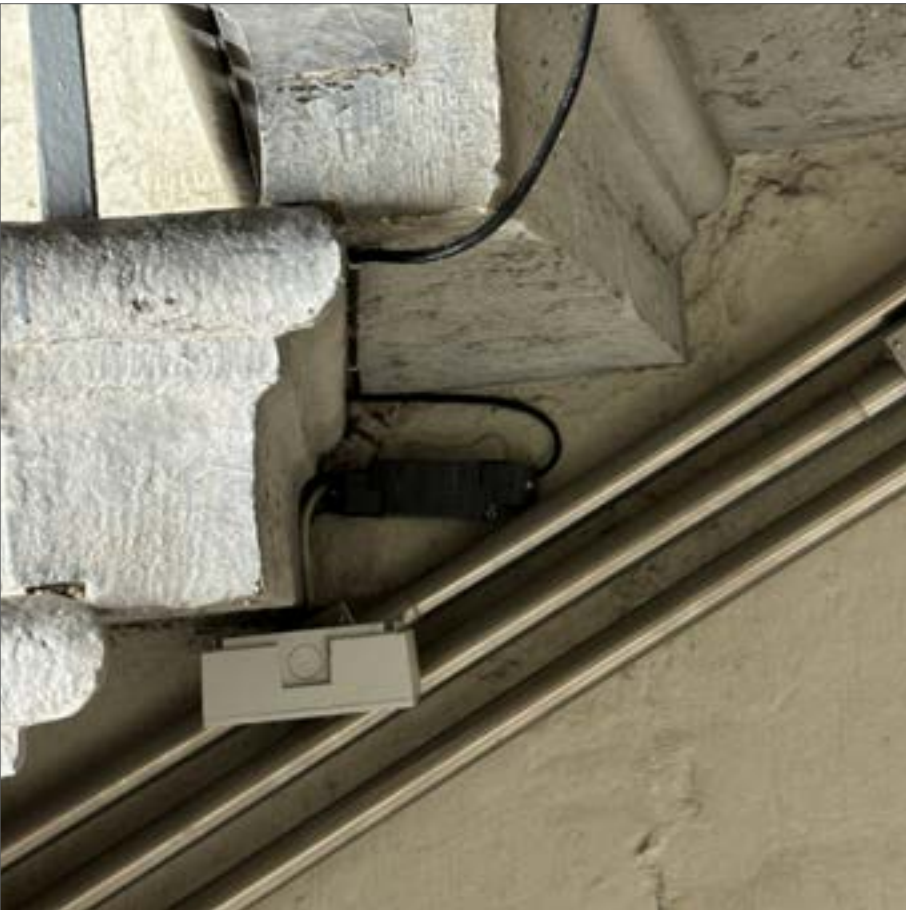
Fig. 99 Black cabling connecting a transformer to the replacement baluster lights, 2024

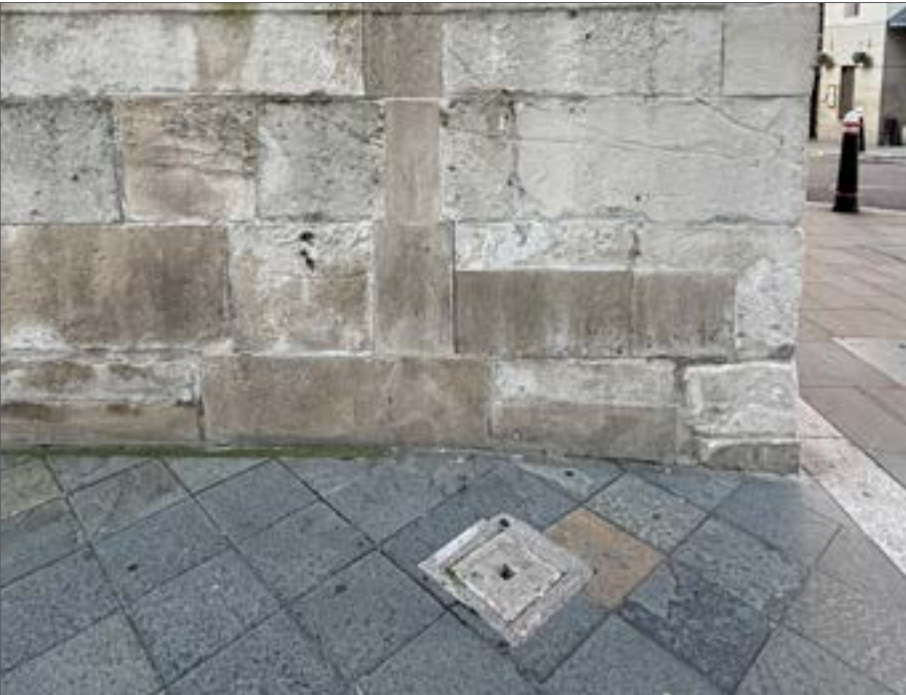
Fig. 108 North elevation down conductor, partly concealed, and test pit, 2024

RECOMMENDATION	PRIORITY	COSTS
7.5 LIGHTNING CONDUCTOR i) Undertake repair work as quotation provided to CoL by Omega Red Ltd	A	Client to Provide Quote
7.6A FIRE RISK ASSESSMENT i) Include regular cleaning of the flame area and cellar on the cleaning rota	A	Incl. Staff Budget

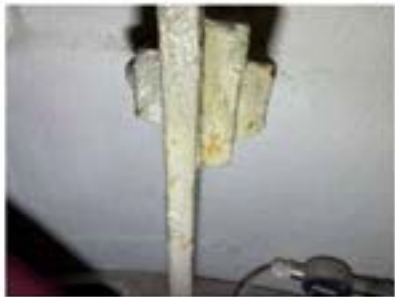
Corrosion to the internal railings below the orb

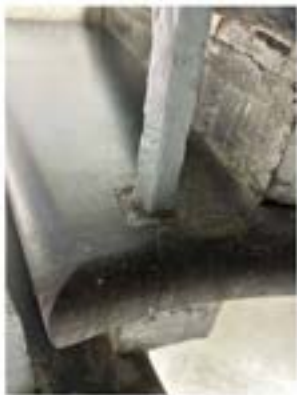
Cracked step at baluster base (#103)

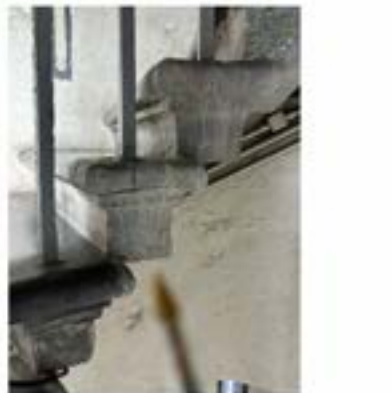
Cracking at base of baluster and horizontal cracking across the end of the stone step (#298)
