Appendix 3 - Photos

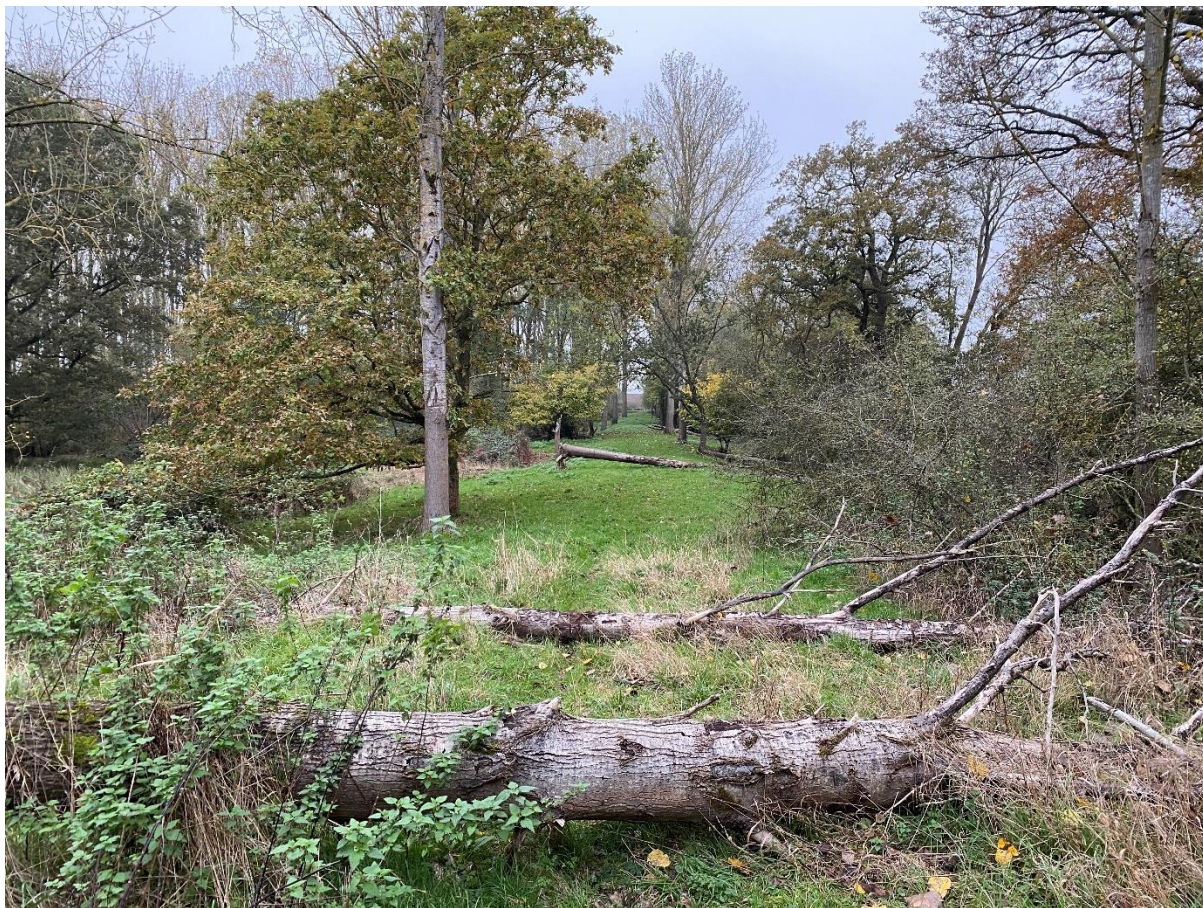
Plate 1 General view along crest of dam, from east end looking northwest, showing trees on dam slopes and in reservoir, which is on left-hand side.

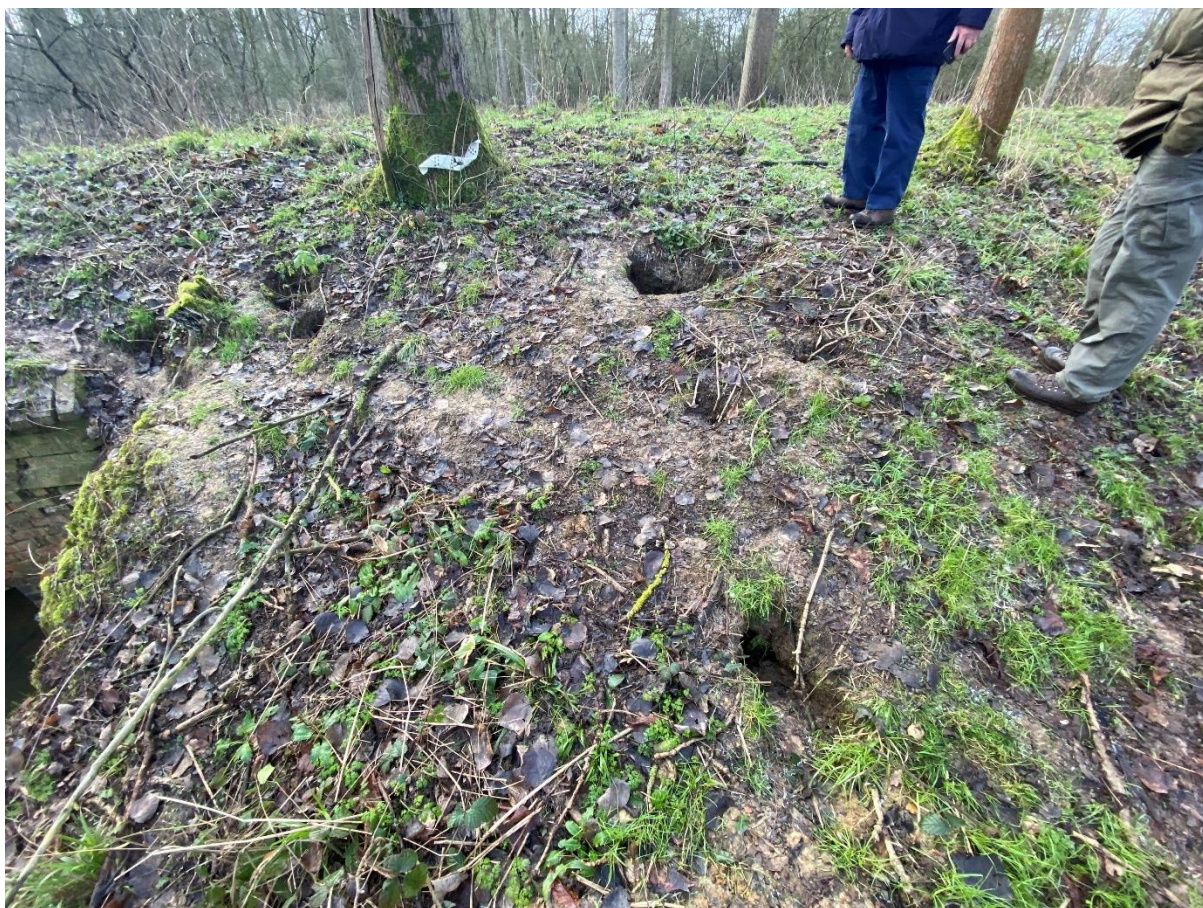
Plate 2 Example of damage to the dam from protected species, near to one of the culverts.

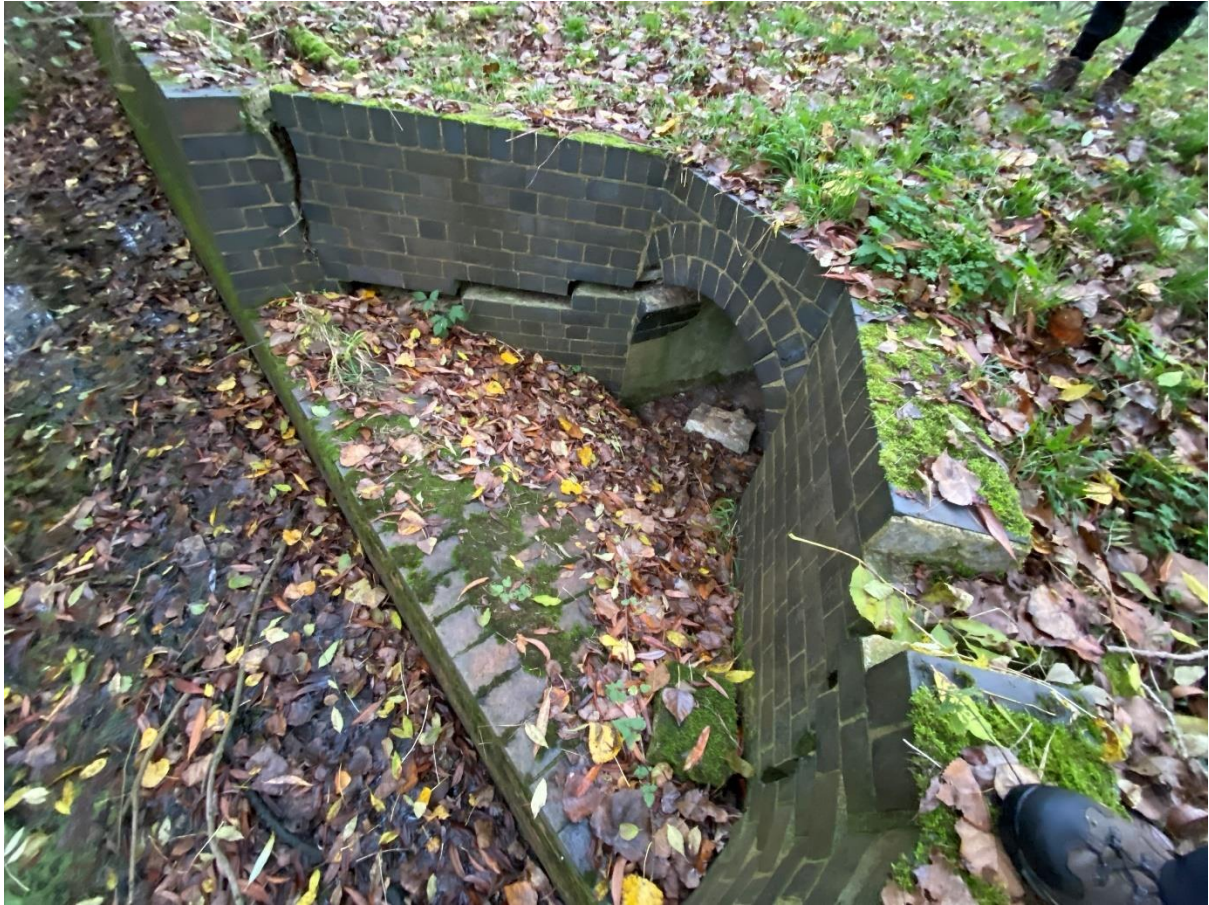
Plate 3 Headwall of one of the culverts shown sunken with broken headwall.
