**Review report on Concrete Testing
Shakespeare, Cromwell & Lauderdale Towers
The Barbican, London**

16 March 2012

Prepared for: City of London Corporation

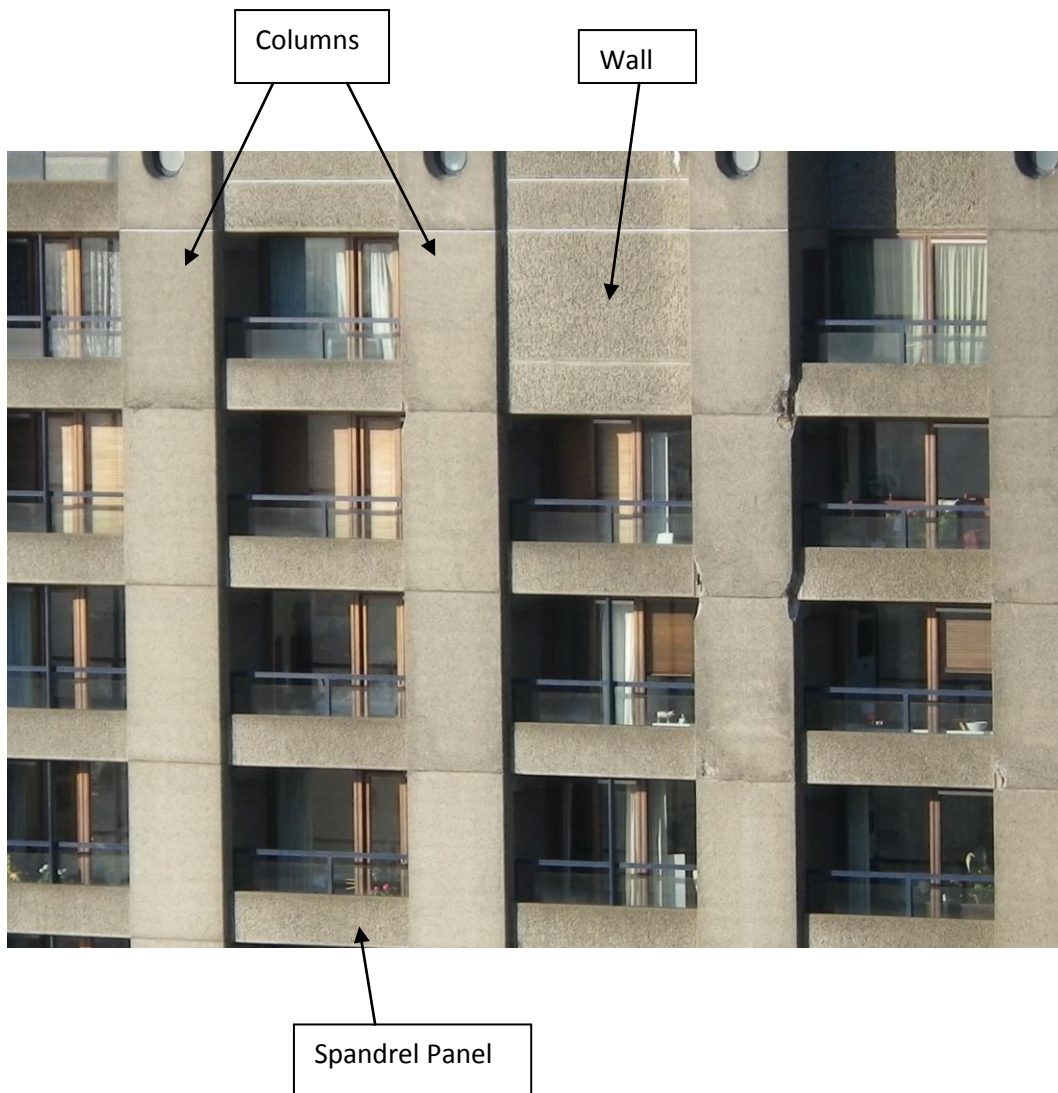
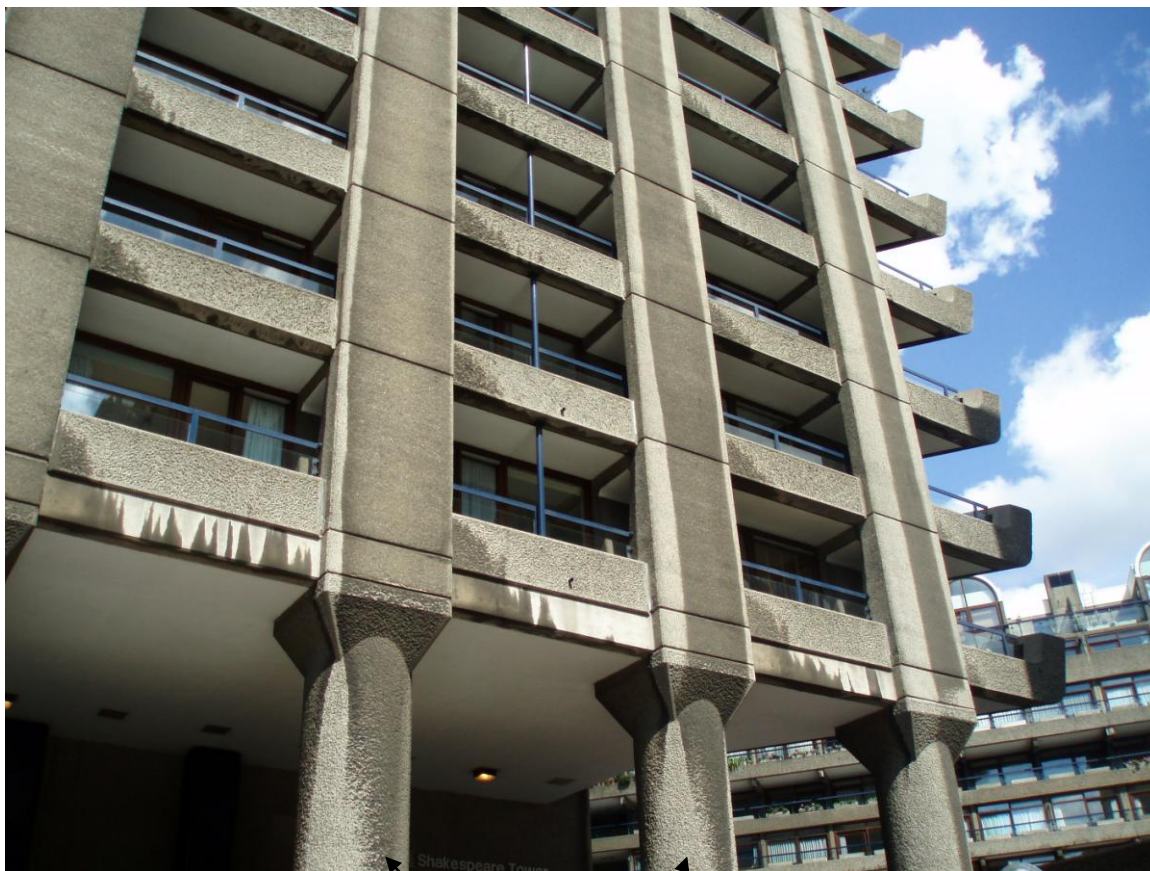
Figure 1
Elements of the buildings

The Elements tests are illustrated in Figure 1.
