North – South Cycle Superhighway, London

Road Safety Audit Stage 3

on behalf of City of London

TMS reference no: 12809

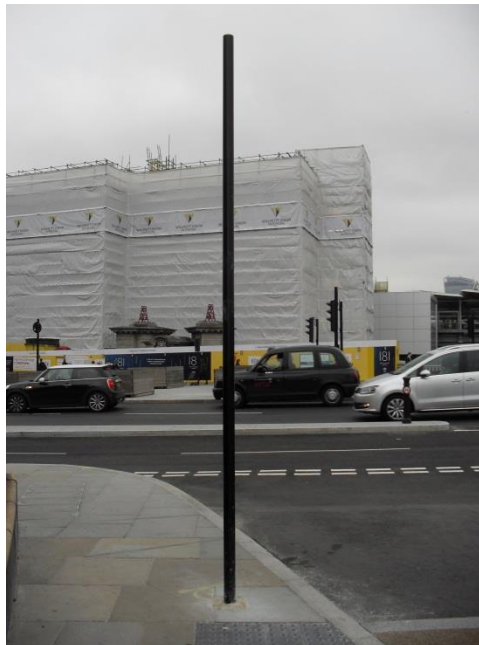
Summary: Potential hazard and obstruction to pedestrians

There is a pole located within the footway that does not feature a sign. It is unclear if the pole is redundant or new and awaiting installation of a sign face. However, the pole is within the middle of the footway and as such is a hazard and obstruction to pedestrians, particularly to those with visual or mobility impairments.

The pole should be removed if redundant. If still required for a new sign, the pole should be relocated to the rear of the footway.

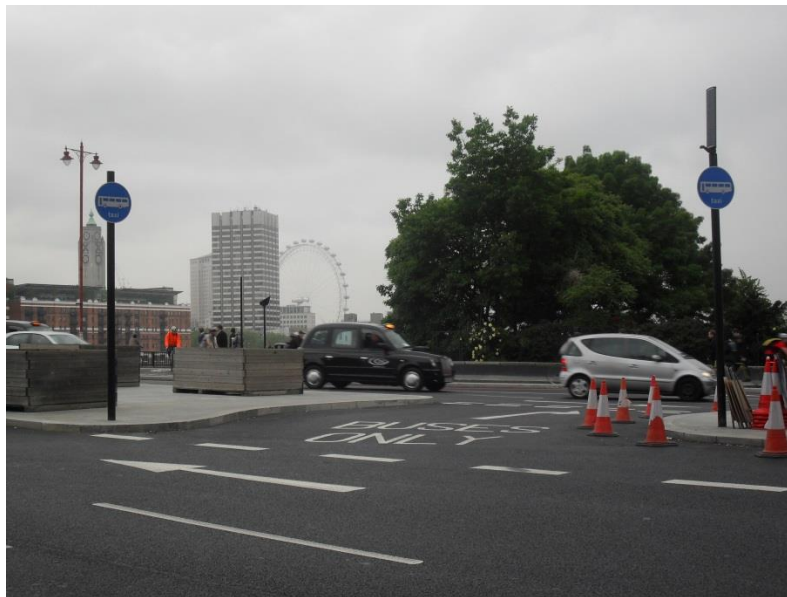
A 'buses only' right turn lane pocket is provided to enable buses to make U-turns from A201 southbound to northbound at the north side of Blackfriars Bridge. However, 'buses only' is marked on the carriageway and the upright signs states 'buses and taxis'. This should be clarified and a consistent signage or road marking provided.
