**Project: 16873 – Barbican Estate****Existing Langley Waterproofing System Guaranteed Roofs Only**

Ben Jonson House  
John Trundle Court  
Bunyan Court  
Bryer Court  
Breton House  
Mountjoy House  
City of London  
EC2Y

## Roof Survey Report & Recommendations

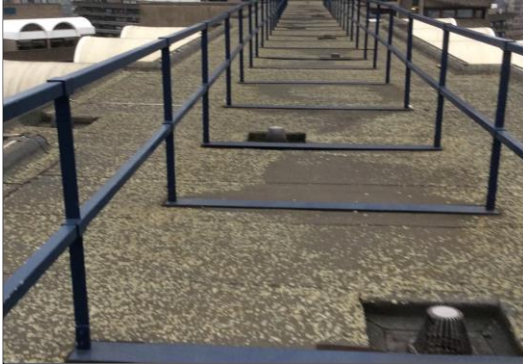
1. John Trundle Court  
– Overview of the roof area.

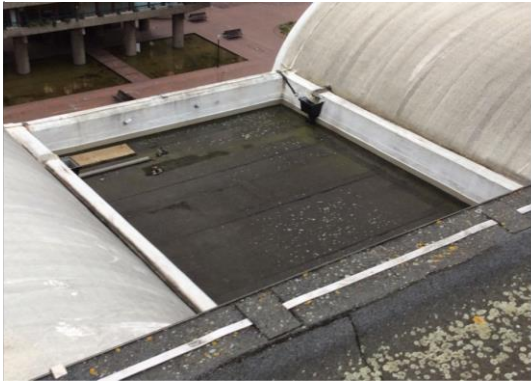
2.  
-Low level roofs.

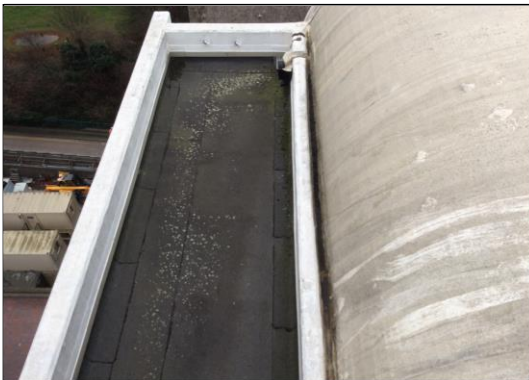
3.  
- As above.

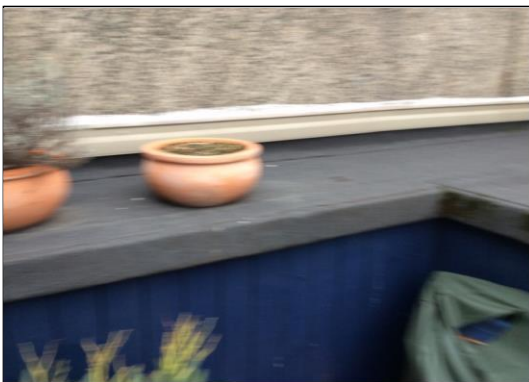
4.  
- Service ducts.

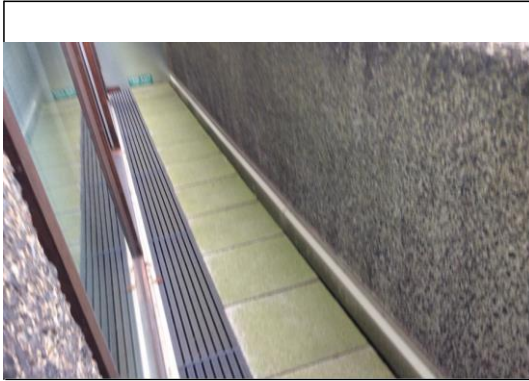
5.  
- Walkway.

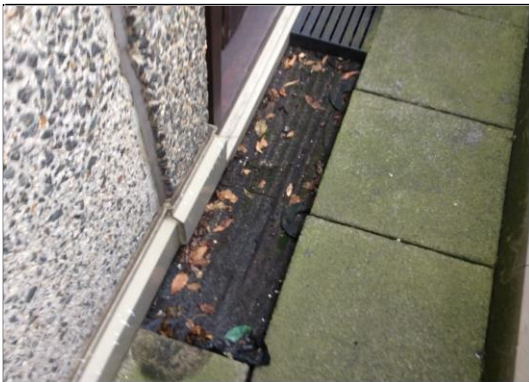
6.  
- Exposed area of walkway.

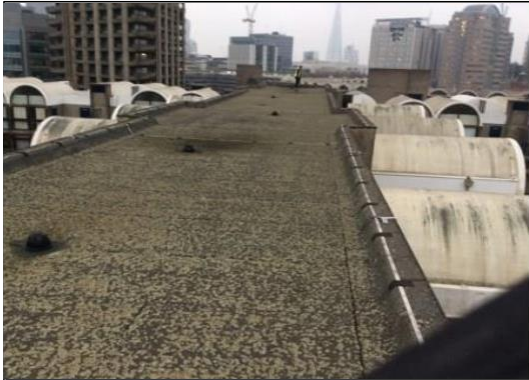
7. Bunyan Court  
- Main roof area.

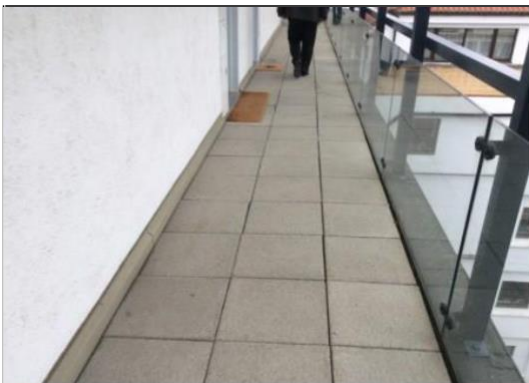
8.  
- Walkway.

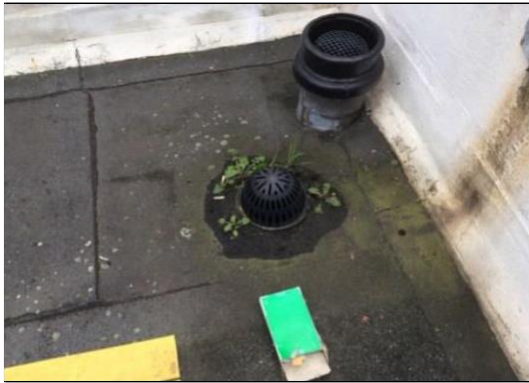
- 9.
- Maintenance required to outlets to clear debris and plant growth.

It is recommended that standard routine maintenance continue to include the clearing of all rainwater outlets, gutters and other drainage outlets, as well as removing any vegetation, loose debris and repair of any paving slabs as required.

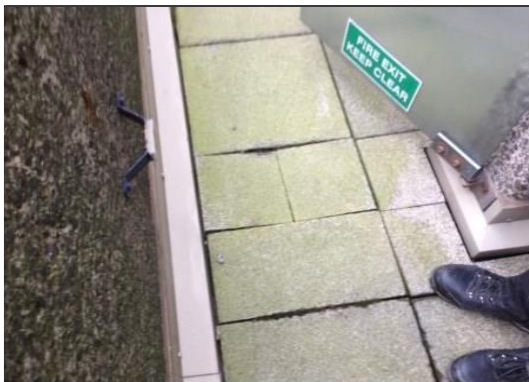
10. Bryer Court
- Example of broken paving slabs.

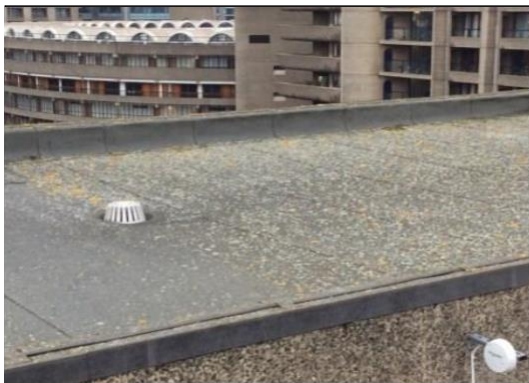
- 11.
- Main roof area.

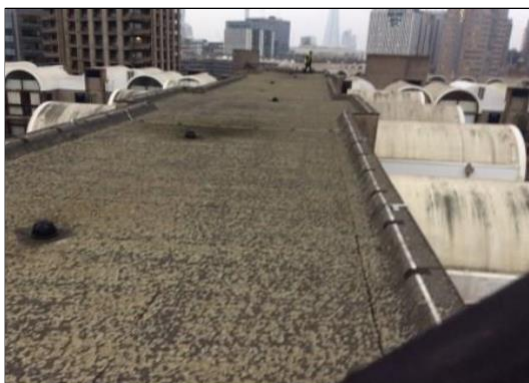
12. Breton House
- Main roof area.

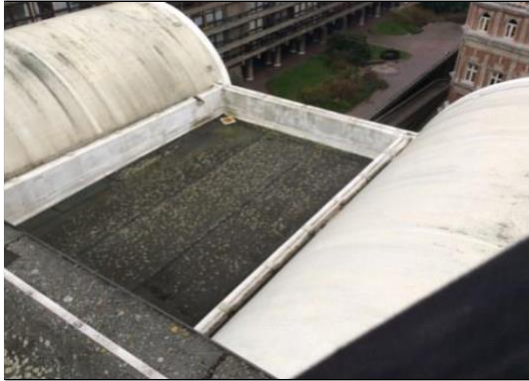
13.  
- Lower Roof area.

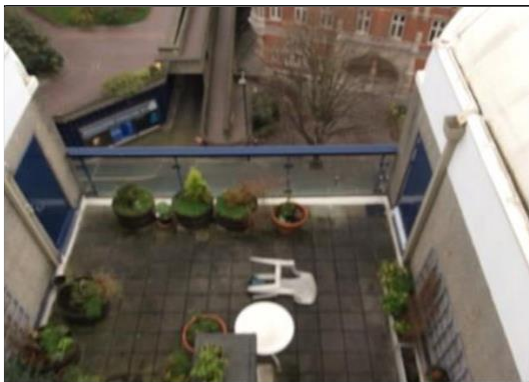
14.  
- Lower Terrace area / Balconies.

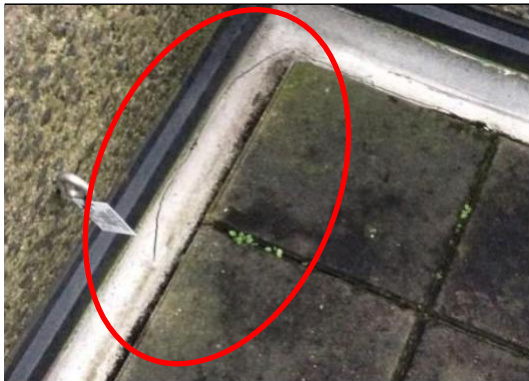
15.  
- Crack found in asphalt in corner of walkway.

The crack in the asphalt should be repaired and protected with solar paint on completion.

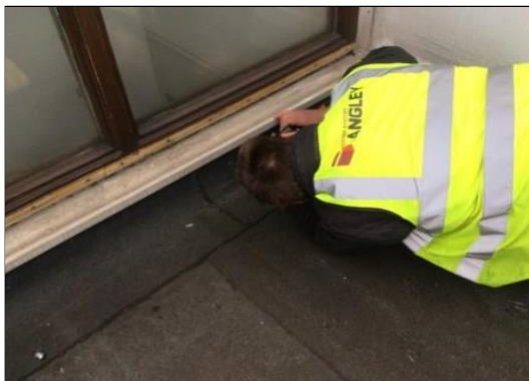
16. Ben Jonson House  
- Water ingress found from detail below window cill.

All areas of roof where water blisters exist (5 small areas) need to be cut back or stripped out and re-install new Reinforced Bituminous Membrane system (with new insulation as required) ensuring details where possible water ingress occurred is also correctly finished. Note: blisters mainly appear to only be between the underlay and cap sheet.

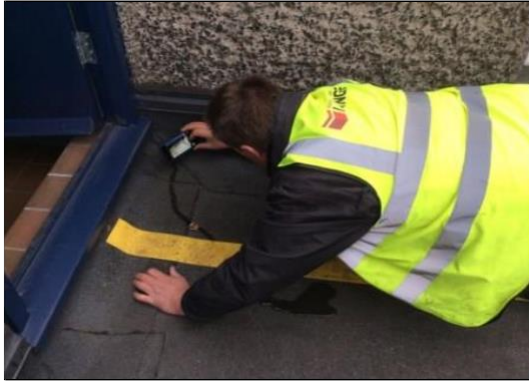
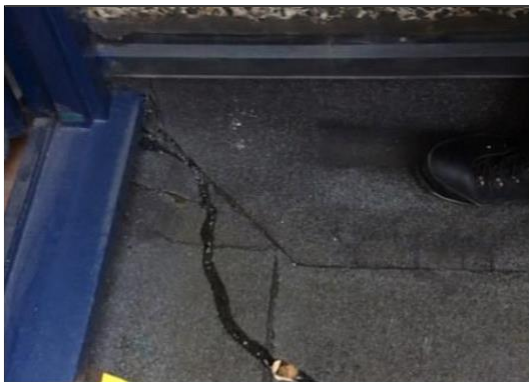
17.

- Water found beneath the cap sheet in area by door threshold.

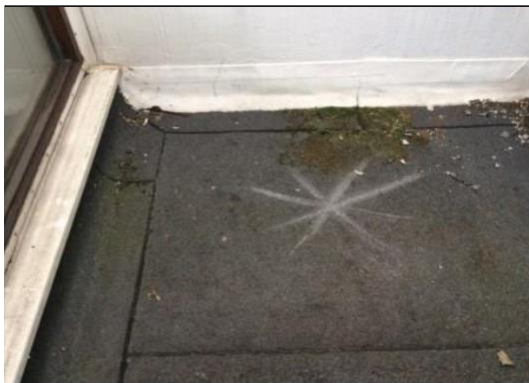
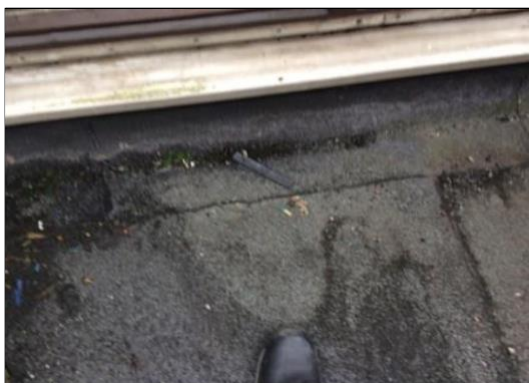
19.

- Water blister within the waterproofing.

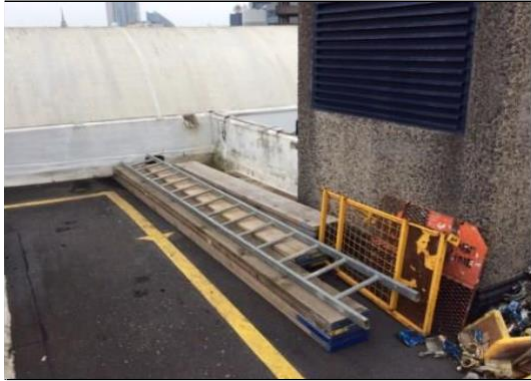
21.  
- Debris left on the roof area.

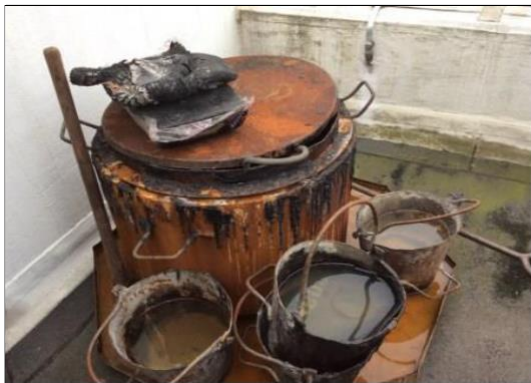
22.  
- Equipment found left on end roof area.  
Note: this may well be the cause of the burn on the roof area as per below:-

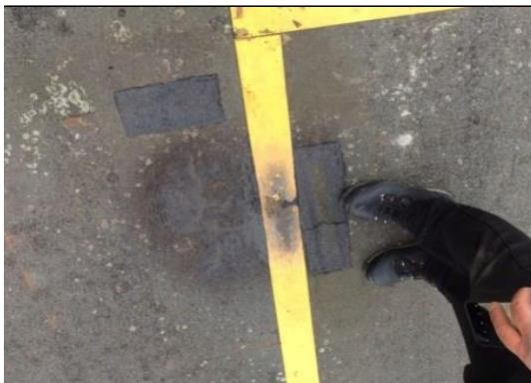
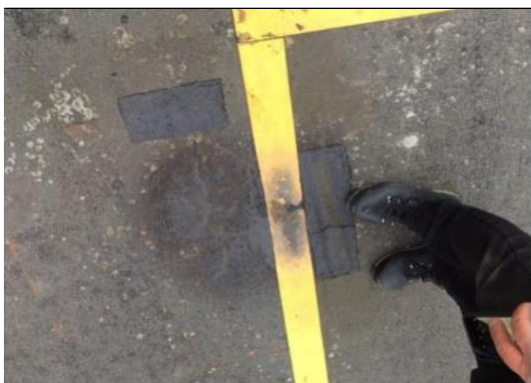
23.  
- Roof has been burned from hot equipment with patch repairs also evident nearby.

Area where surface has been burned to be patched with new cap sheet, over an area circa 2m<sup>2</sup>.

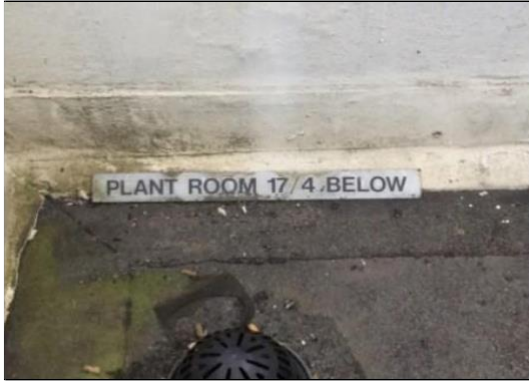
25.

- Position of problematic terrace area below, above unit "506".

We would recommend that a CCTV survey is carried out to the drainage outlet and internal drainage pipework, as in our opinion, this would be the likely cause of the water ingress issues. Following this, a full assessment can be made to decide on an appropriate course of action with regards to the current waterproofing.

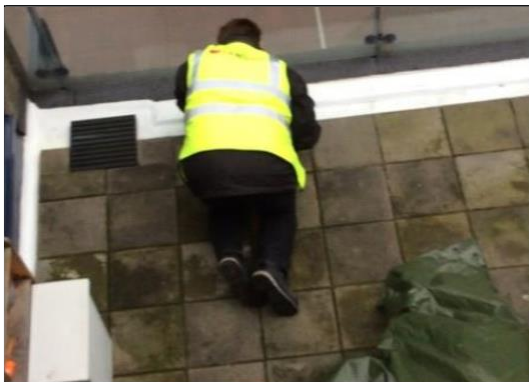
26.

- External perimeter has been overlaid with felt membrane.

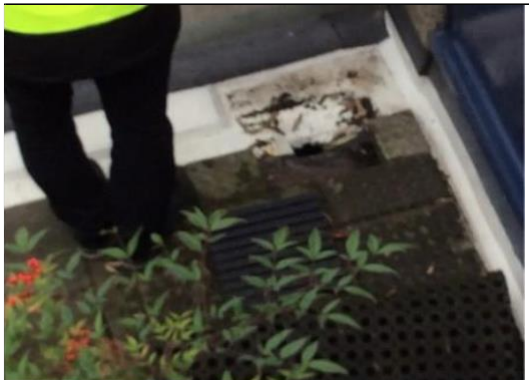
27.

- Issue appears to be centred round the outlet, likely the drainage system itself.
- There appears to be little evidence that this area has indeed been fully repaired, with likely localised repairs only carried out.

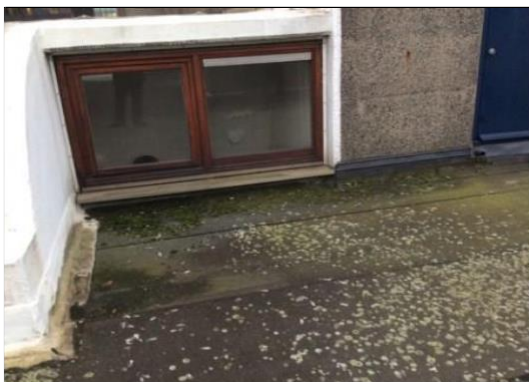
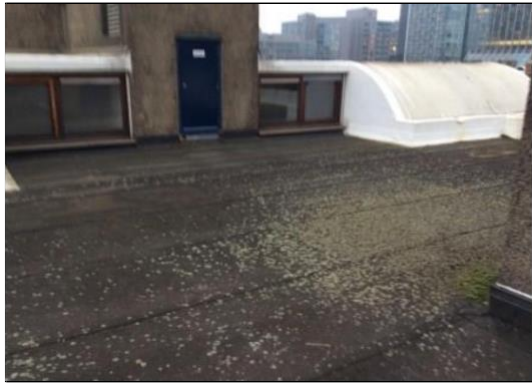
28. Mountjoy House

- General detail to roof areas.

Note: the roof is divided into sections by dividing Tank / LMR rooms. Sections 1 and 2 were found to be in good condition for the age of the system.

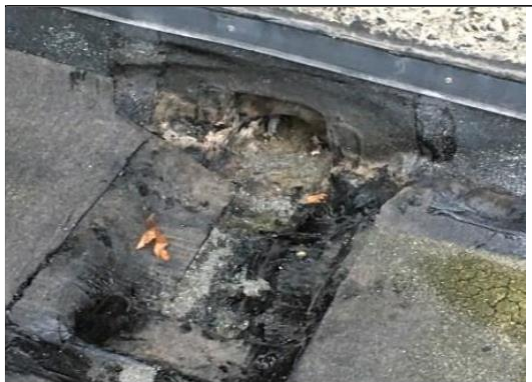
30.  
- Section "3" - Area has been stripped and a form of temporary repair carried out.

The roof area has been compromised considerably with wet insulation, degradation of the cap sheet and numerous repairs carried out across the roof area.

We would suggest that this roof area is fully stripped back to the deck, and a new waterproofing system installed, including tapered insulation as original. A new 20 year guarantee would be supplied for this area, while the existing guarantee remains in place on all other areas.

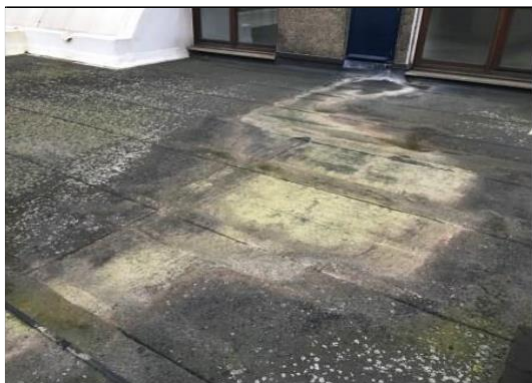
31.  
- Heavy staining across the roof area, likely also debris from repair works carried out.

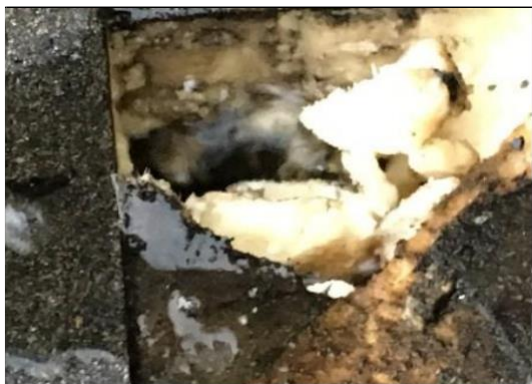
32.  
- Saturated insulation within the waterproofing.

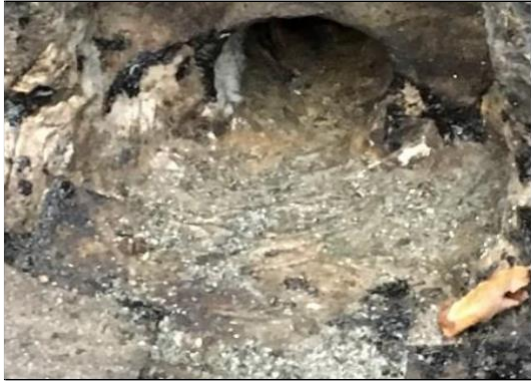
33.

- Outlet has been waterproofed, indicating the issue may be related to the structural drainage.

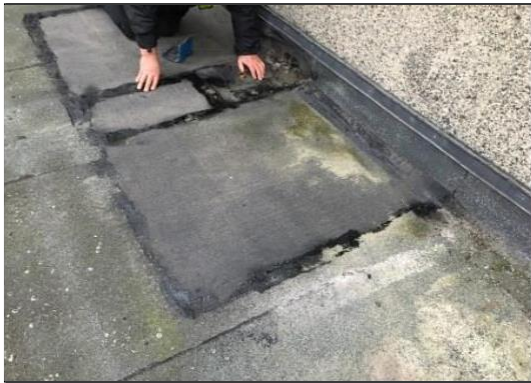
34.

- Overview of repair carried out.
