Project: 17105 REV1

Barbican Estate
Non-Langley Roof Areas
City of London
EC2Y

Roof Survey Report & Recommendations

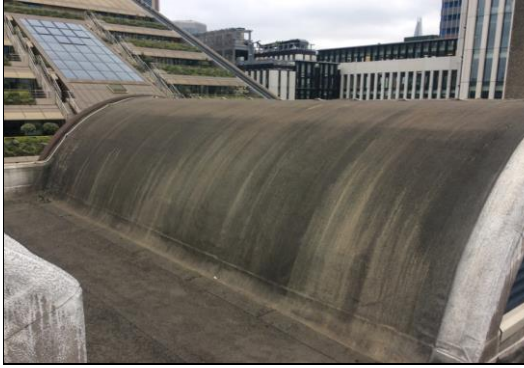
1.
General condition of all barrel roofs that would benefit from being cleaned.

We recommend that drainage is be maintained and kept unblocked, all lightning strips are to be re-fixed were needed. All barrel roof areas could be prepared, primed and coated with 2 additional re-enforced layers of liquid offering a 20-year guarantee.

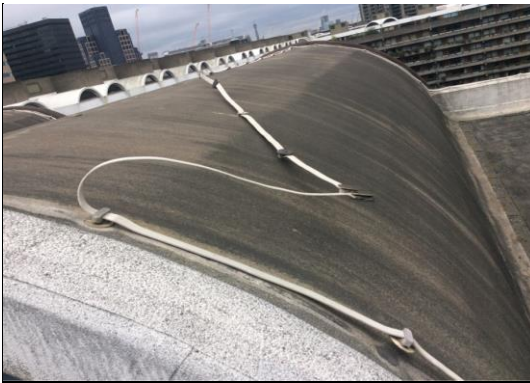
2.
In many areas, lightning strips need to be re-fixed. This is evident on many of the Barrel Roof areas.

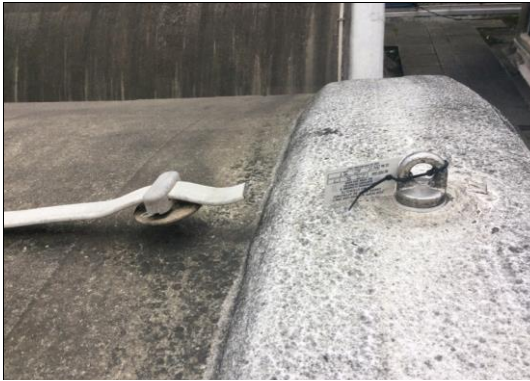
3.
As above.

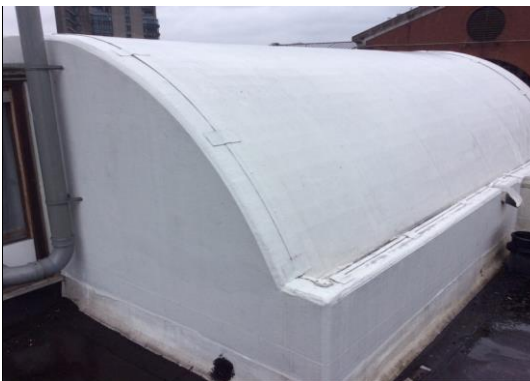
4.
Barrel Roof area that has been painted / coated.

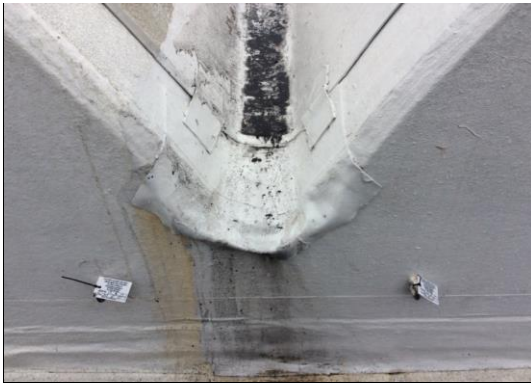
5.
Close up of the existing lead and gutter that has been painted / coated.

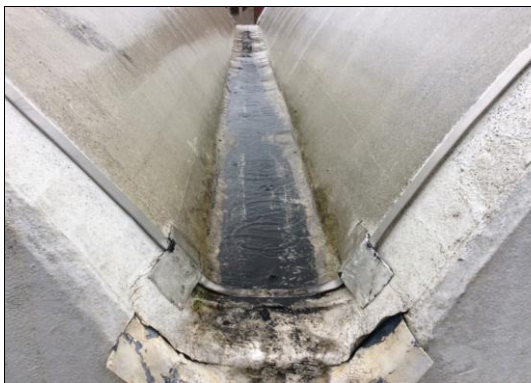
6.
Barrel Roof drainage needs to be maintained and unblocked in places.

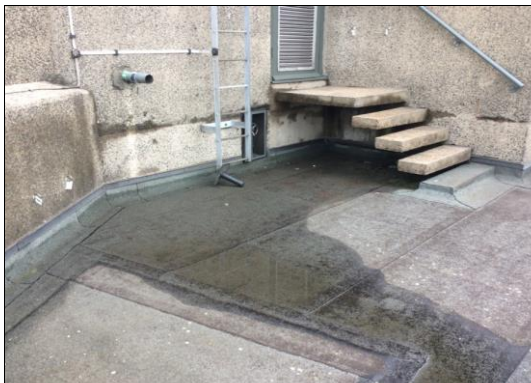
7.
Main roof for Cromwell and Shakespeare Tower; BUR felt in average condition and no signs of repairs or failure.

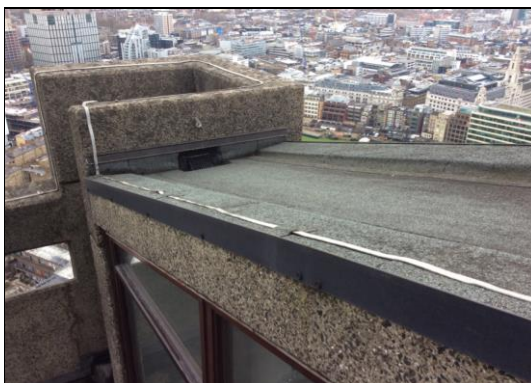
8.
Overview of Cromwell and Shakespeare Tower link roofs that are in average condition.

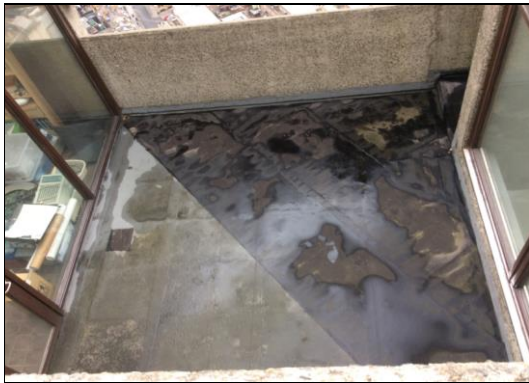
Cromwell Tower balcony roof

Overview of Cromwell Tower balcony roof; in poor condition and has previous repairs.

The existing roof area has been repaired with various materials such as BUR felt and liquid in different areas indicating previous water ingress issues; in places the repairs have started to fail becoming ruckled, blistered and worn. The existing asphalt has started to slump underneath the wooden door threshold.

We recommend that the repairs are to be stripped back and the existing asphalt is to be overlaid with 2 layers of bituminous elastomeric felt with counting flashing protection to the concrete upstand and door threshold.

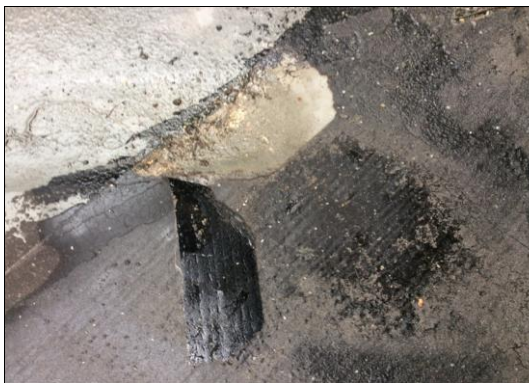
Cromwell Tower balcony roof

Felt repair has started to fail leaving an aperture for potential water ingress.

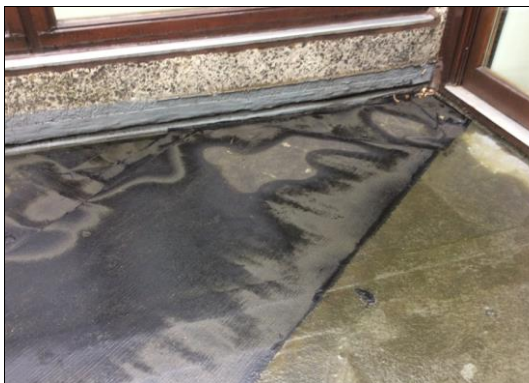
Cromwell Tower balcony roof

Felt repair has become ruckled and blistered and liquid repairs have taken place to the concrete upstand.

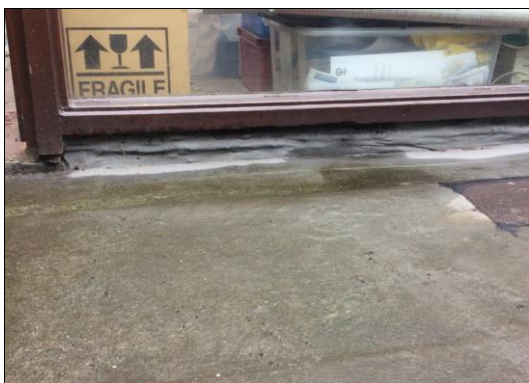
Cromwell Tower balcony roof

Existing asphalt underneath the door threshold has started to slump.

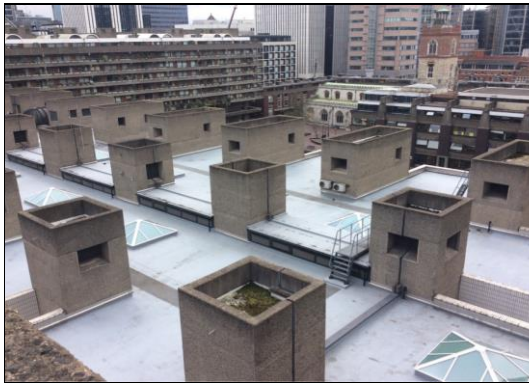
13.
Barbican Centre roof
Overview of the Barbican Centre roof.

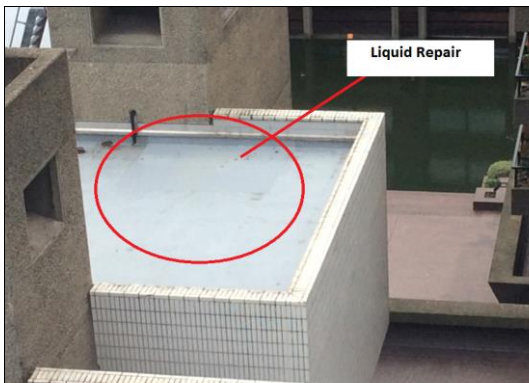
14.
Barbican Centre roof
Liquid repair indicating previous water ingress issues.

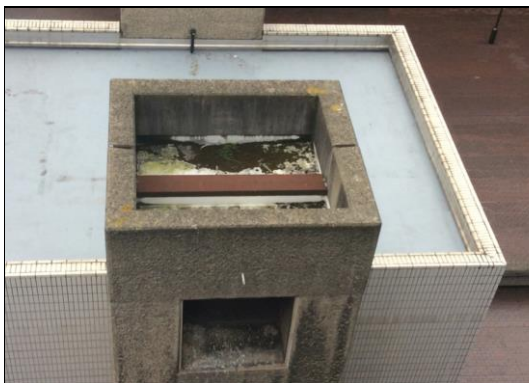
15.
Barbican Centre roof
Vegetation growth on existing asphalt stairwell roof.

It is recommended that standard routine maintenance continue to include the clearing of all rainwater outlets, gutters and other drainage outlets, as well as removing any vegetation, loose debris and repair of any paving slabs as required.

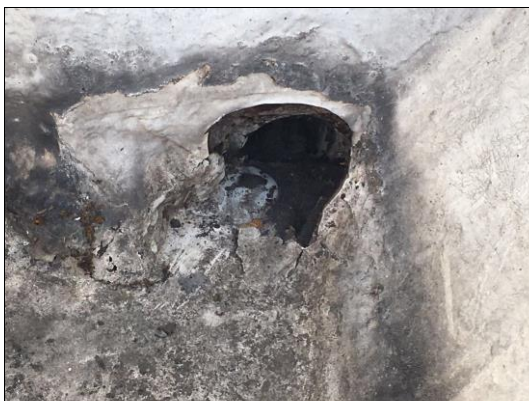
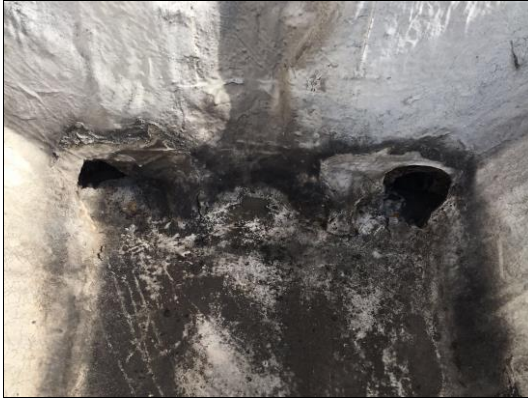
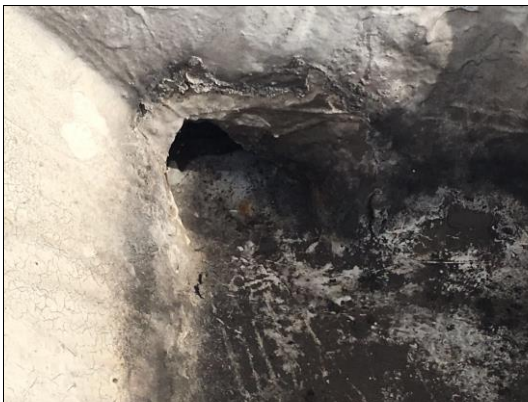
16.
Andrewes House Barrel Roof Areas
Liquid has de-bonded from the concrete upstand with cracking also evident causing water ingress.

17.
As Above.

18.
As Above.

One valley of the existing barrel roof area is leaking with reported water ingress from failed 2No. scupper outlets through an expansion joint and down to the bottom of the building. The existing liquid waterproofing has de-bonded from the concrete upstand causing repeated leaking, with cracking of the existing liquid waterproofing also evident around both the failing scupper outlets with the metal guards currently loose and unfixed. This area will need to be repaired with a reinforced liquid system, and may require some substrate repairs also. Please note that a repair only would not carry any guarantee, and consideration should be made to upgrade the complete roofing area, depending on guarantee period remaining.
