Churchyard Enhancement Programme Churchyard Assessment Sample

Appendix 3

## **Churchyards Assessments**

Name of Churchyard: St Anne & St Agnes

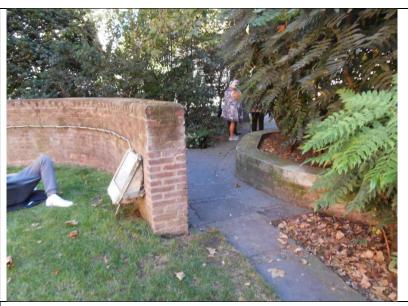
7	Historic background	Churchyard first recorded 1269. The form of it has changed considerably over time; the Ogilby and Morgan map shows it has two roughly square pieces of land bordering the east of the church. By 1745 it had become much more hemmed in by buildings, and took the form of a polygonal open space in front of the church. It remained thus until the Blitz of the 1940s, when the buildings dividing it from Noble Street were destroyed. The small area of land to the north of the church was formed by c.1880. In 1971-2 the churchyard was extended to the south and east when an open garden was made of these blitzed plots, part of a wider landscaped area. Planning permission has been granted for an extension on the north part of the churchyard.
		Physical Condition
8	Hard Landscape	Okay condition, narrow paths.

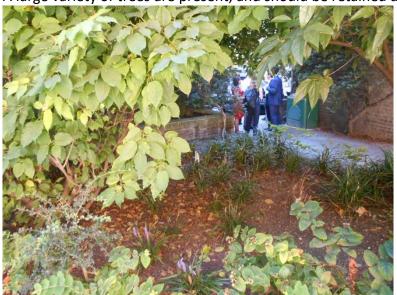
The current planting makes the church garden very secluded, which can lead to anti-social behaviour. There is currently a lot of soil with no planting that covers a lot of the space.

A large variety of trees are present, and should be retained as part of any landscaping scheme if possible.

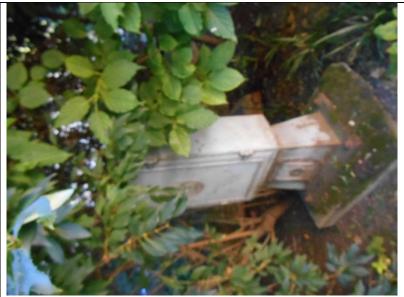
Ruins from WWII bomb damage

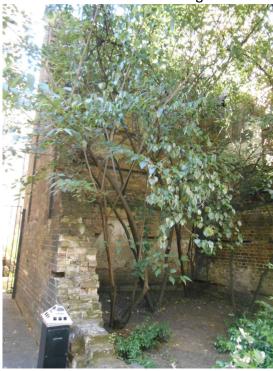
Churchyard site is adjacent to the London Wall, and this will require careful consideration
