Crescent House
Planning & Transportation Committee

Crescent House

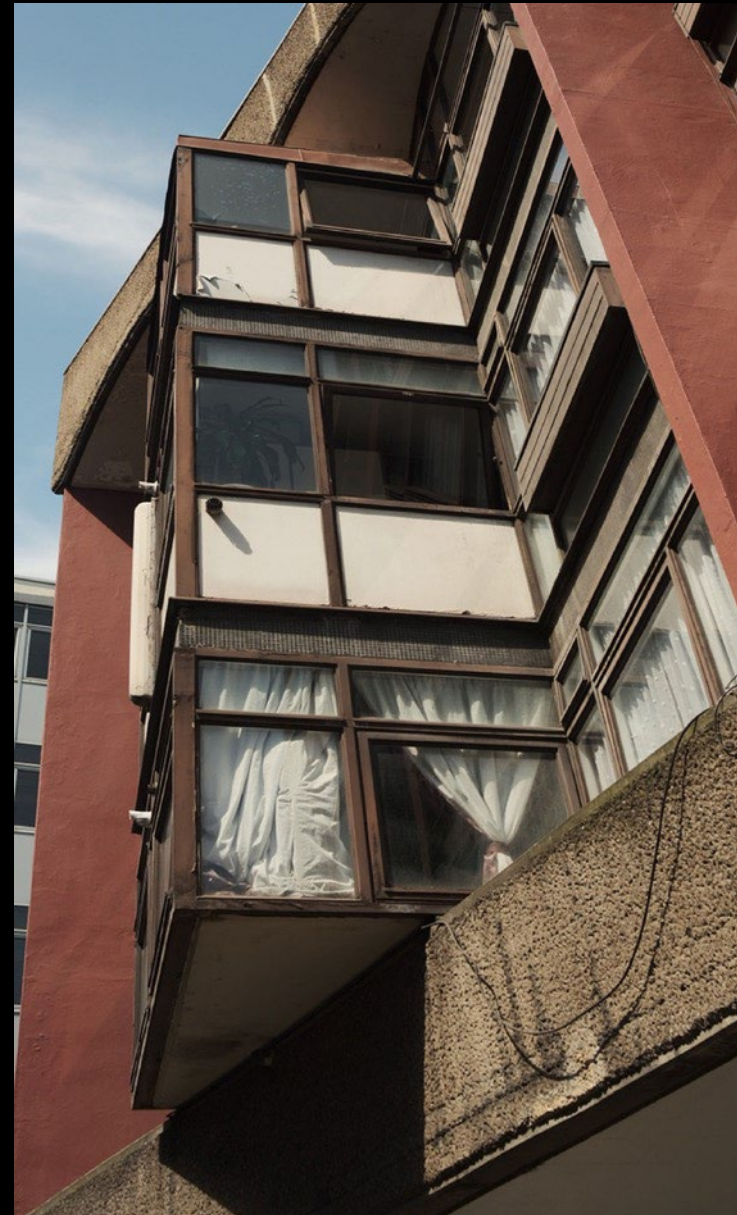
Typical window – 2023

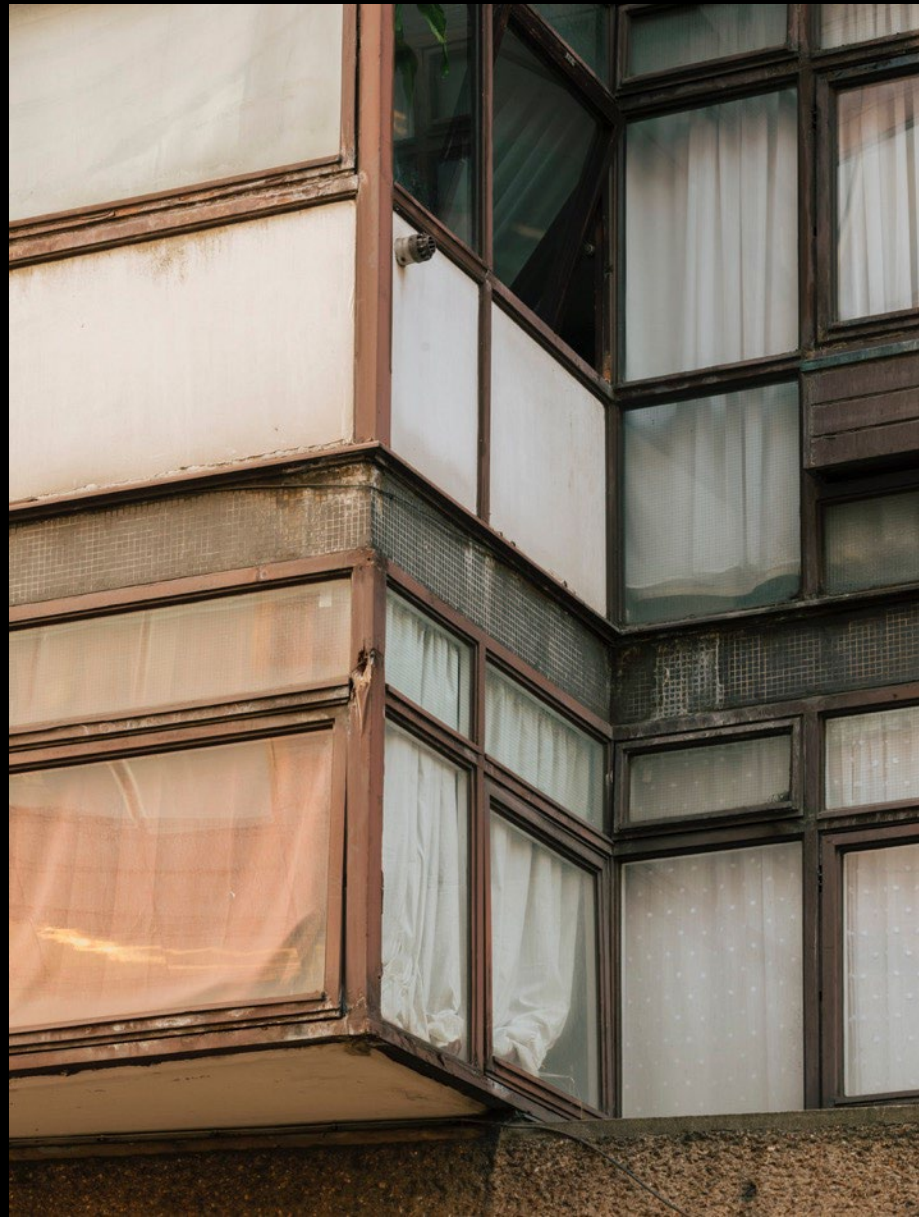
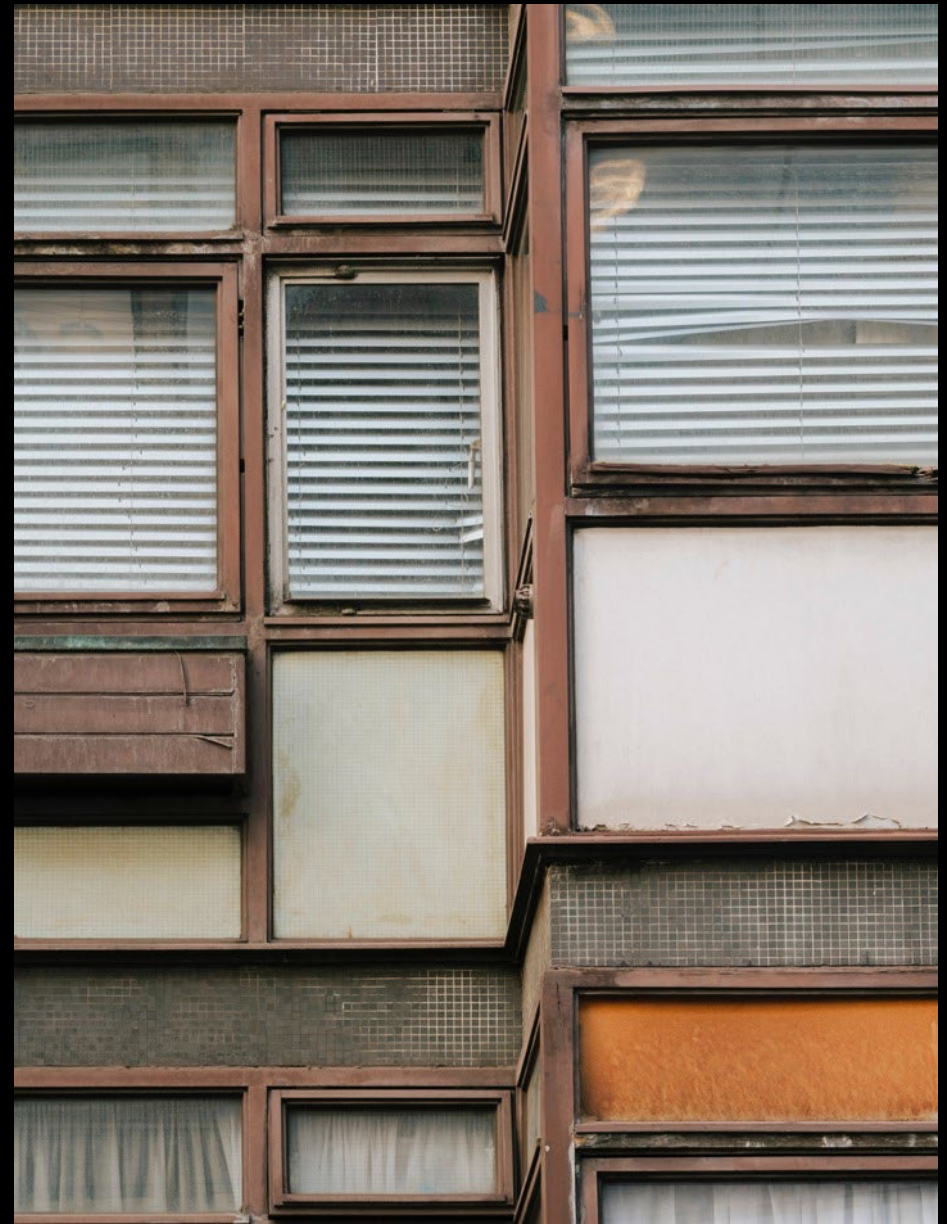
Window Condition 2023

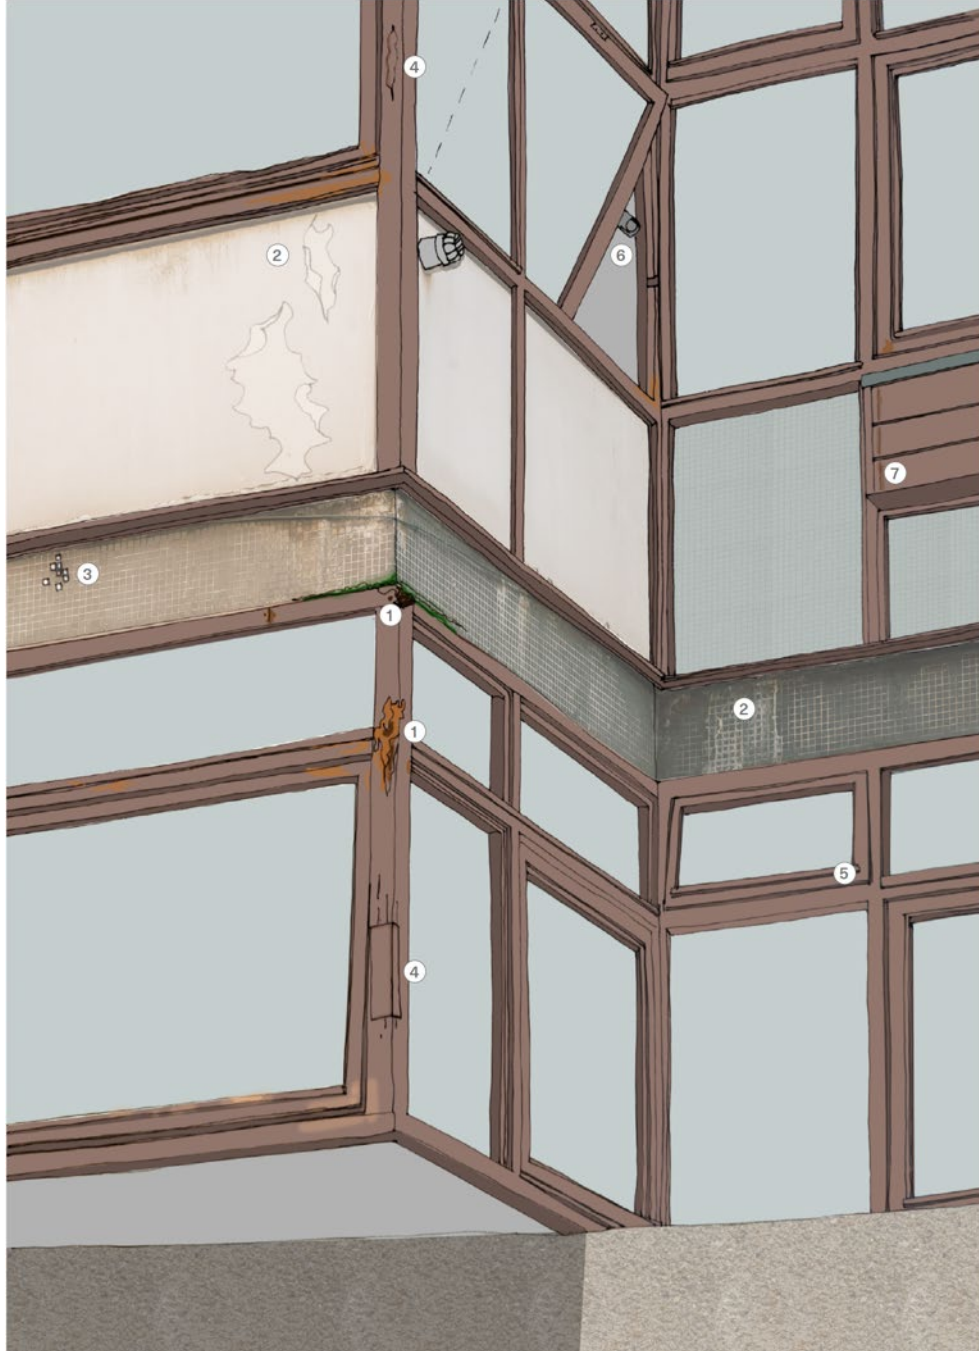
Types of Window Repairs & Refurbishments

- ① Damaged or decayed wood
- ② Stained/dirty surfaces
- ③ Damage/failure of mosaics
- ④ Historic repairs
- ⑤ Failure of opening casements
- ⑥ Damaged or missing ironmongery/hardware
- ⑦ Poor quality paintwork

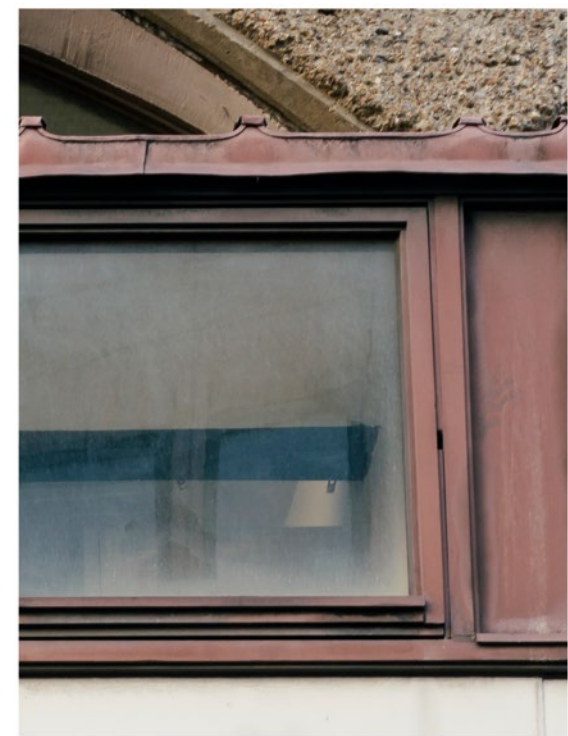
Original Window –
no obvious rot

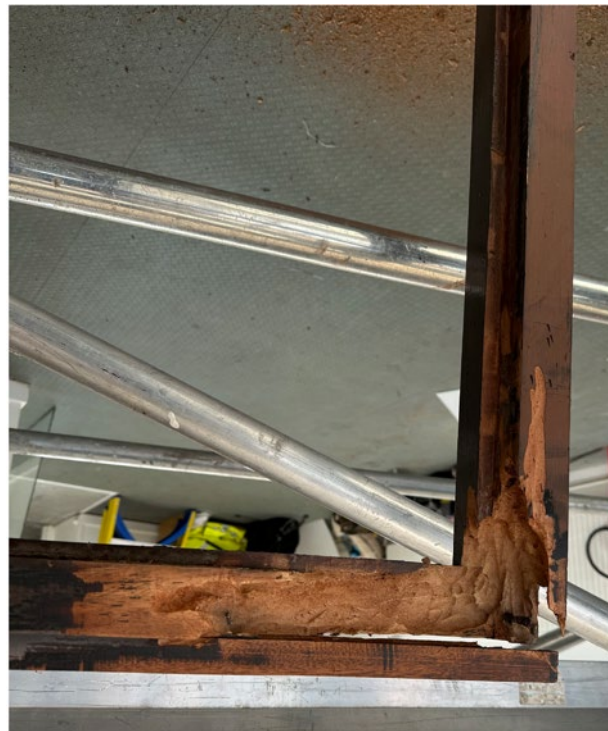
Window removed
from frame and rot
discovered

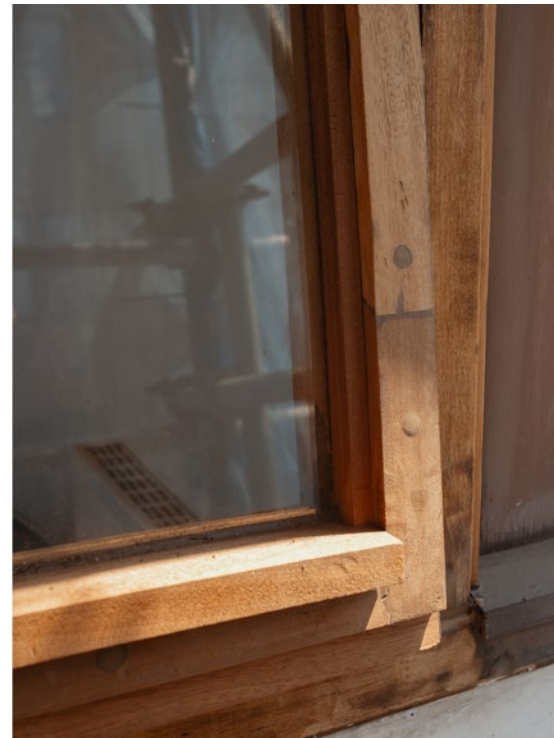
Window repaired
with new sapele
spliced into frame

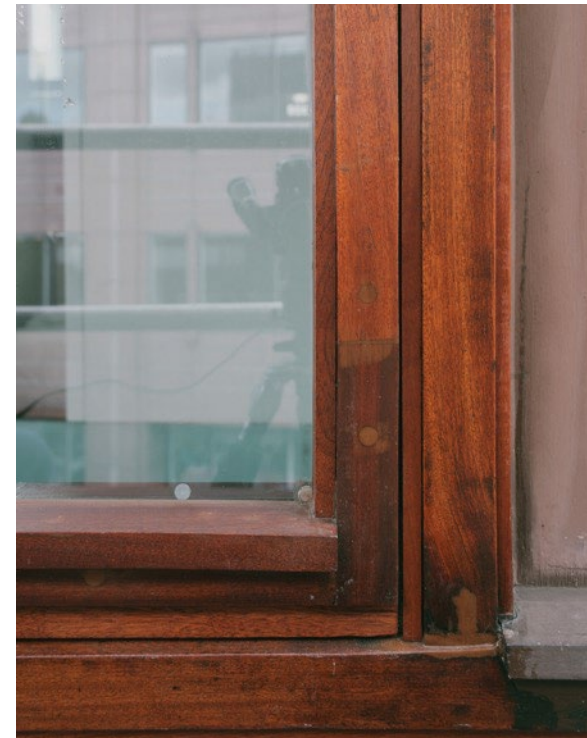
Completed repair,
window reinstalled
and oil finish applied

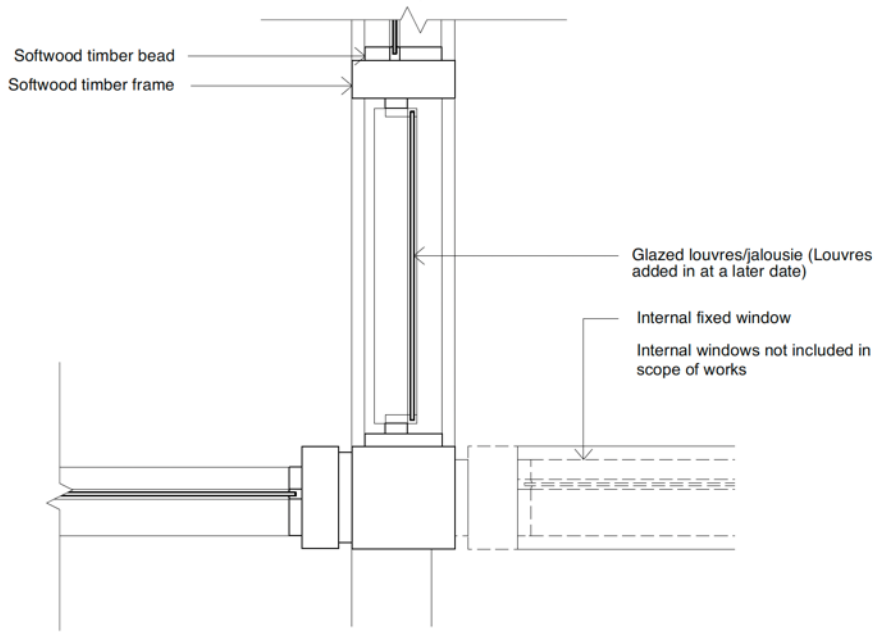
Existing jalousie window

The existing jalousie window is a significant route for heat loss in the home. It is proposed to remove and replace with a fixed panel of VIG.

The BRE testing data shows the air leakage through this window (when closed) accounts for 18% of the measured air leakage from the entire property.

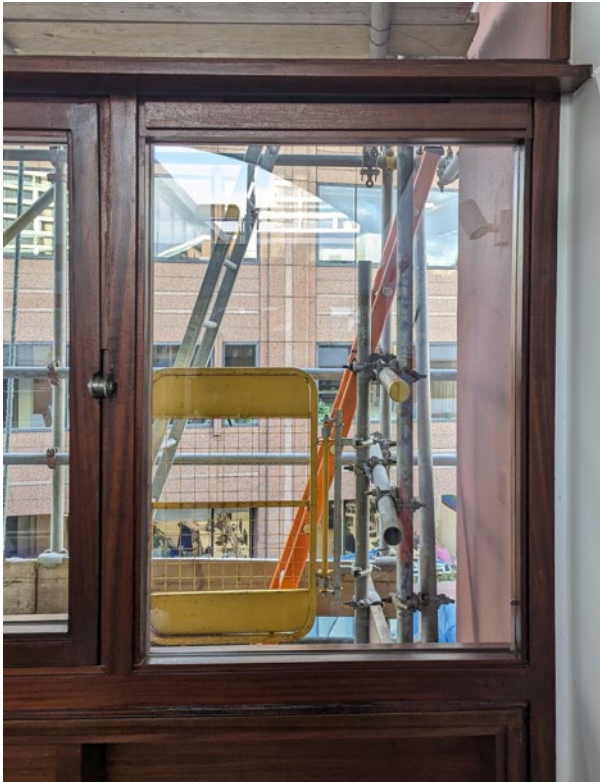
Internal view of trickle vent

The existing windows have non-controllable trickle vents incorporated into the jambs of the pivot windows. In the process of overhauling the windows these will be removed and new beads installed to close the gaps.

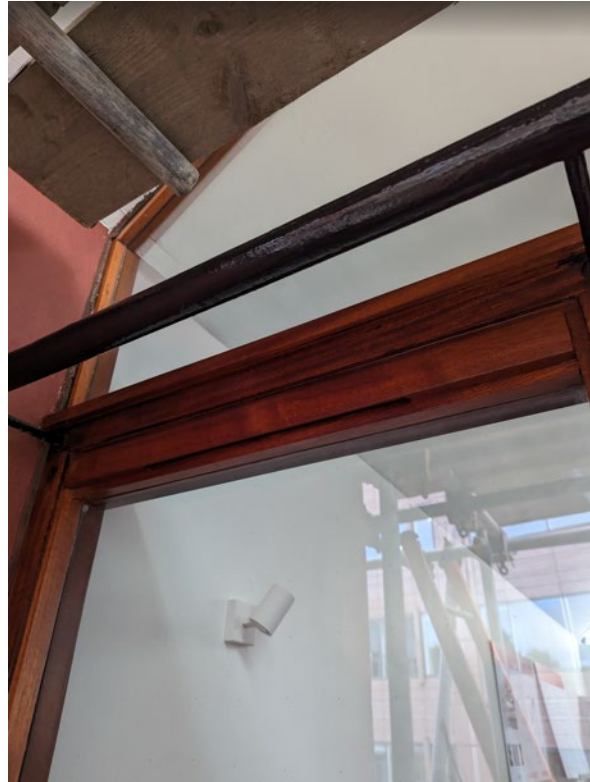
External view of trickle vent

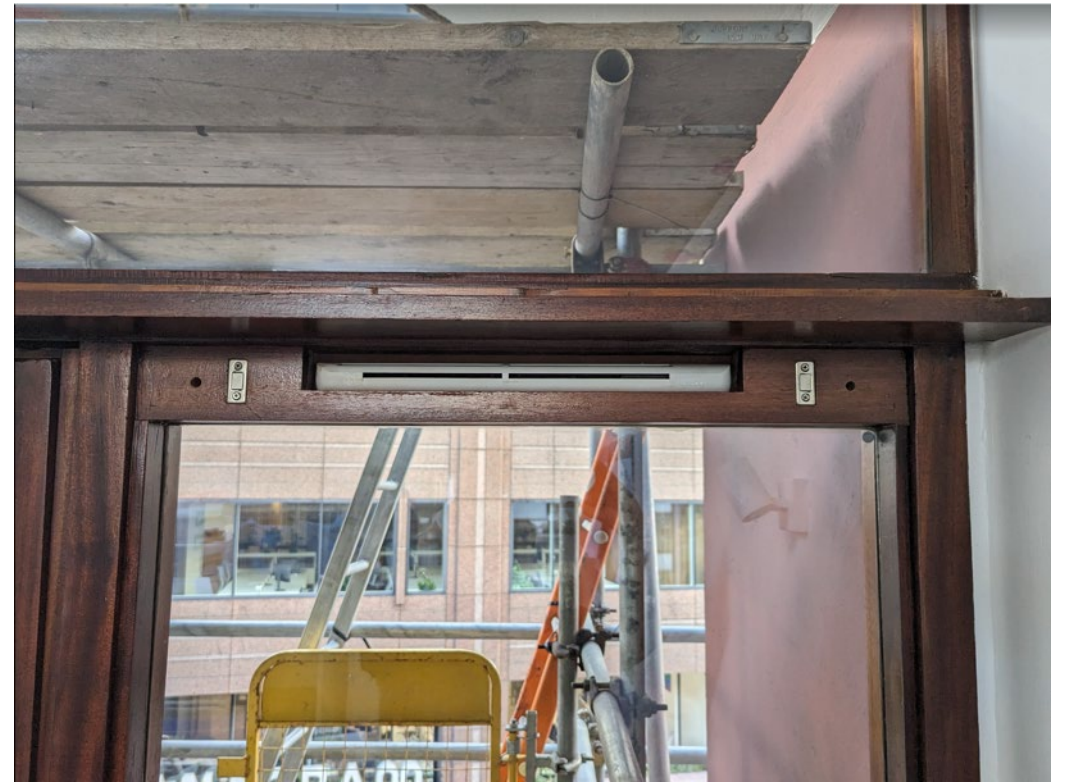
Trickle vent with sapele cover removed

A new head section is proposed to the frame of the fixed light above the bookshelf, to allow installation of a concealed demand controlled trickle vent, to provide background ventilation as part of the demand controlled ventilation system.
