## Hampstead Heath, Highgate Wood and Queen's Park Committee

**Date:** MONDAY, 23 MARCH 2015

**For Information**
  7. **HILL GARDEN PERGOLA**  
Report of the City Surveyor.

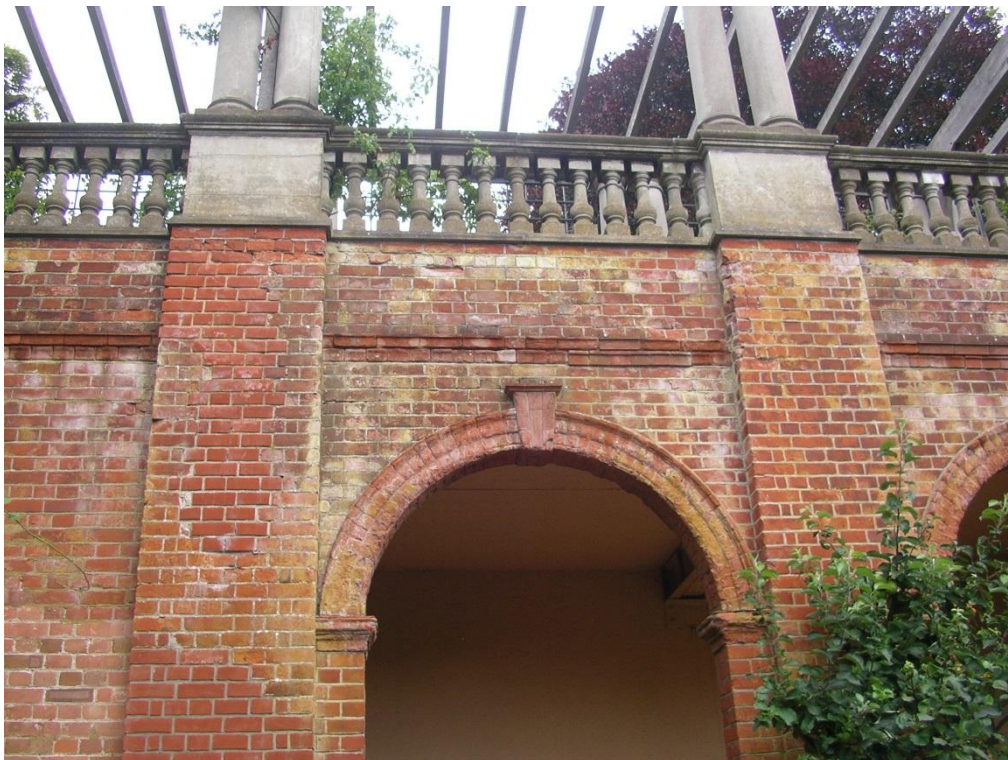
Section 1: Brickwork arcade to lower level walkway showing deterioration due to dampness.

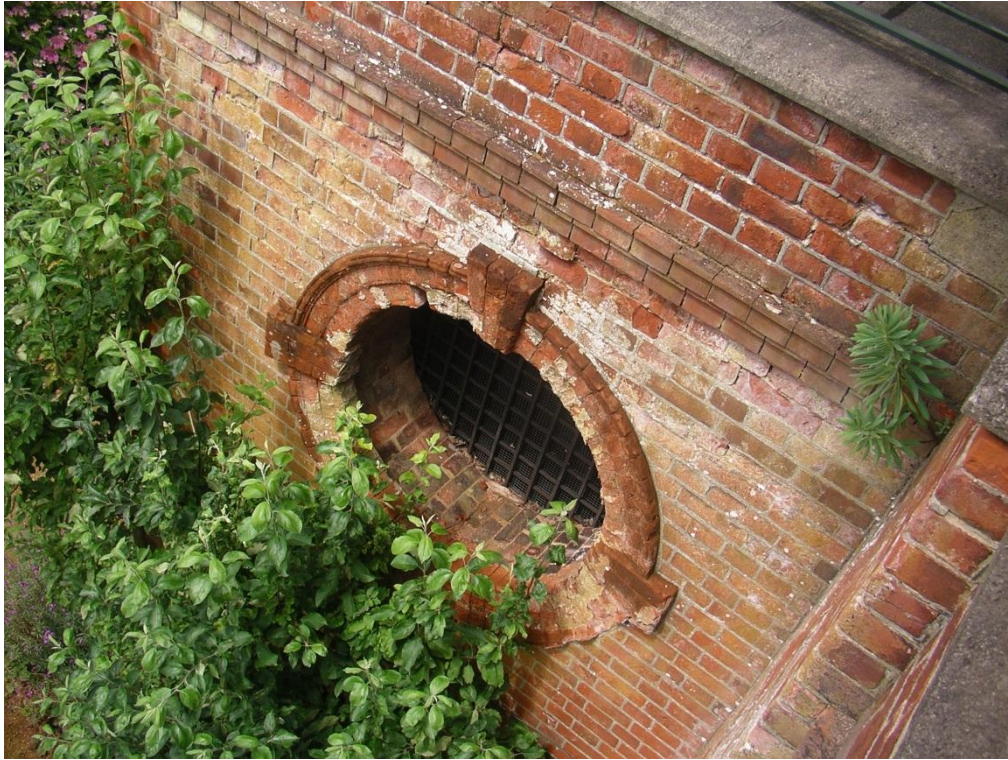
Section 1: brickwork deterioration around a circular window feature and efflorescence below the level of the structural slab to the walkway.

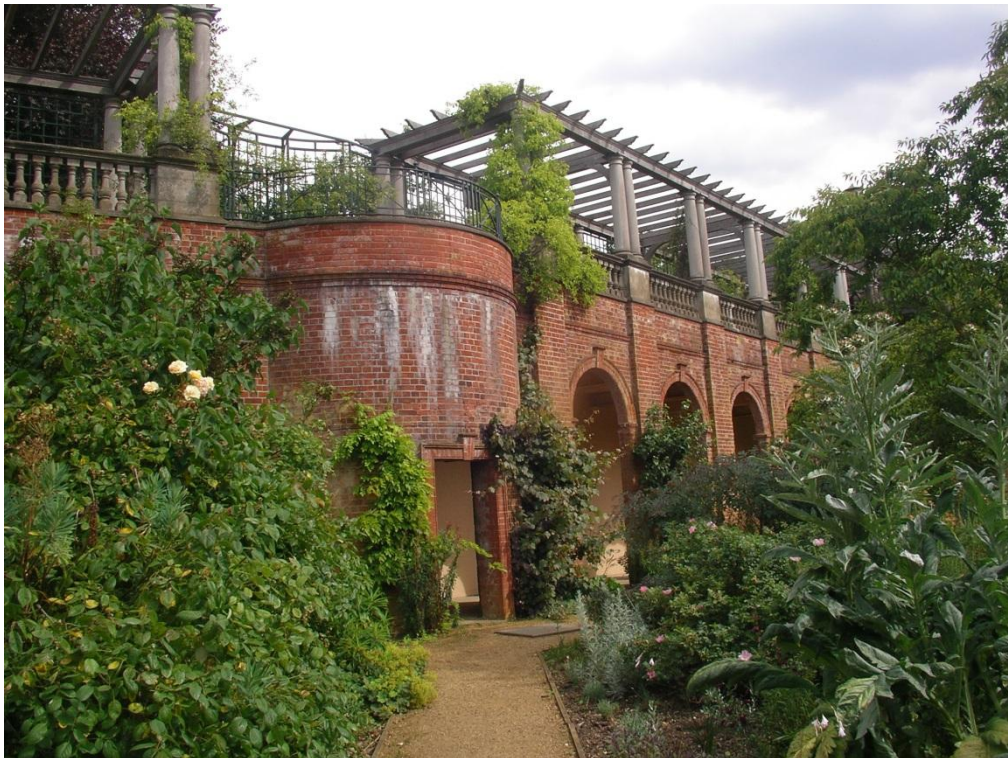
Section 1: The rotunda feature showing unsightly efflorescence.

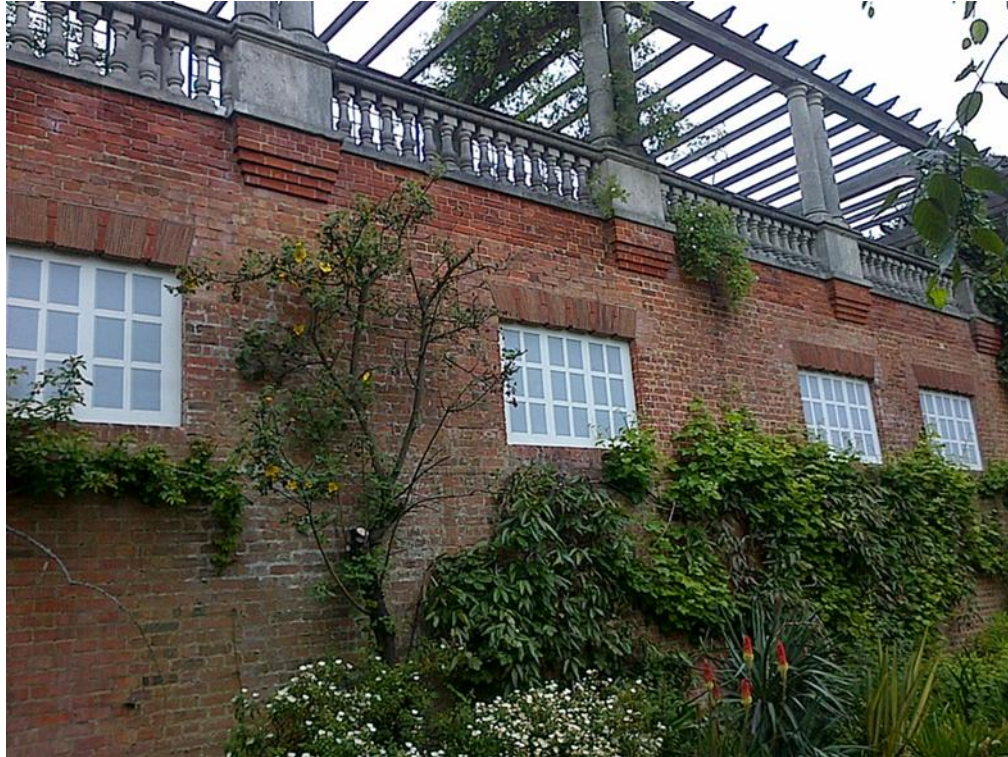
Section 2: The false windows after renovation in 2013.

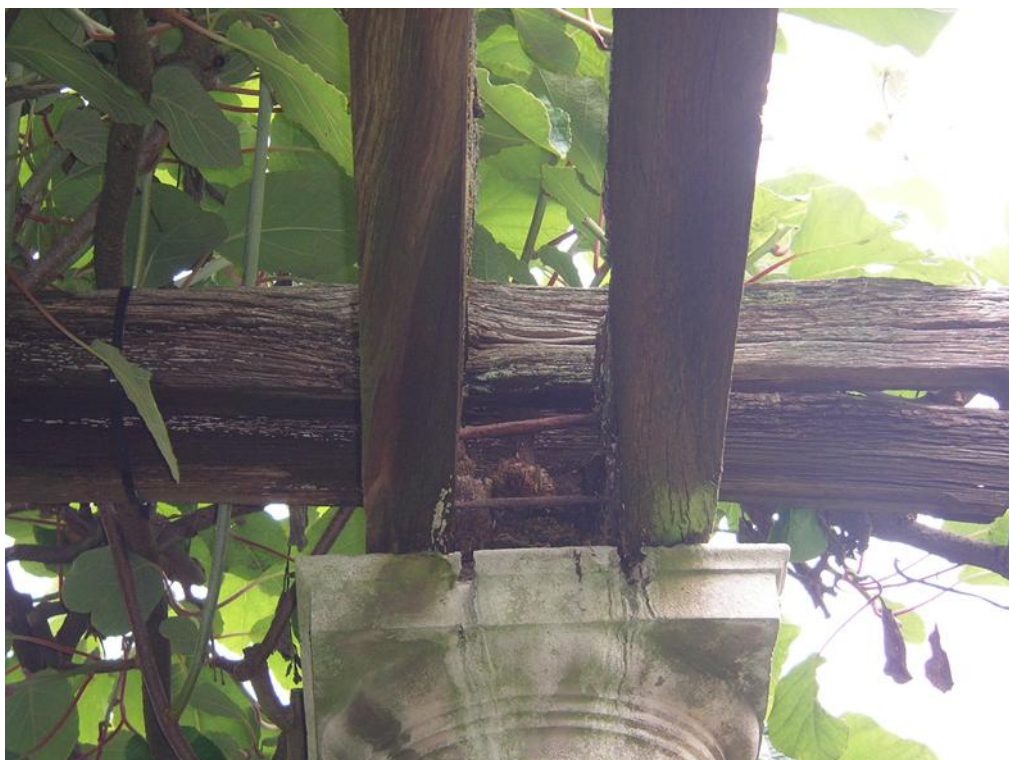
Section 2: showing decayed timbers and acid attack to Portland stone column from oak timbers.

Stone columns are located throughout the Pergola. These are a mixture of original columns made from Portland stone and replacement columns made from reconstituted stone. The columns are located on the upper walkways of the Pergola and form a fixing platform for pergola timberwork superstructure. The timberwork and the stonework are fixed together with a centrally located dowel in the head of columns. A lead capping has been fitted to separate the oak timber section from the Portland stone to form a barrier to alleviate the acid attack that is evident in section 2.

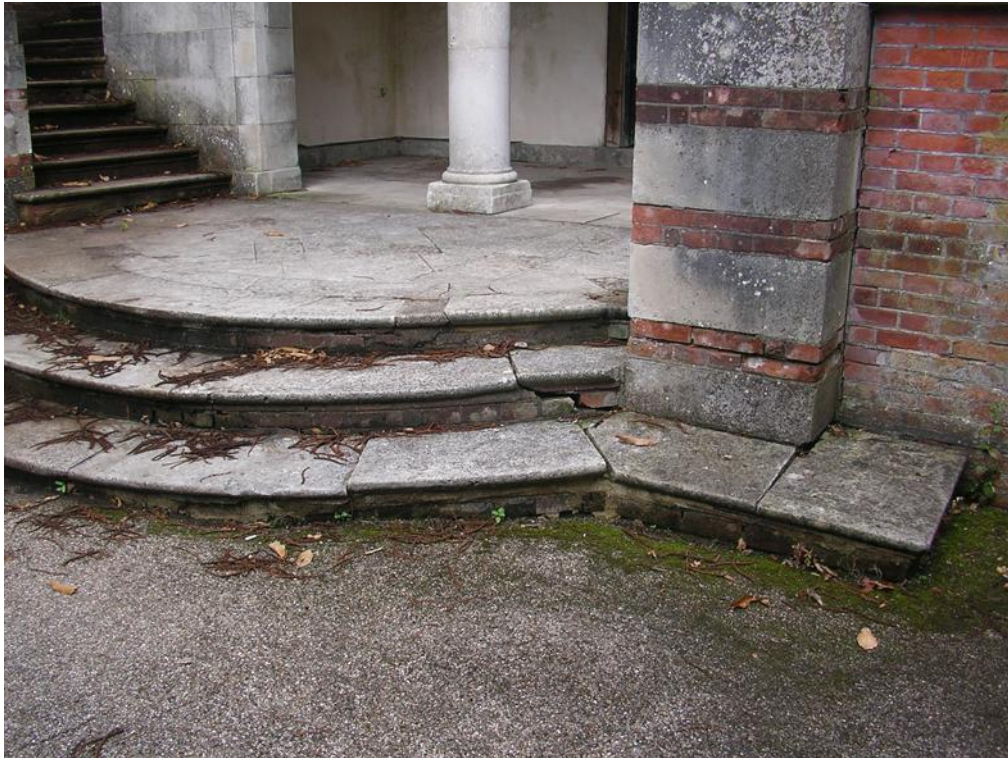
Section 2: cracked staircase at the Belvedere structure which will be repaired as part of the 2015/16 cyclical maintenance programme.

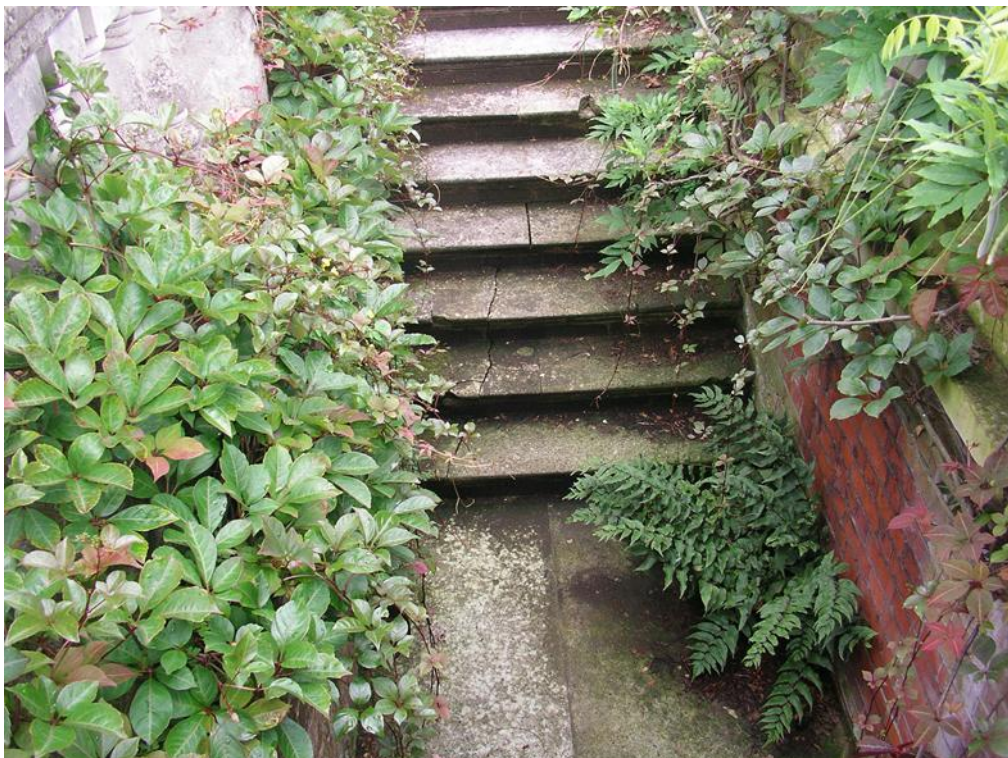
Section 2: one of the minor staircases showing cracked treads.

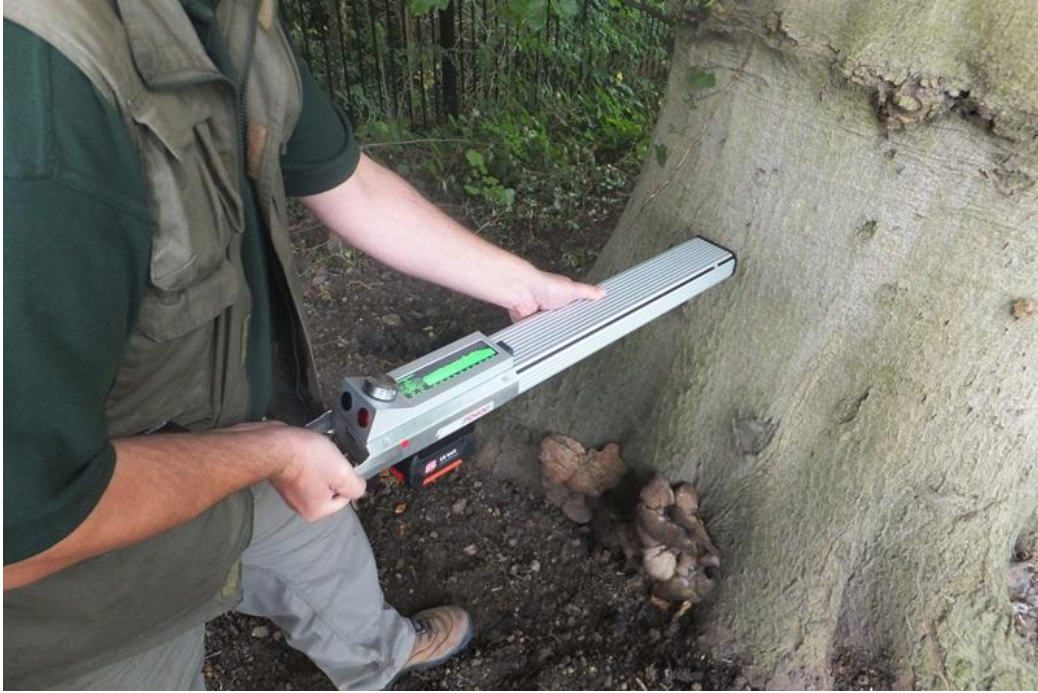
19. Members of the Tree Team have developed their skills and experience in carrying out detailed tree assessment over the past six years, and can now employ a variety of technical investigatory procedures that can determine structural integrity and the extent of decay in older or damaged trees. They can employ a micro drilling device called a Resistograph, which provides an instantaneous visual display of the internal structure of the branch or stem being assessed. This device allows the Team to determine the 'residual wall' strength of the tree and make decisions on whether the tree requires a crown reduction or other suitable management. The acceptable rule of 30% of the known radius of the tree's main stem is considered to be the optimum wall thickness, but there are exceptions to this guidance, depending on age and species.

Figure 2: Resistograph being used to test for internal decay

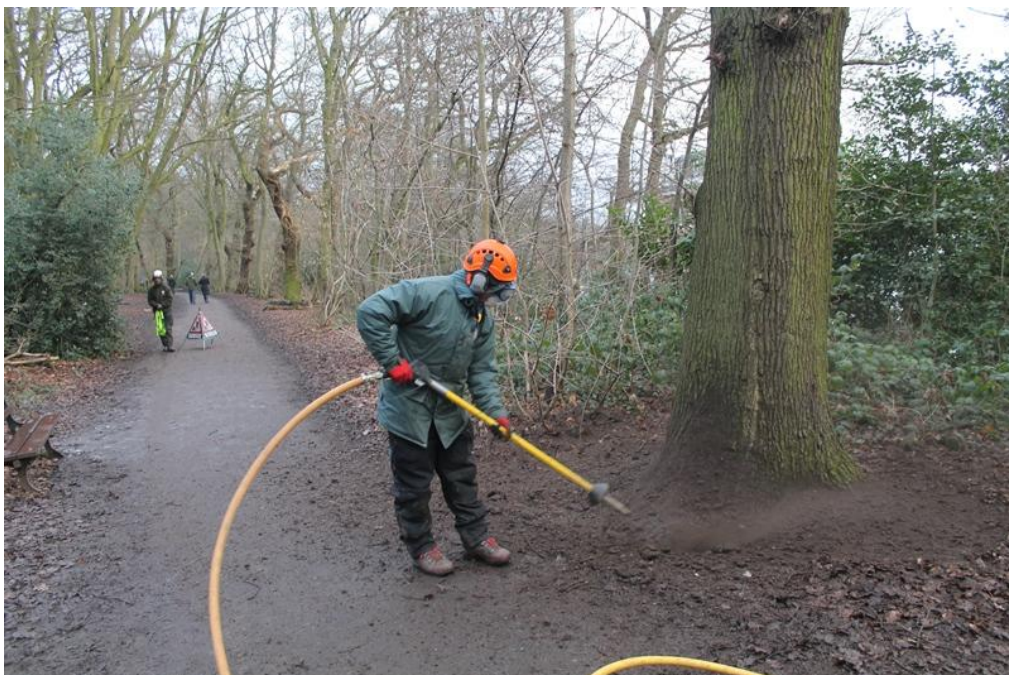
20. The Tree Team has also started to carry out more root inspection work when possible, often on trees where there are evident fruiting fungal bodies, or where the root zone is compacted. The Team uses a compressor-powered air lance or air spade to carry out the excavation work, which prevents damage to the larger, more significant lateral and supportive roots. This equipment has been used to great effect on a number of trees where root damage has been suspected and allowed construction design to be altered to avoid further damage. Air spading has proven very effective at reducing compaction around veteran trees on the busier, more frequented areas of Hampstead Heath. The image below is from a recent investigation in Highgate Wood on one of the larger oaks near Muswell Hill Road. The tree was previously damaged in the 1987 storm and it was discovered that the main stem has a significant crack that has now occluded over but can still be detected using the Resistograph.

Figure 3: Oak tree root investigation at Highgate Wood
