Appendix 3

Air Quality

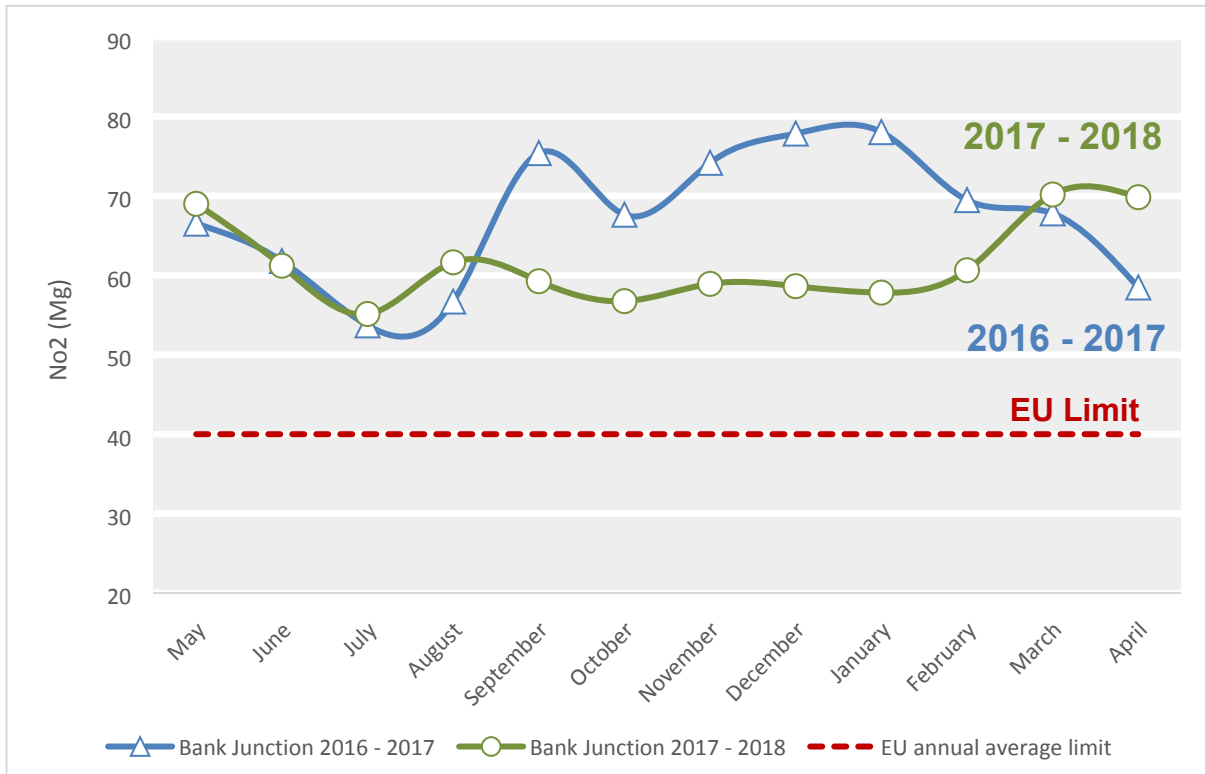
Figure 3 (in main report): Changes in No₂ between 2016 and 2017 at Bank Junction

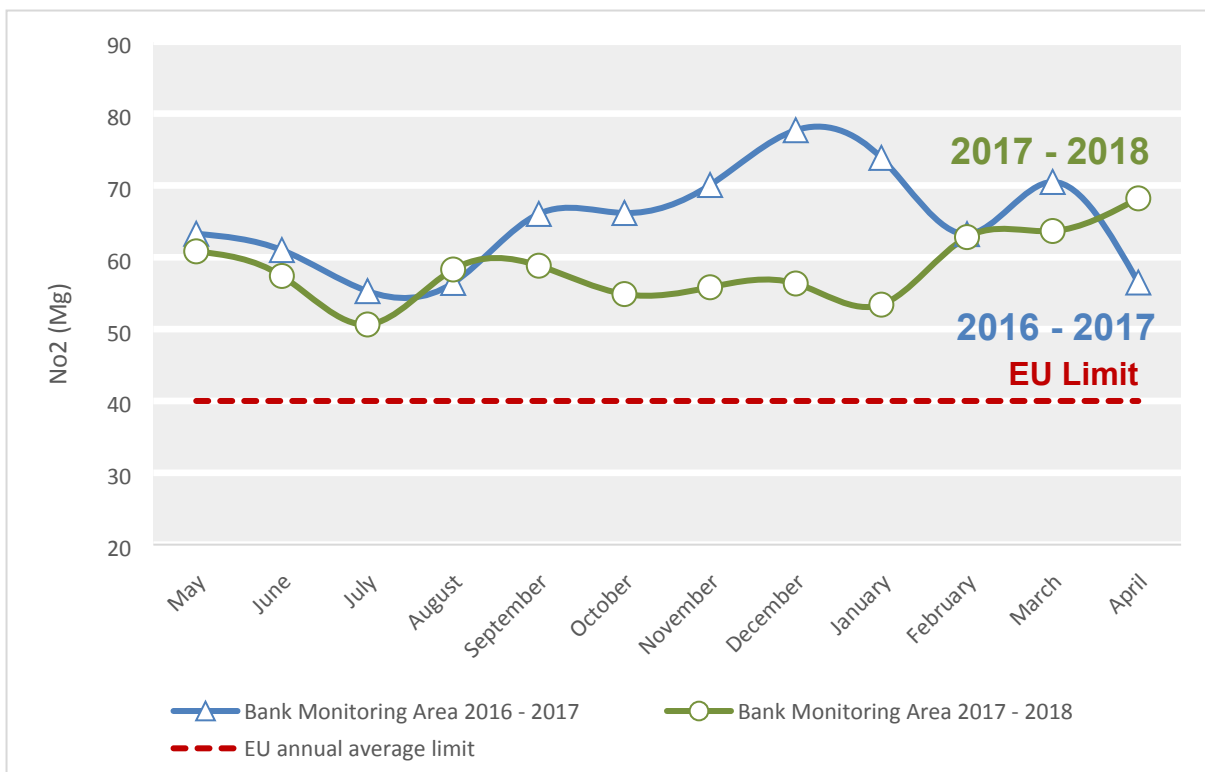
Figure 9: changes in No₂ between 2016 and 2017 in the Bank Monitoring Area

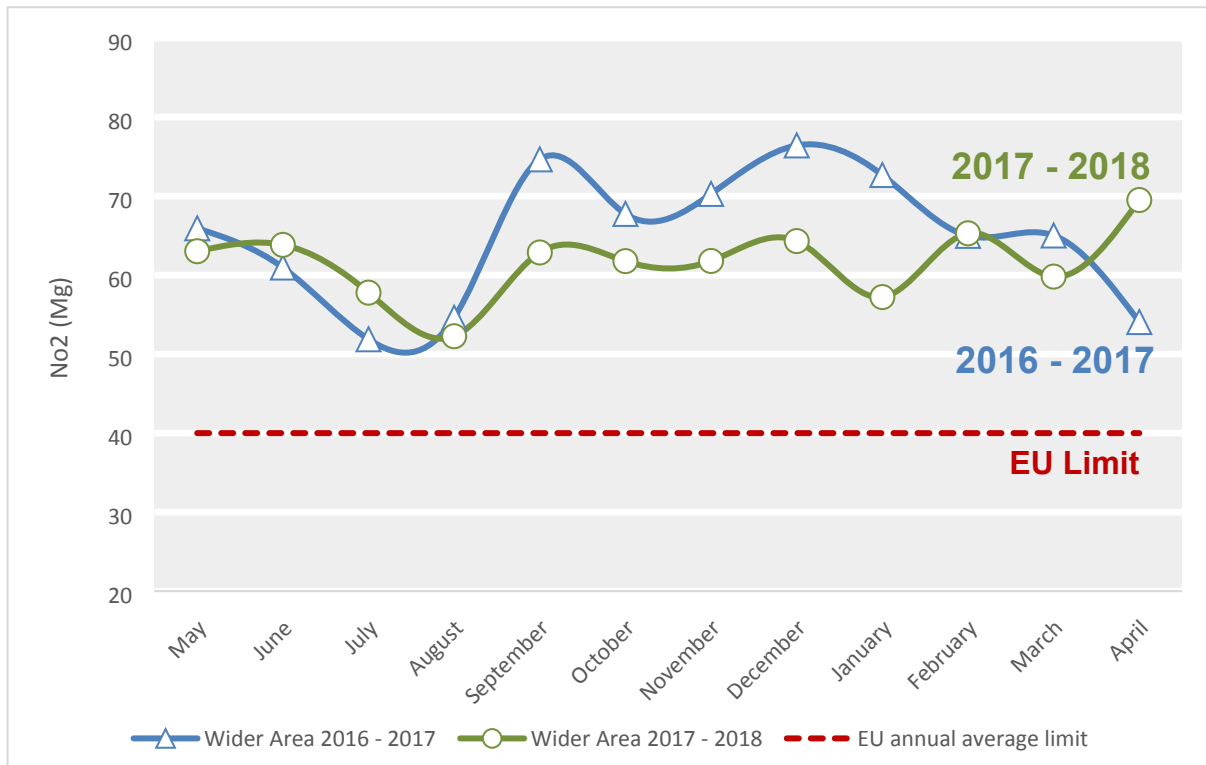
Figure 10: changes in No₂ between 2016 and 2017 in the wider area

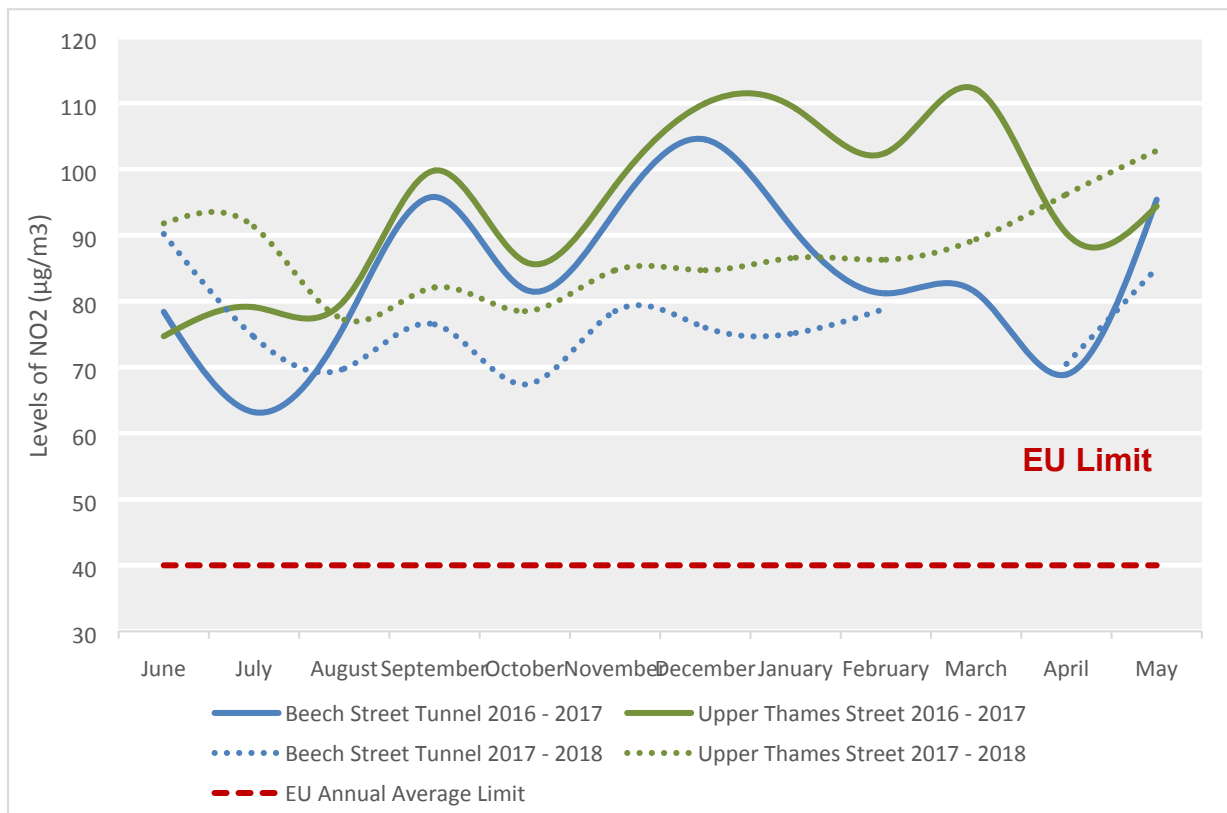
Figure 11: changes in No₂ between 2016 and 2017 at City of London continuous monitoring stations
