## Existing layout of the Education Centre at Highgate Wood

## Alterations to the Education Centre at Highgate Wood: Option 1

## Alterations to the Education Centre at Highgate Wood: Option 2

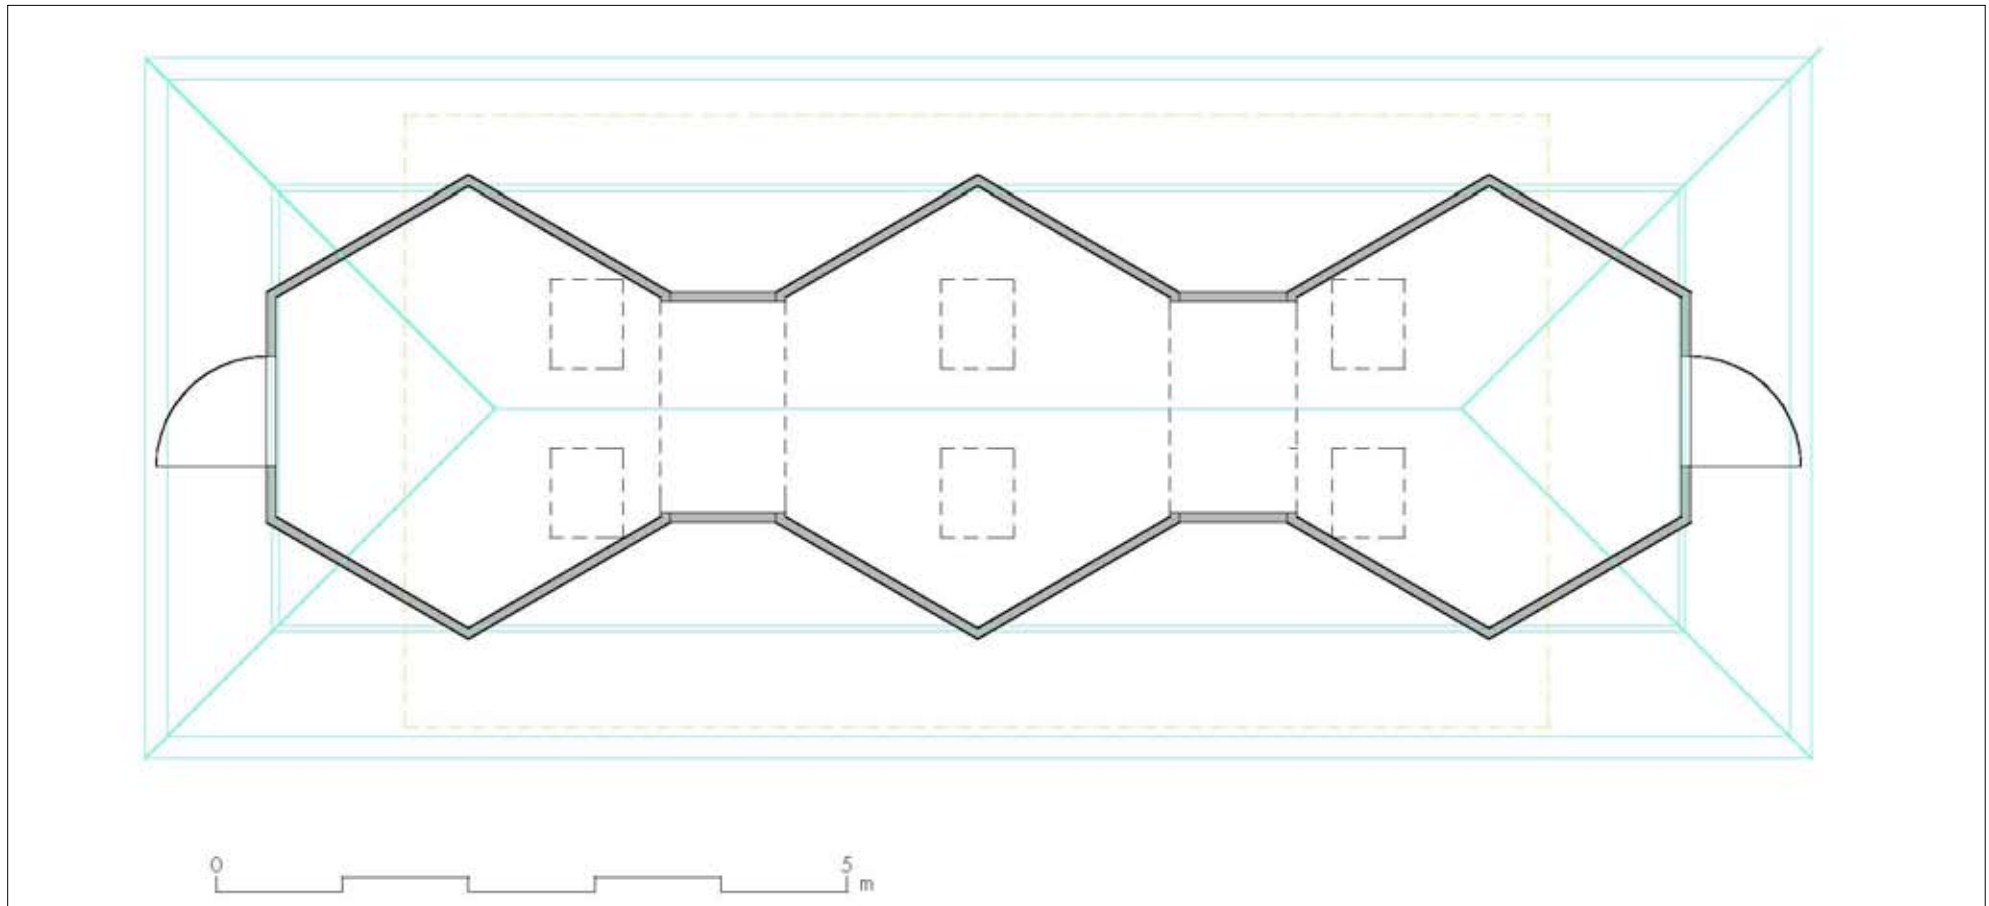
The existing Education Centre was erected in 1995 by Norwegian Log. The walls of the structure are formed of plywood sheets clad on both sides with log profiles.

The plan below suggests that there was a smaller building on a concrete slab which predated the present building. It appears the existing building was placed with the principal loads on the old slab.

The original plan of three linked hexagons is simple and clear although the logic is more apparent on the plan than in reality.

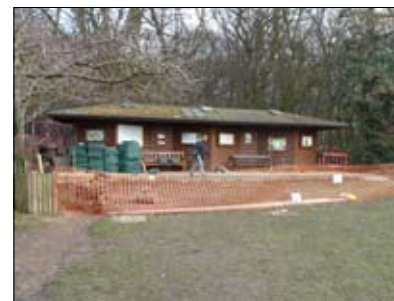
The existing Education Centre.
