Committees:	Dates:	
Planning and Transportation Committee Projects Sub Court of Common Council	30 October 2018 07 November 2018 06 December 2018	
Subject: Blackfriars Bridge Parapet Refurbishment and Bridge Re-Painting	Gateway 3/4 Options Appraisal(Regular)	Public
Report of: Director of the Built Environment Report Author: Thomas Creed		For Decision

Blackfriars Bridge Refurbishment

Parapet and Maintenance Painting Study

July 2018

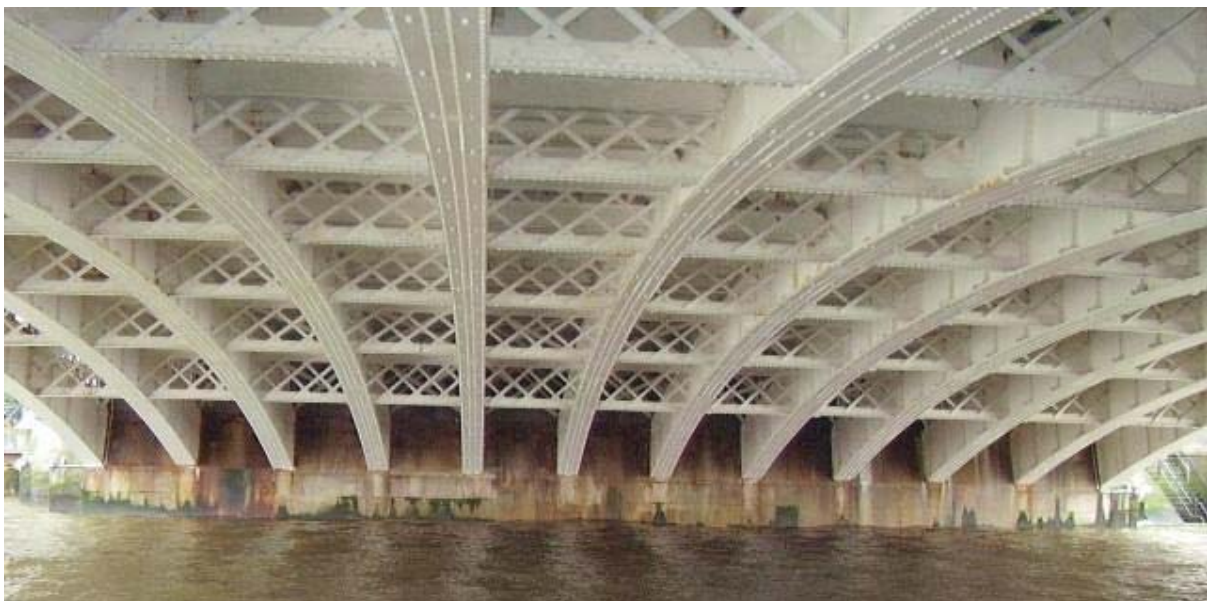
Figure 2. View of the underside of the bridge

The flanges of the wrought iron main ribs comprise two plates 610mm wide with a total thickness of 38.1mm. The web plate varies in height and is 22.2mm thick. Pairs of 102x102x12.7mm angles connect the web plate to the top and bottom flanges.

The flanges of the newer steel ribs consist of two plates 610mm wide with a total thickness of 44.5mm. The web plate is similar to the wrought iron webs but the angle sections are 114x114x19mm thick.

All the ribs have 152x102x12.7mm T-section transverse stiffeners at approximately 1.676m centres.

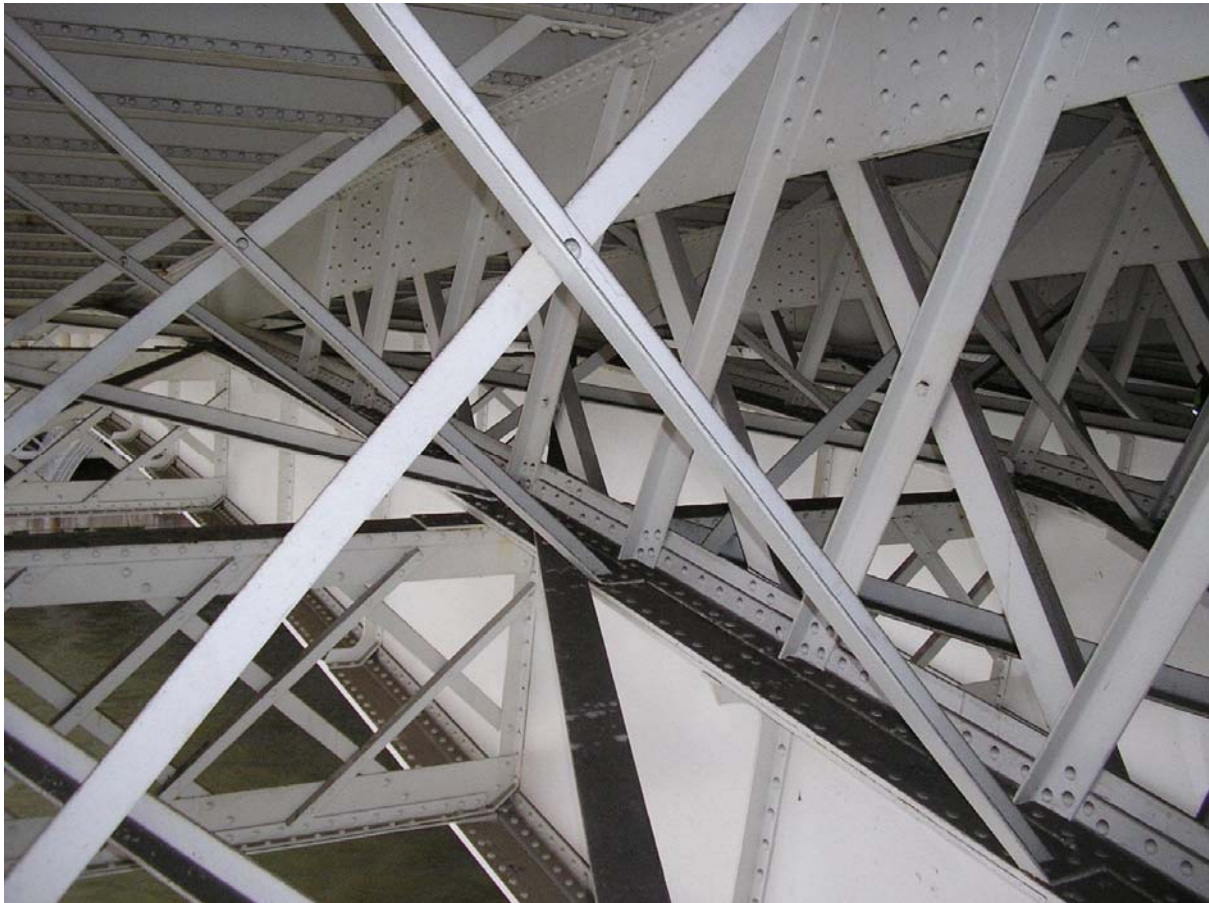
Figure 3. Braces between arch ribs

Transverse bracing members exist between the main ribs. The transverse bracing members are located approximately every third transverse web stiffener in the main ribs and are connected to the webs of the main ribs.

Transverse deck girders sit on top of the spandrel top chord or are connected directly to the web of the main arches in the centre of the spans. The girders are spaced at an average of 1m when on top of the spandrel top chord. Where the girders are riveted directly into the main arch ribs they generally occur at the same location as the transverse web stiffeners.

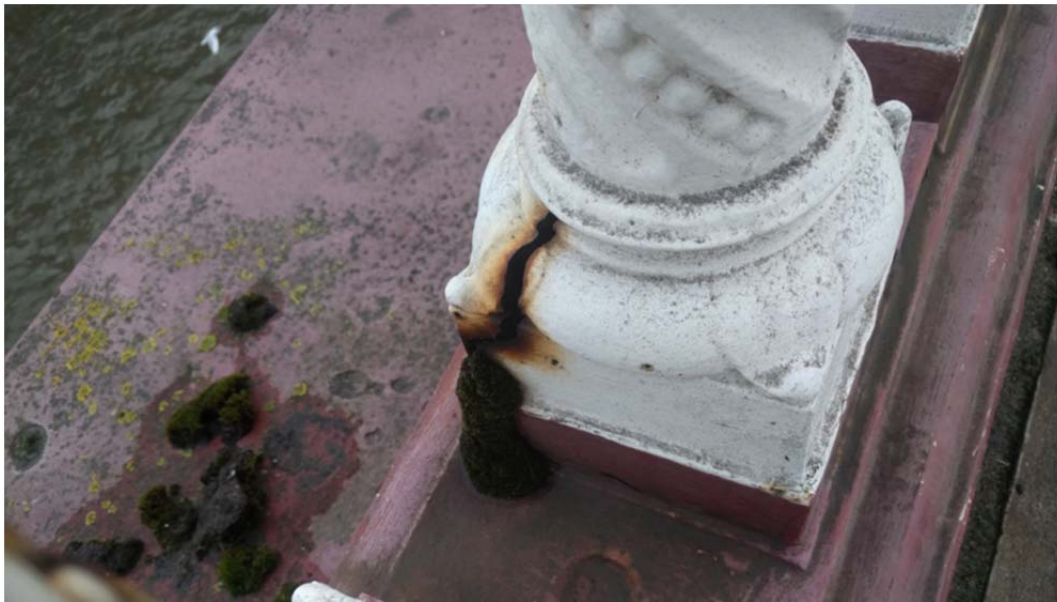
Several cracks along the parapet were noted having propagated from the corners of the base of the balusters and this has caused section loss on the baluster in a number of locations. This deterioration is causing rust staining along the bridge which is highlighting the cracks and damage on some balusters. The vertical casting joints are separating in some instances and are showing signs of rusting. The balusters are also pitting in some locations along the bridge.

Figure 4. Example of large crack in the corner of baluster base that is required to be filled with epoxy filler.

Due to Blackfriars Bridge's location and prominence it is important its appearance maintains a high level. As part of this option the major defects in the parapet will be repaired or replaced. This option includes completely replacing some of the balusters columns due to section loss or large cracks. As a Grade II structure the replaced baluster columns will need to replicate the original balusters. This option would also include the larger cracks being filled with an epoxy filler to prevent further corrosion and deterioration of the parapet. Before the cracks are filled, the cracks will be cleaned by being grit blasted. The connecting plates between the parapet and the piers will be replaced where cracked or missing. The longitudinal cracks in the mortar where the parapet meets the footway will be dug out and replaced. These works will be done before the bridge is repainted.

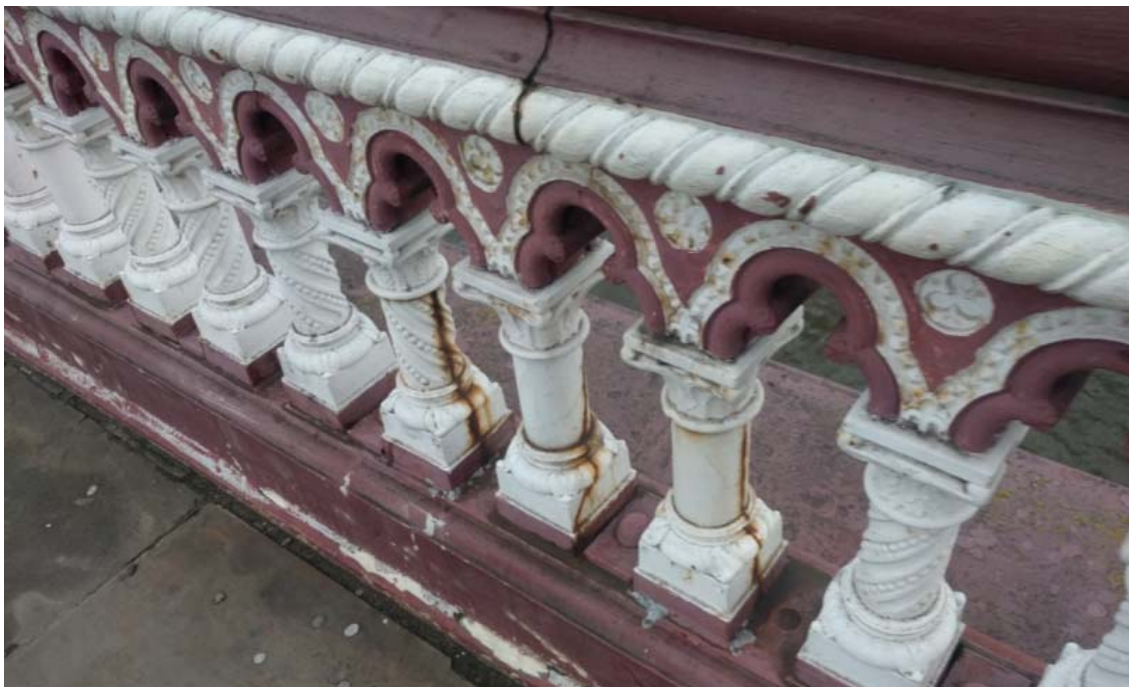
Figure 5. Example of the rusting staining of the vertical casting joints

In addition to patch repairs this option would address the issue of the rust staining of the majority of the baluster posts. Not only would it remove the staining from the parapet but it would prevent staining as the minor cracks causing staining of the parapet would be sealed by the paint. The pitting found on a number of the baluster posts would also be covered by the protective paint.

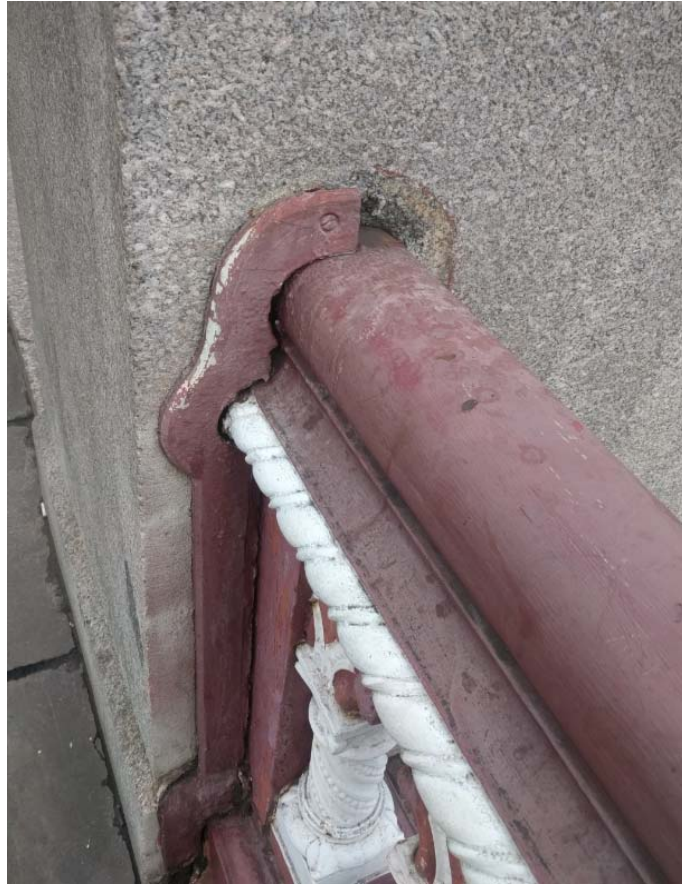
Several of the plates at the interface of the parapets and the piers are missing or displaced.

Figure 6. A missing plate connecting the parapet to the pier

As shown in Appendix C the parapet can be detached in sections and the balusters replaced easily. The connecting plates between the parapet and the piers will be replaced where cracked and missing. The longitudinal cracks in the mortar where the parapet meets the footway will be dug out and replaced. These works will be done before the bridge is repainted.

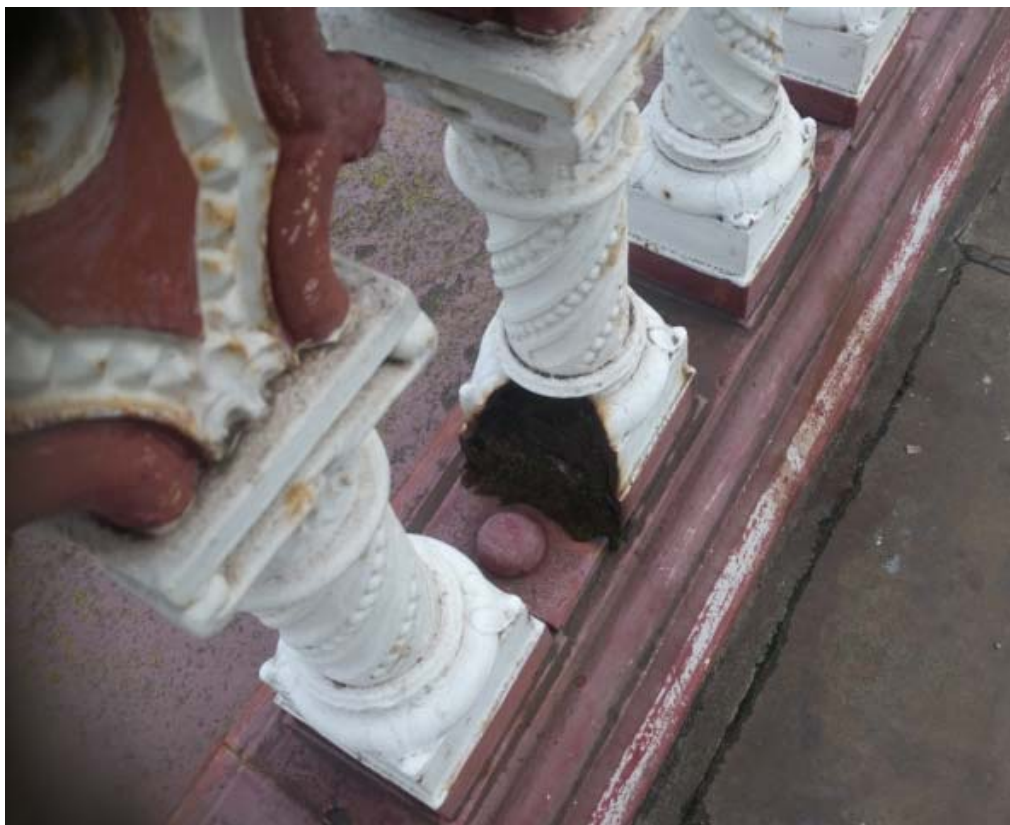
Figure 7. An example of section loss at the base of the baluster

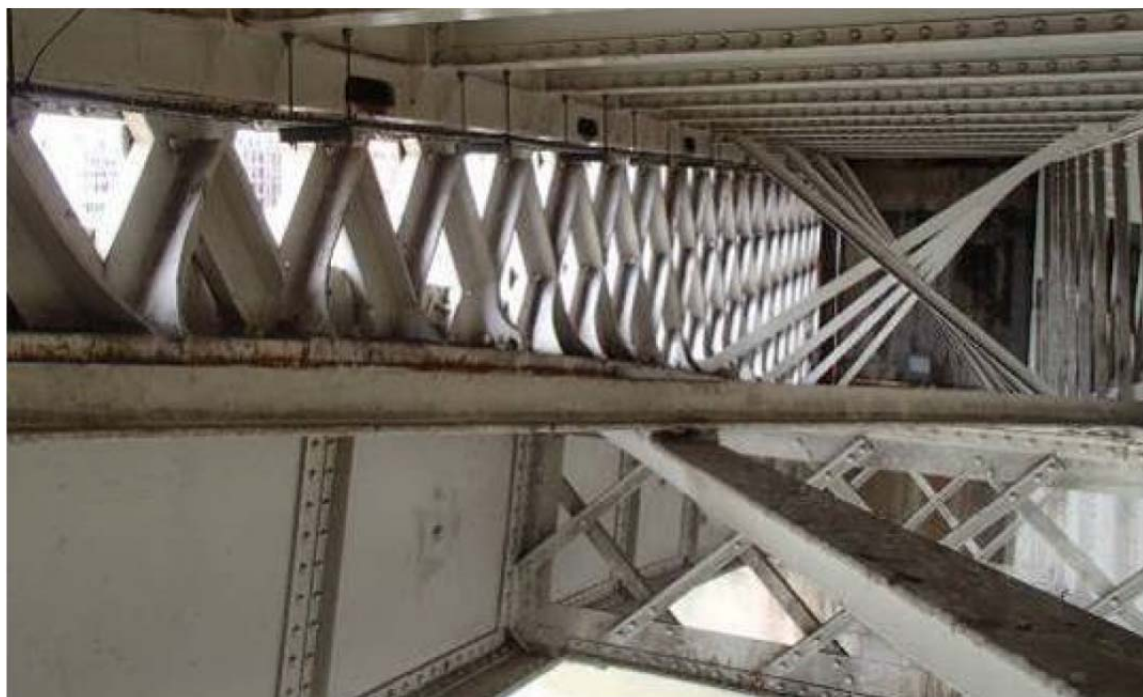
The condition of the paint throughout the soffit of the arches is quite good. It is believed that most of the paint is in good enough condition to be cleaned and over coated as opposed to being taken back to bare metal and 3 coats applied. It is likely that 5-10% of the soffit where rust is visible will need a full preparation and paint system.

Figure 9. Condition of structure on the underside

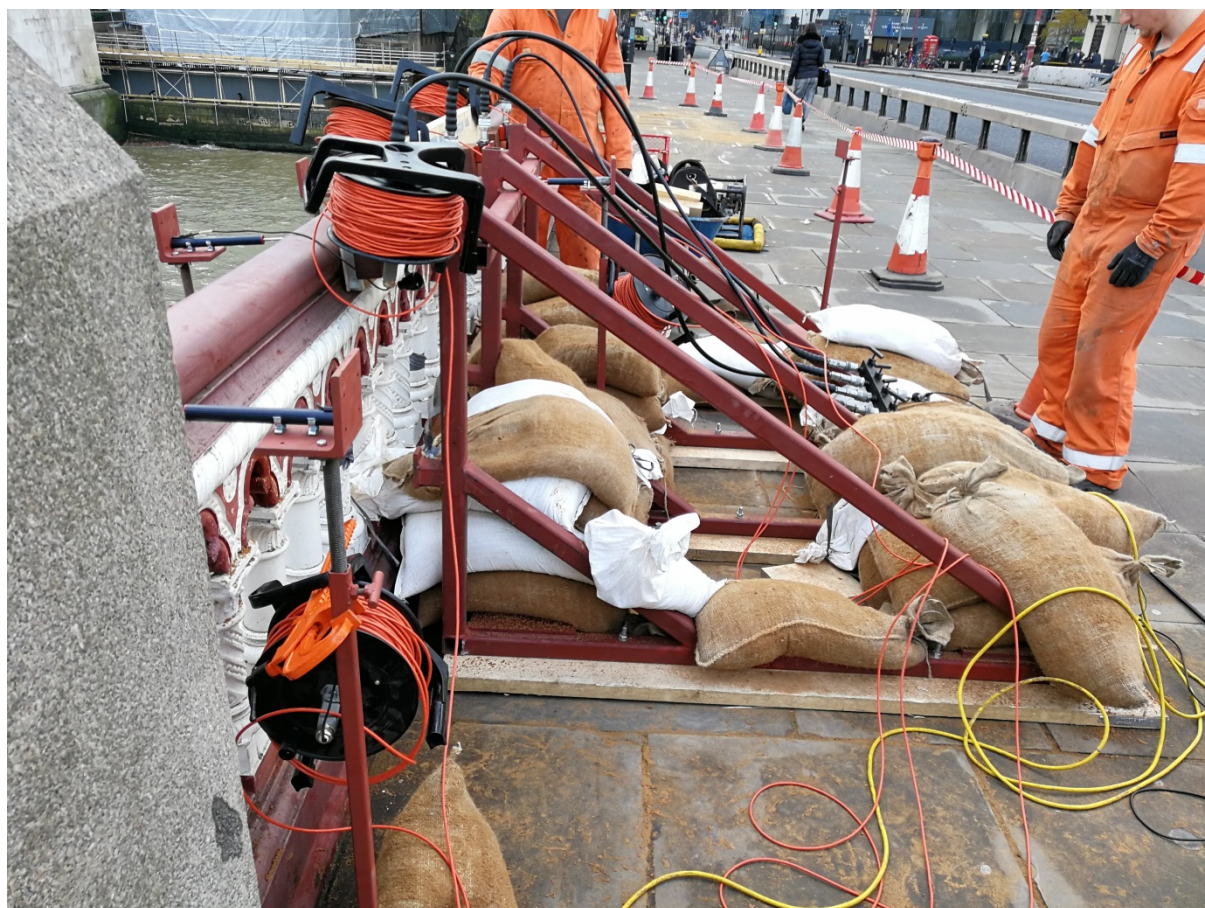
Figure 10. Parapet test

In 2018 the City of London commissioned AECOM to arrange a test of the parapet to determine whether it was possible to retain the current parapet or if strengthening would be required. The test involved constructing a frame to apply a static horizontal load to a section of the parapet. The loads were applied at handrail level and baluster level

The test found that the parapet is satisfactory under ULS and SLS and so as a result does not need strengthening or replacing. However, it was recommended that the parapet be repainted and localised cracks be repaired to prolong the life of the parapet.

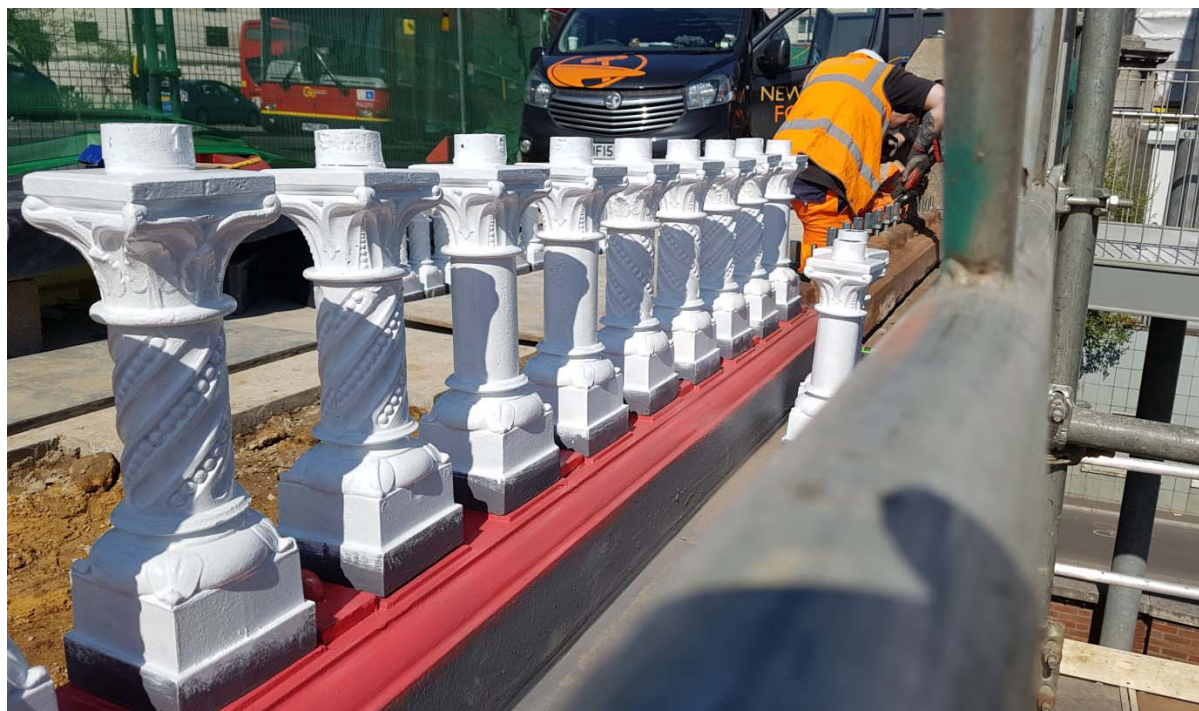
Figure 111. Parapet Repairs

In preparation for the Tideway works a new staircase was installed on the eastern side of span 1 recently. This involved the removal and repair of a section of the parapet. We have used knowledge gained of this work to inform our estimate of the works required to refurbish the parapet on the rest of the bridge, while it is appreciated there will be some economy of scale there is a limited number of specialist companies who will be able to carry out these works to the required standard.

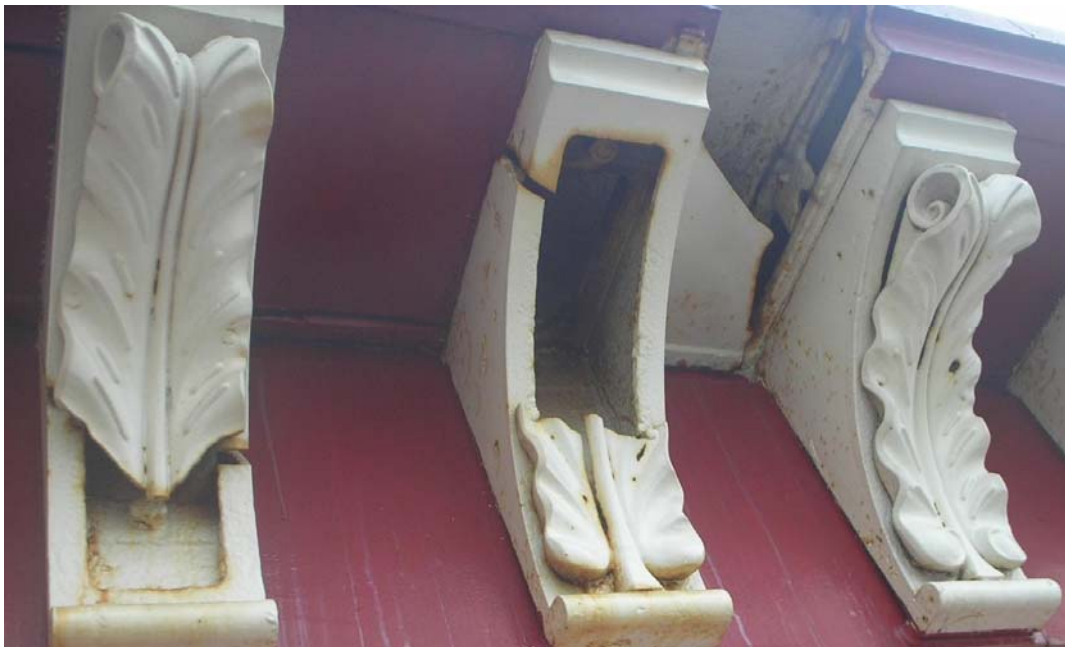
Figure 146. Current rust staining on the bridge

Once a casting specialist has been employed for the parapet it may be decided to extend the repairs to some of the other damaged cast iron elements such as those shown in Figure 16. A nominal sum has been included in the options wherein the parapet is being repaired for further unspecified repairs.

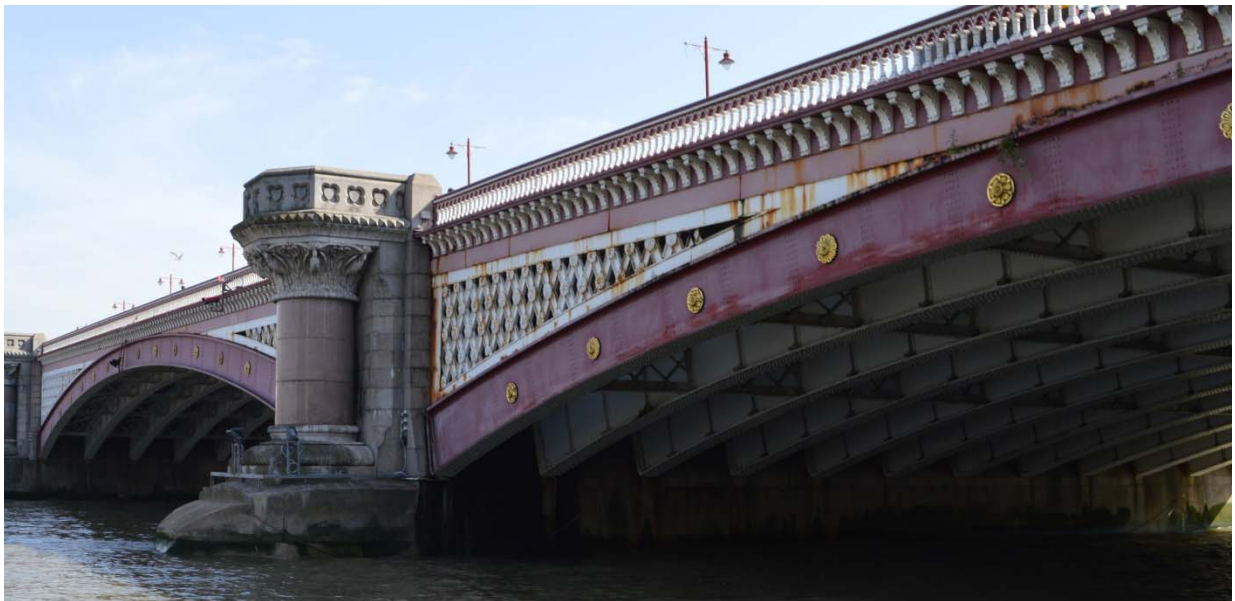
Figure 157. Current rust staining on the bridge
