# **(Final Draft) HAMPSTEAD HEATH PONDS AND WETLANDS CONSERVATION PLAN**

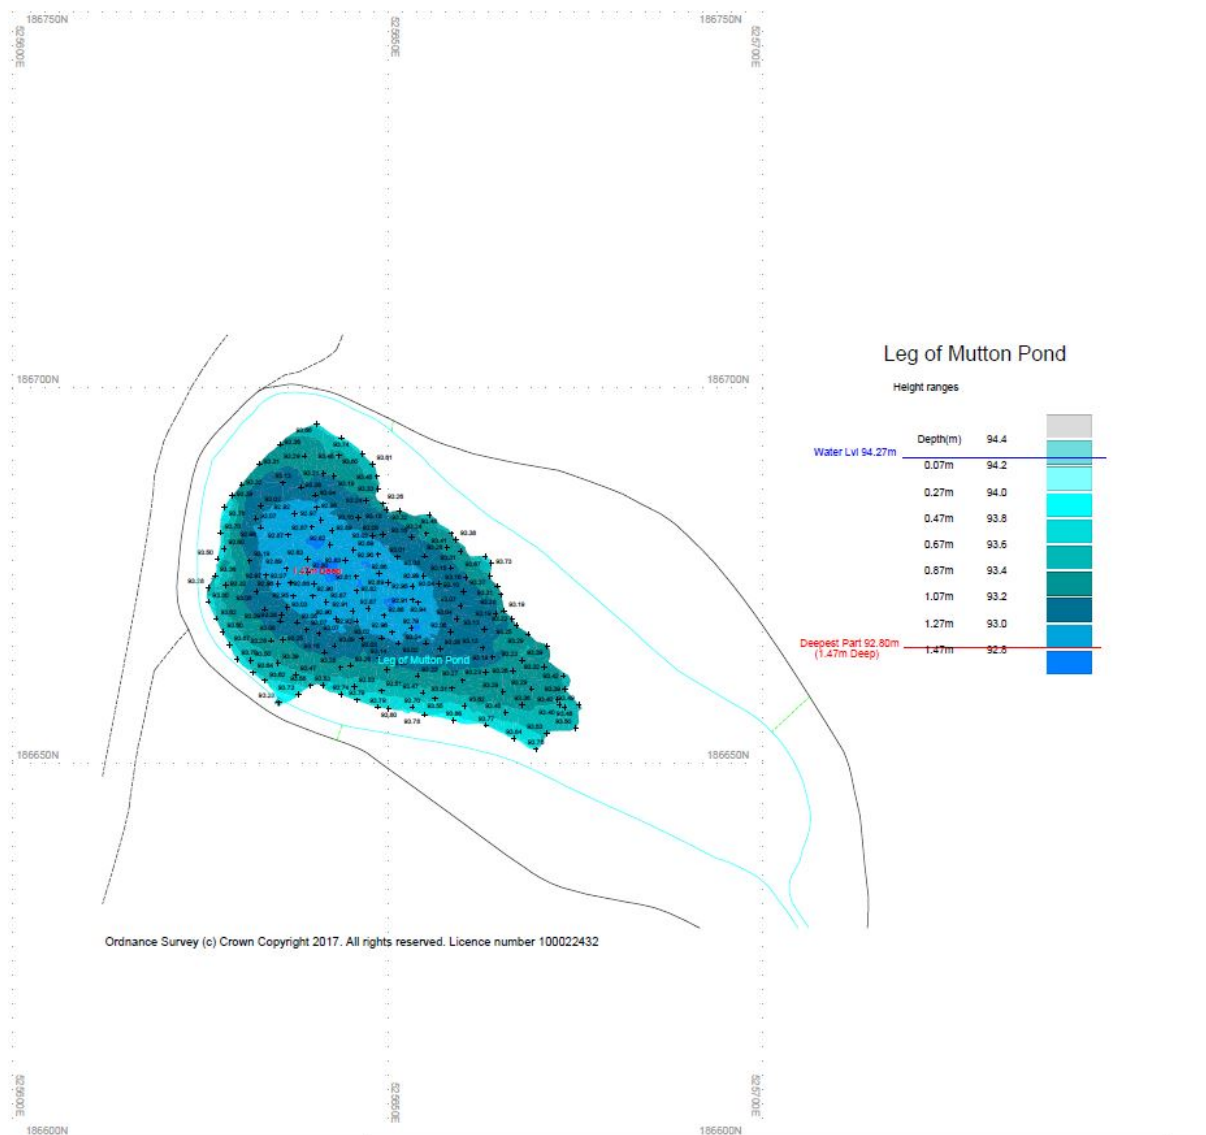
**Figure 1: Leg of Mutton depth measurements 2019**

22. Bathymetric analysis has recently been completed on the Heath pond chains. The aim of this was to determine current depth levels as well as an indication of the sediment volumes established within the pond. It should be noted that the sediment volumes can only be used as a rough estimate, and they are based on bathymetric analysis undertaken as part of the Ponds Project. This will aid long-term planning and allow for more informed decisions. A PhD student is currently undertaking research work on Highgate No.1 pond which may give an idea of the sedimentation rates and thus give an idea of the rate of succession.

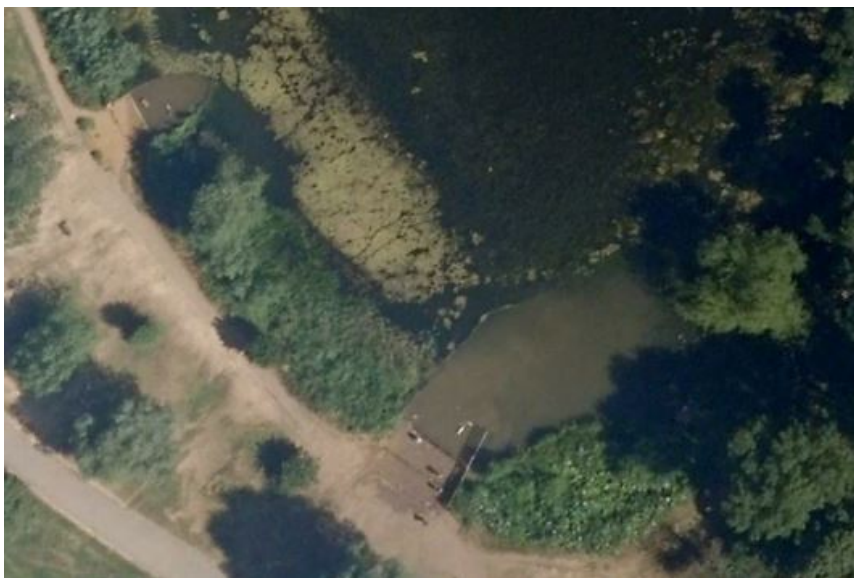
**Figure 2:** Highgate No.1 main dog swim May 2018- cloudy water to SE and smaller dog swim area to NW

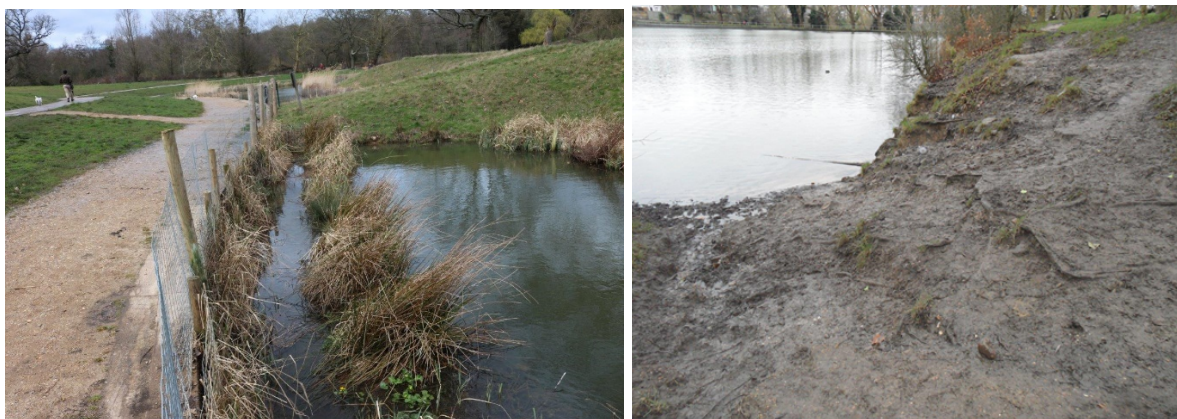
**Figure 3:** Boating pond plant damage and Hampstead No.2 dog erosion.

84. Published literature also suggests that dogs can discourage nesting birds, increase turbidity and even possibly introduce chemicals from flea and parasite treatments which can be harmful to invertebrates. This increase in turbidity can easily be seen on aerial photographs (Figure 2) or visually when a dog or person enters the water. This can cause reduced light penetrating for plant growth and the increase sediment disturbance can release more nutrients into a water body. A good deal of erosion occurs in and around ponds directly attributable to dog activity. Entry points at Hampstead No.2 are heavily eroded as a result of the continued action of dog coming and going into the water. Open access points at the Model Boating pond had to be reconstructed due to erosion caused by dogs and an experiment to open the fencing around the Model Boating pond resulted in damage to emergent plants (Figure 3).

85. Figure 3 (page 21) shows the effect of dog swimming on pond turbidity, although in certain circumstances this could be beneficial with the creation of open water. The image shows the lack of filamentous algae growth in the dog swim area and disturbance can reduce the extent of other 'non-desirable' plant growth such as extensive duckweed cover.
