<b>Committees:</b> Streets and Walkways Sub - <i>for decision</i>	<b>Dates:</b> 14 May 2024
<b>Subject:</b> Globe View Walkway – Opening up and enhancing the Riverside Walk  <b>Unique Project Identifier:</b> 10793	<b>Gateway 6:</b> <b>Outcome Report</b> Regular
<b>Report of:</b> Interim Executive Director Environment  <b>Report Author:</b> Leila Ben-Hassel	<b>For Decision</b>
<b>PUBLIC</b>

**Core Project Name:** Globe View Walkway

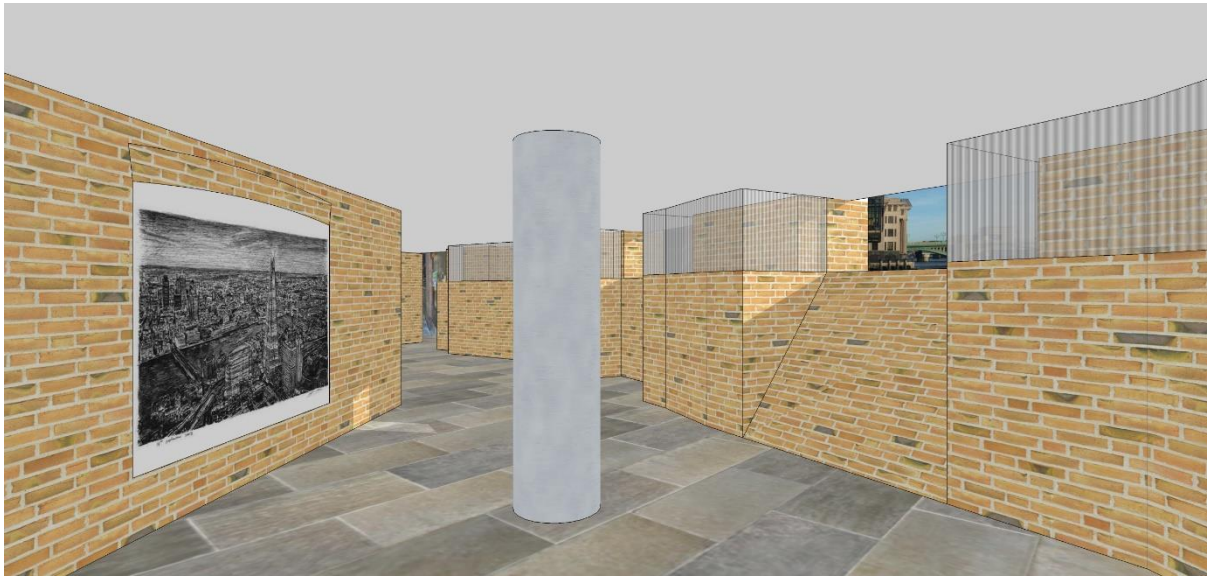
*Day time view - Globe View walkway looking east towards Stew Lane*

Option 1 was preferred at public consultation stage (Summer 2019) and developed to detailed design stage. The design of option 1 focused on brick work alterations and minimisations to abutments and ledges on the southern wall and public art on the southern wall. As explained in the report, following the loss of TfL funding, the project was descoped to meet the reduced budget and the public art is now being undertaken by external partners.

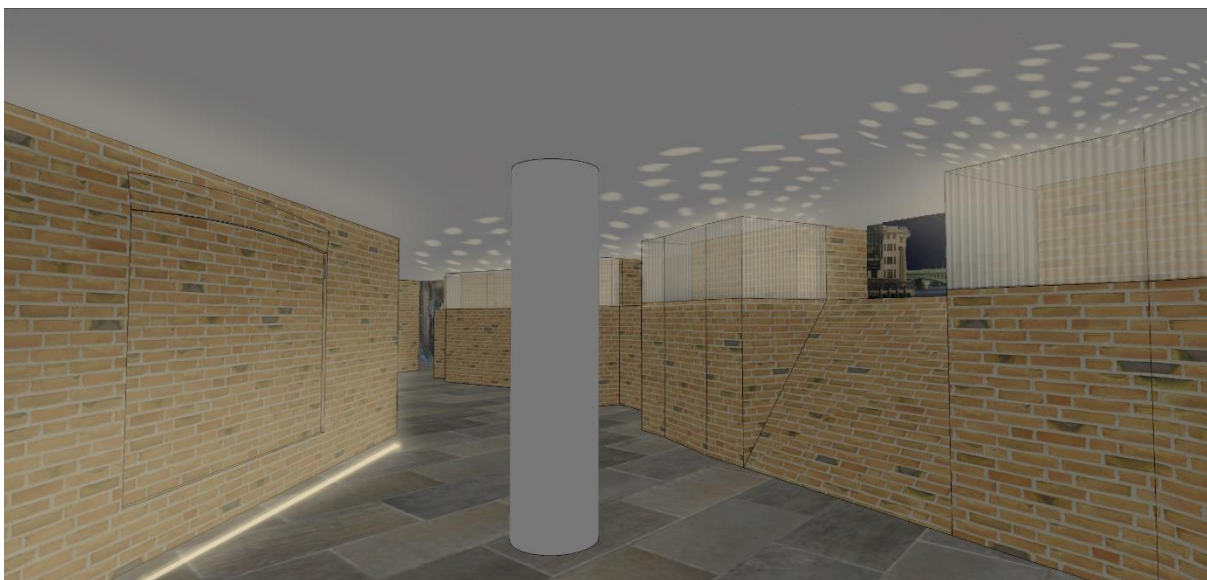
*Night time view - Globe View walkway looking east towards Stew Lane*

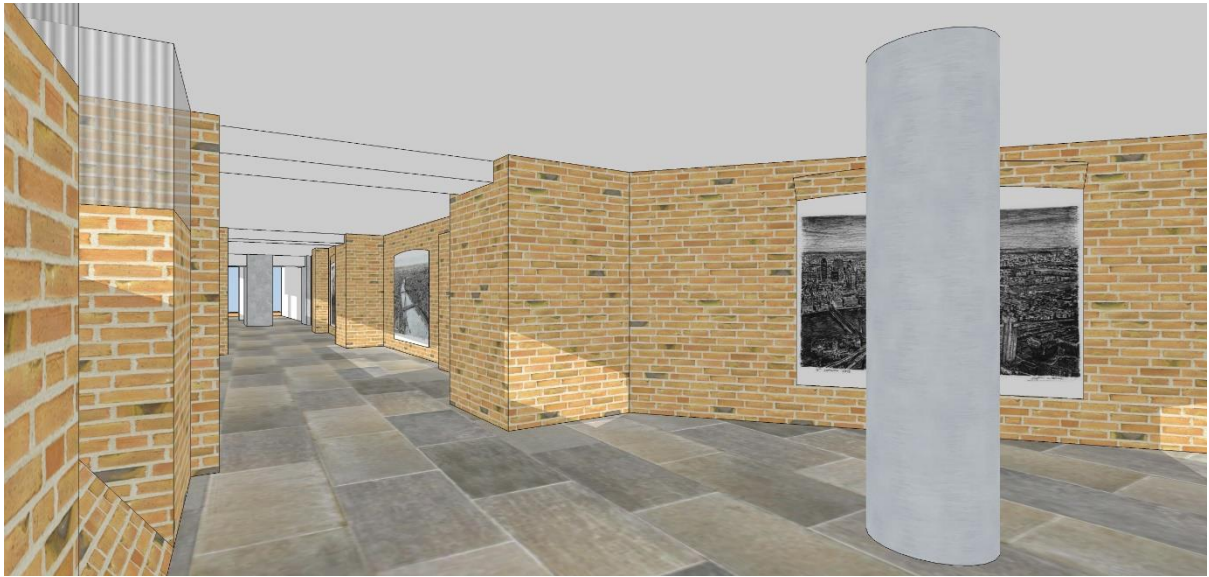
*Day time view - Globe View walkway looking west towards Broken Wharf*

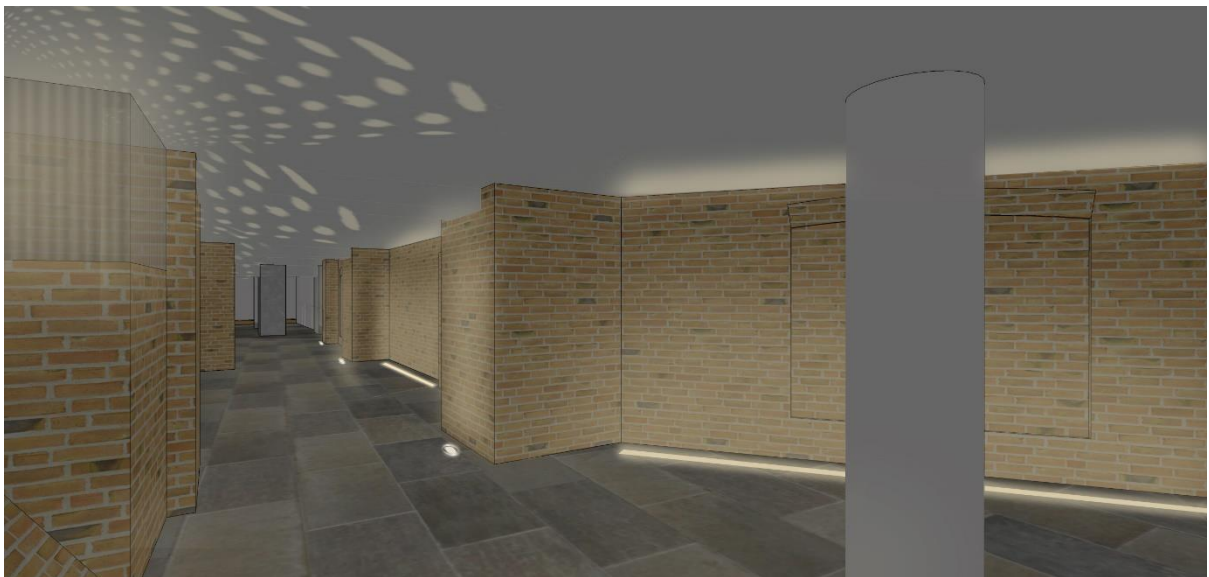
*Night time view - Globe View walkway looking west towards Broken Wharf*

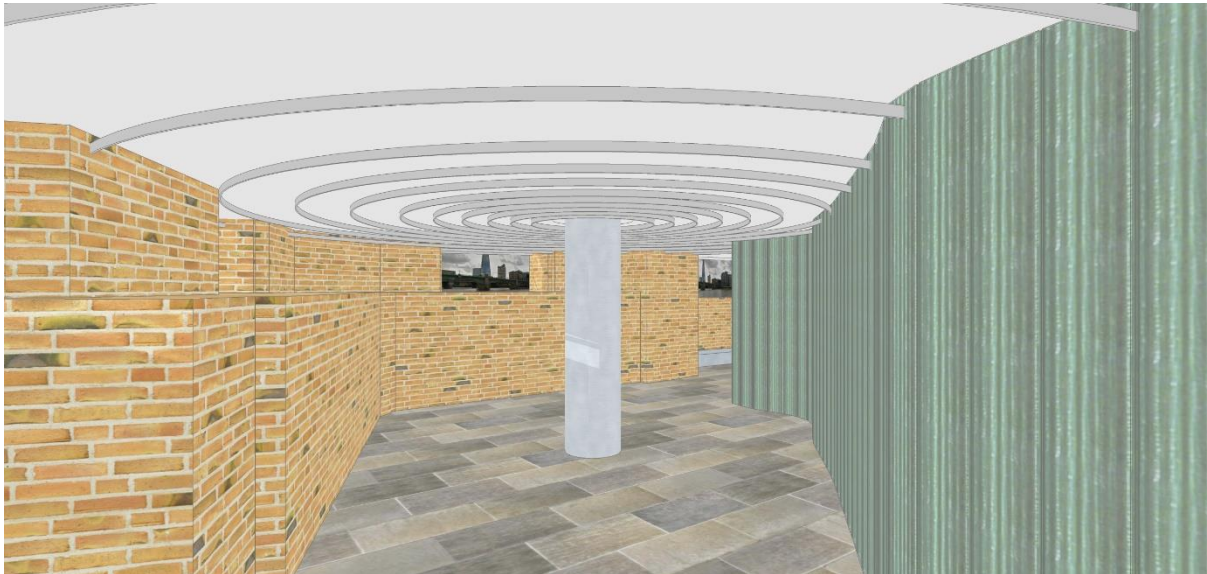
*Day time view - Globe View walkway looking west towards Broken Wharf*

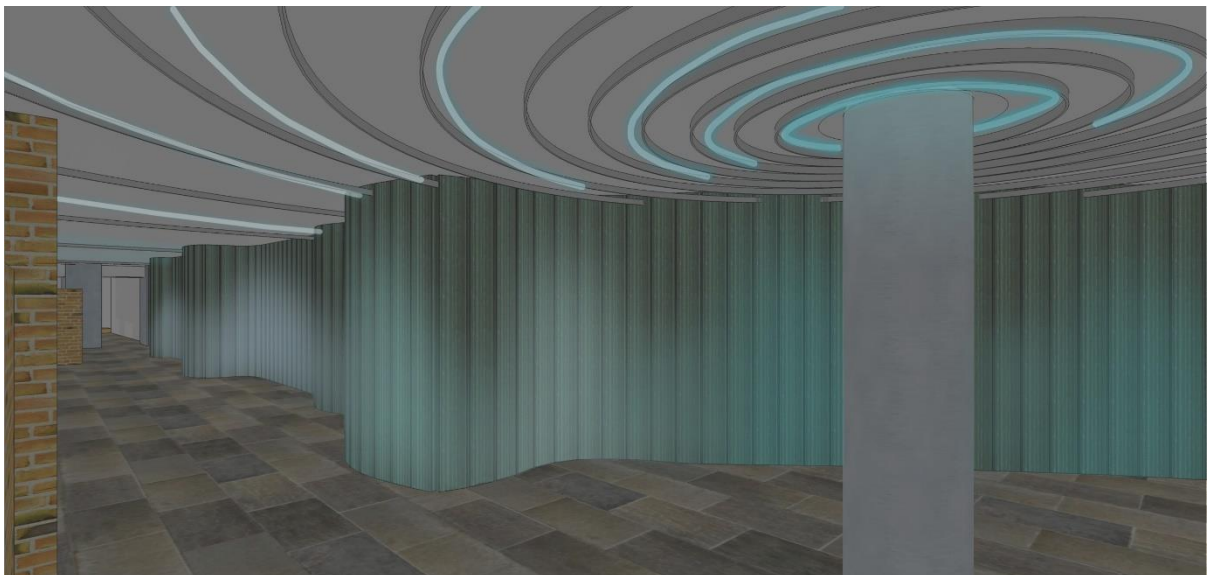
*Night time view - Globe View walkway looking west towards Broken Wharf*

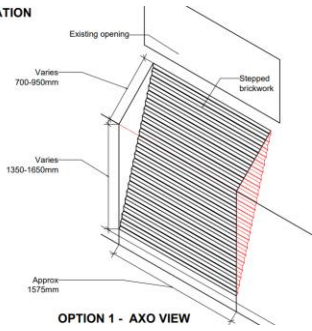
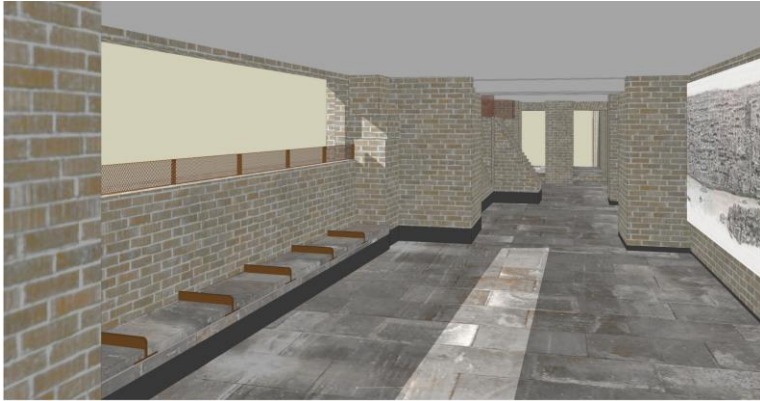
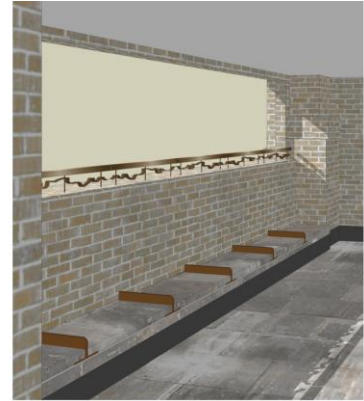
**TYPICAL BRICKWORK BELOW OPENINGS - ELEVATION**

Within that design approach several options were considered regarding the type of brick work alterations and materials. See below:

KEY PLAN - DETAILS  
NTS

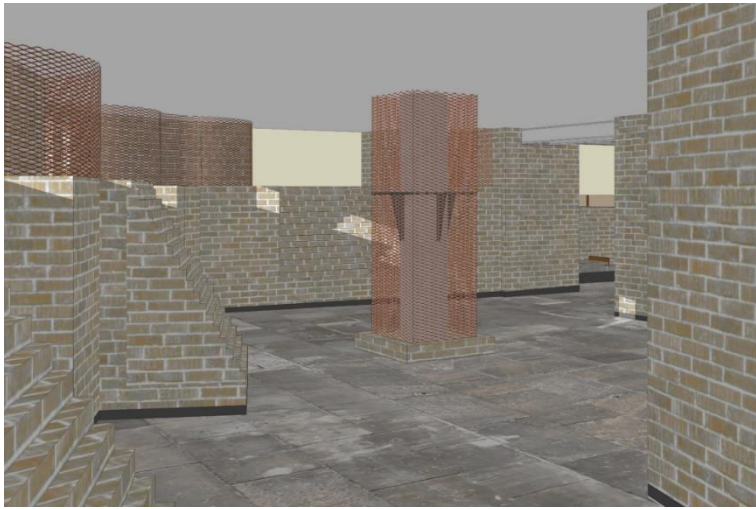
**Metal mesh and screens - Lighting test**

**Selected pattern**  
Expanded Metal Co (image to left)  
Ref - 4894 (MS)  
- N8131 (Coreten)  
- N8321 (Coreten)

**Also tested (images to right)**  
Ref - Graepels - Hex  
- EMC - Circle  
- Multimesh - Small mesh  
- St Anth (SS)

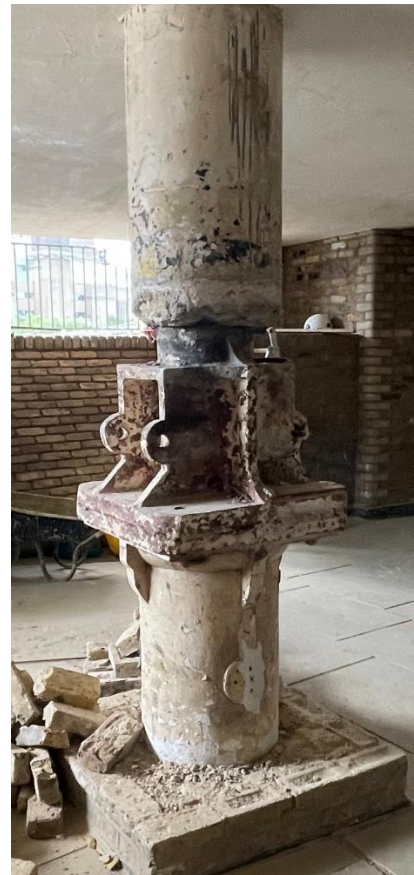
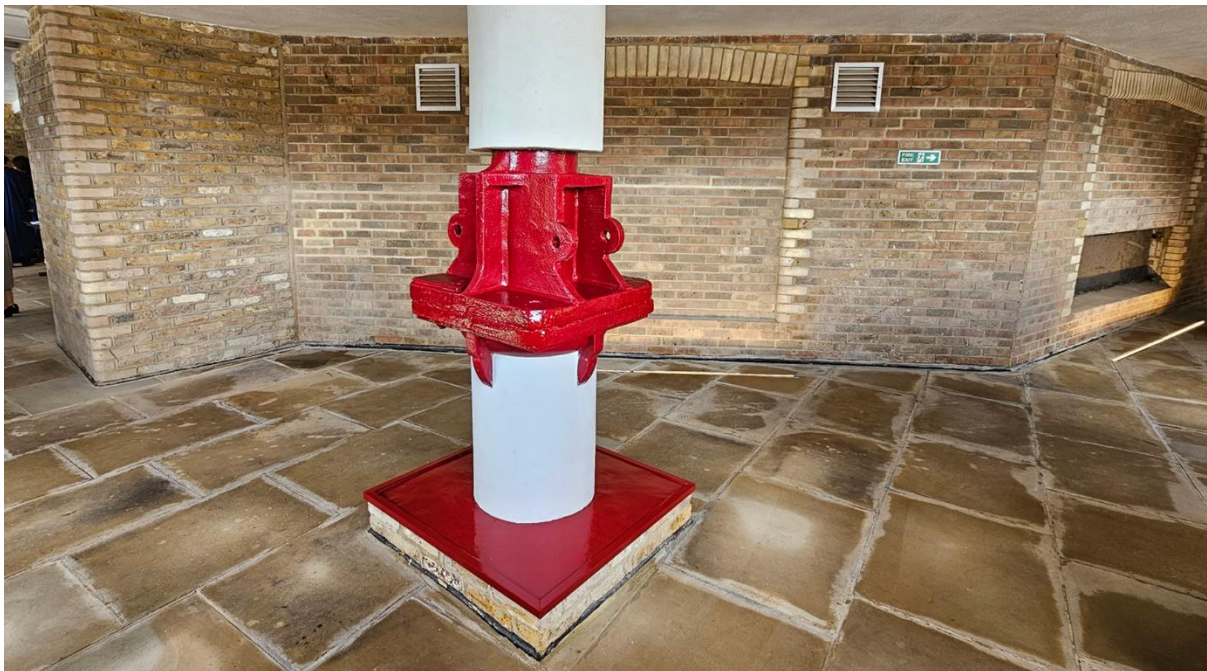
Despite research of historic drawings of Globe View buildings and investigative works of the central brick column at the initial stages of the design development, an old metal joint was discovered during demolition works. Officers amended the design and decided to no longer proceed with the metal mesh surround to instead celebrate this historic feature by painting it in the City of London's heritage red found at Blackfriars Bridge and Holborn Viaduct.

<p>During construction, the infill of two abutments was uncovered and deemed not sufficiently structurally sound. Rebuilding was undertaken with the appointed structural engineer and the Freeholder's own engineer jointly supervising works on site.</p> <p>An historic cast iron collar on the central column was uncovered during demolition work which was not shown on historic plans. It was decided to celebrate this unexpected historic feature painting it in City of London's heritage red (matching Holborn Viaduct and Blackfriars Bridge. Please see pictures in Appendix 2.</p>
<p><b>5. Options appraisal</b></p>	<p>The option that was favoured during consultation was developed to detailed design stage. The design focused on brick work alterations and minimisations to abutments and ledges on the southern wall the covered walkway to maximise natural light and minimise blind spots.</p> <p>Within that design approach several options were considered regarding the type of brick work alterations and materials (See appendix 2). Choices for brickwork alterations were informed by detailed structural investigations and all options considered were developed to ensure structural loading capacity was maintained. The options included:</p> <ul style="list-style-type: none"> <li>• sloped brick work faced with York Stone or rendered (this was not chosen as officers were concerned it could attract graffiti and require more cleansing.</li> <li>• sloped ledges into informal seating (this was not chosen due to concerns from residents about increased noise from loitering and potential social gatherings).</li> <li>• stepped brickwork with minimum ledges to avoid climbing opportunities and littering. This option was preferred as it re-used the historic brickwork and was the best way to minimise anti-social opportunities.</li> </ul> <p>Material choices were also considered sensitively. Instead of new bricks, existing ones were carefully salvaged during demolitions and re-used for the alterations. Metal work and paint colour palette was chosen to complement the historic setting of this old warehouse building whilst maximising brightness.</p>

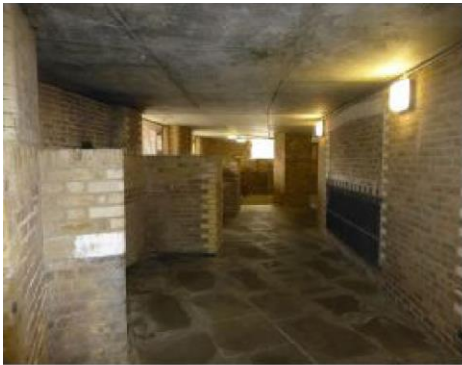
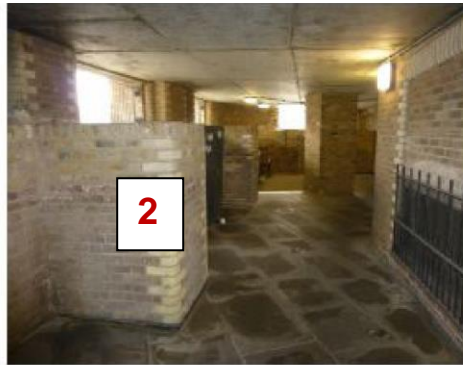
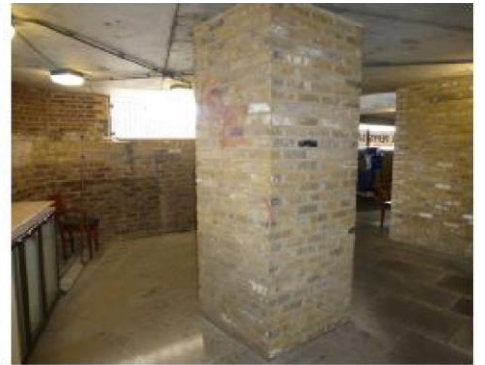
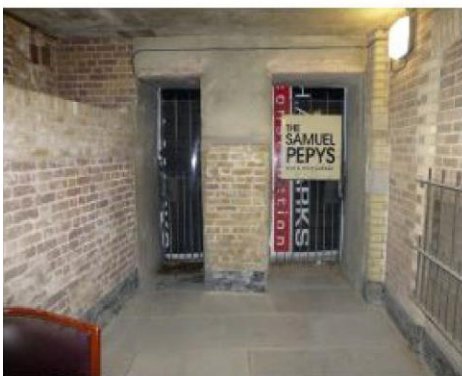
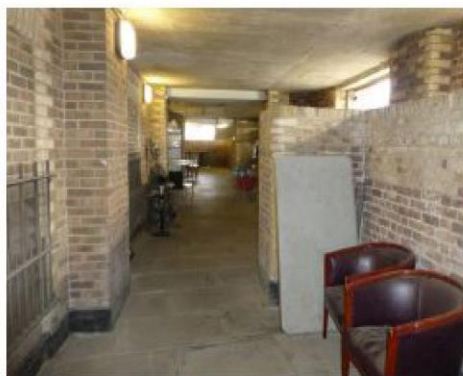
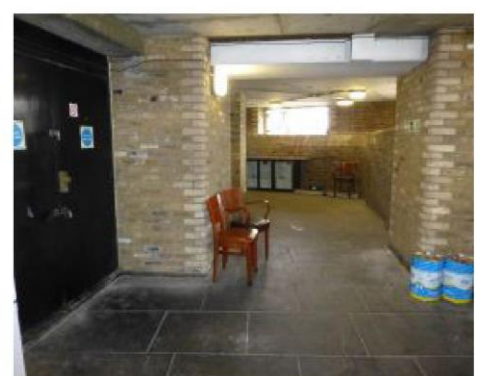
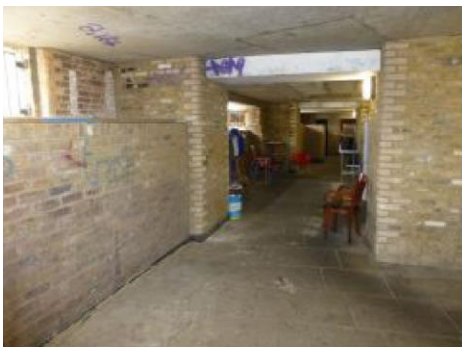
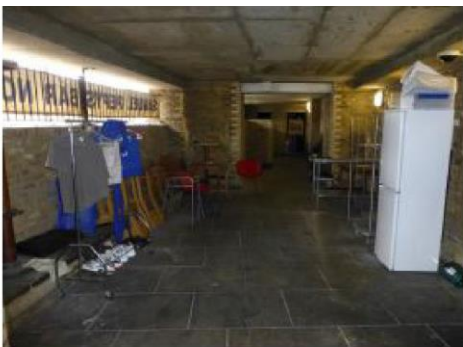
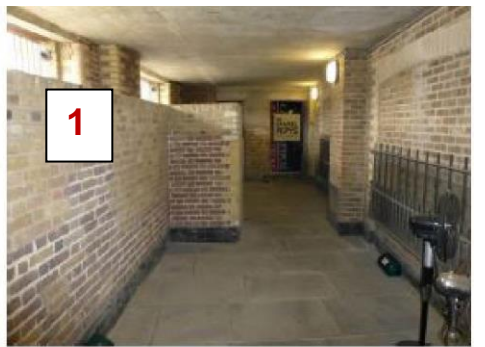
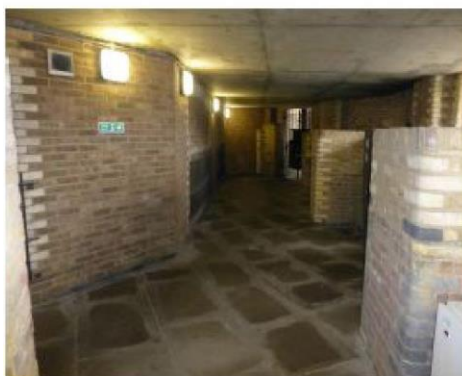
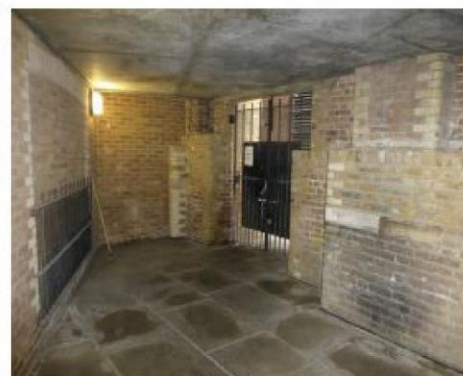
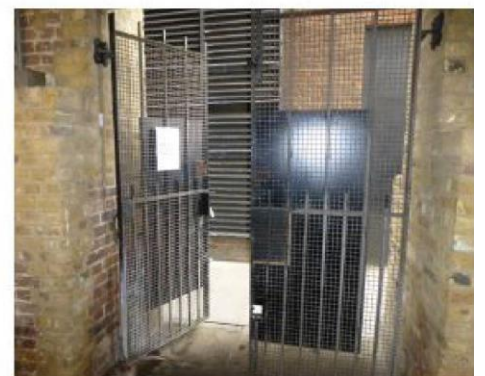
### Before pictures:

- maximising natural light through sloping the brick work beneath openings.
- screening areas above the ledges (see annotated picture 1 in Appendix 5 – Before Photos) to minimise opportunities for rough sleeping and provide additional lighting.
- designing out potential anti-social behaviour by minimising blind spots through alterations to the brickwork of abutments (see annotated picture 2 in Appendix 5 – Before Photos)

- 1** – Ledges
- 2** – Abutments

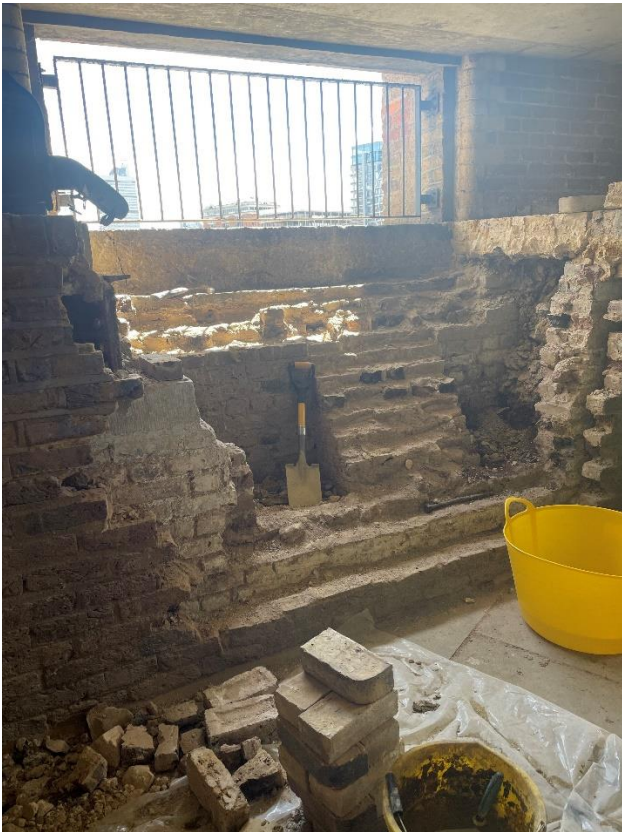
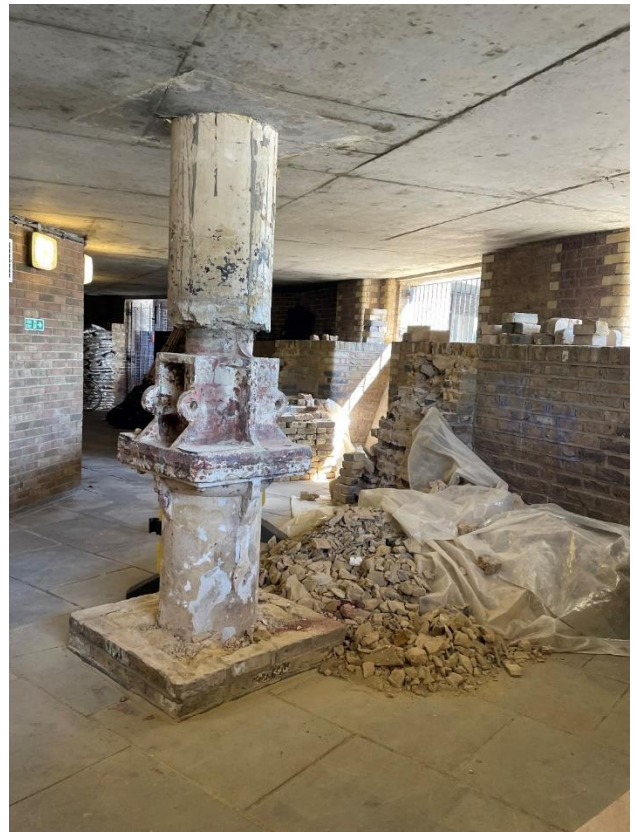
**During construction:**

Works started on site in May 2022. Demolitions uncovered steel support beams that were not fireproofed. To maximise the feeling of height in the covered walkway, it was decided to leave the steel beams exposed and treat them appropriately. They were painted the same colour as the ceiling to maximise brightness and with specialist fire retardant paint in accordance with professional fire safety advice. These additional fire safety works impacted on the budget as explained in section 11 of this report.
