Appendix 1 - Concrete repairs to Cullum Welch House

Schedule of Photographs

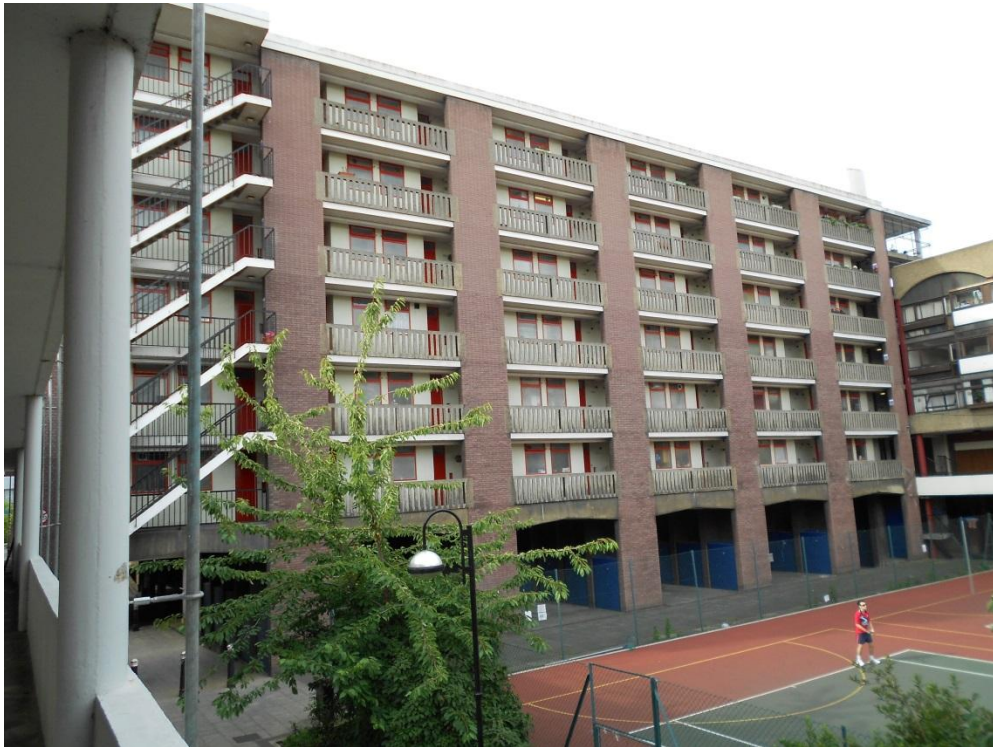
Photograph 1: North Elevation, Cullum Welch House. Showing balustrades and external staircase.

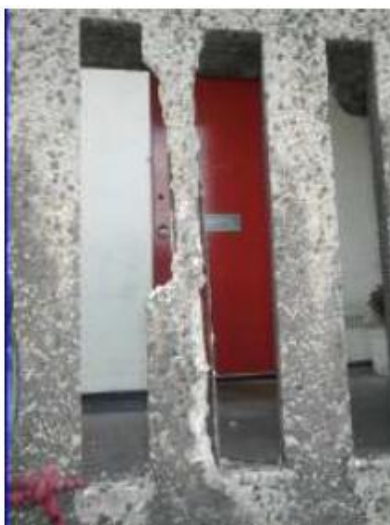
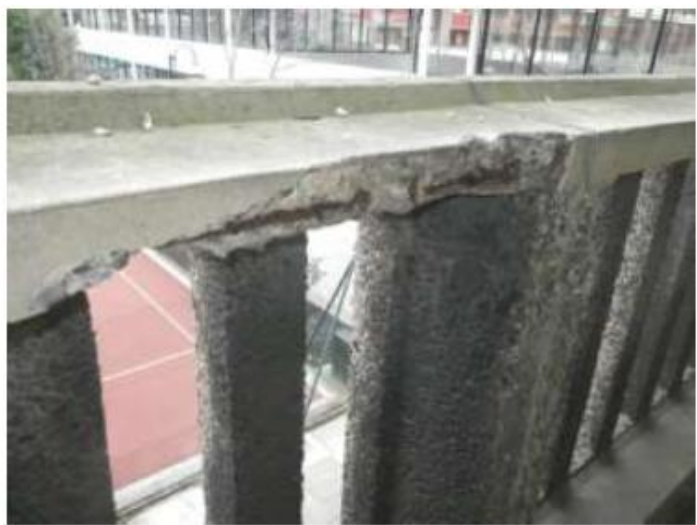
Photographs 2a and 2b: North Elevation, Cullum Welch House. Showing damage to vertical bars of balustrade and to a cill after removal of loose concrete. Photographs were taken before the installation of safety netting.

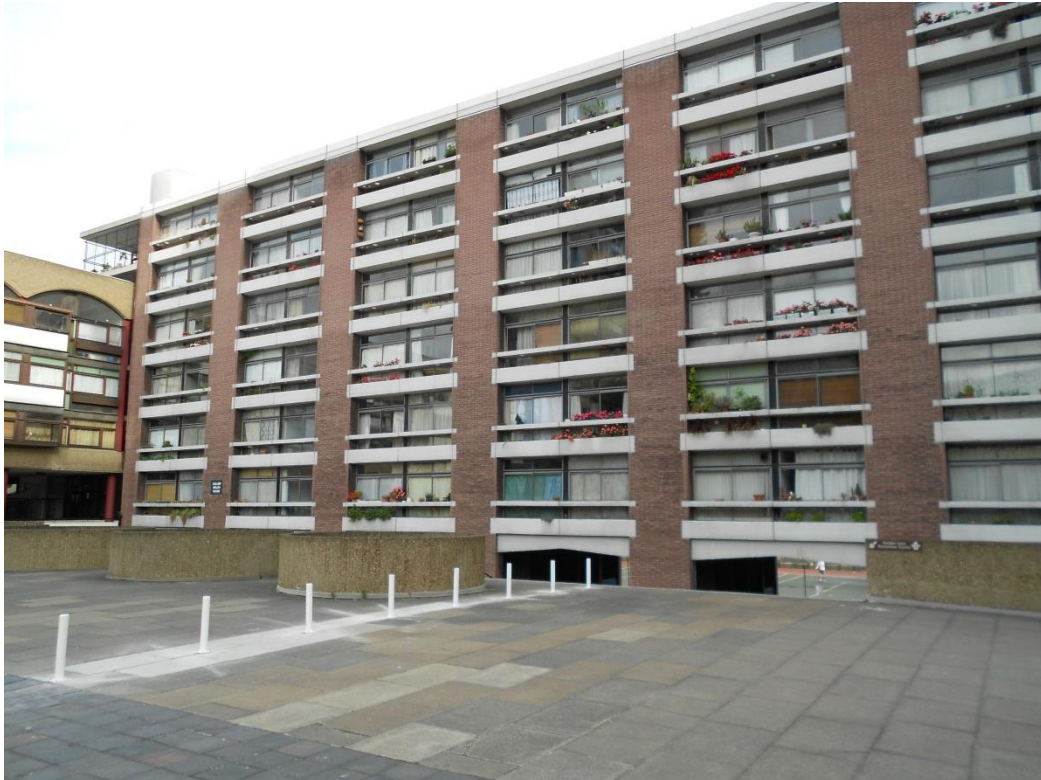
Photograph 3: South Elevation, Cullum Welch House. Concrete elements are painted white.

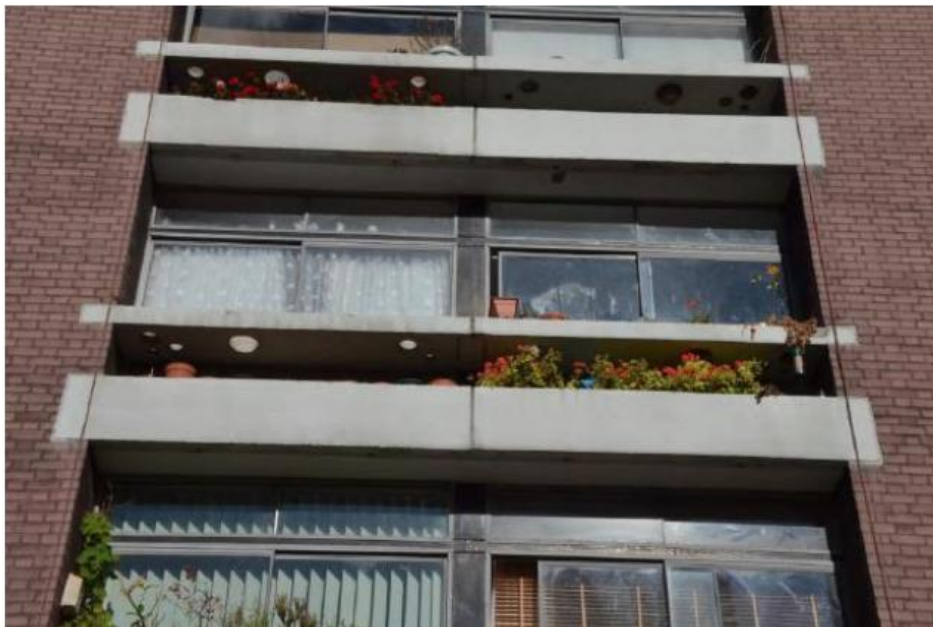
Photograph 4: South Elevation, Cullum Welch House. View of typical windows planters and pot holders which span two dwellings (partition wall at the centre of the view). Photograph was taken before the installation of safety netting.

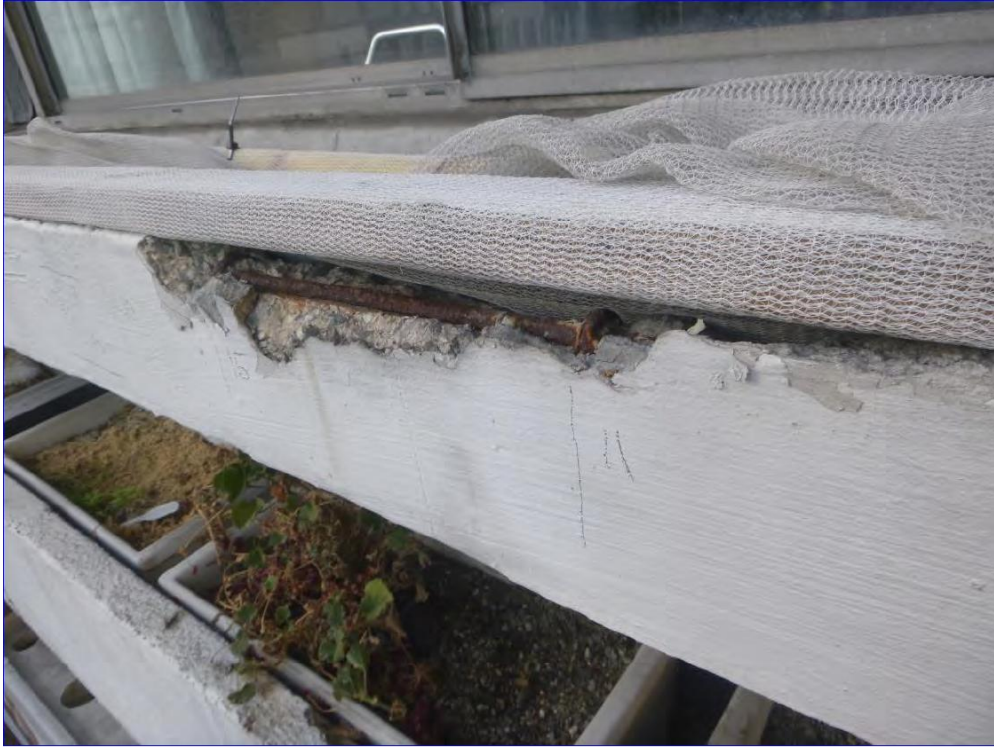
Photograph 5: South Elevation, Cullum Welch House. Close up view of planter and pot holder showing spalled concrete and exposed rebar after removal of loose material.
