# Hampstead Heath Pathways Review

## Shared Use **Pathway Improvements**

10053-LD-REP-101 V7

Prepared by LUC on behalf of The City of London  
March 2018

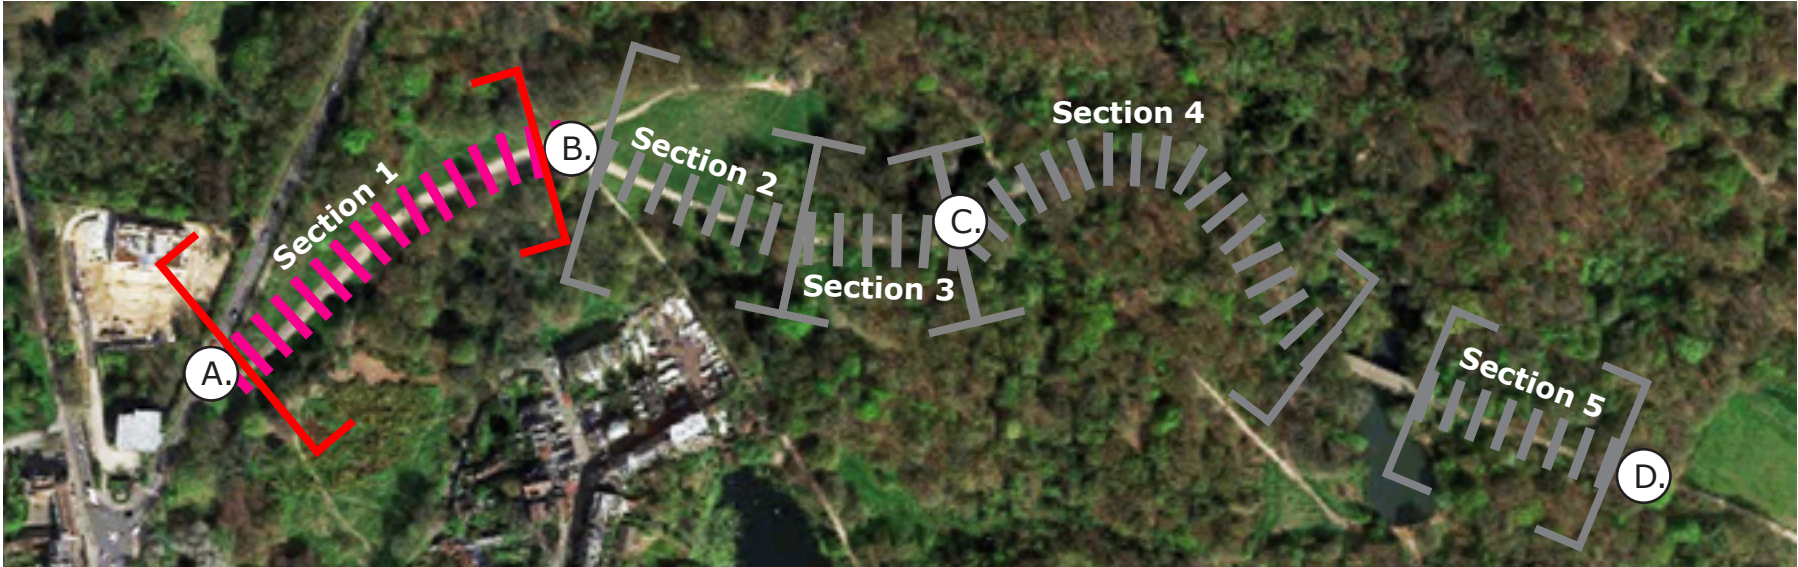
Figure 2a. Analysis & Key Issues - Pathway 1 - Spaniards to Lime Avenue

- Space A.**
- Large amount of signage is confusing
  - Wide timber gated entrance has narrow day to day pedestrian/cyclist openings that may heighten the chance of a clash
  - Gravel (grey in colour) surface in good condition

- Section 1.**
- Wide route 6 -7m in places with no clear edge
  - Gravel (golden in colour) in bad state of repair in places due to erosion from water run off across the pathway
  - Historically significant features such as granite cobbles related to fairground pitches

- Space B.**
- Large expanse of gravel surface undefined edge
  - Sense of hierarchy of pathway poor
  - This junction has an accumulation of loose gravel and presents a hazard to cyclists.

**2.3** The results of the surveys and information provided by the City of London of the issues they have experienced with the paths are summarised in **Figures 2a, 2b and 2c; Analysis and Key Issues**. As part of the analysis we have divided the paths into sections defined by the nature of the path, its surroundings and condition and applied a priority to dealing with the issues based on the current condition of the path in that section.

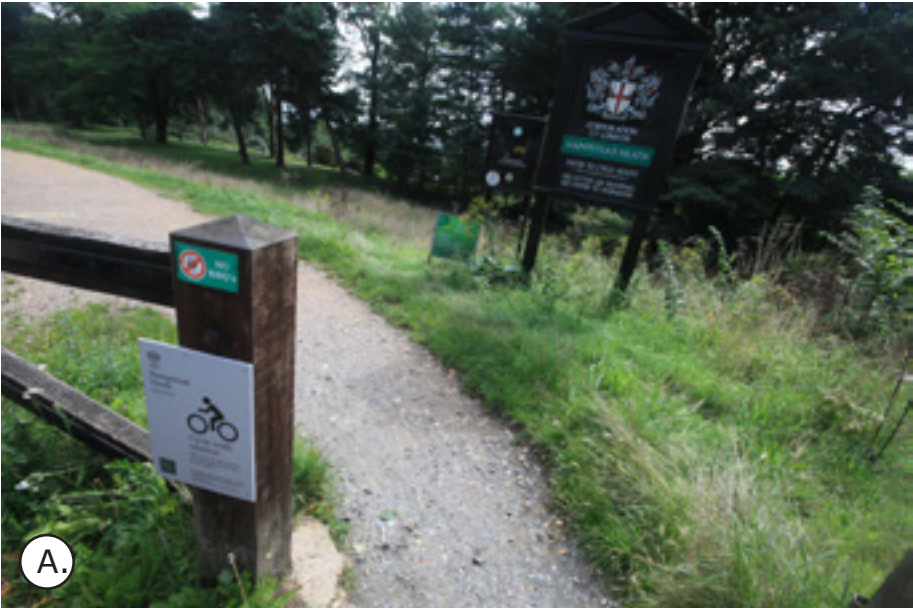
**Priority: Medium**

Space A.

- Simplify signage remove unnecessary signs
- Widen pedestrian/cycle entrance to allow comfortable passing point
- Define the margin between the tarmac pavement with the gravel path with setts or similar to mark boundary

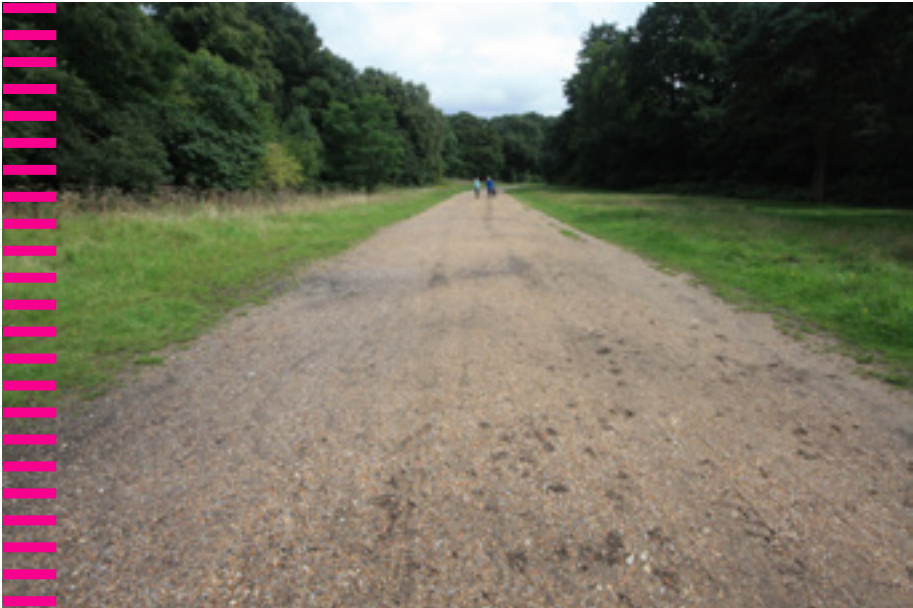
**Priority: Medium**

Section 1.

- Potential to reclaim 1m each side of pathway back to Heath and redefine natural edge
- Combat persistent localised puddling by building in cross fall where there is a lateral slope from one side of the path to the other, or through creating a camber to raise the path above surrounding areas where there is no cross fall.
- Introduce camber to pathway to assist with drainage
- Potential for drainage feature along southern edge

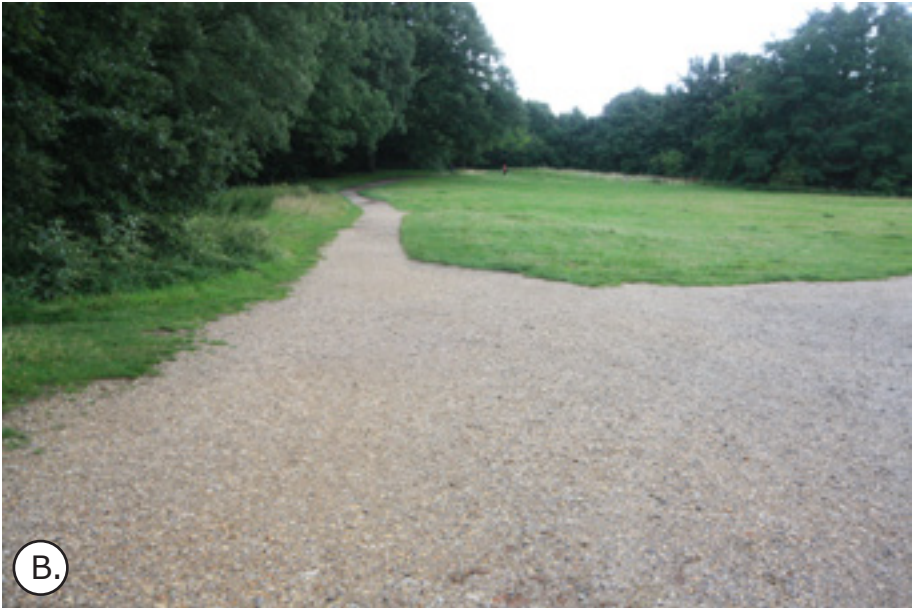
**Priority: High**

Space B.

- Potential to reclaim Heath through reducing expanse of hard surfacing at fork
- Re-establish pathway hierarchy through route to the right being emphasised as main route
- Potential to introduce bench/bin/signage that acts as focal point to fork

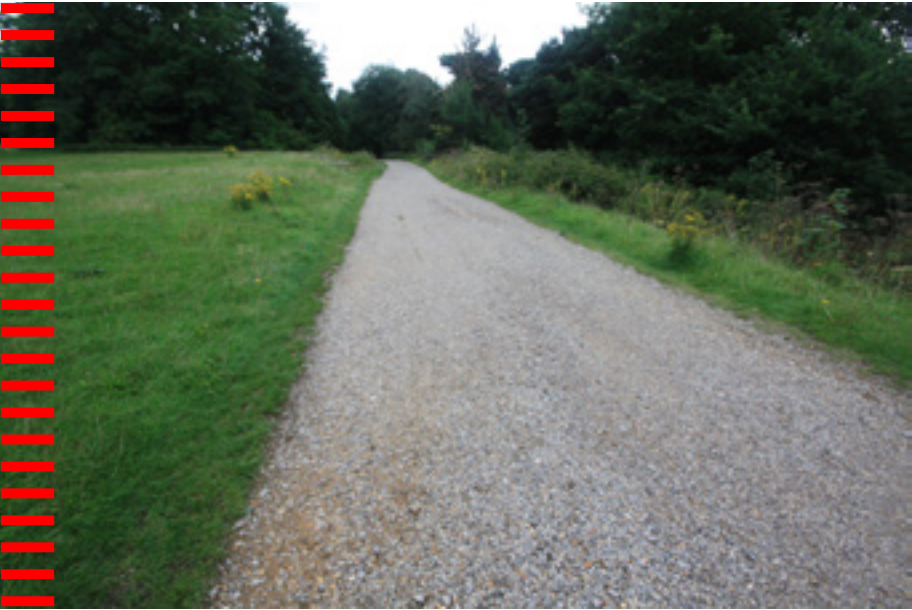
- Route 5m with linear defined edge
- Gravel grey in colour with underlying golden generally in good condition although showing localised depressions related to poor drainage. Overall a good even gradient.

Priority: Low

#### Section 2.

- Where puddling regularly occurs, build in cross fall to path surface, ensuring that water can freely run off the path surface into the adjacent ground.
- Repair localised potholes by scarifying existing surface and then topping with chosen surface material, rolling in when damp to provide a firm surface.
- Redefine thresholds between main path and secondary paths to clarify changes in surface, eg from gravel to asphalt.

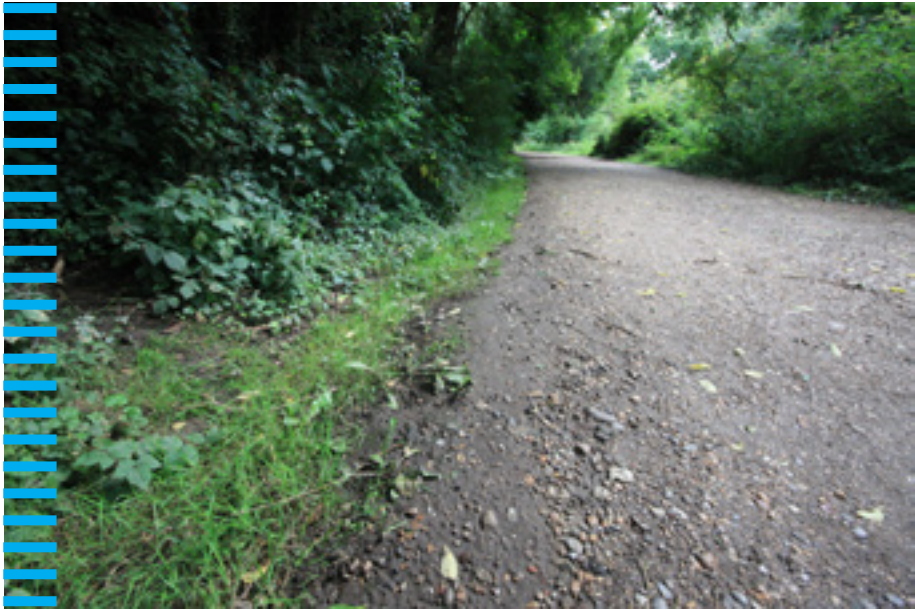
- Gravel/earth pathway of varying width which lacks definition

Priority: Medium

#### Section 3.

- Where puddling regularly occurs, build in cross fall to path surface, ensuring that water can freely run off the path surface into the adjacent ground.
- Repair localised potholes by scarifying existing surface and then topping with chosen surface material, rolling in when damp to provide a firm surface.

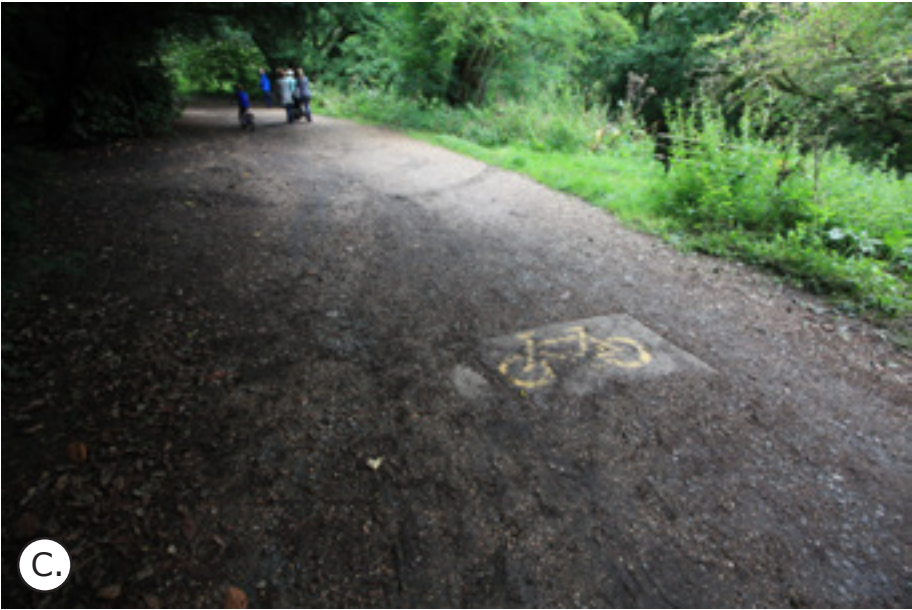
- Gravel/earth pathway of varying width which lacks definition
- Signage is uncoordinated and toilets access not clearly signed

Priority: Medium

#### Space C.

- Where puddling regularly occurs, build in cross fall to path surface, ensuring that water can freely run off the path surface into the adjacent ground.
- Repair localised potholes by scarifying existing surface and then topping with chosen surface material, rolling in when damp to provide a firm surface.
- Where path width exceeds 4m, redefine margins to give path width of 4m, scarify areas of excess width and allow to revegetate, protecting with temporary fencing until vegetation is established.
- Remove hazards such as the concrete block signs, applies to all areas of the paths.

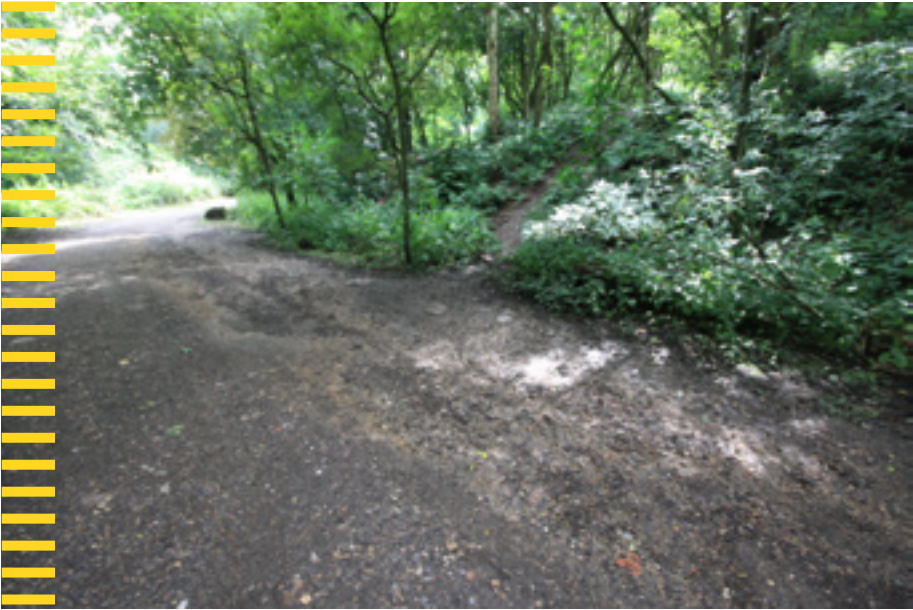
**Section 4. (Figure 2b)**

- Gravel/earth pathway of varying width which lacks definition
- Memorial seating along pathways length and varying angles contributing to route’s character
- Surface water channel apparent following the route of services

**Priority: Medium**

#### Section 4.

- Where puddling regularly occurs, build in cross fall to path surface, ensuring that water can freely run off the path surface into the adjacent ground, using the existing gully to catch the water and lead it into adjacent ground.
- Redefine the southern boundary of the path on the upslope side of the existing gully, scarify areas of excess width and allow to revegetate, protecting with temporary fencing until vegetation is established.

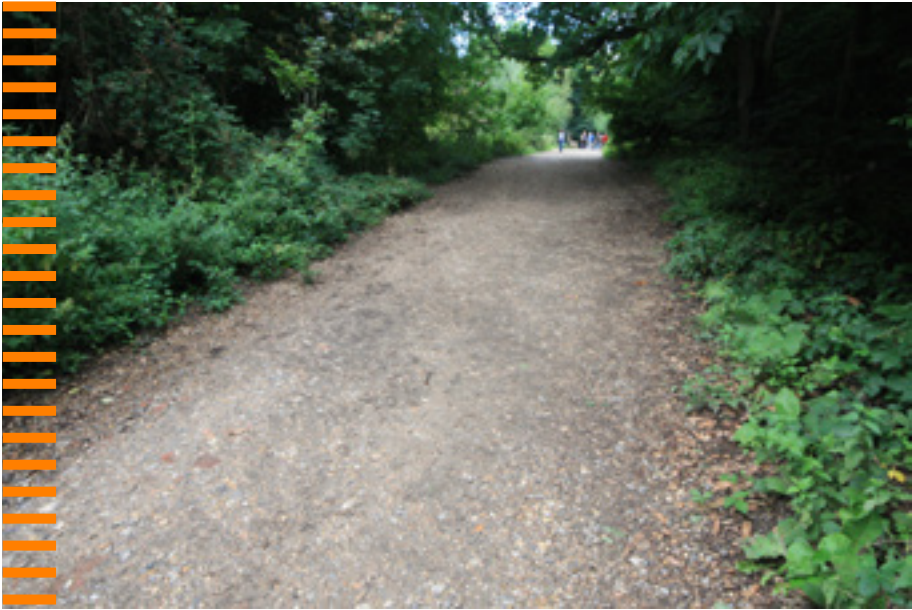
**Section 5: Route between bridge and Lime Avenue Junction**

- Route 5m wide with linear defined edge
- Gravel golden in colour generally in good condition although showing localised depressions related to poor drainage. Overall a good even gradient.

**Priority: Low**

#### Section 5.

- Combat persistent localised puddling by building in cross fall where there is a lateral slope from one side of the path to the other, or through creating a camber to raise the path above surrounding areas where there is no cross fall.
- Repair localised potholes by scarifying existing surface and then topping with chosen surface material, rolling in when damp to provide a firm surface.

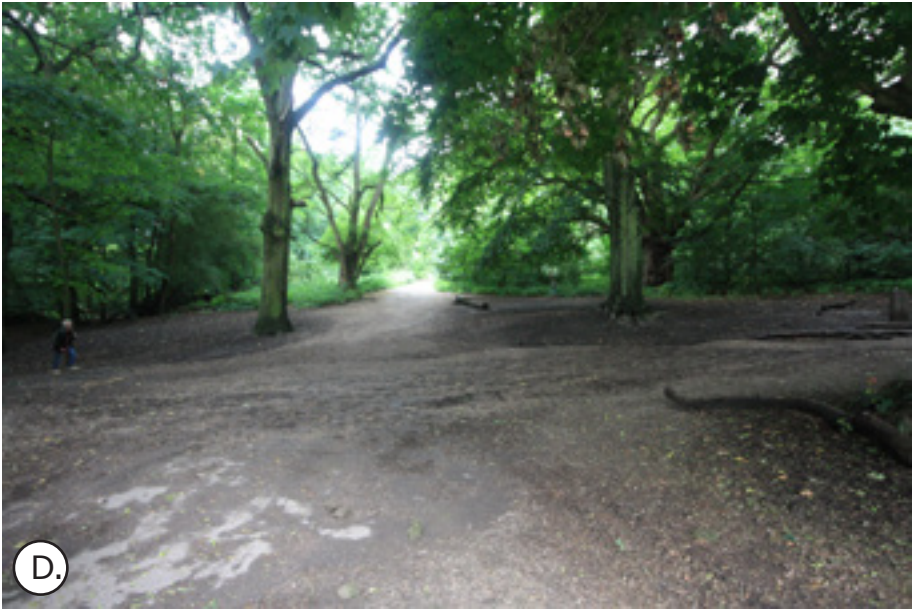
**Space D.**

- Undulating earth/gravel surface with cross flows of pedestrians/cyclist making it a space with high risk of clashes
- Lack of definition of route/space
- Uncoordinated signage / wayfinding
- This junction has an accumulation of loose gravel and presents a hazard to cyclists.

**Priority: High**

#### Space D.

- Raise the centre of the path to create a camber to allow water to flow sideways off the path to existing drainage channels.
- Where not well defined, deepen existing drainage channels, still retaining a gently sloping wide 'U' section. Clean out existing drainage pipes. Install subsurface cross drains under path where necessary to provide an outlet for water draining off the path.
- Use logs to define edge of path, but without impeding access or drainage off the path.

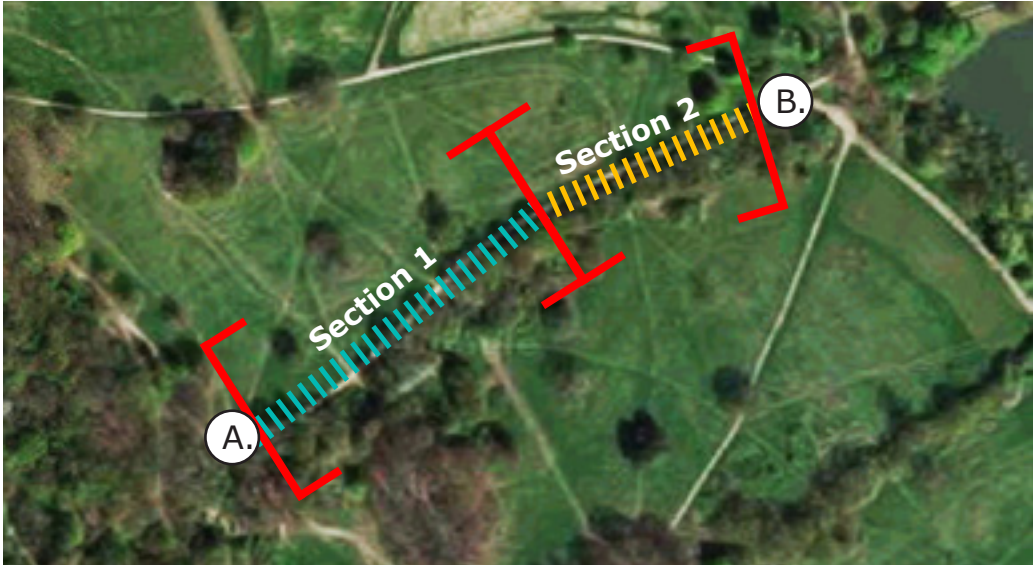
Figure 2d. Analysis & Key Issues - Pathway 2 - Hampstead Ponds to Highgate Ponds

Space A.

- Surface, earth and gravel, even width with localised undulation
- Signage uncoordinated across the Heath

- Surface gravel golden in colour in good condition, even gradient and cross falls well defined edge

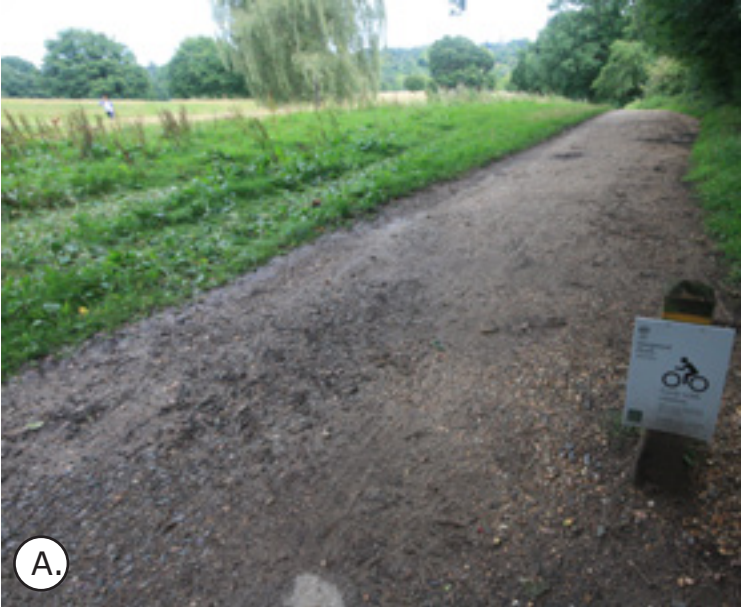
Priority: Medium

#### Space A.

- Include in core signage improvement strategy ensuring coherence
- Reintroduce camber to allow for positive drainage evenly across pathway
- Create shallow swales on either side of the cambered section of to track water running off the hill, and from the path and lead the captured water to suitable drainage areas. Install cross drains at intervals to take water from the up slope section of the path and into the drainage area.

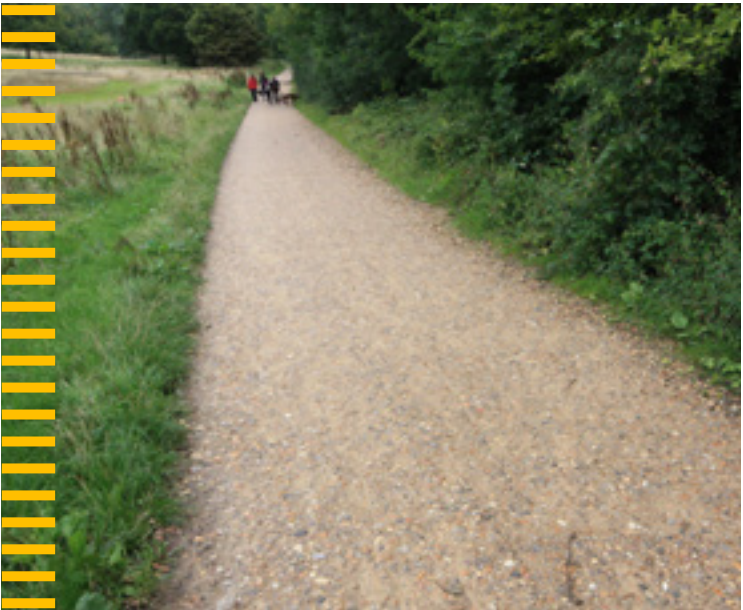
Priority: Low

#### Section 2.

- Pathway section in good order - continue regular maintenance

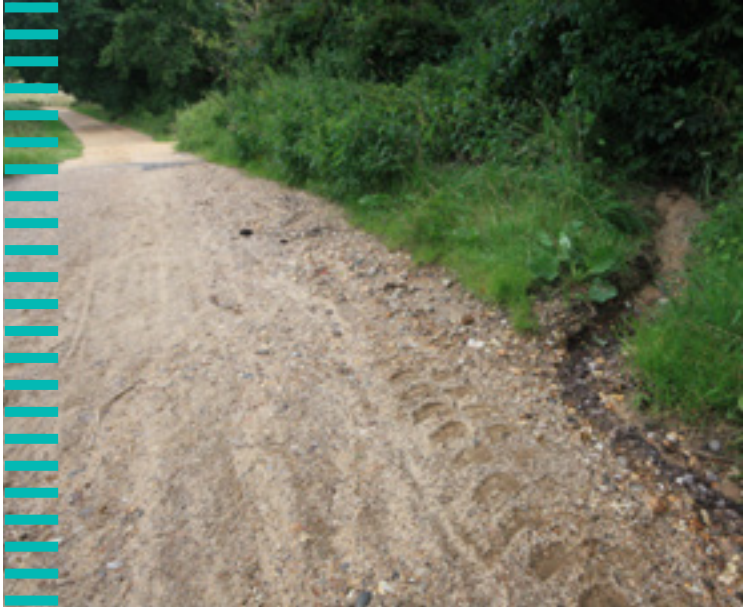
Section 1. (Figure 2c)

- Gravel surface golden in colour showing evidence of fines being washed out. Drainage issue causing localised runs of water

Priority: High

#### Section 1.

- Reintroduce camber to allow for positive drainage evenly across pathway
- Consider localised gully issues with topping up gravel and reintroducing even crossfall
- Create shallow swales on either side of the cambered section of to track water running off the hill, and from the path and lead the captured water to suitable drainage areas. Install cross drains at intervals to take water from the up slope section of the path and into the drainage area.

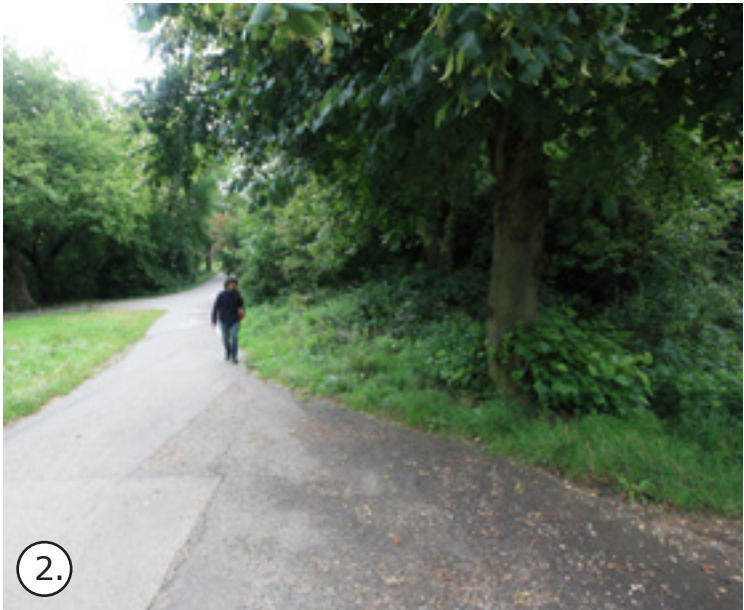
- High possibility of clashes due to partially hidden junction
- No current definition between routes

Priority: High

#### Space B.

- This junction is potentially hazardous if cyclists travel down the gravel path at speed and cannot stop for other users who step into their path.
- Keep sight lines to and from path junction clear.
- Clearly delineate the boundary between the incoming asphalt path and the gravel path, eg with granite setts. Place warning signs on the approaches to the junction from both the asphalt path and the gravel path

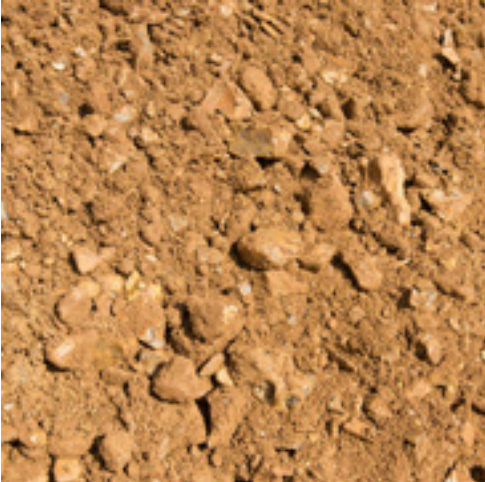
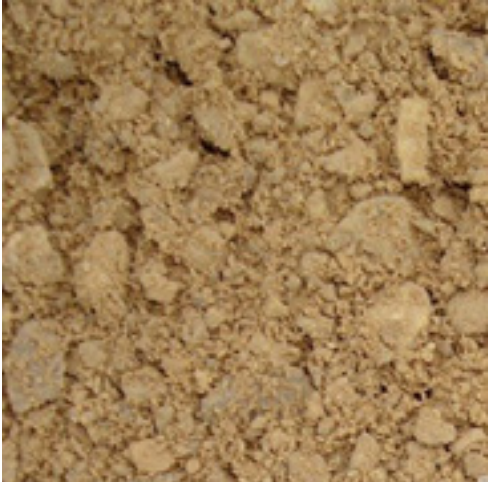
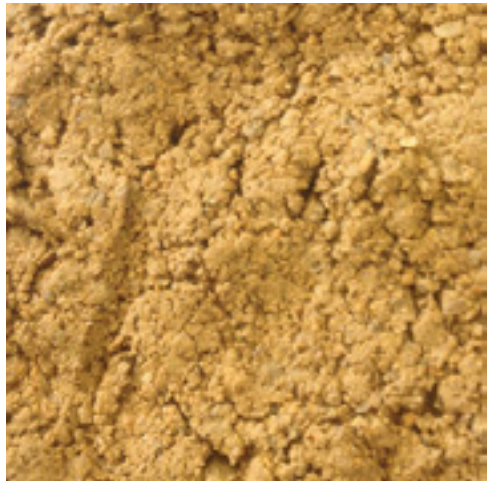
Path surface - Figure 3

**Breedon Gravel**

- Naturally occurring limestone gravel
- Attractive colour/finish
- Pedestrian / cyclist friendly
- Quarried material

**Hoggin**

- Mix of quarried clay, sand and gravel
- Attractive colour/finish
- Pedestrian / cyclist friendly but can become bumpy as the fine material wears and larger stones are exposed
- May become slippery in wet conditions as high proportion of clay

**Old English Self Binding Gravel**

- Attractive colour / finish
- Pedestrian / cyclist friendly but can become bumpy as the fine material wears and larger stones are exposed
- Must have a free draining sub base

**3.7** There are a number of alternative materials and in Table 1 we describe four of these that have been used for similar paths, with Figure 3 showing images of the materials. They are:

- Breedon gravel, a grey/brown relatively smooth surface with good binding properties and small stone size. Formed from limestone gravel bound with a marly clay, the material is alkaline. Following feedback this material was highlighted as suitable yet efforts should be taken to soften its colour and ensure it is inkeeping with the natural environment it surrounds;

- Coxwell gravel, has a more orange colour than the Breedon, has a neutral pH, binds well forming a smooth hard crust but prone to wash off on slopes and the crust is easily broken by horse hooves;

- Hoggin, which is similar to the current material used on Path 2, but the fine binding constituent has a greater clay content and hence probably less prone to wash off. However the stone size in hoggin tends to vary and can include quite large stones causing a less smooth surface than the Breedon or the Coxwell gravels;

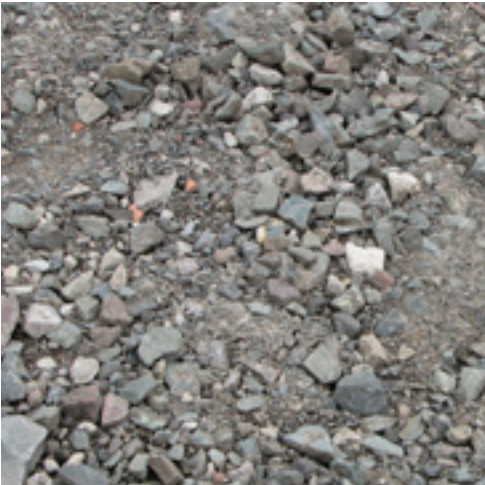
**Coxwell Gravel**

- Naturally occurring combination of sponge gravel and grit sand
- Attractive colour/finish
- Pedestrian / cyclist friendly
- Prone to rutting and may migrate on gradients

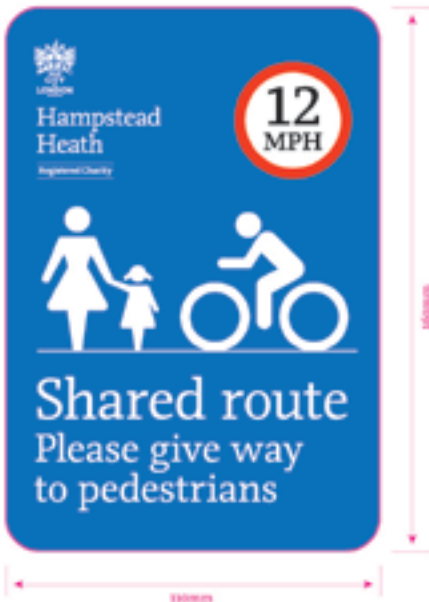
In principle all signs will follow a common style in terms of background colour/text size and font, and construction. The example below shows the current style for information boards on the Heath. These would be positioned at the entrances to paths and at key junctions.

Timber bollards with symbols based on those in the signs will be used to outline the route of the paths.

A coordinated series of information boards and signage bollards that relate to each other using the same palette of material while retaining the rural/ countryside aesthetic.

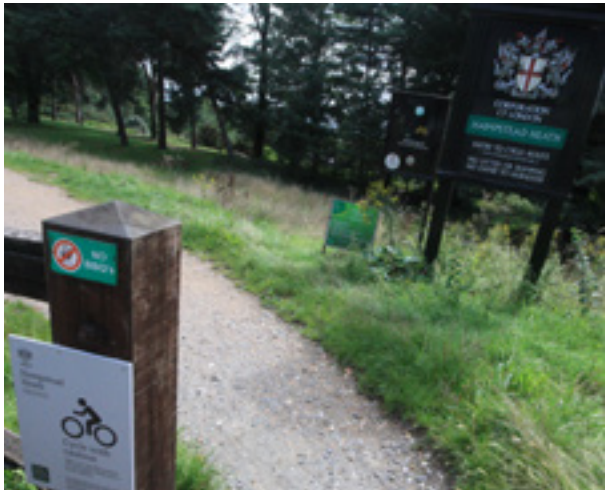
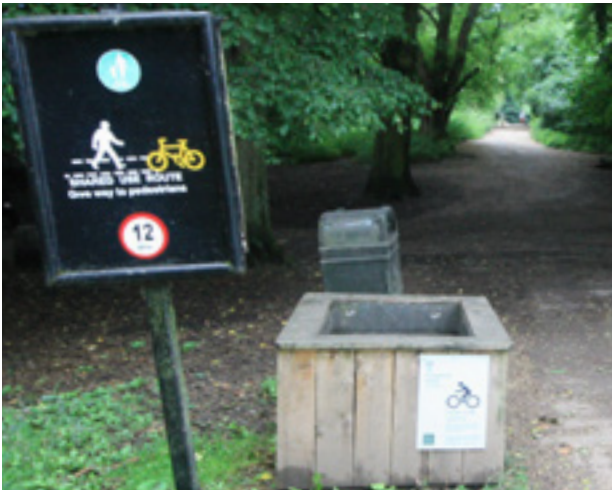
Entrances and key orientation points have too many signs that could confuse users

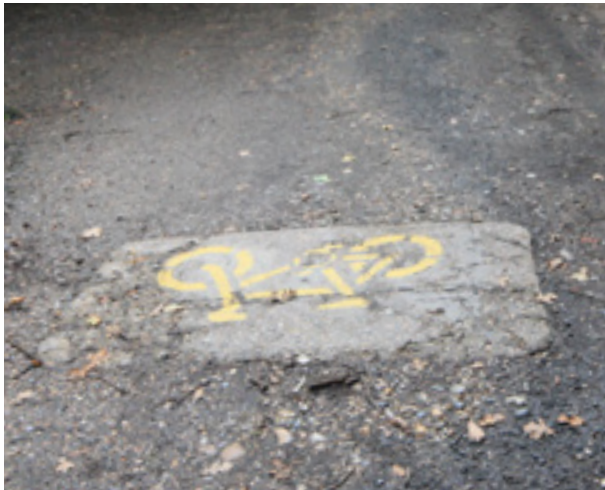
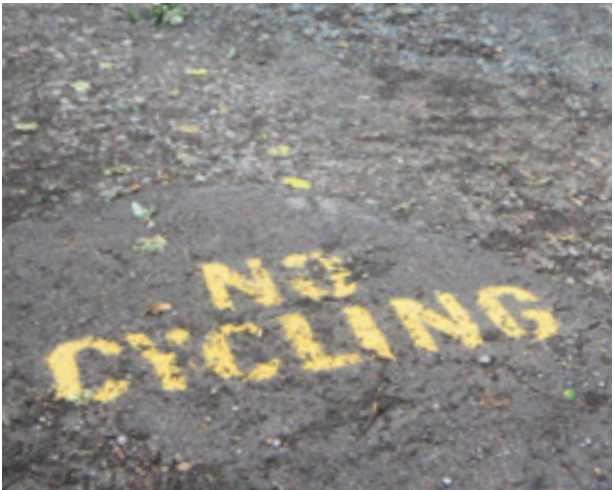
Existing signage, concrete pads in the path, protrude causing a hazard and are neither consistent nor clear.

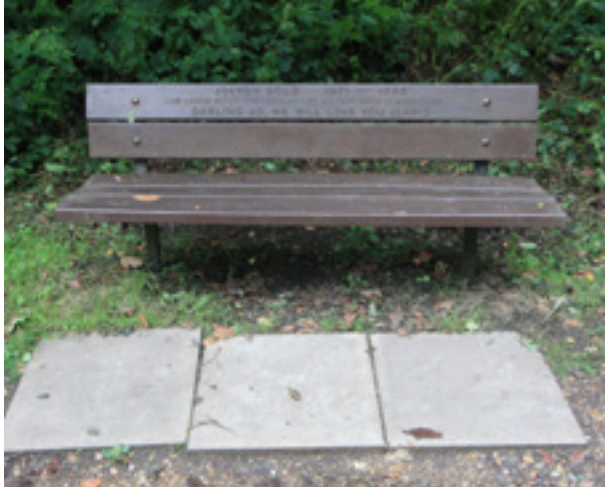
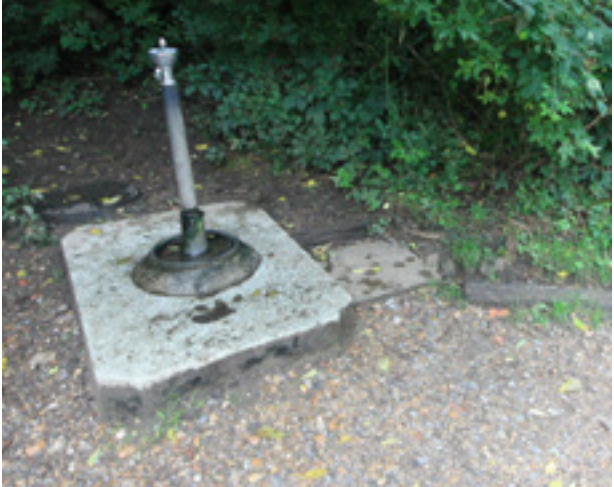
Elements along the path are varied and are not always positioned appropriately.
