Planning Applications Sub-Committee

4. **POULTRY MARKET AND GENERAL MARKET AND THE ANNEXE BUILDINGS
WEST SMITHFIELD LONDON EC1A 9PS**

Museum of London, West Smithfield
Planning & Transportation Committee
22.11.2022

Museum of London West Smithfield

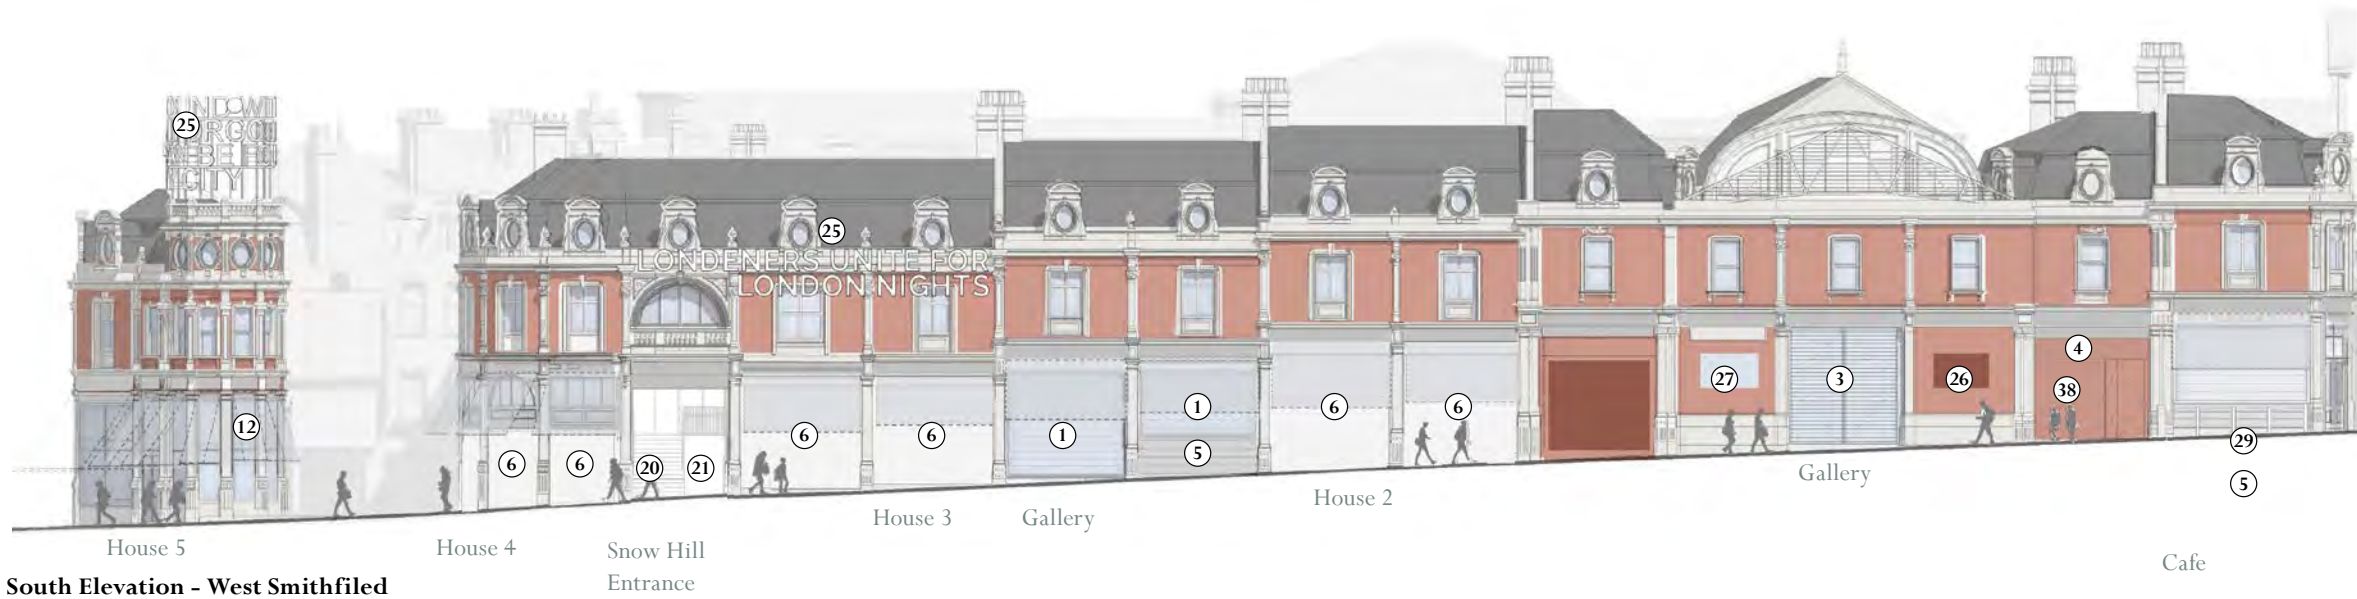
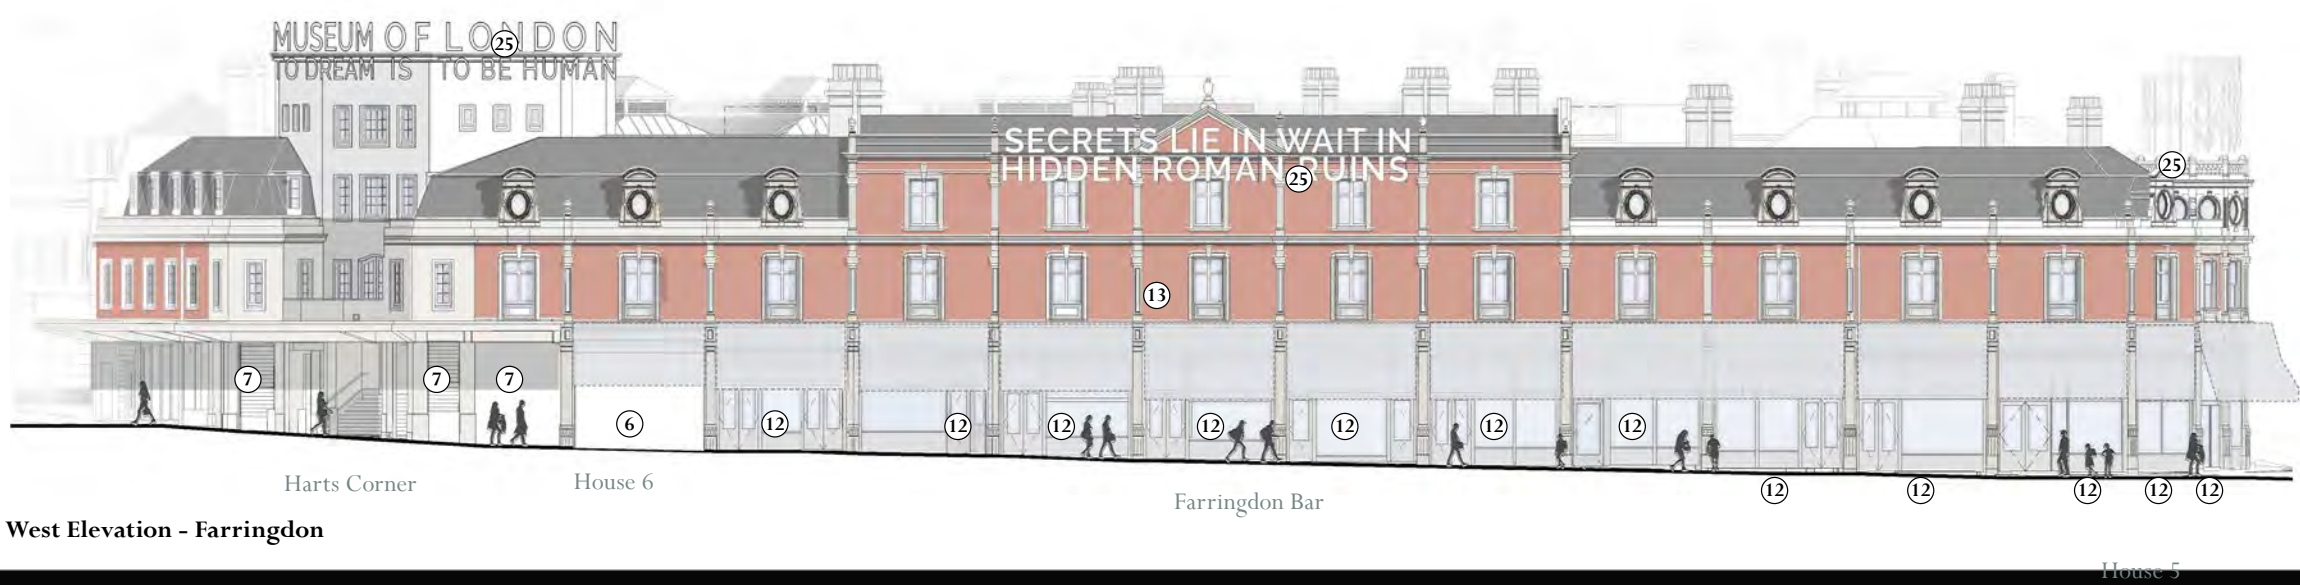
- 1 Proposed 'Museum Gallery Window'
- 3 Proposed 'Museum Doors'
- 4 Proposed infill, brickwork
- 5 Proposed stainless steel panels
- 6 Tenant shopfront
- 12 Restored historic shopfront
- 20 Proposed entrance stairs
- 21 Proposed platform lift
- 25 Proposed 'Art Canvas'
- 26 Proposed stained finish to existing brickwork
- 27 Proposed illuminated poster frame
- 29 Proposed 'Museum Window'
- 38 Existing brickwork rebuilt

- 1 Proposed 'Museum Gallery Window'
- 2 Proposed 'Museum Vitrine'
- 3 Proposed 'Museum Doors'
- 4 Proposed infill, brickwork in stacked bond
- 5 Proposed stainless steel panels

- 6 Tenant shopfront
- 7 Open shopfront, with roller shutter
- 8 Proposed doors
- 9 Proposed escape door
- 10 Existing stone plinth restored
- 11 Proposed escape door

- 12 Restored historic shopfront
- 13 Existing brickwork
- 14 Existing slate roof repaired
- 15 New timber display alcove
- 16 Restored historic door
- 17 Existing stone work cleaned and repaired

- 18 Existing concrete canopy cleaned
- 19 Proposed roof extension/lift overrun
- 20 Proposed entrance stairs
- 21 Proposed platform lift
- 22 Existing entrance stairs

- 23 Existing tilework cleaned and repaired
- 24 Proposed tilework to match existing
- 25 Proposed 'Art Canvas'
- 26 Proposed stained finish to existing brickwork

- 27 Proposed illuminated poster frame
- 28 Blind brick window
- 29 Proposed 'Museum Window'
- 30 Restored timber panelling
- 31 Restored window
- 32 New high level window to match adjacent shopfront

- 33 Proposed portland stone infill
- 34 Window dormer
- 35 Louvre dormer
- 36 Metal gate to snow hill ramp
- 37 Metal louvred doors / panel
- 38 Existing brickwork rebuilt

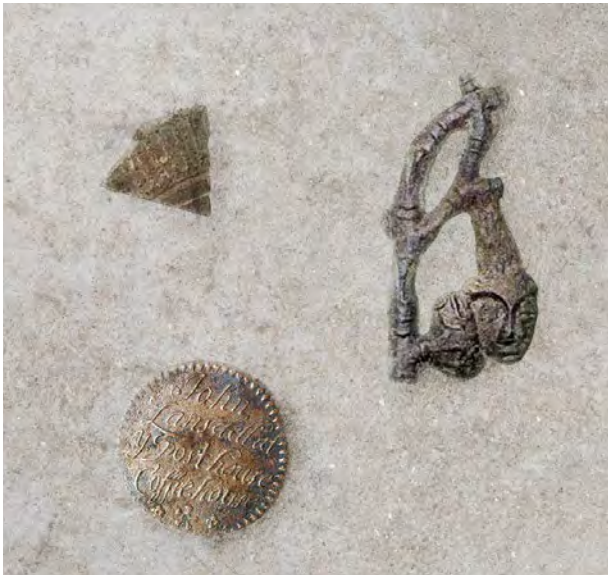
Development of concrete flooring with embedded objects
