Barbican Estate: LUL Noise and Vibration

Measurements and Mitigation

Report 18/0197/R3

City of London

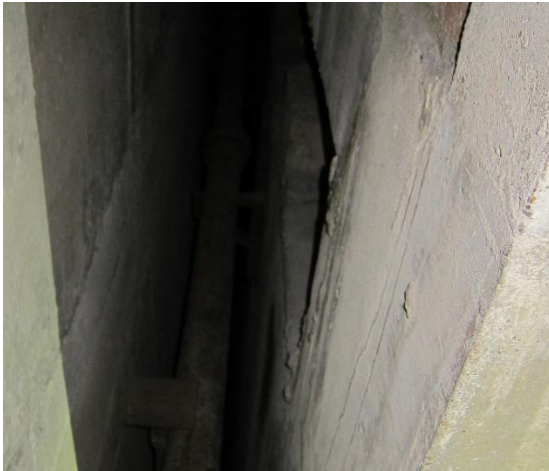
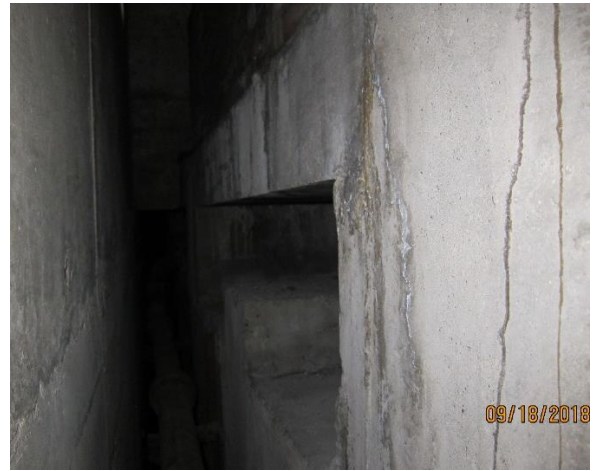
Interface of Defoe House structure with LUL running tunnel, showing a clear gap of $\sim 400\text{mm}$

- 8.1.6 The gap between the tunnel and Defoe House is in the order of 400mm. The gap is observed to extend from the very bottom of both structure to a point above the roof of the tunnel. The Defoe House structure spans above the tunnel and, so far as we were able to observe, the two remain independent of each other.

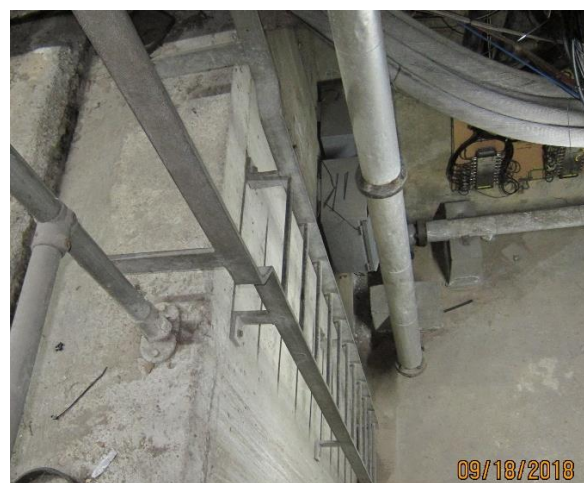
- 8.1.12 We believe that Brandon Mews is structurally connected to the LUL running tunnels to a significant extent. Like Lambert Jones Mews this is a relatively low-rise town house structure, and we would anticipate it is built on a ground bearing slab, founded at a higher level than the base of the running tunnels.
- 8.1.13 However, Brandon Mews spans directly across the LUL tunnels, and the arrangement within the basement of the building clearly reveals the location of the tunnel and how the Brandon Mews structure appears to be built directly on top of it for the spanning section.
- 8.1.14 The arrangement is shown in the photos below.

Basement of Brandon Mews spanning across the LUL tunnels, the top of breaks into the space

- 8.1.15 The direct physical connection between Brandon Mews and the railway tunnel, together with the fact that the track has not recently been replaced and contains points and crossings directly

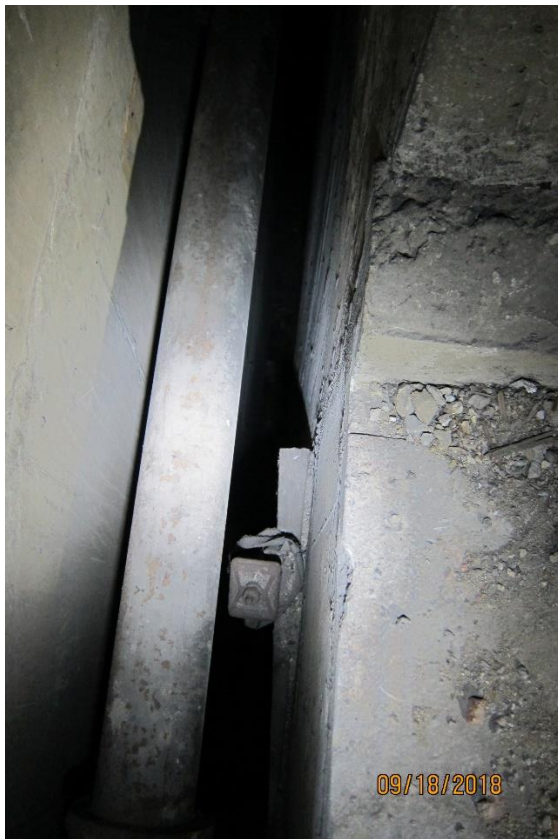
- 8.2.2 There are locations where services are routed in the space between the Barbican structure and the tunnel. Examples are shown in the images below.

Soil/water pipe at Defoe House

- 8.2.3 There is the risk that where services are clearly connected to both the building and the tunnel structures, they provide a direct transmission path for vibration between the two. This is particularly the case where the service may span between an isolated section of the tunnel and the adjacent structure.
- 8.2.4 A related concern is that even if services do not actually bridge from tunnel to building, they could form obstructions for the accumulation of debris or discarded materials which could in turn act as bridging elements.

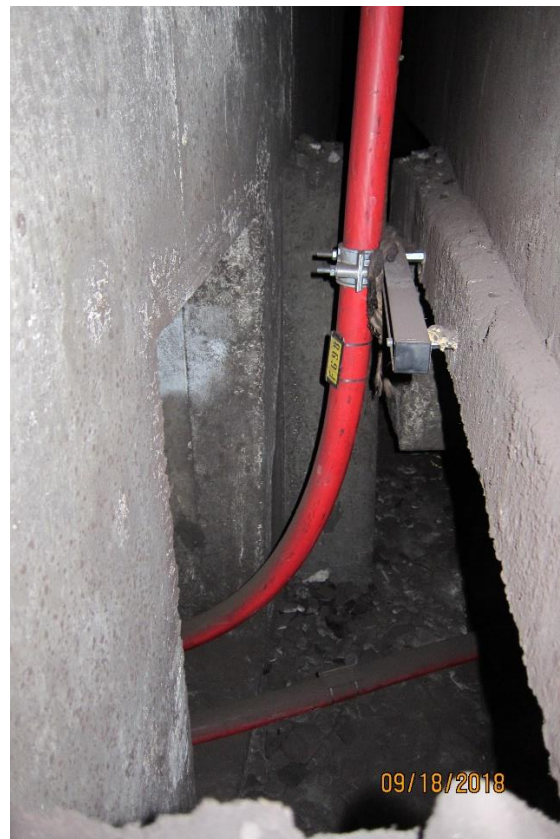
Electric cable on the tunnel at Gilbert House

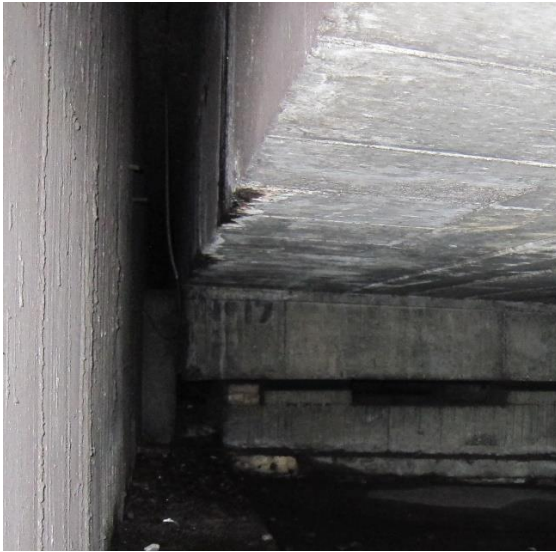
- 8.2.5 There are locations where, even in the absence of services, the design and construction of the tunnels leads to a particularly narrow separation to the adjacent building structure. Examples are shown in the images below.

Isolated tunnel adjacent to Barbican structure

- 8.2.6 As noted above for services located between the two structures, care must be taken to ensure that at points of constriction there is no direct transmission path for vibration. Similarly, it is important that pinch points do not form obstructions for the accumulation of debris or discarded materials which could in turn act as bridging elements.

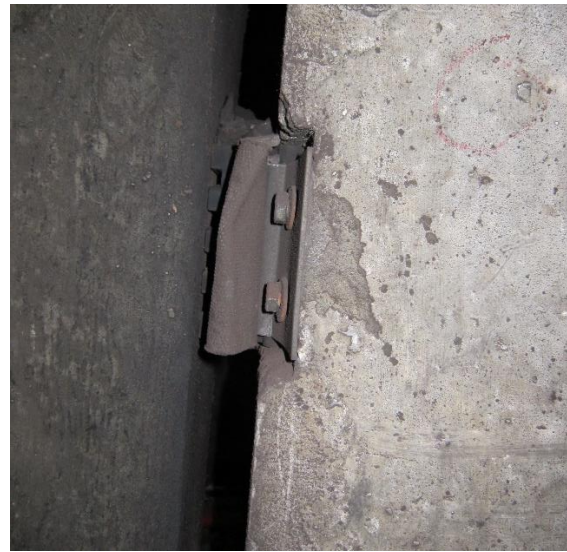
Flexible connection at 'pinch point'

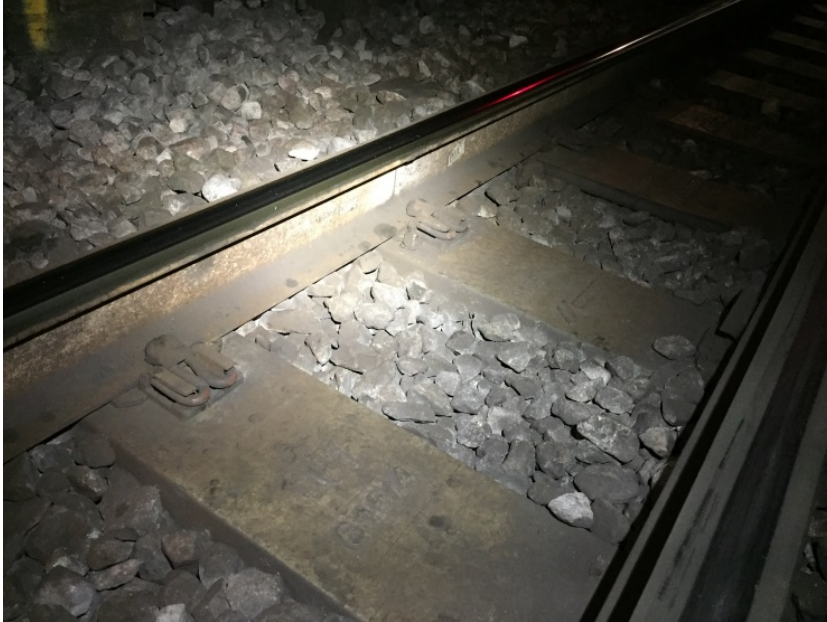
From the tunnel entrance at Barbican station the formation of track on the Eastbound Outer line is ballasted track with flat-bottom rail on concrete sleepers for approximately the first 90m (figure 1). The track then changes to bullhead rail on timber sleepers (figure 2) for the next 410m, all the way to Platform 1 at Moorgate station.

Figure 1 – Flat-Bottom Rail on Concrete Sleepers

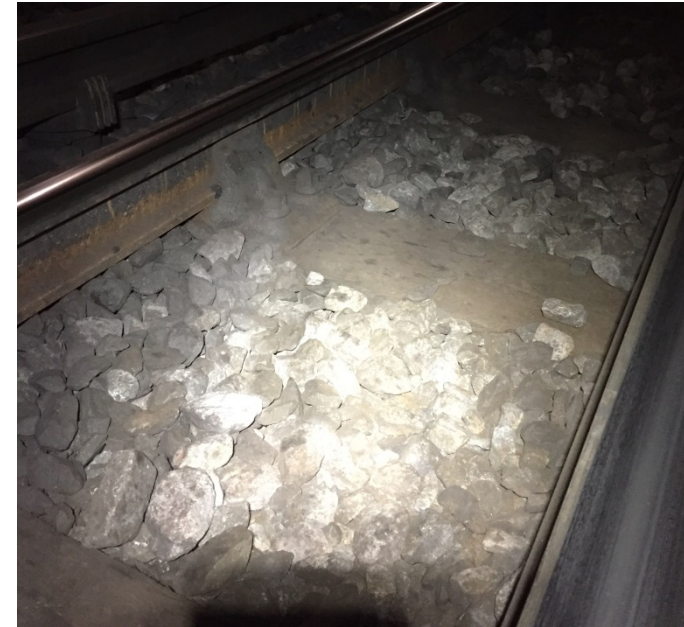
Figure 2 – Bullhead Rail on Timber Sleepers

On the Westbound Inner line the rail is also ballasted track with bullhead rail on timber sleepers for 390m from the tunnel entrance at platform 2 at Moorgate station and changes to flat-bottom rail on concrete sleepers for the next 110m, up to platforms at Barbican station.

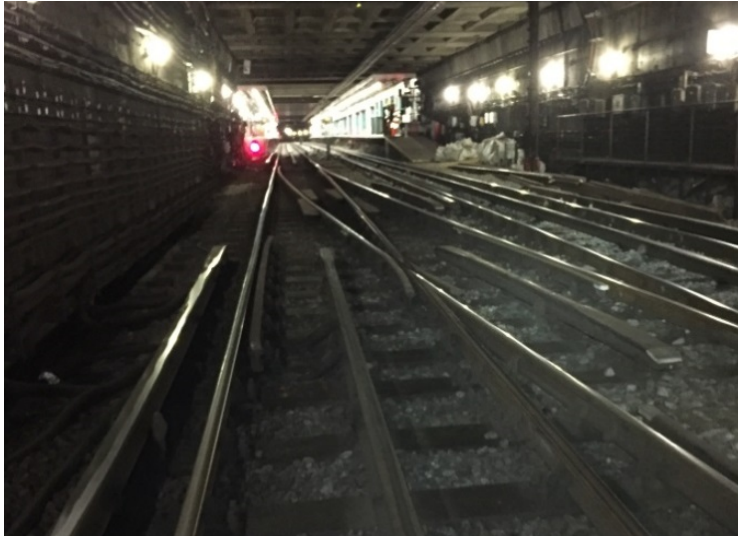
There are sets of points and crossings on the track of the Eastbound line at approximately 300m (31b) and 480m (35a) from Barbican station (figure 3), and at 60m (35b) and 160m (31a) on the Westbound line from Moorgate station.

Figure 3 – Points 35 on both the Eastbound and Westbound Line

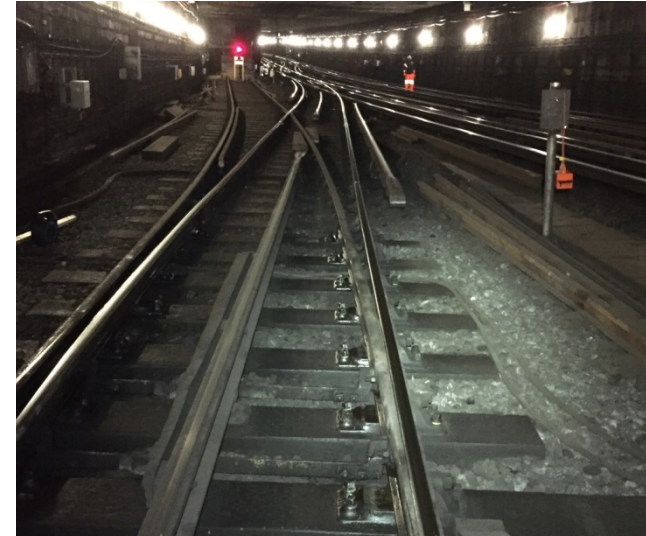
The track formation of the sidings from platforms 3 and 4 is flat-bottom rail on concrete sleepers (figure 4) which travels over set of points 32a/34 at approximately 67m from the platforms, before joining the Westbound line at set of points 31a/32b.

Figure 4 – Sidings Flat-bottom Rail on Concrete Sleepers from Platform 3

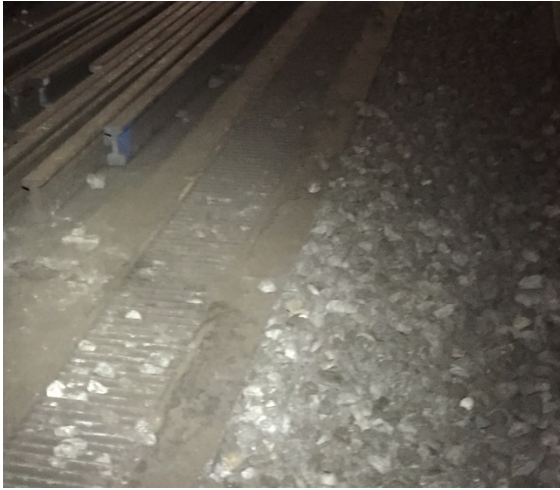
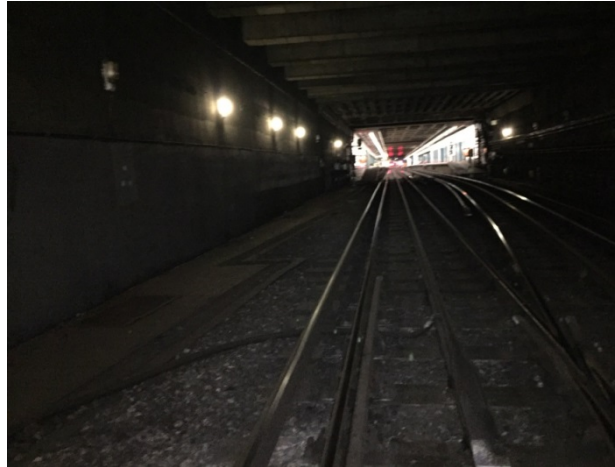
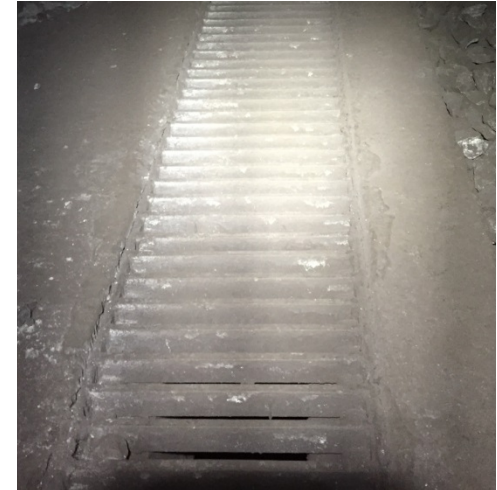
The location of the vibration isolation chamber (highlighted in yellow on the map in figure 5) was found to be between **140m to 450m** underneath the track ballast on the Eastbound line and **50m to 360m** on the Westbound. The chamber also runs underneath the entire length of the sidings track ending at platforms 3 and 4 at Moorgate station. This was determined by location of the metal grills on concrete that run parallel with sections of the track (figures 6-8) below.

Figure 6 – Metal Grills on Concrete Running Parallel with Rails

Figure 7 – Metal Grills on Concrete Running Parallel with Rails

Figure 8– Metal Grills on Concrete Running Parallel with Rails

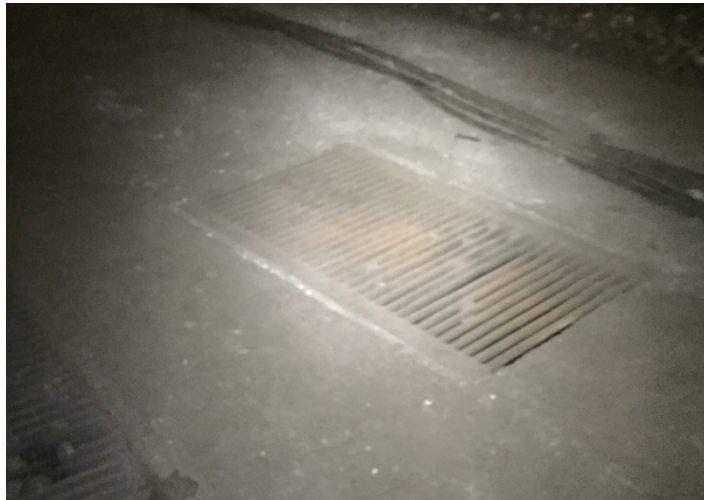
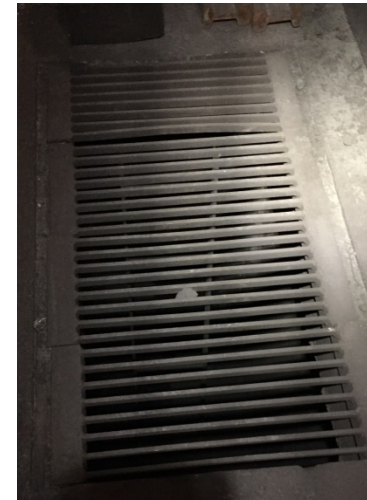
The vibration isolation chamber is accessible via sections of removable metal grills, on the left hand side of the westbound road, and has attached ladders leading down into the chamber (figures 9 and 10).

Figure 9 – Removable Grills to Access Chamber

Figure 10 – Removable Grills to Access Chamber

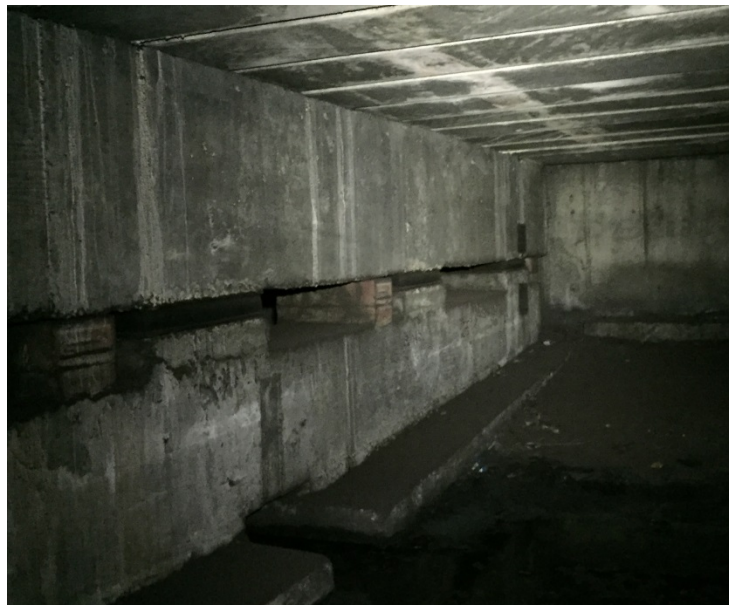
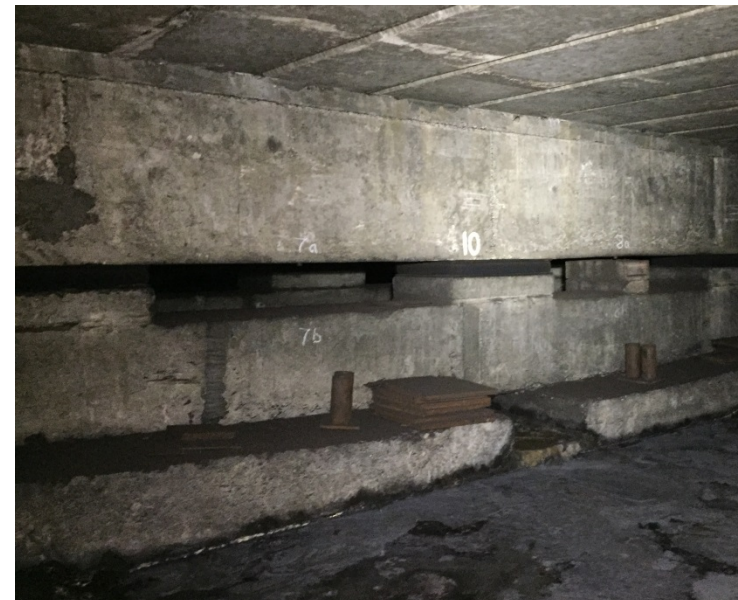
Figure 11 and 12 below show inside of the vibration isolation chamber, which consists of a concrete structure supporting the suspended track with resilient rubber bearings in the centre (figures 13 and 14) isolating the direct contact between the chamber floor and ceiling.

Figure 11 – Concrete Structure Supporting the Track

Figure 12– Concrete Structure Supporting the Track

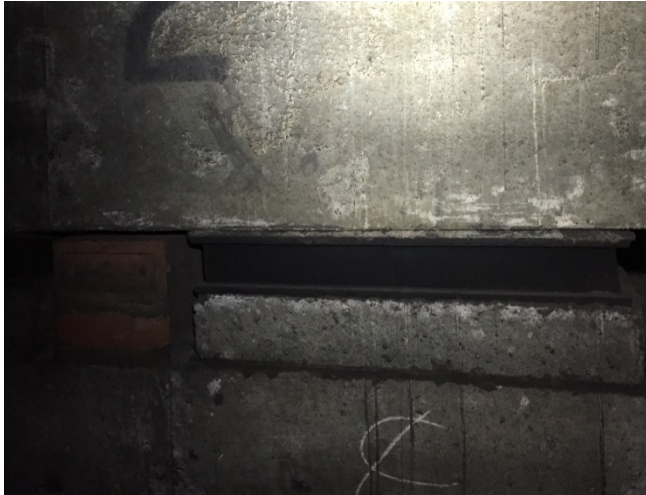
Figure 13 – Resilient Rubber Bearings within the Concrete Structure

Figure 14 – Resilient Rubber Bearings within the Concrete Structure

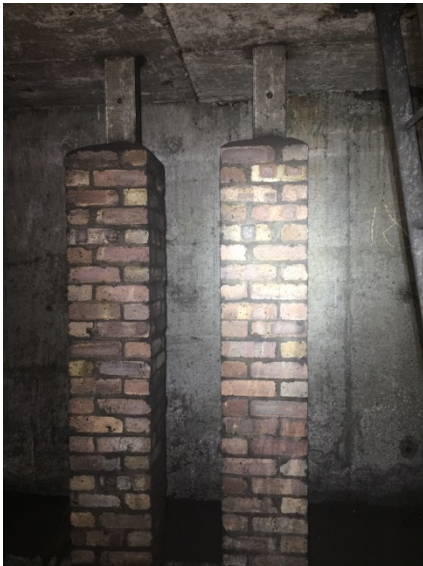
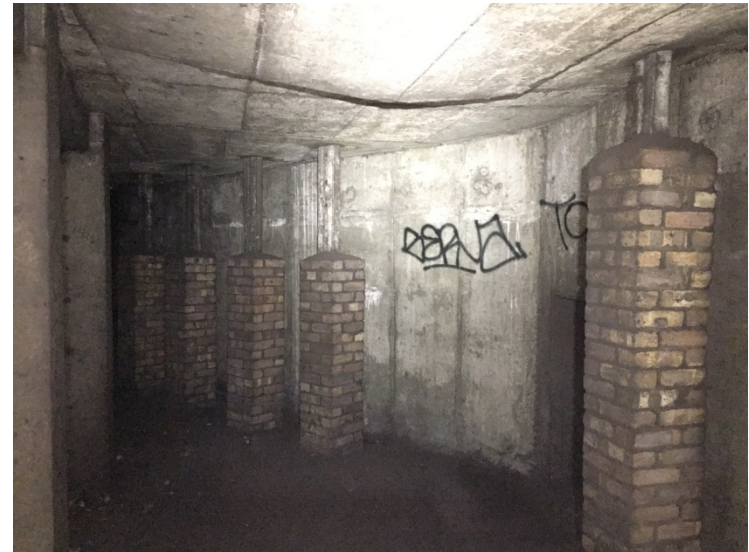
The chamber ceiling is supported by brick columns with a concrete rod (figures 15 and 16) which is located outside of the chamber. They are not directly underneath the rail itself, but supporting the tunnel invert in the left hand side of the westbound line.

Figure 15 – Supporting Brick Columns

Figure 16 – Supporting Brick Columns

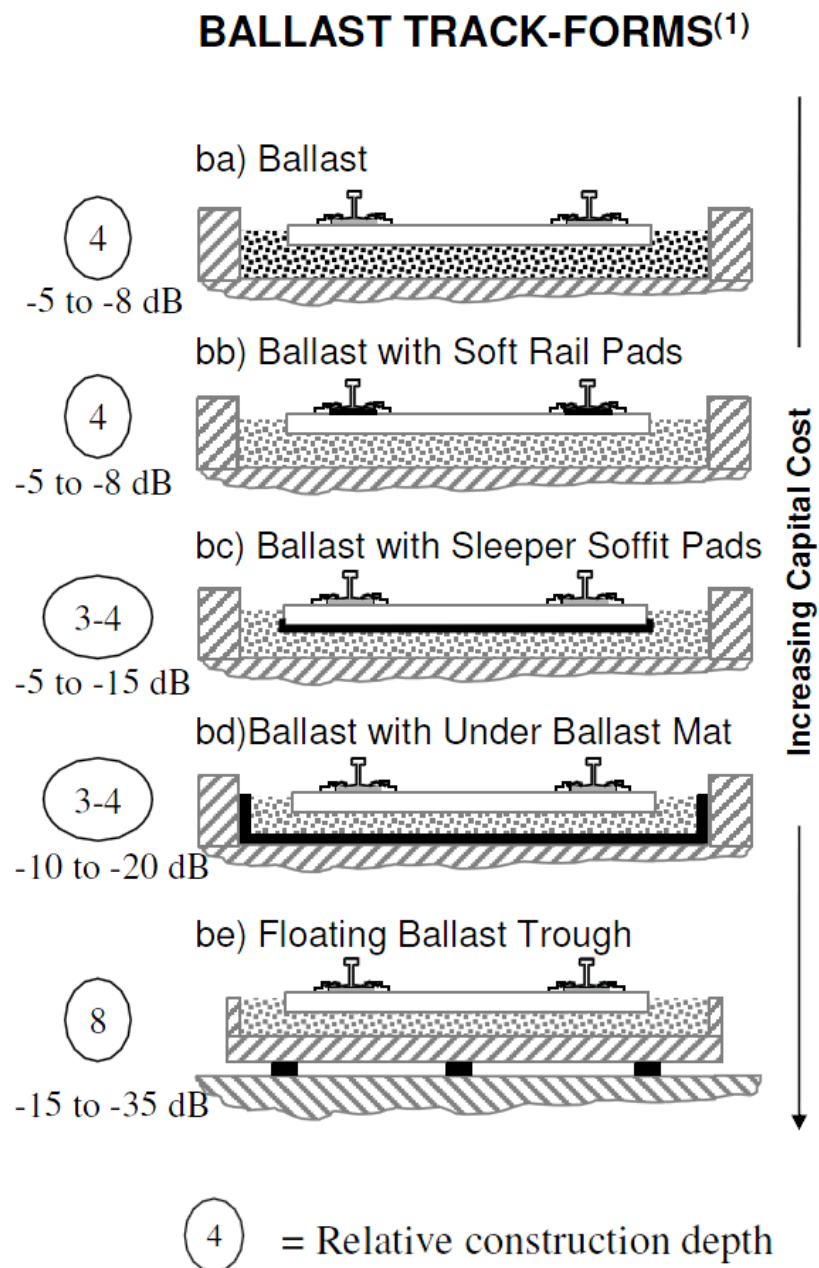
Mitigation⁴

Track Mitigation Options and Under Ballast Mat details.

- Replace that section of track under the estate that still comprises jointed bull head rail on timber sleepers with continuously welded, flat bottom rail on concrete sleepers;
- That section of track beneath Brandon Mews and Willoughby House that is not within the isolated tunnel shall incorporate an appropriate Under Ballast Mat ^{1 2 3};
- That section of track between Barbican Station and Defoe House that has already been replaced but is not within the isolated tunnel shall be modified to incorporate an appropriate Under Ballast Mat.
