City of London Audit and Risk Management Committee

Members Briefing November

East Poultry Avenue -scope of works and programme

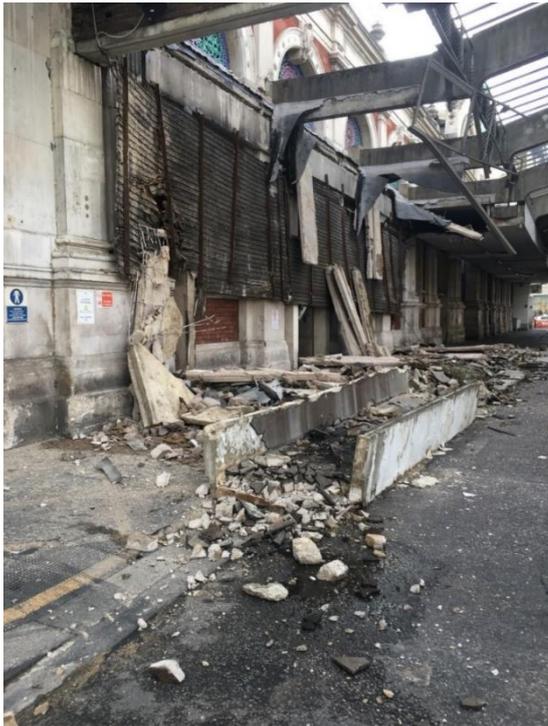
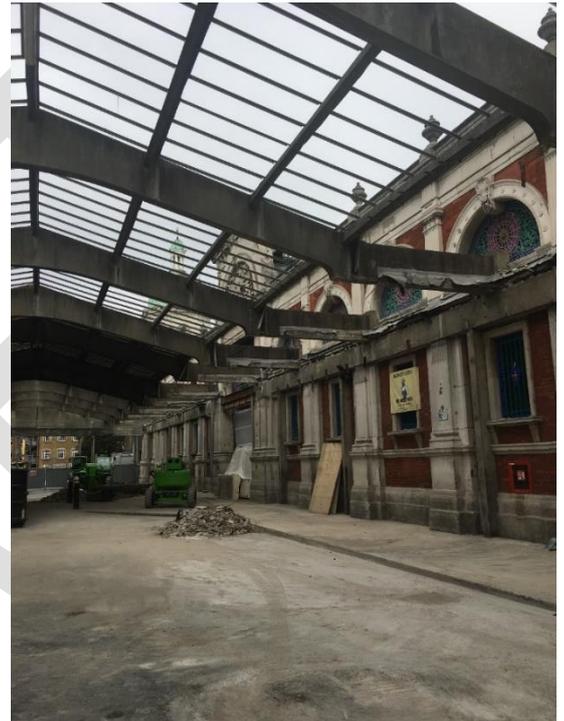
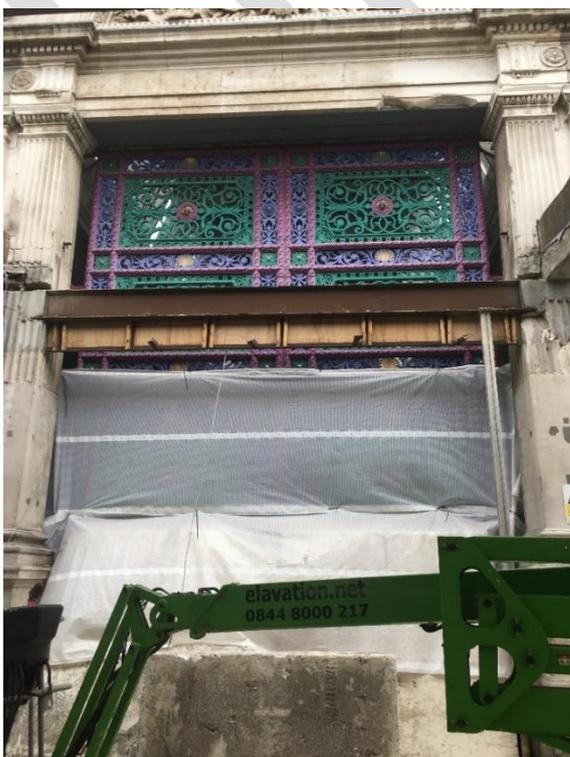
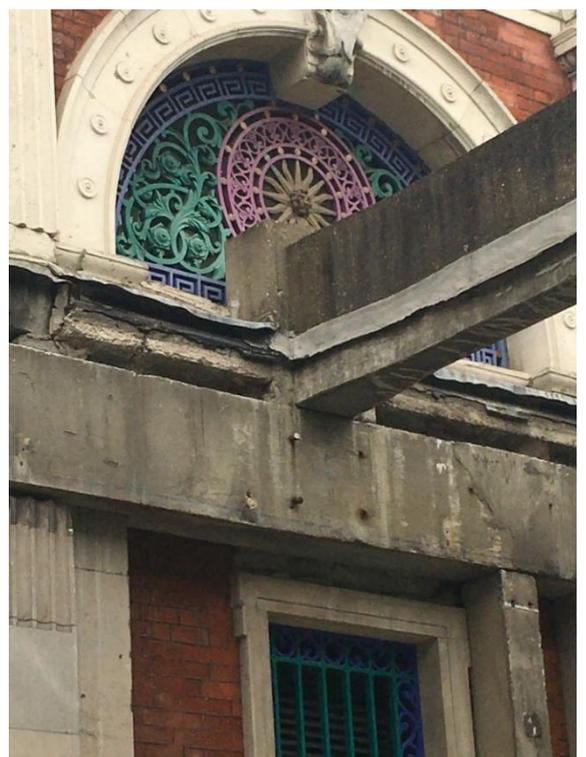
On Saturday 15th August 2020 at 11.50pm three sections of concrete gutter and canopy on part of the east side of East Poultry Avenue (EPA) collapsed onto the pavement below. The whole of EPA was closed to pedestrians and vehicles within 15 minutes of the collapse with temporary barriers and on Monday 17th permanent Heras fencing was installed.

Their initial assessment and subsequent detailed report confirmed that the metal tie rods holding the gutter to the underside of the canopy had corroded and failed. The force of gutter collapse had 'unbalanced' the structural loading of the canopy pulling it down at the same time.

Based on these recommendations, the City appointed demolition specialists Keltbray to undertake the deconstruction of the concrete gutter and canopy on EPA immediately as this posed a live H&S concern. The gutter on WPA was of less concern of any immediate collapse and a programme for its deconstruction was agreed with works commencing on 27th October.

Works to deconstruct the canopy and gutter on EPA commenced on Monday 7th September and completed on Friday 18th September removing the immediate H&S concern and the footpath on the western side of EPA was then opened to the public and traders.
