The Grotto, Wanstead Park Conservation Management Plan Prepared for City of London Corporation September 2019

***CONDITION SURVEY AND CONSERVATION APPRAISAL FOR
THE LOW LEVEL STANDING REMAINS***

THE GROTTO, WANSTEAD PARK

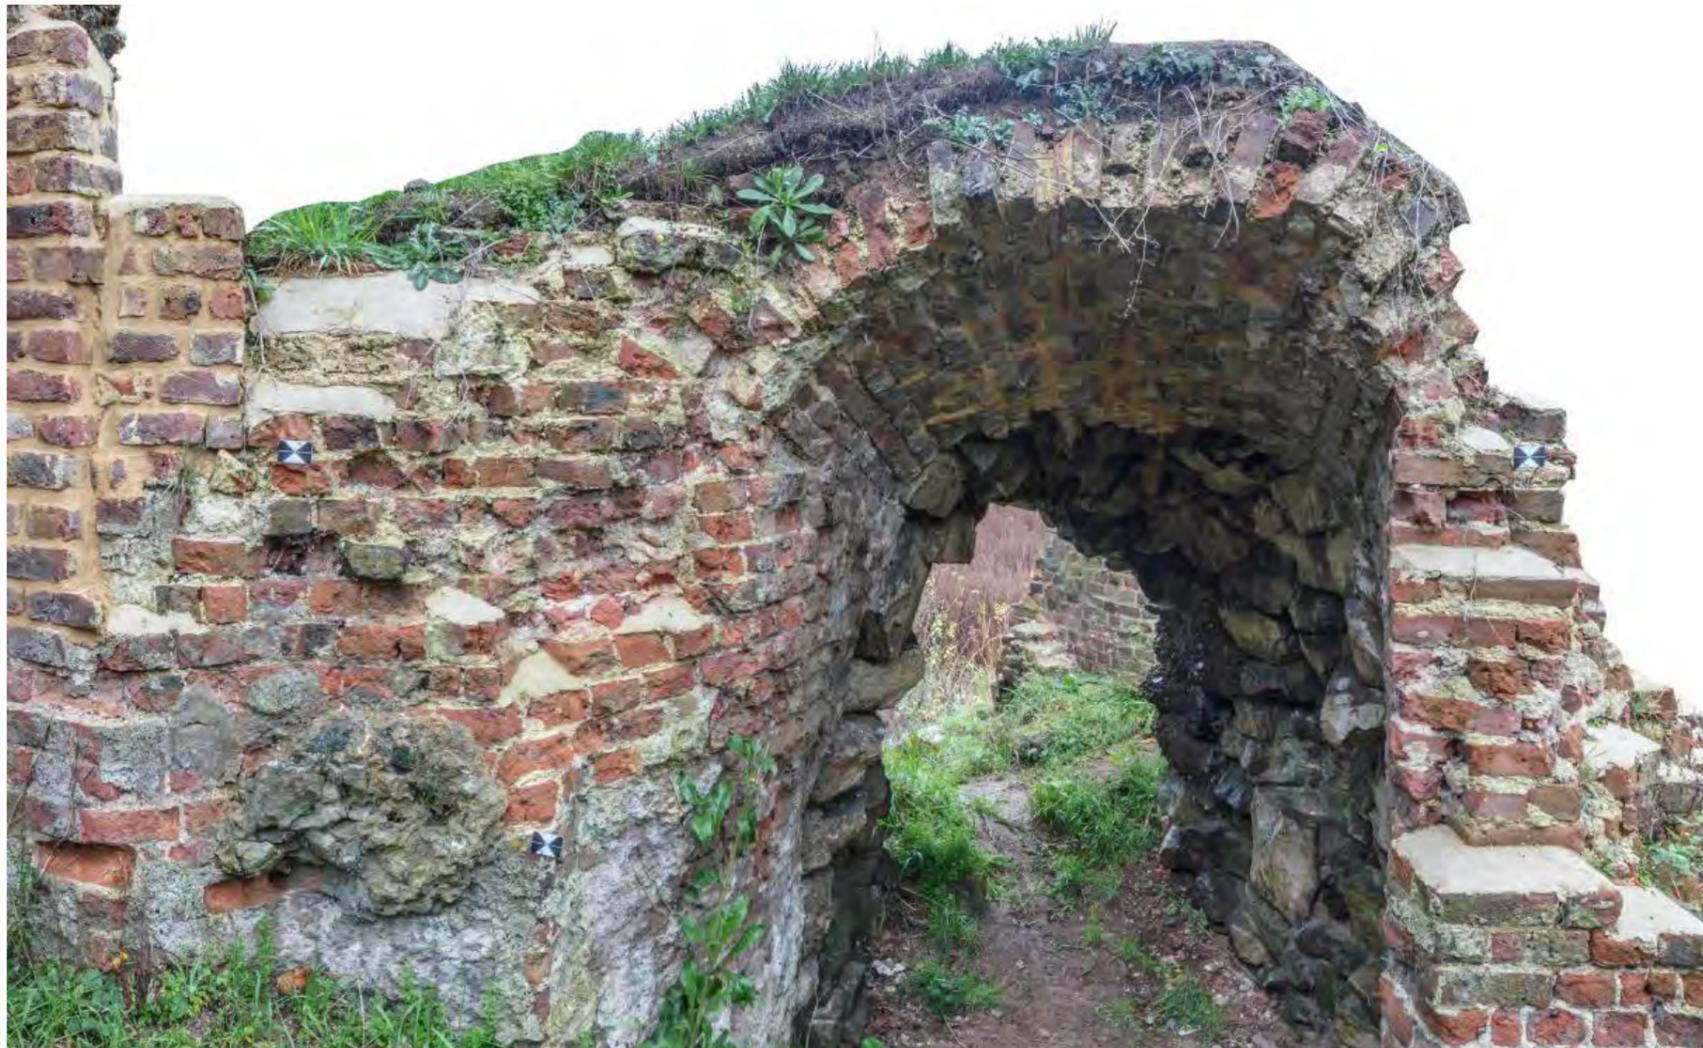
Figure 15: Rectified photography of a section of the Grotto, showing the variety of different repairs

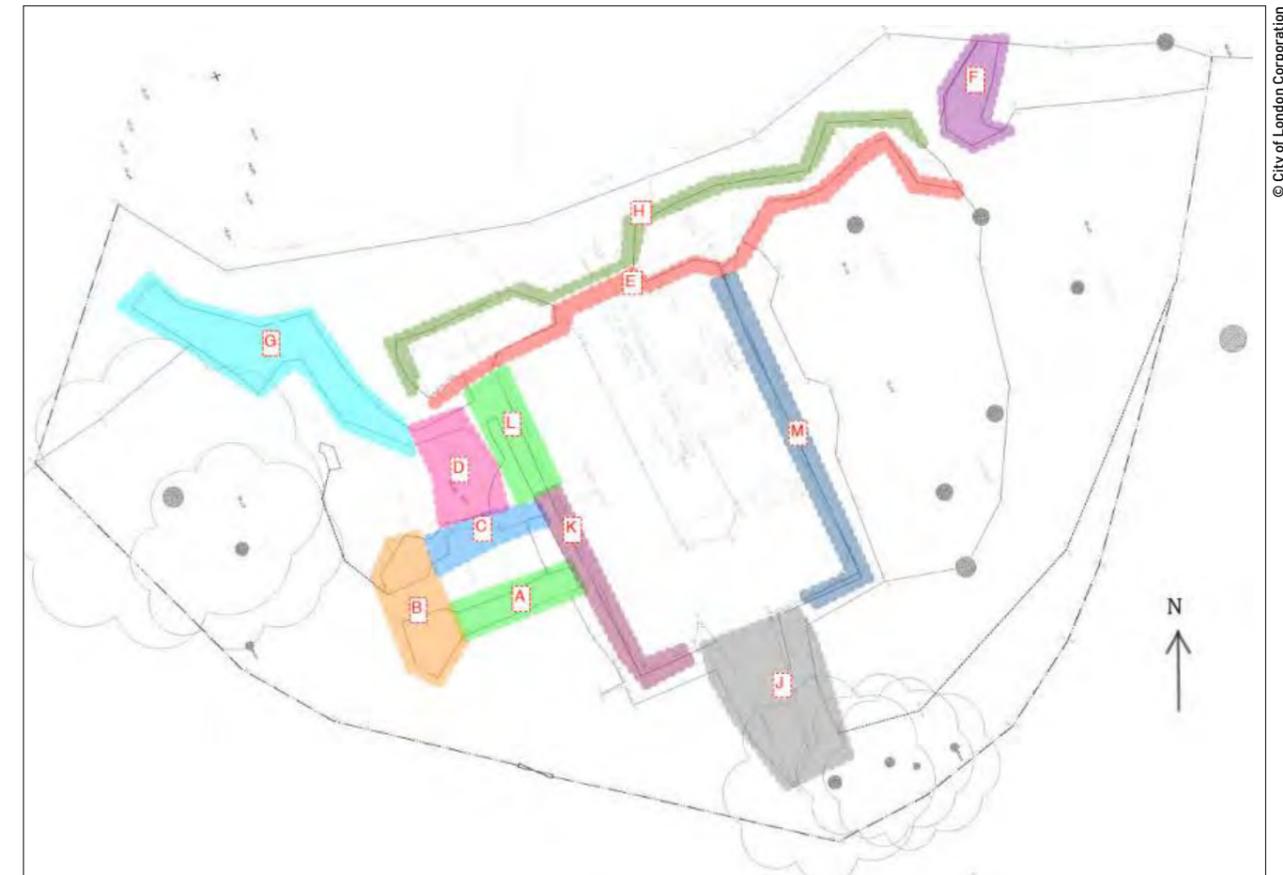
Figure 18: Areas specified in Odgers Conservation Condition Survey (2017)

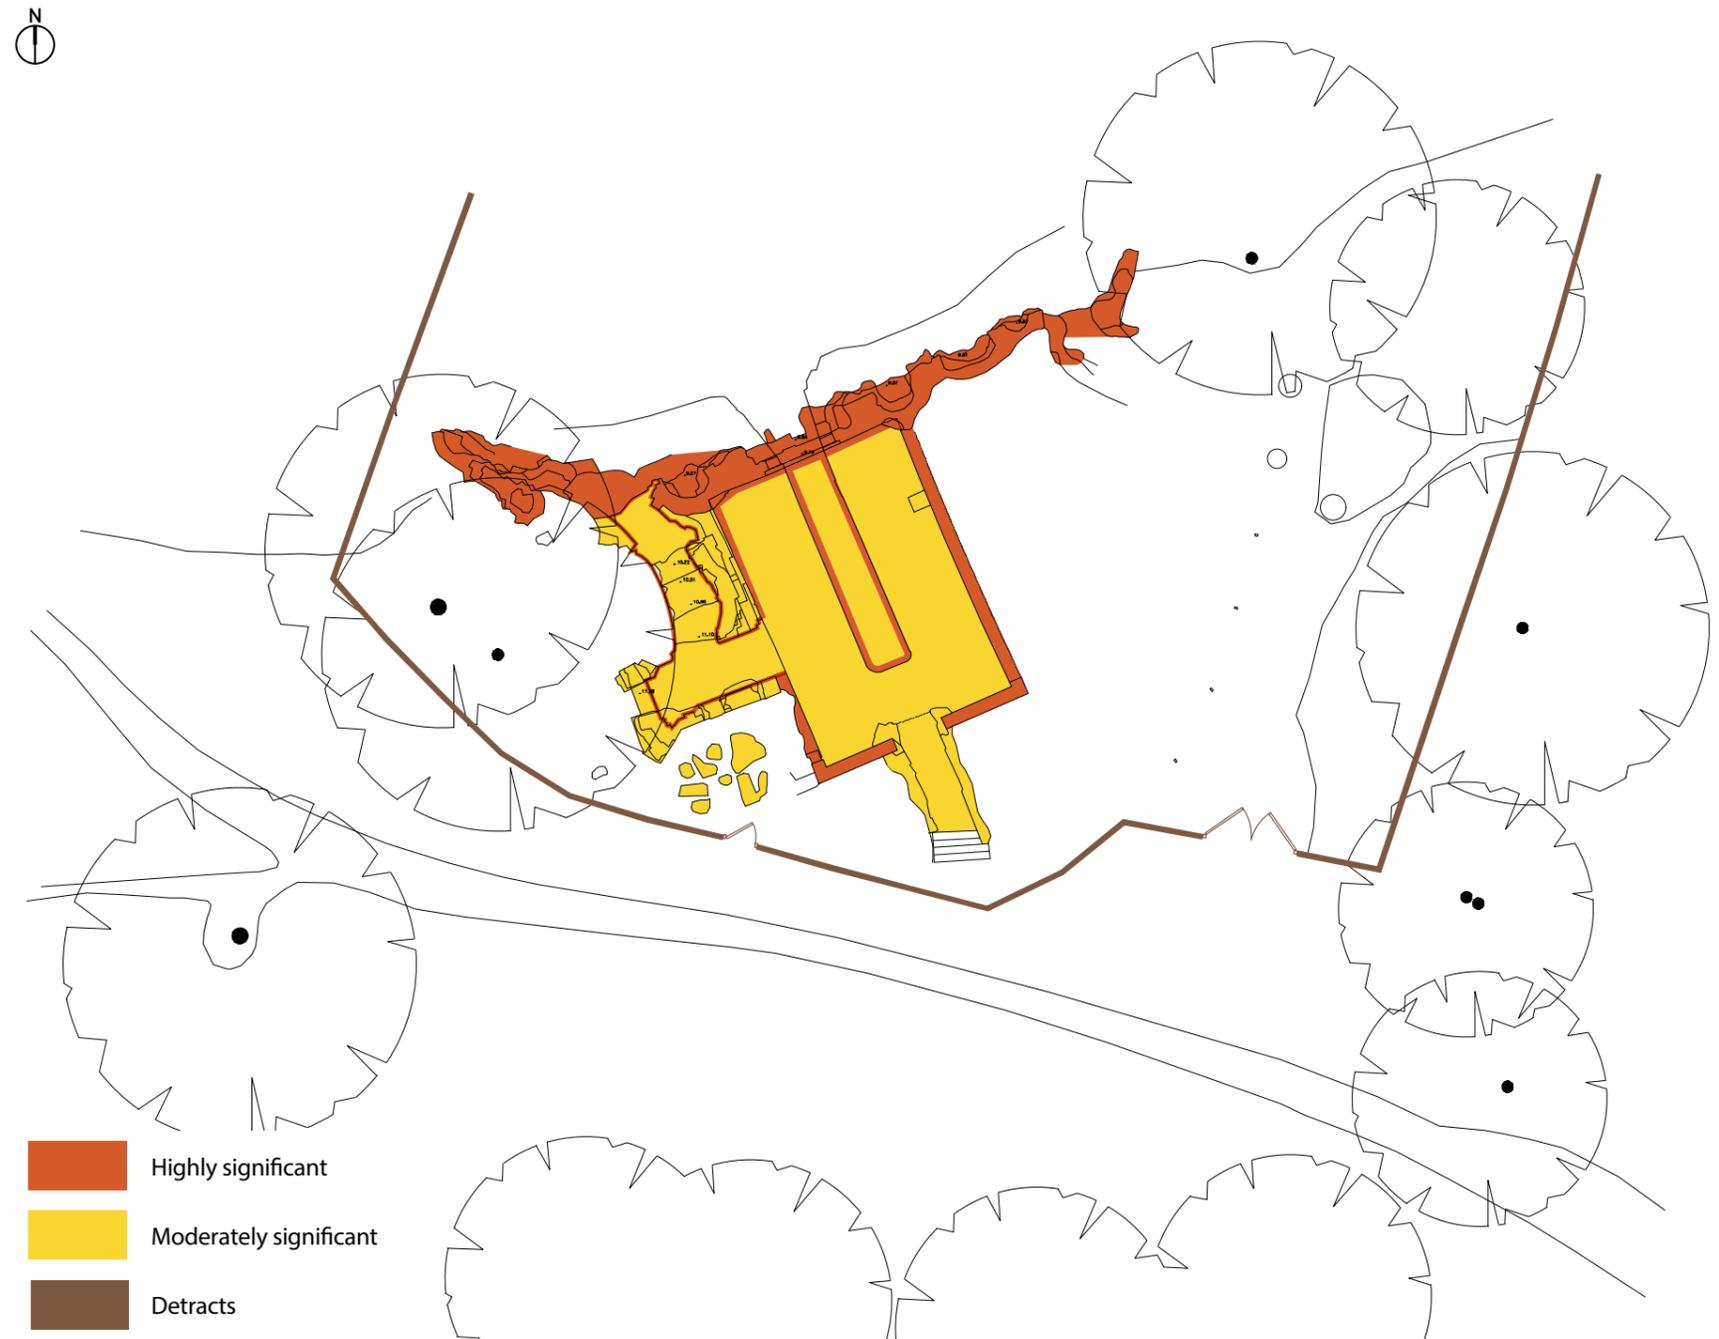
Figure 23: Significance plan of the Grotto

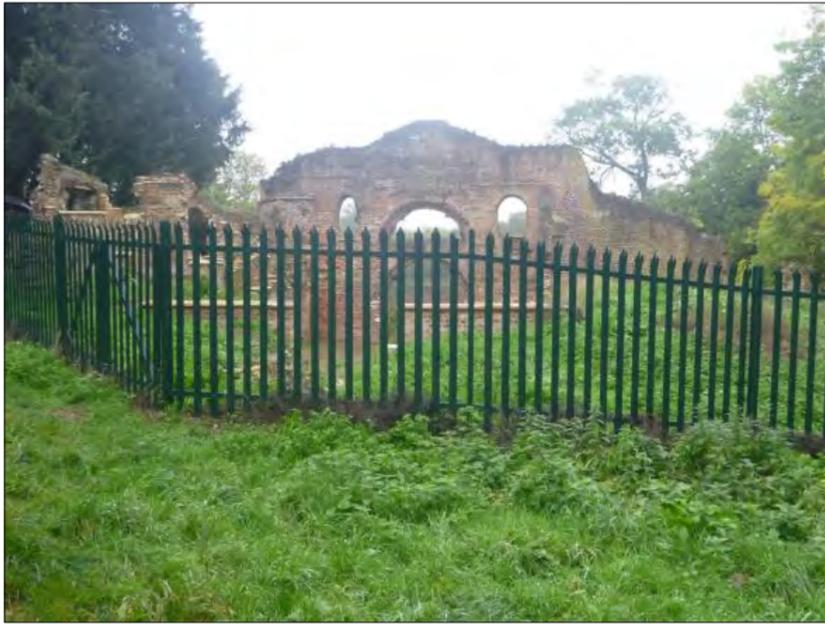
**View 1**

This view looks north through the rear of the Grotto ruins to the Ornamental Water beyond. It was created purely as the result of the 1884 fire and today it allows visitors to appreciate the Grotto's intimate relationship with the Ornamental Water. This view is gradually revealed or obscured as visitors walk respectively towards or away from the structure on the path to the south. Before the fire, this area would have been the location of the rear of the Grotto building and the privileged views out over the Ornamental Water would have been experienced from the boat dock and the Grotto above.

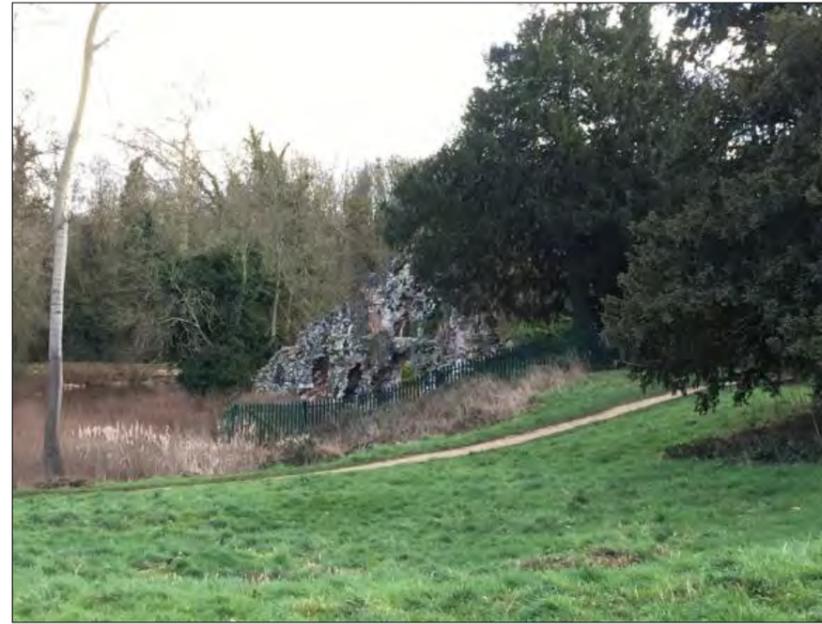
**View 2**

This view looks east towards the side of the Grotto from the path connecting the Ornamental Water to the Temple. Because of its proximity to the Temple, this is often visitors' first experience of the Grotto. Due to the planting of trees in this area, the Grotto is gradually revealed as visitors walk further northwards along this path.

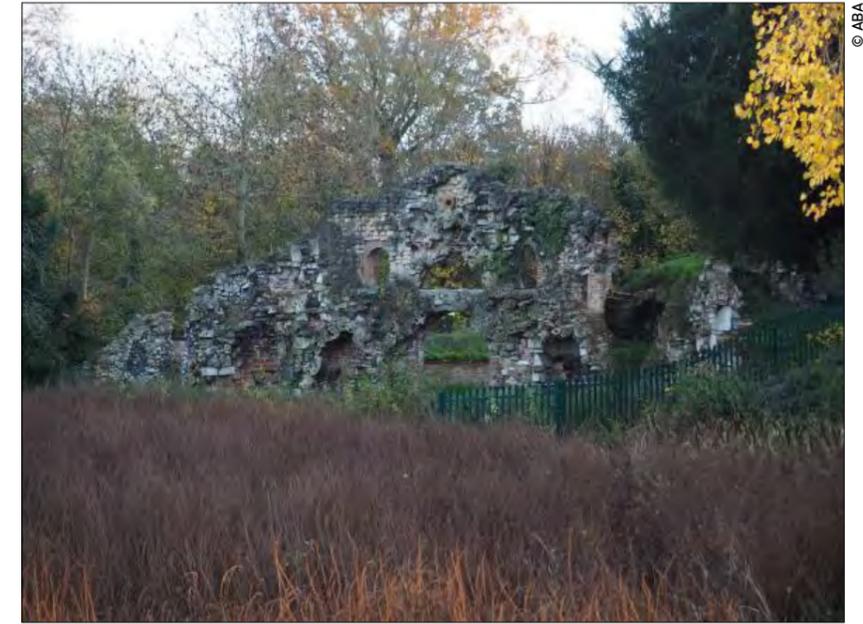
**View 3**

This view looks south-east towards the front of the Grotto from the eastern bank of the Ornamental Water. It is one of two short-distance, oblique views of the Grotto and, because of its proximity to the Temple, is likely the most familiar view to visitors.

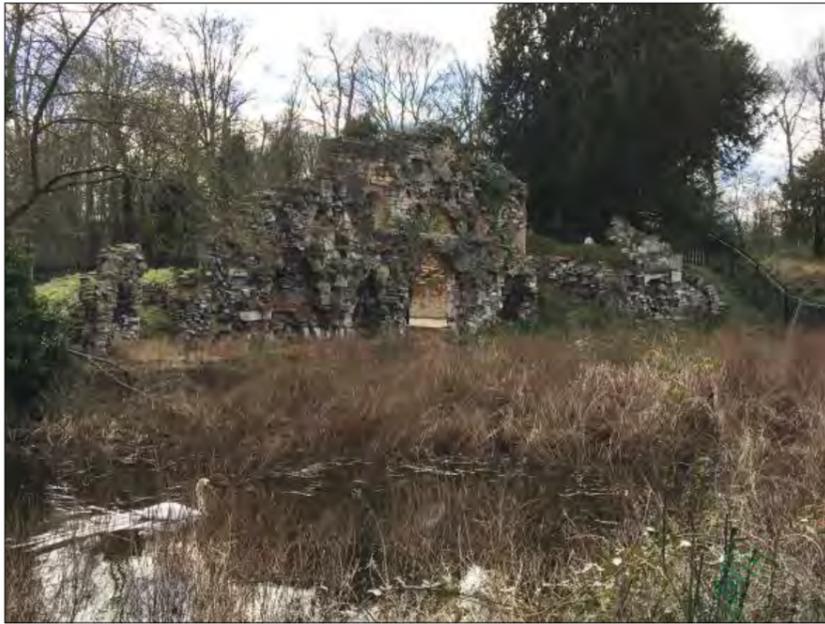
**View 4**

This view looks south-west towards the front of the Grotto from the western bank of the Ornamental Water. This is the second of two short-distance oblique views of the Grotto. However, as this bank is located closer to the Grotto than View 3, this view offers a better viewpoint to appreciate the Grotto's facade.

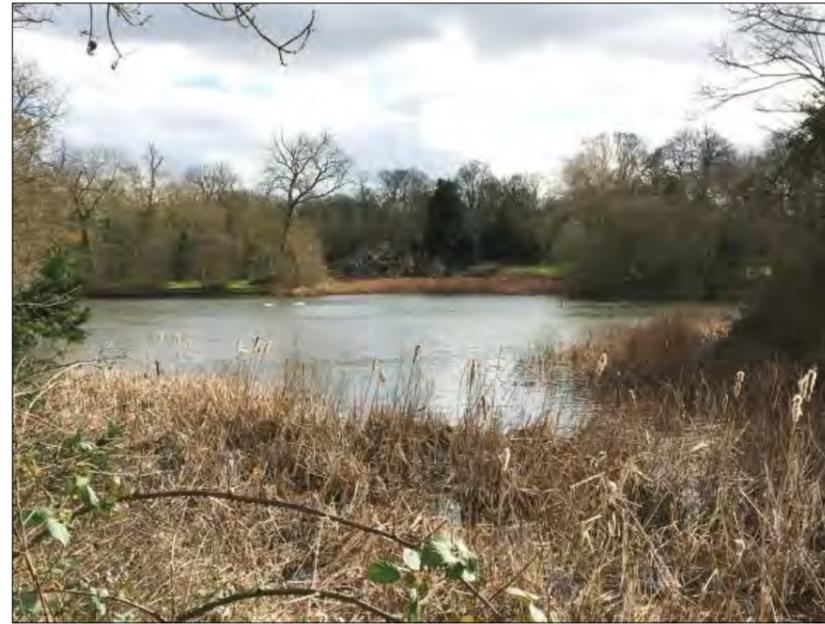
**View 5**

This long view looks south towards the Grotto from a point on the eastern bank of the Ornamental Water just south of The Fortification. This view demonstrates the glimpse of the Grotto in the distance, which is gradually revealed and obscured, which is experienced by visitors along this route.

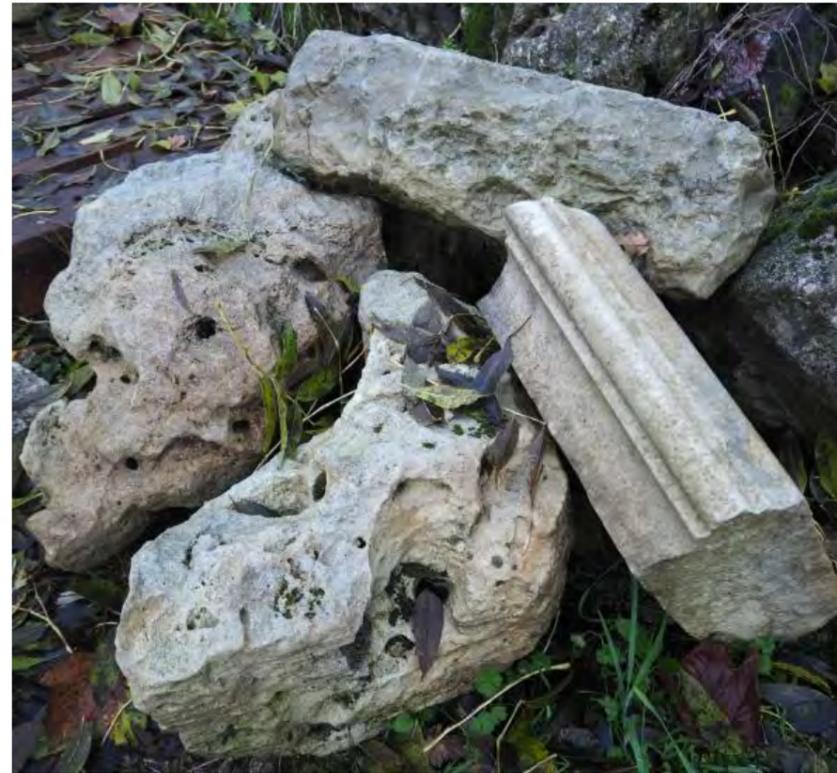
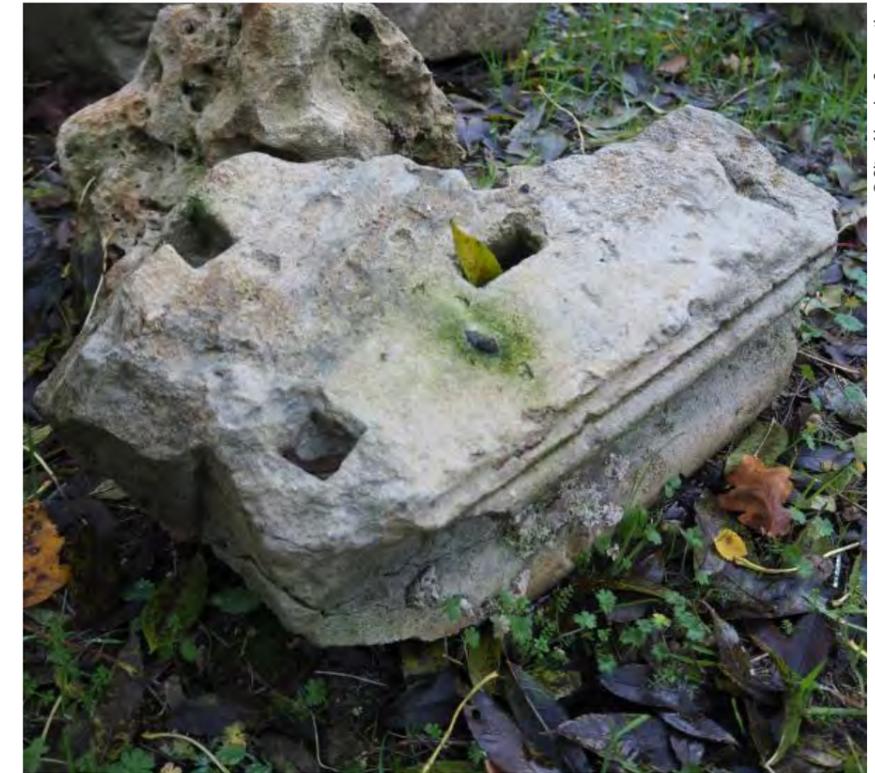
Figure 28: Recovered material currently stored in the open

- 012.** The City Corporation will work with Historic England to investigate a more secure way to store the recovered material on site, including the construction of a temporary structure
- 013.** The City Corporation will commission an archaeological recording exercise to determine each stone's geology and likely historic location (if possible)

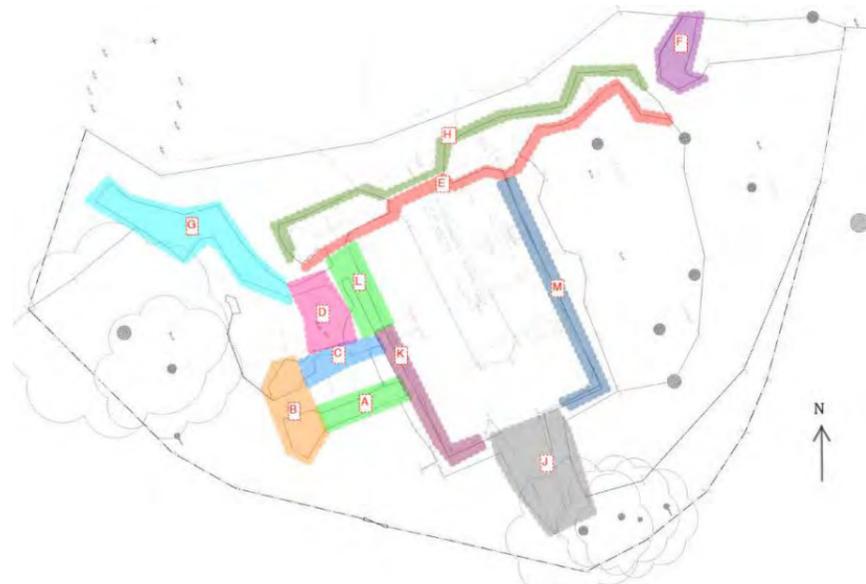
Fig 1: outline of the surviving parts of the Grotto showing the zones that have been used in the survey

For convenience and in order to allow easy identification, the site has been divided into a number of zones (see Fig 1).

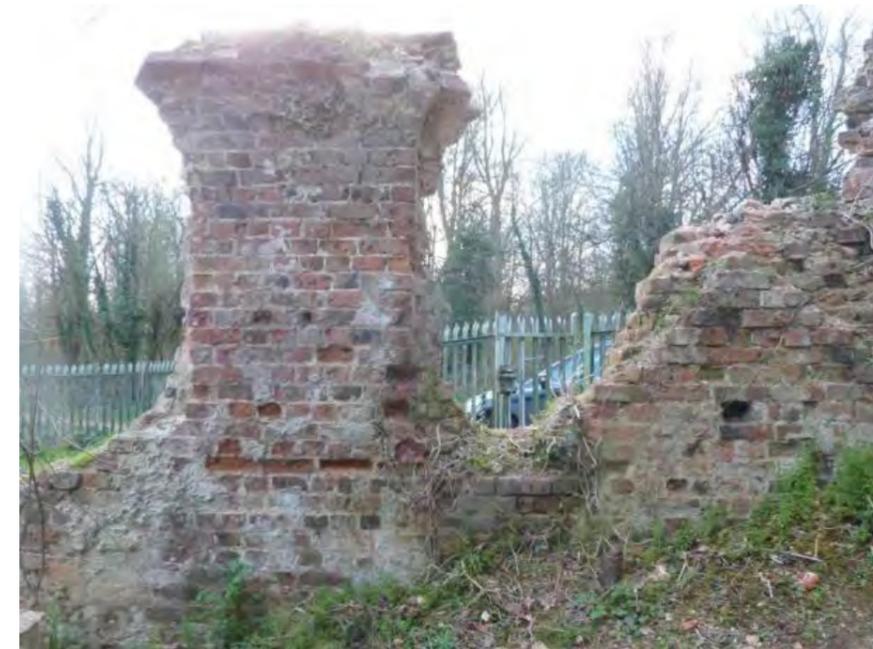
Fig 2: north elevation of Zone A

The current condition is fair but there are quite a lot of areas where the mortar is crumbling and if this continues, it will inevitably lead to loss of bricks. Already some bricks on the top surface are loose and there are others on the broken section to the west of the opening (Fig 4), especially on the south side. There is some localised crumbling of bricks themselves. There are loose bricks at the east end adjacent to the void at low level (Fig 5).

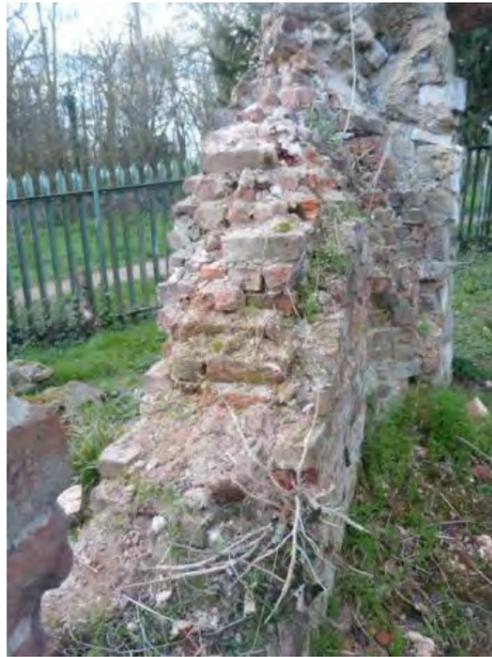
Fig 4: loose bricks on west side of opening of Zone A

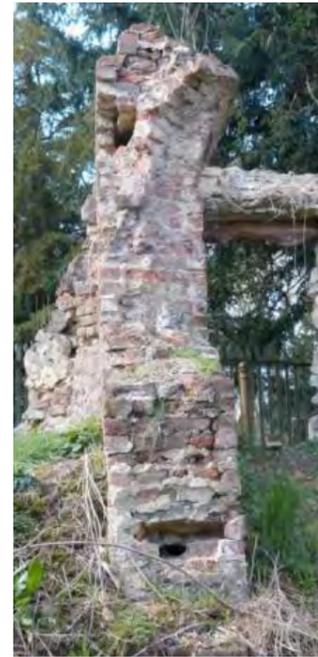
Fig 5: east elevation of zone A of showing voids and loose bricks

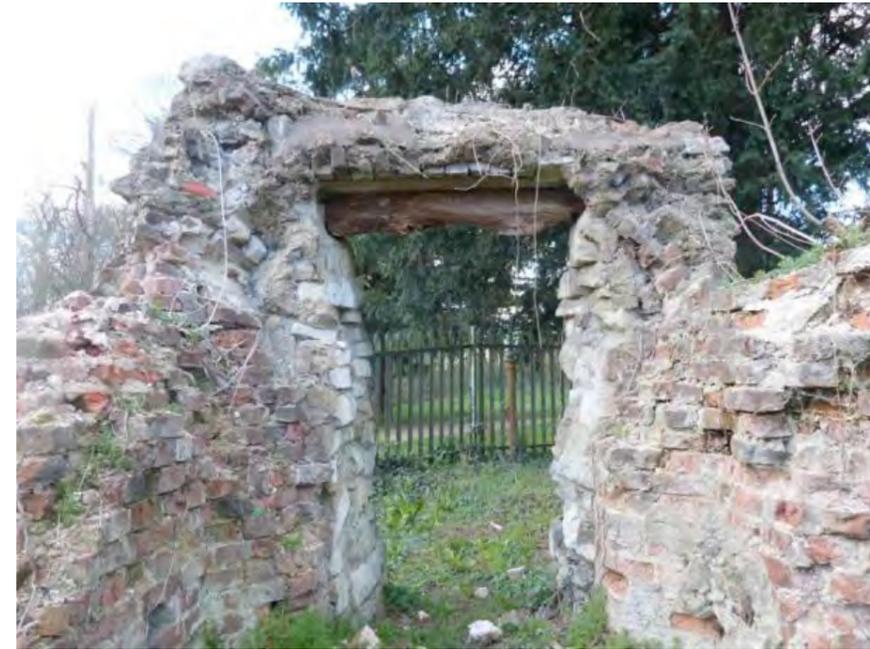
Fig 6: east elevation of Zone B

- B1 Remove mortar capping above door and lay slate capping to allow water run-off
- B2 Using salvaged masonry and mortar, fill voids in buttress (allow 6 No mostly at low level)

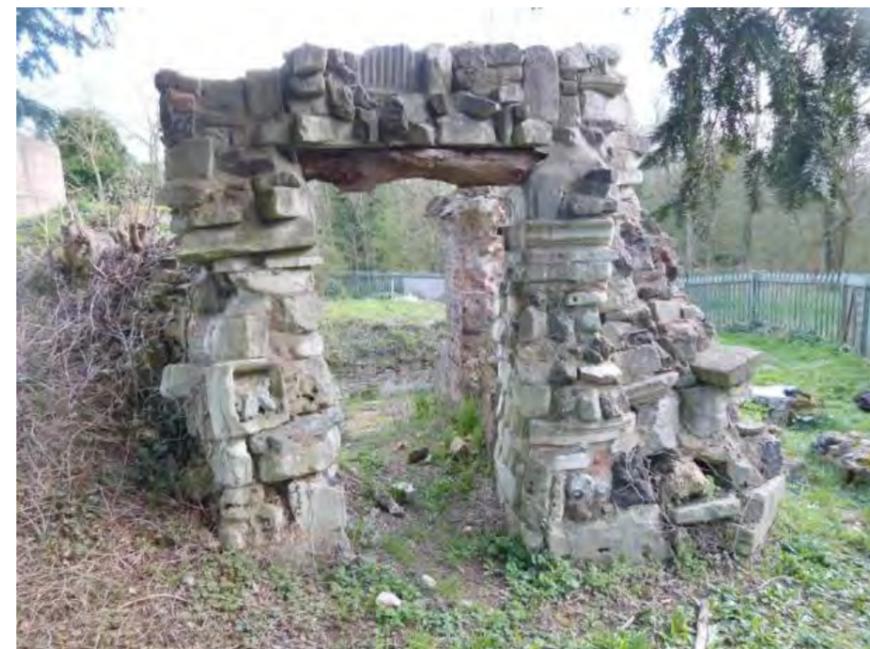
The condition appears generally sound with no obvious signs of current deterioration or imminent collapse. There is one void in the SW buttress that has a loose stone; there are also others voids and fissures in this area. These are not compromising the structure but they provide ideal locations for vegetation to become established. There are some areas of concrete at the north end. A mortar capping has been applied to the top horizontal surface but this has started to deteriorate and some of the capping is now loose (Fig 8).

Fig 7: west elevation of Zone B – note voids in buttress on the right

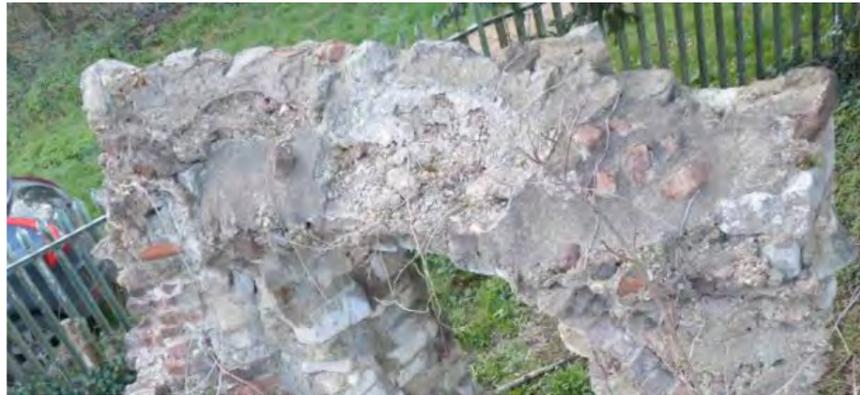
Fig 8: detail of top of wall showing decayed mortar capping

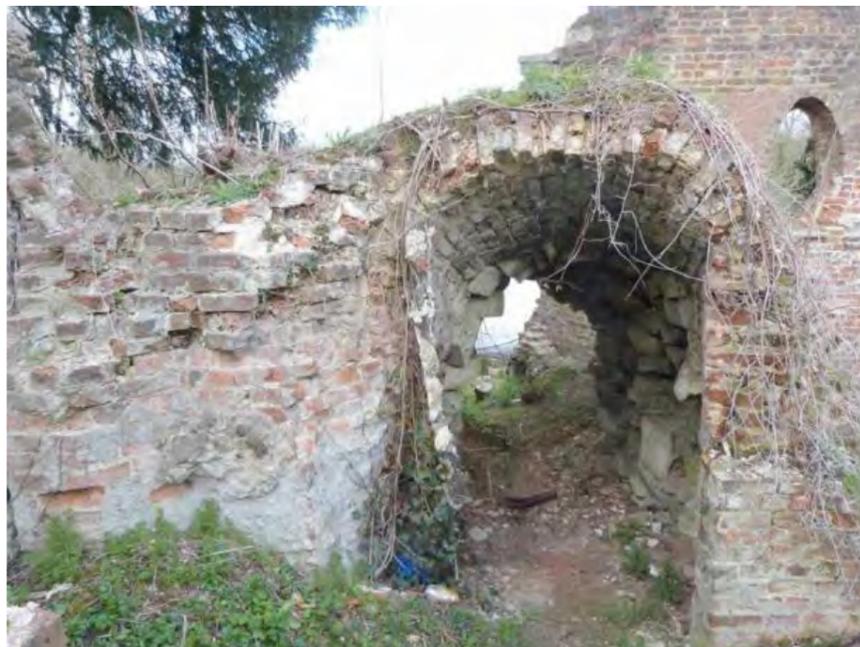
This is the brick entrance to the south side of the tunnel. It starts adjacent to Zone B and slopes up over the top of the arch and down to the buttress of the arch on the east side. This area had clearly been infested with substantial ivy growth; this has now been killed but tendrils and roots remain; some of the bricks beneath this residue are loose. There are higher plants (sycamore?) which are well-established on the top surface; these have been cut back but are still alive and new shoots are appearing.

Fig 9: front face of Zone C – note sycamore tree growing on top left

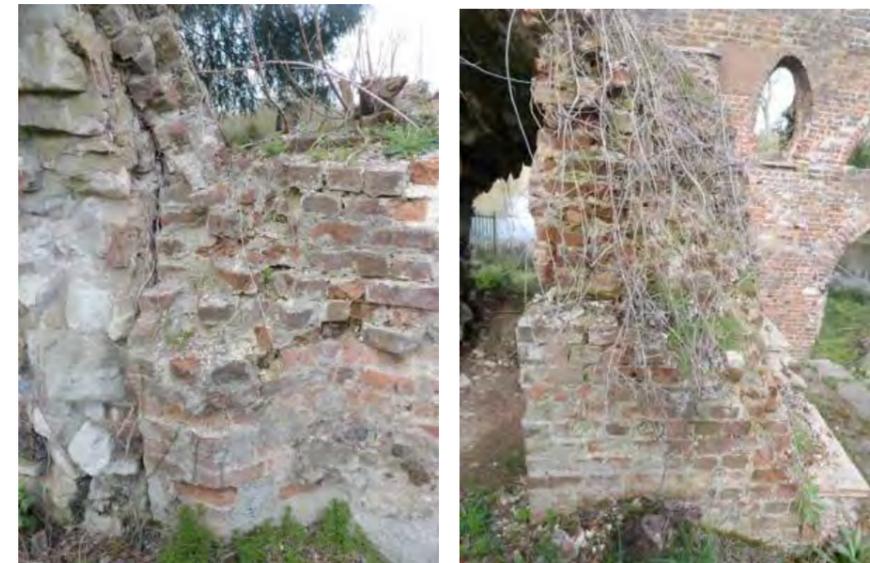
The front face of the arch has previously been consolidated with stainless steel mesh and mortar but this has failed and now hangs down. The underlying brickwork still seems sound. On the west side of the arch, there are some loose bricks on top of the quoins but overall the front face is sound.

Fig 10: Zone C – east jamb of door showing void Fig 11: Zone C – east section

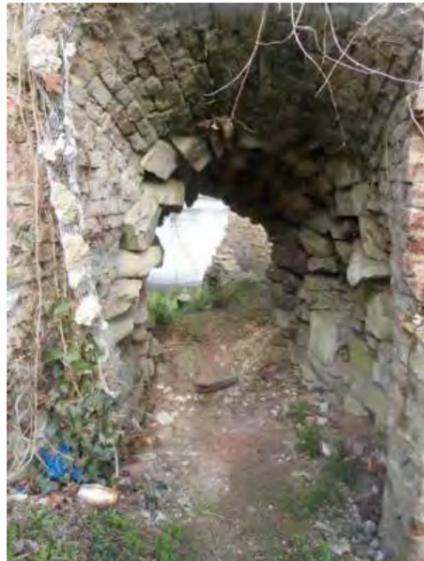
This is the tunnel constructed from many random facing stones applied onto the brickwork lining which provides the structural integrity. There are a few areas of concrete repairs and in a couple of places, the stones have become dislodged and the brickwork is revealed. The overall condition is very sound with a few sections of loose mortar but these are not a problem.

Fig 12: Tunnel (Zone D) looking north

- No work required

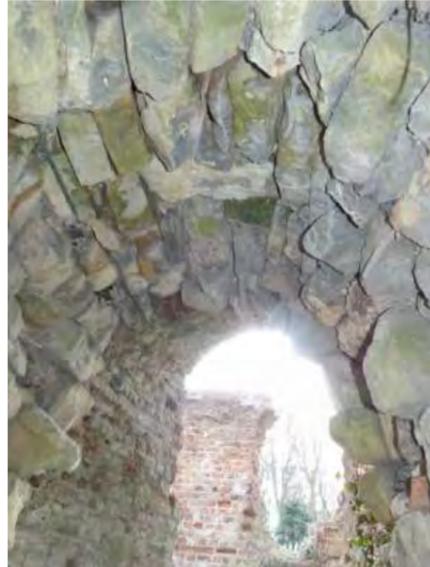
Fig 13: Tunnel (Zone D) looking south

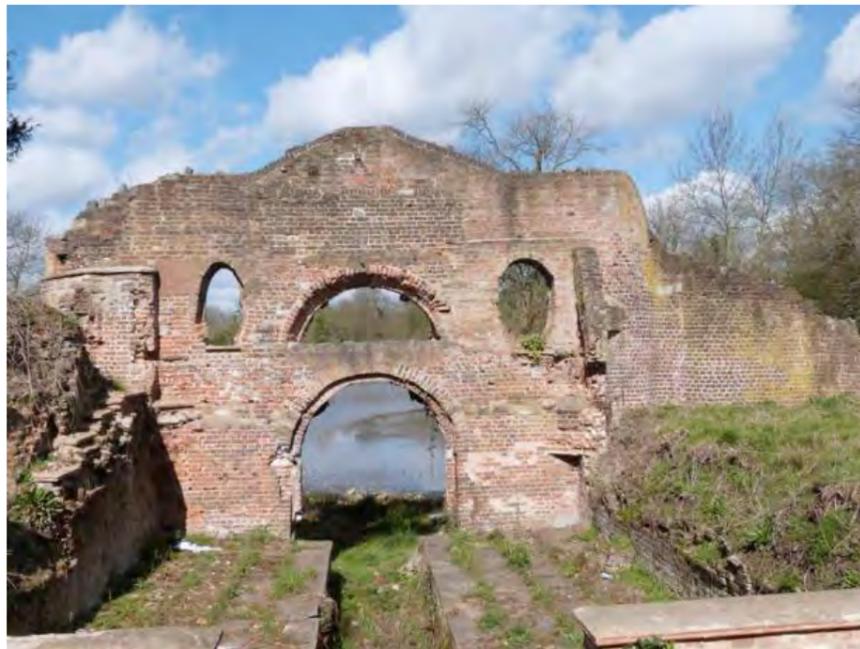
This is the elevation to the boat dock and was the subject of extensive repair and consolidation works in 2011. These were well carried out, remain intact and have been very successful. The whole of the elevation remains in good condition. There is some ivy and plant growth (Buddleia) on the window on the east side of the central arch; the area of brickwork at the bottom of the opening shows slight disruption (Fig 15) but there are no other issues of decay. The mortar capping seems sound.

Fig 14: overall view of Zone E

- E1 Remove ivy and Budleia from eastern opening
- E2 Flush out and fill any cracks in cill area
- E3 Allow to lay tile creasing on cill of eastern opening

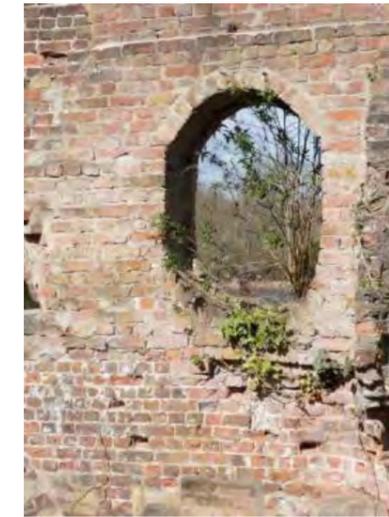
Fig 15: detail of window opening with ivy and Budleia

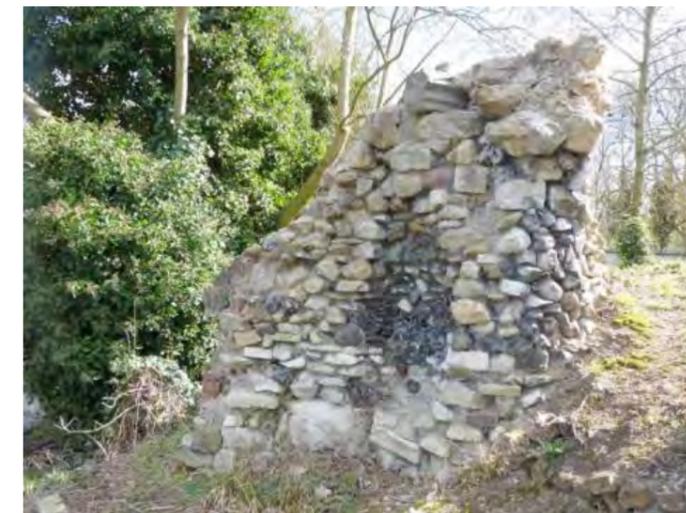
This stand-alone section of masonry has a flint arch and is otherwise constructed from random stones. It has been capped with mortar and the section on the east side has been rebuilt. The current condition is sound except for one loose stone at the foot of the extreme east side of the structure. The tile creasing is sound but there is slight deterioration of the mortar capping on the top; there is also some cracking which provides a potential location for vegetation to become established.

Fig 16: Zone F, north elevation

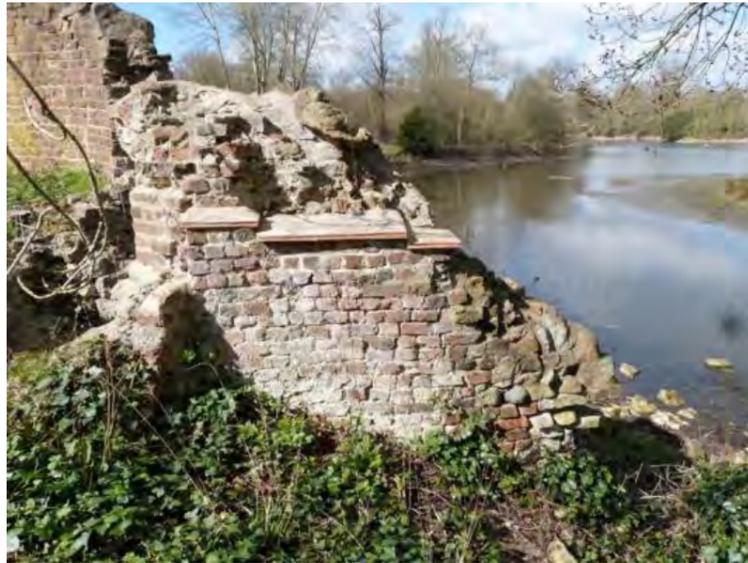
Fig 17: Zone F, south elevation

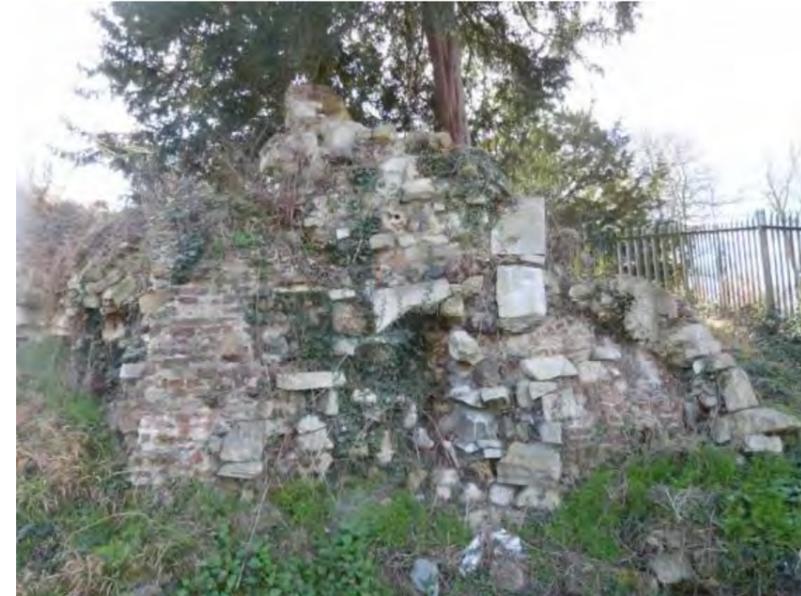
This area to the west of the main elevation is a confusing collection of masonry. Urgent works were proposed in 2011 but these were not carried out and, as a result, this section has continued to deteriorate. There is still live ivy growth and there is also a large live tree stump at the top of the slope on the west side.

Fig 18: Zone G – north elevation (west section)

- G1 Clear off vegetation taking care not to disrupt masonry
- G2 Cut back and remove as far as possible the root systems of 5 No trees; using appropriate brush killer or copper nails into each stem, kill off any roots that cannot be removed
- G3 Cut back and treat other shrubs from upper horizontal surface
- G4 Consolidate front edge of masonry especially around arch (allow to re-set 20 No bricks)
- G5 Apply soft capping to upper horizontal surface including whole area of raised ground flanked by zones G, C and L (see <http://www.geog.ox.ac.uk/research/landscape/rubble/swc/swc-report.pdf> (pages 51 - 56) for methodology)
- G6 Flush out, deep pack and fill any fissures that become apparent once vegetation has been cleared

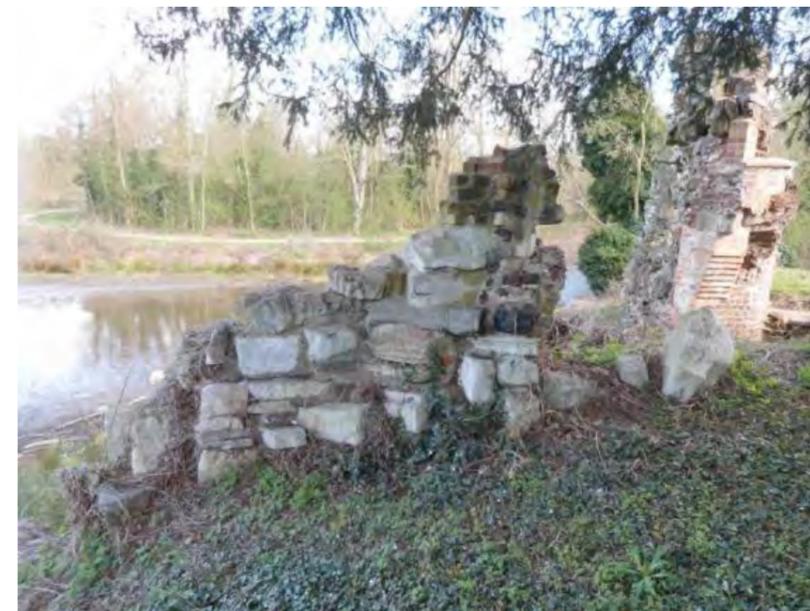
Fig 19: Zone G – south elevation from top of mound

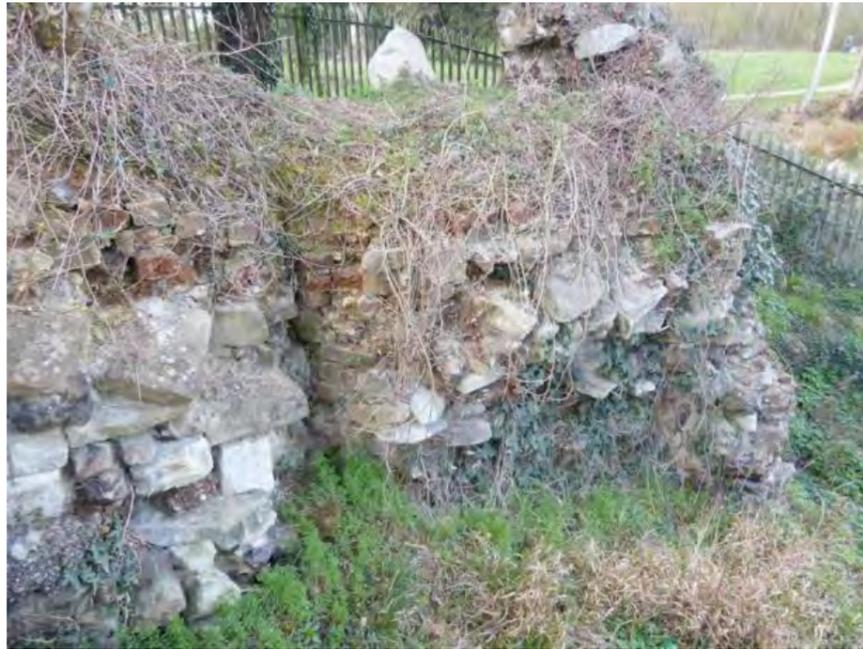
Fig 20: Zone G – east facing section with fissure

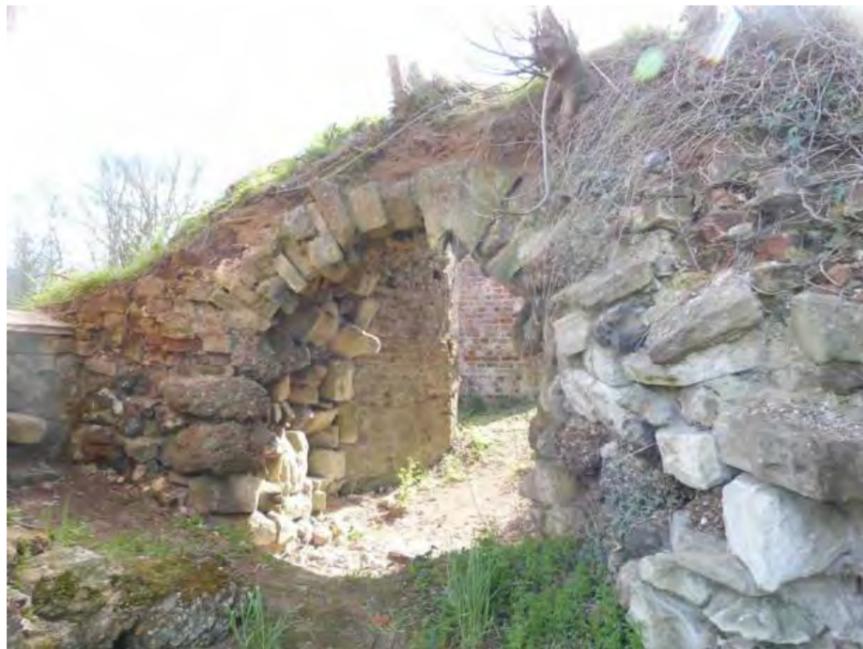
The eastern section (including the area over the arch to the tunnel, Fig 21) has a number of large live well-established trees and one of these has caused a substantial vertical crack. There is some powdering of mortar at low level just to the east of the crack. At high level, there is quite a lot of loose material but there is also erosion of the clay soil on the top of the masonry; this is evident particularly at the top of the arch. This has led to water ingress into the masonry and, as a consequence, there are a number of loose bricks.

Fig 21: Zone G – north elevation (east section)

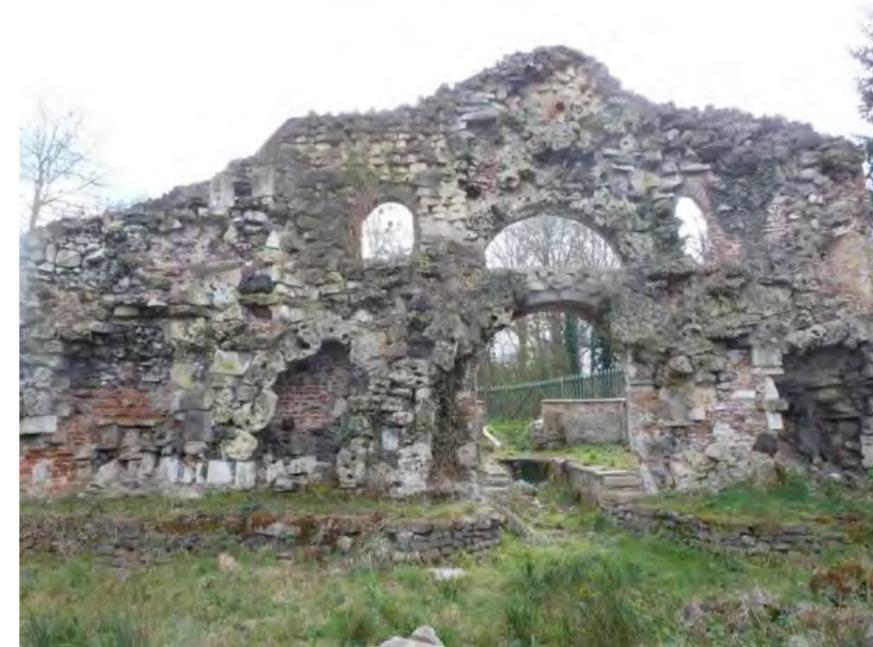
There is a higher plant (Budleia – see Zone E)) established in the cill of the eastern window; this will cause further damage unless removed. A bramble has become established to the east of the springing of the central arch and there is some vegetation on the top of the wall adjacent to the capping.

Fig 22: overall view of Zone H

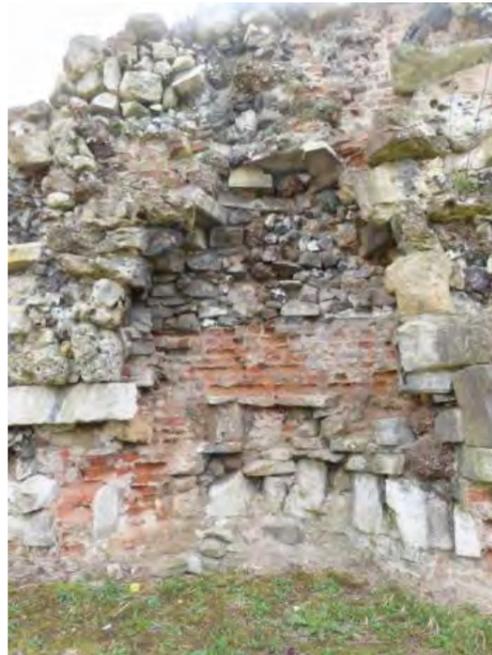
There is powdering of brick and mortar within the eastern niche and some small sections of loose material at low level (Fig 23); these do not constitute a hazard. The eastern return also has some areas of loose brick and stone.

Fig 23: Zone H - detail of niche at east end

- H1 Remove higher plant from eastern window cill (see E1)
- H2 Flush out and fill any cracks in cill area (see E2)
- H3 Provide tile creasing for eastern window cill (see E3)
- H4 Cut back and remove or treat other higher plants (brambles, etc)
- H5 Remove and re-set loose stones and bricks from eastern return (10 No)
- H6 Apply mortar capping to eastern return area to ensure water run-off

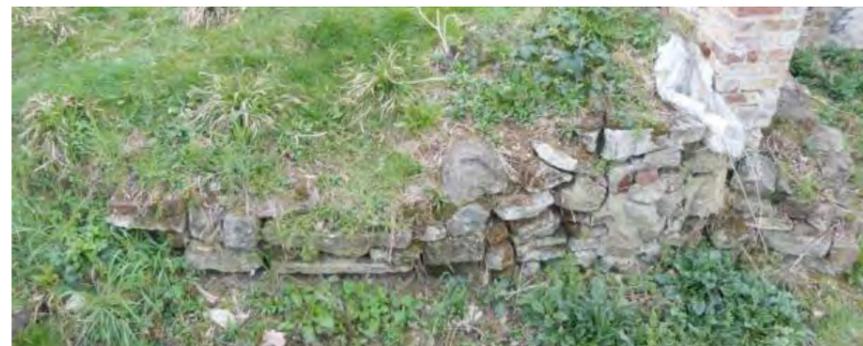
The entrance steps consist of timber treads between low-level stone walls that were probably constructed with mortar but most of it has been washed away; the walls retain the earth bank behind. On the east side, there are some loose blocks, some of them quite large. One stone at the south end has fallen out completely. On the west side there is significant bulging of the wall and some quite large loose sections of masonry. At the north end, attempts have been made to provide stability by the crude application of cementitious mortar (Fig 25). There are other loose stones adjacent to the brick wall (zone K).

Fig 24: Zone J – east side

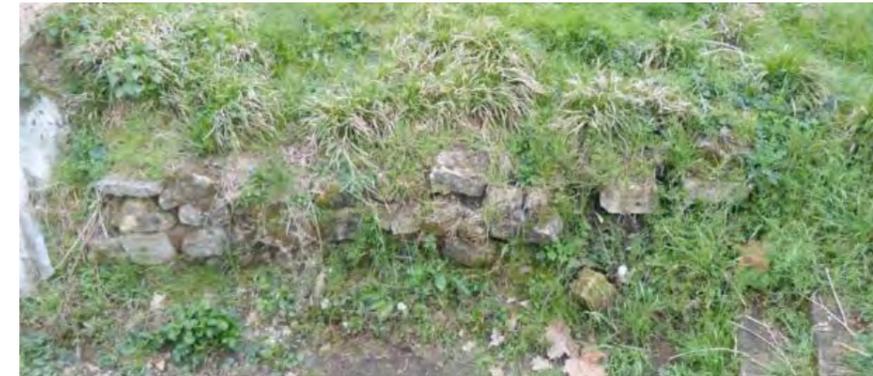
Fig 25: Zone J – west side

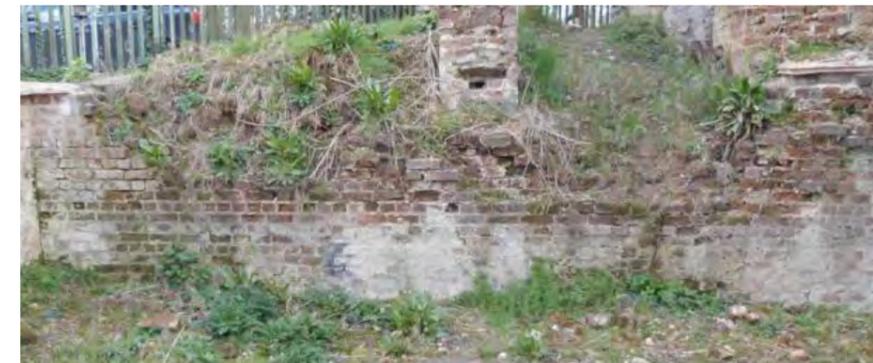
This brick wall stands about 1 metre high and consists of an inner and outer skin. It has been extensively colonized by vegetation and has many loose bricks from both skins. Bricks continue to become dislodged. There is one vertical crack towards the centre at the junction with zone L.

Fig 26: Zone K

- K1 Carefully cut back and remove all vegetation
- K2 Remove and set aside all loose bricks (approx. 100 No)
- K3 Reconstruct removed bricks to form wall to follow profile of existing (allow 3 sq.m. reconstruction in all)
- K4 Allow to introduce tile creasing to exposed ledges to ensure effective run-off (total area 2 sq.m)
- K5 Lay soft capping over top horizontal face (see <http://www.geog.ox.ac.uk/research/landscape/rubble/swc/swc-report.pdf> (pages 51 - 56) for methodology)

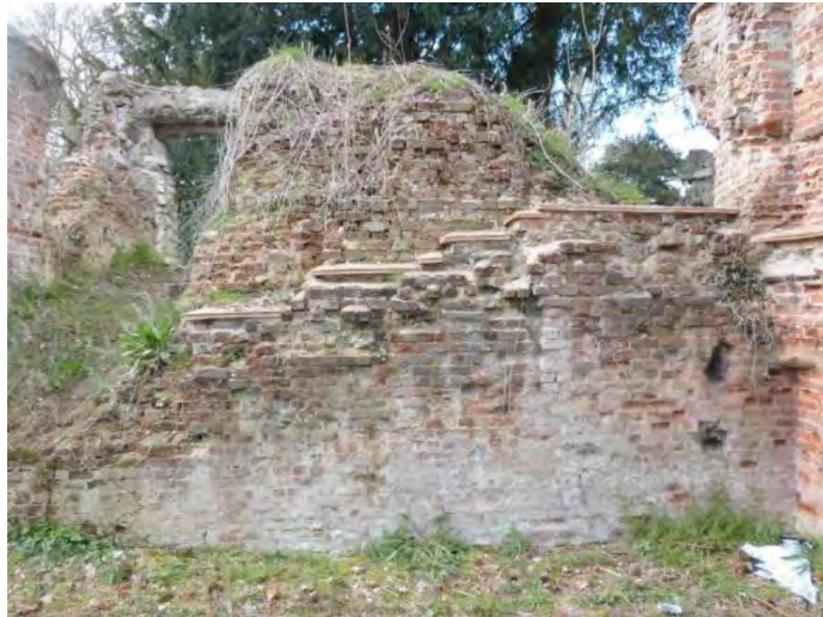
Fig 27: Zone L with tile creasing

- L1 Remove remaining ivy and other roots taking care not to dislodge underlying bricks
- L2 Lift off, clean off and re-set loose bricks (100 No)
- L3 Introduce new creased tiles capping on south end (2 No locations)
- L4 Flush out, deep pack and fill fissures
- L5 Remove cracked flaunching at lower level and replace
- L6 Apply soft capping to upper horizontal surface including whole area of raised ground flanked by zones G, C and L (see <http://www.geog.ox.ac.uk/research/landscape/rubble/swc/swc-report.pdf> (pages 51 - 56) for methodology)
