The Grotto, Wanstead Park Conservation Management Plan Prepared for City of London Corporation September 2019

***CONDITION SURVEY AND CONSERVATION APPRAISAL FOR
THE LOW LEVEL STANDING REMAINS***

THE GROTTO, WANSTEAD PARK

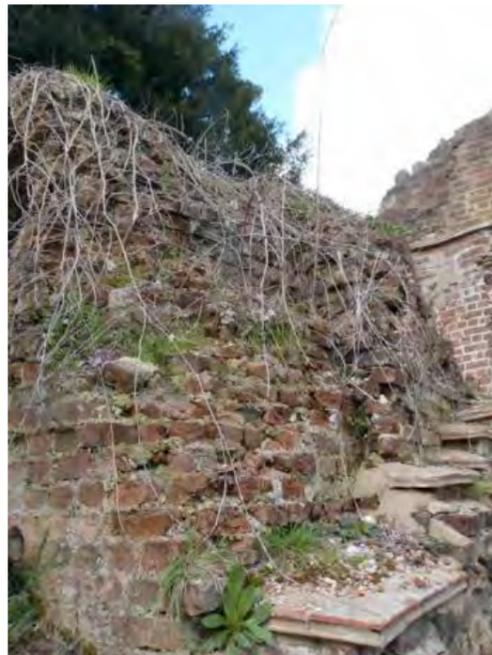
Fig 28: detail of brickwork showing separation of front face due to root growth

- L1 Remove remaining ivy and other roots taking care not to dislodge underlying bricks
- L2 Lift off, clean off and re-set loose bricks (100 No)
- L3 Introduce new creased tiles capping on south end (2 No locations)
- L4 Flush out, deep pack and fill fissures
- L5 Remove cracked flaunching at lower level and replace
- L6 Apply soft capping to upper horizontal surface including whole area of raised ground flanked by zones G, C and L (see <http://www.geog.ox.ac.uk/research/landscape/rubble/swc/swc-report.pdf> (pages 51 - 56) for methodology)

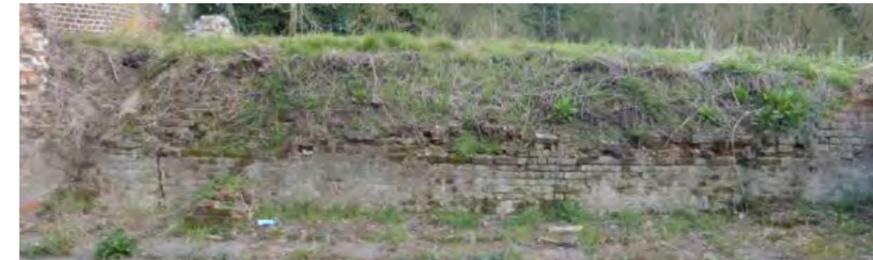
This brick wall stands throughout its length at a fairly consistent level of approximately 1 metre. The top few course are disrupted over the entire length with bricks either loose or missing. As a result the bank behind the wall is giving way in places. There is some animal burrowing activity at the north end along with some vertical cracking.

Fig 29: Zone M

- M1 Take down, clean off and set aside bricks along the whole length to four courses beneath the top
- M2 Re-set bricks incorporating (as required) additional bricks from pile of salvaged material retained on site; finished wall can have variable height
- M3 Flush out and fill fissures at north end
- M4 Apply tile creasing to top horizontal surface; this should be set slightly proud of brick wall beneath
- M5 Lay soft capping over top horizontal face
- M6 Remove or treat all higher plants from bank behind brick wall

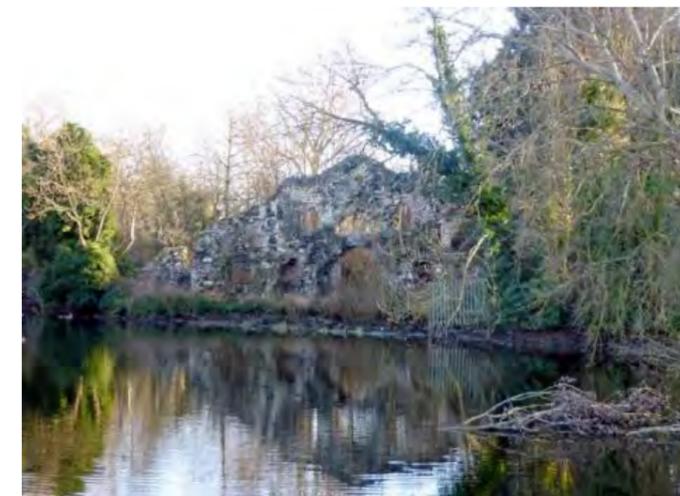
Vegetation: The comparatively wild parkland environment inevitably allows vegetation to become established. There have been a number of recent programmes of clearance (see Figs 30 and 31) and currently there is a maintenance regime in place to try and keep on top of the problem.

Fig 30: Zone H in 2015

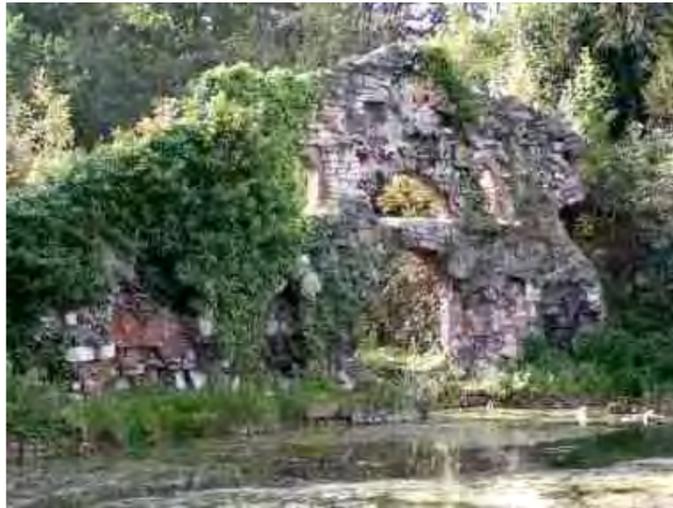
Fig 31: Zone H in 2005

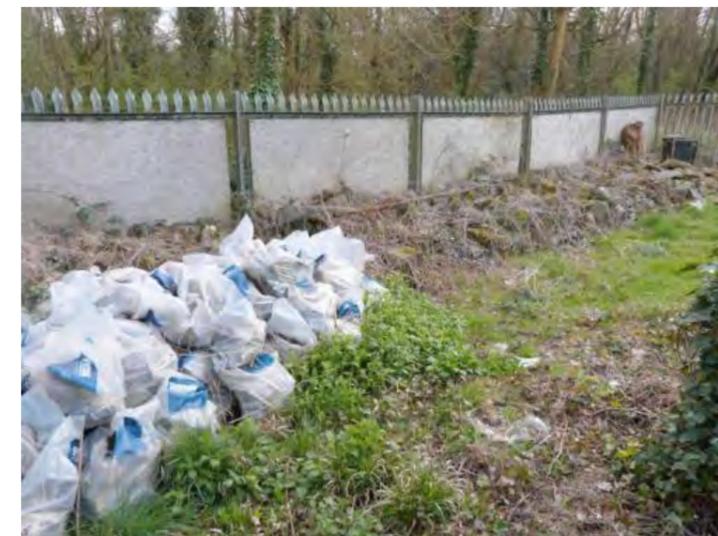
One of the biggest problems over the years is that as any element of masonry/brickwork becomes dislodged, it loses its context and is just added to the pile of salvaged material that is stored on one side of the site. This is clearly not a sustainable way forward as there will just be a continuing depletion of the fabric. It is therefore imperative that steps are taken to reintegrate any loose or fallen areas as soon as they occur.

Fig 32: accumulated fallen masonry materials (stone and brick) stored on the site

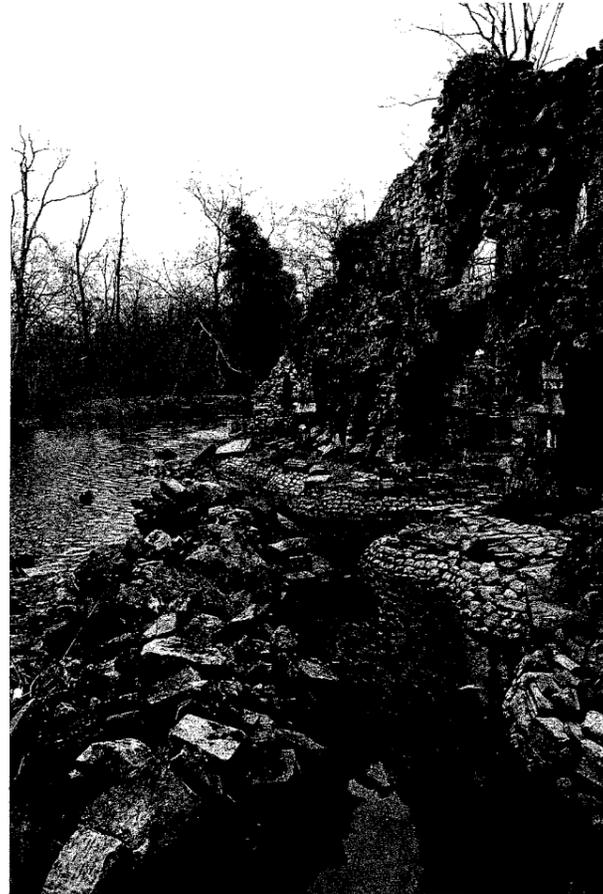
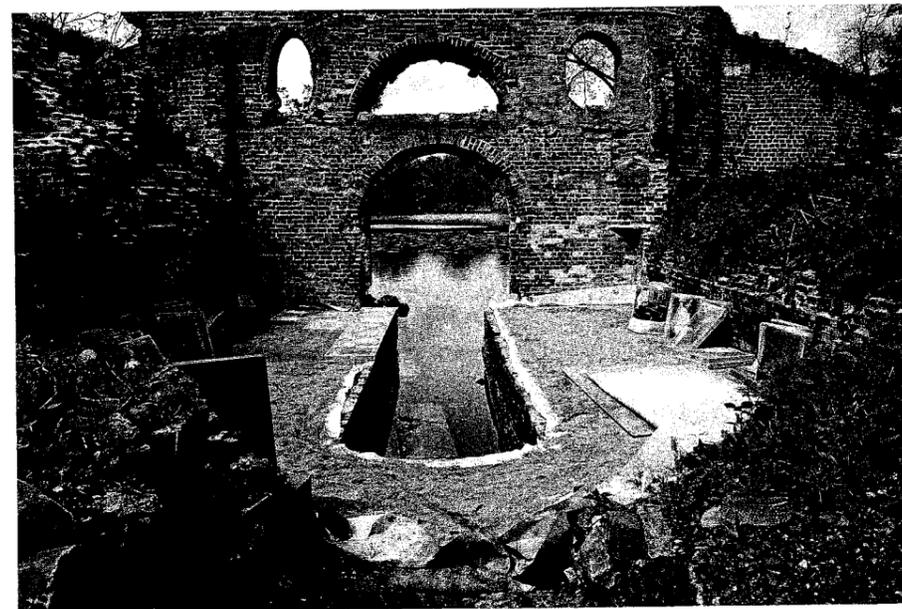
32. (a) The causeway by the lake at the Boathouse-Grotto in 1998.
(b) The boat dock at the grotto, as revealed and consolidated in 1998.
