Forest Operations

Path Condition Assessment: Feb-Mar 2021

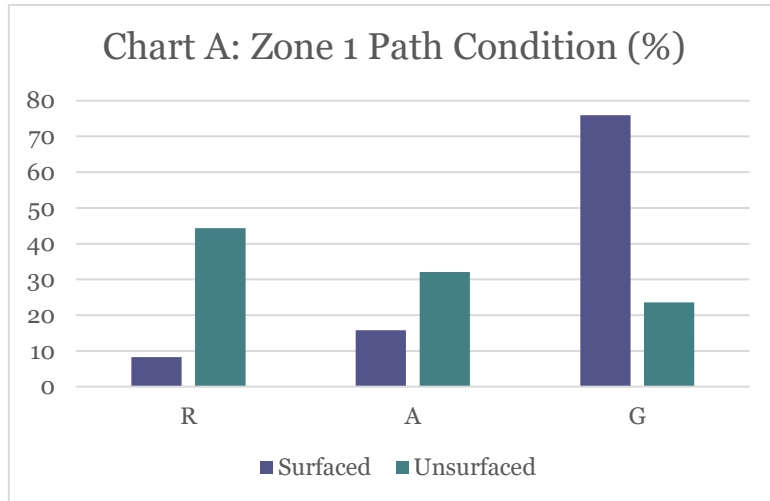
Zone 1: Pathway (Chart A)

Charts A, B and C give RAG assessment for the three path zones. The length of path in each RAG category was converted to a percentage of the overall path distance assessed. Surfaced and unsurfaced path were summarised separately.

8.2% of Zone 1 on surfaced paths was in the Red, or very poor category while for unsurfaced paths 44.4% of the paths were very poor. Overall, 24% of surfaced and 76% unsurfaced paths were either in the R or A categories in Zone 1.

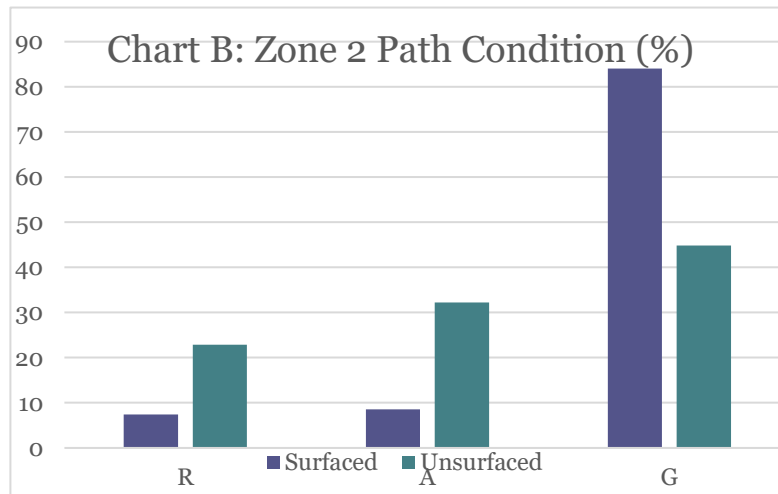
Zone 2: Verge (Chart B)

7.4% of the Zone 2 on surfaced paths was in the Red category while for unsurfaced paths 22.9% of the verge were very poor. Overall, 16% of surfaced path verges and 55% of the unsurfaced path verges were in the R and A categories in Zone 2.

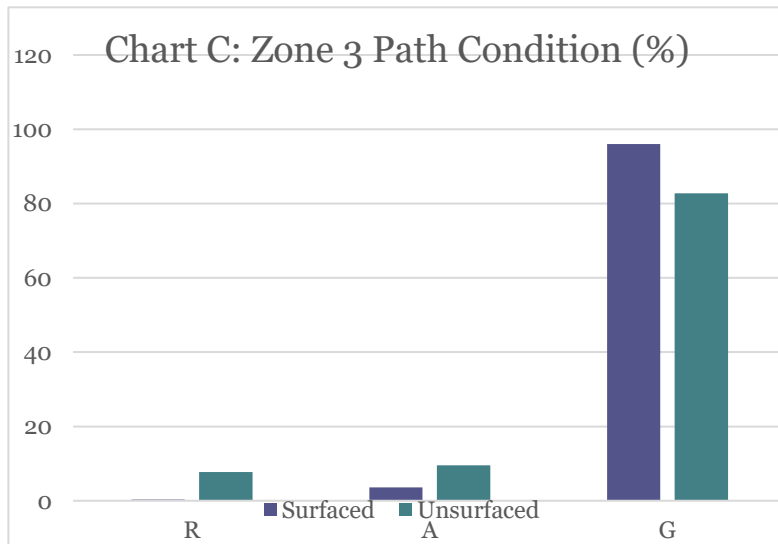
Zone 3: Wide verge area (Chart C)

There were effectively no surfaced paths with the wider verge zone in the R category however 9% of unsurfaced paths had their zone 3 in the R category. Overall, 4% of surfaced and 17% unsurfaced paths were either in the R or A categories in Zone 3.

It is clear that surfaced paths lead to a significant reduction in environmental damage to both the verge (Zone 2) and the wider verge area (Zone 3).

The unsurfaced path Zone 3 result is concerning as it shows that 17% (23.5 km) of these paths are experiencing a very wide area of environmental damage. The width of Zone 3 is widely variable however as a working figure of 5m width this represents an area of 23.6 ha of wider verge severely impacted.
