Appendix 3: Before and After photo's.

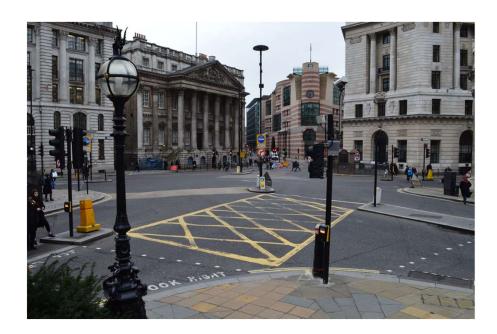
Before

Looking west towards Mansion House and No 1 Poultry

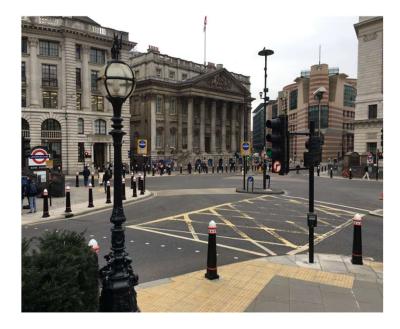
After: Pavement extended on the southside of Cornhill which narrows the carriageway at the enforcement point – making the signage more visible.

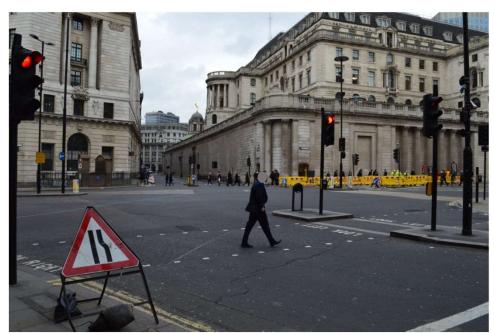
Before

Looking towards Princes Street from the west side of Lombard street

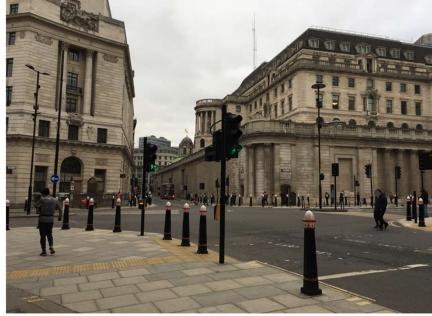
After: Pavement widened on the west side of Lombard street, centre island removed. Pedestrian crossing distance reduced.

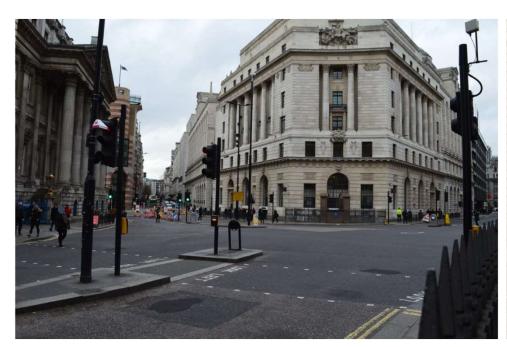
Before

East Side of Lombard Street looking west towards Poultry

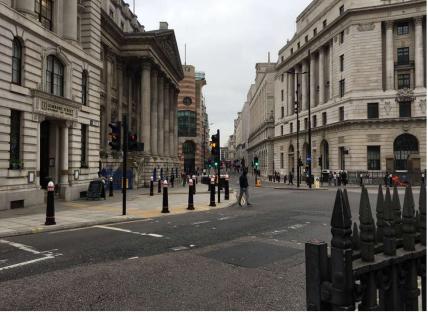
After: Significant pavement widening outside 1 Lombard and Mansion House. Narrowing the carriageway, making it clearer to vehicles where they should be on the carriageway.

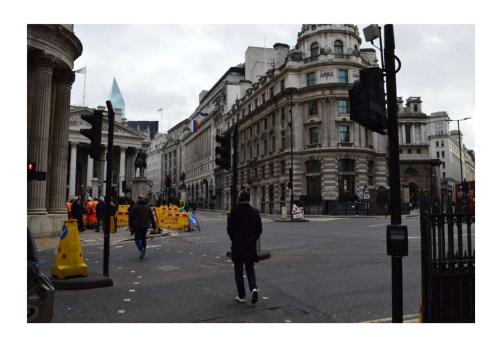
Before

Princes Street pedestrian crossing towards the Bank of England

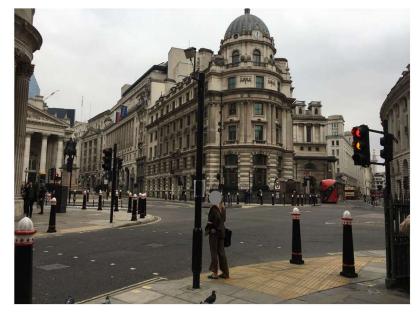
After: Pavement widened on both sides of the road moving the crossing waiting area away from the top of the Underground entrance. Pedestrian crossing straightened and centre islands removed (as crossing distance reduced).

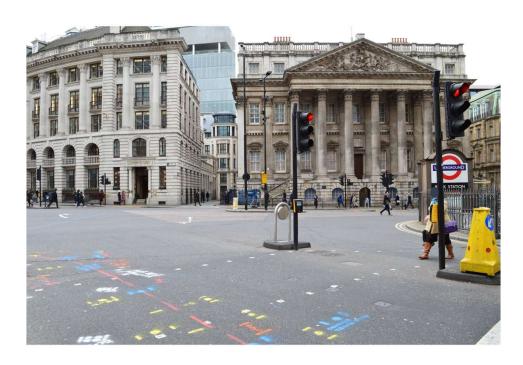
Before

Princes Street crossing looking towards the NatWest and Mansion House.

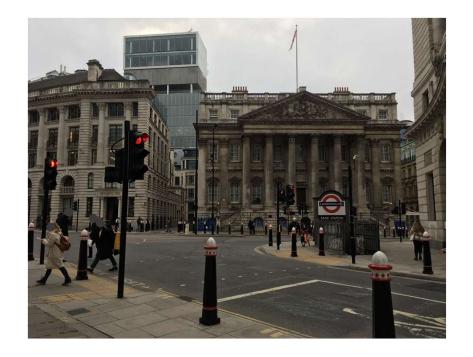
After: Pavement created on the carriageway around the Underground entrance, providing additional space for people to walk to avoid the pinch point between the Underground entrance and the NatWest Bank.

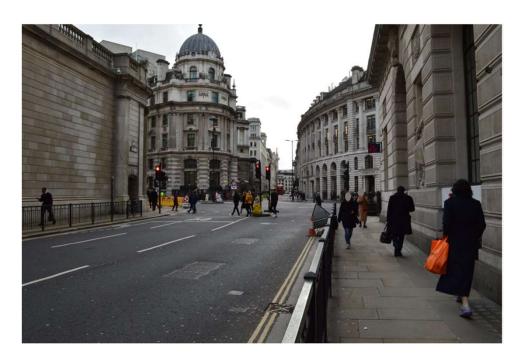
Before

Looking south along Princes Street

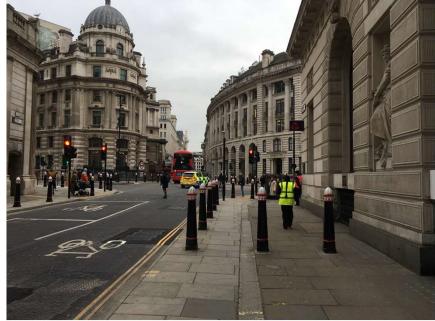
After: Pavement widened on both sides of the street, number of traffic lanes reduced from three to two.

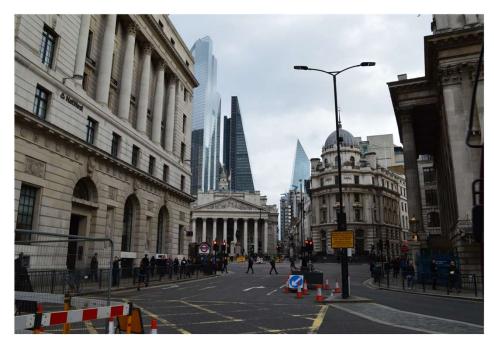
Before

Looking east into Mansion House Street

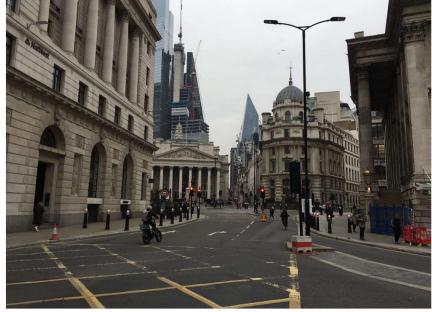
After: Pavement widened on both sides of the street, reducing the eastbound traffic lanes from three to two.

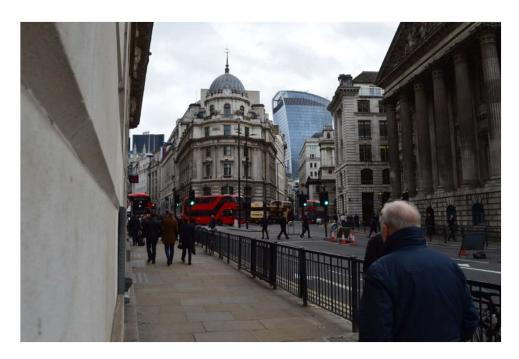
Before

North side of Mansion House Street looking east

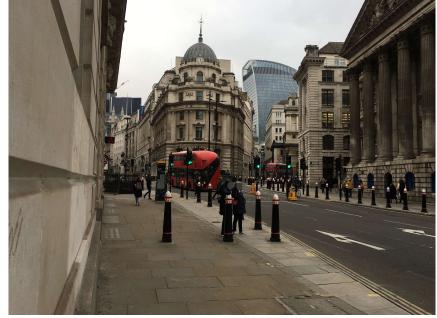
After: Guardrail removed, pavement widened on both sides of the street.
