Museum of London, West Smithfield

Planning & Transportation Committee

22.11.2022

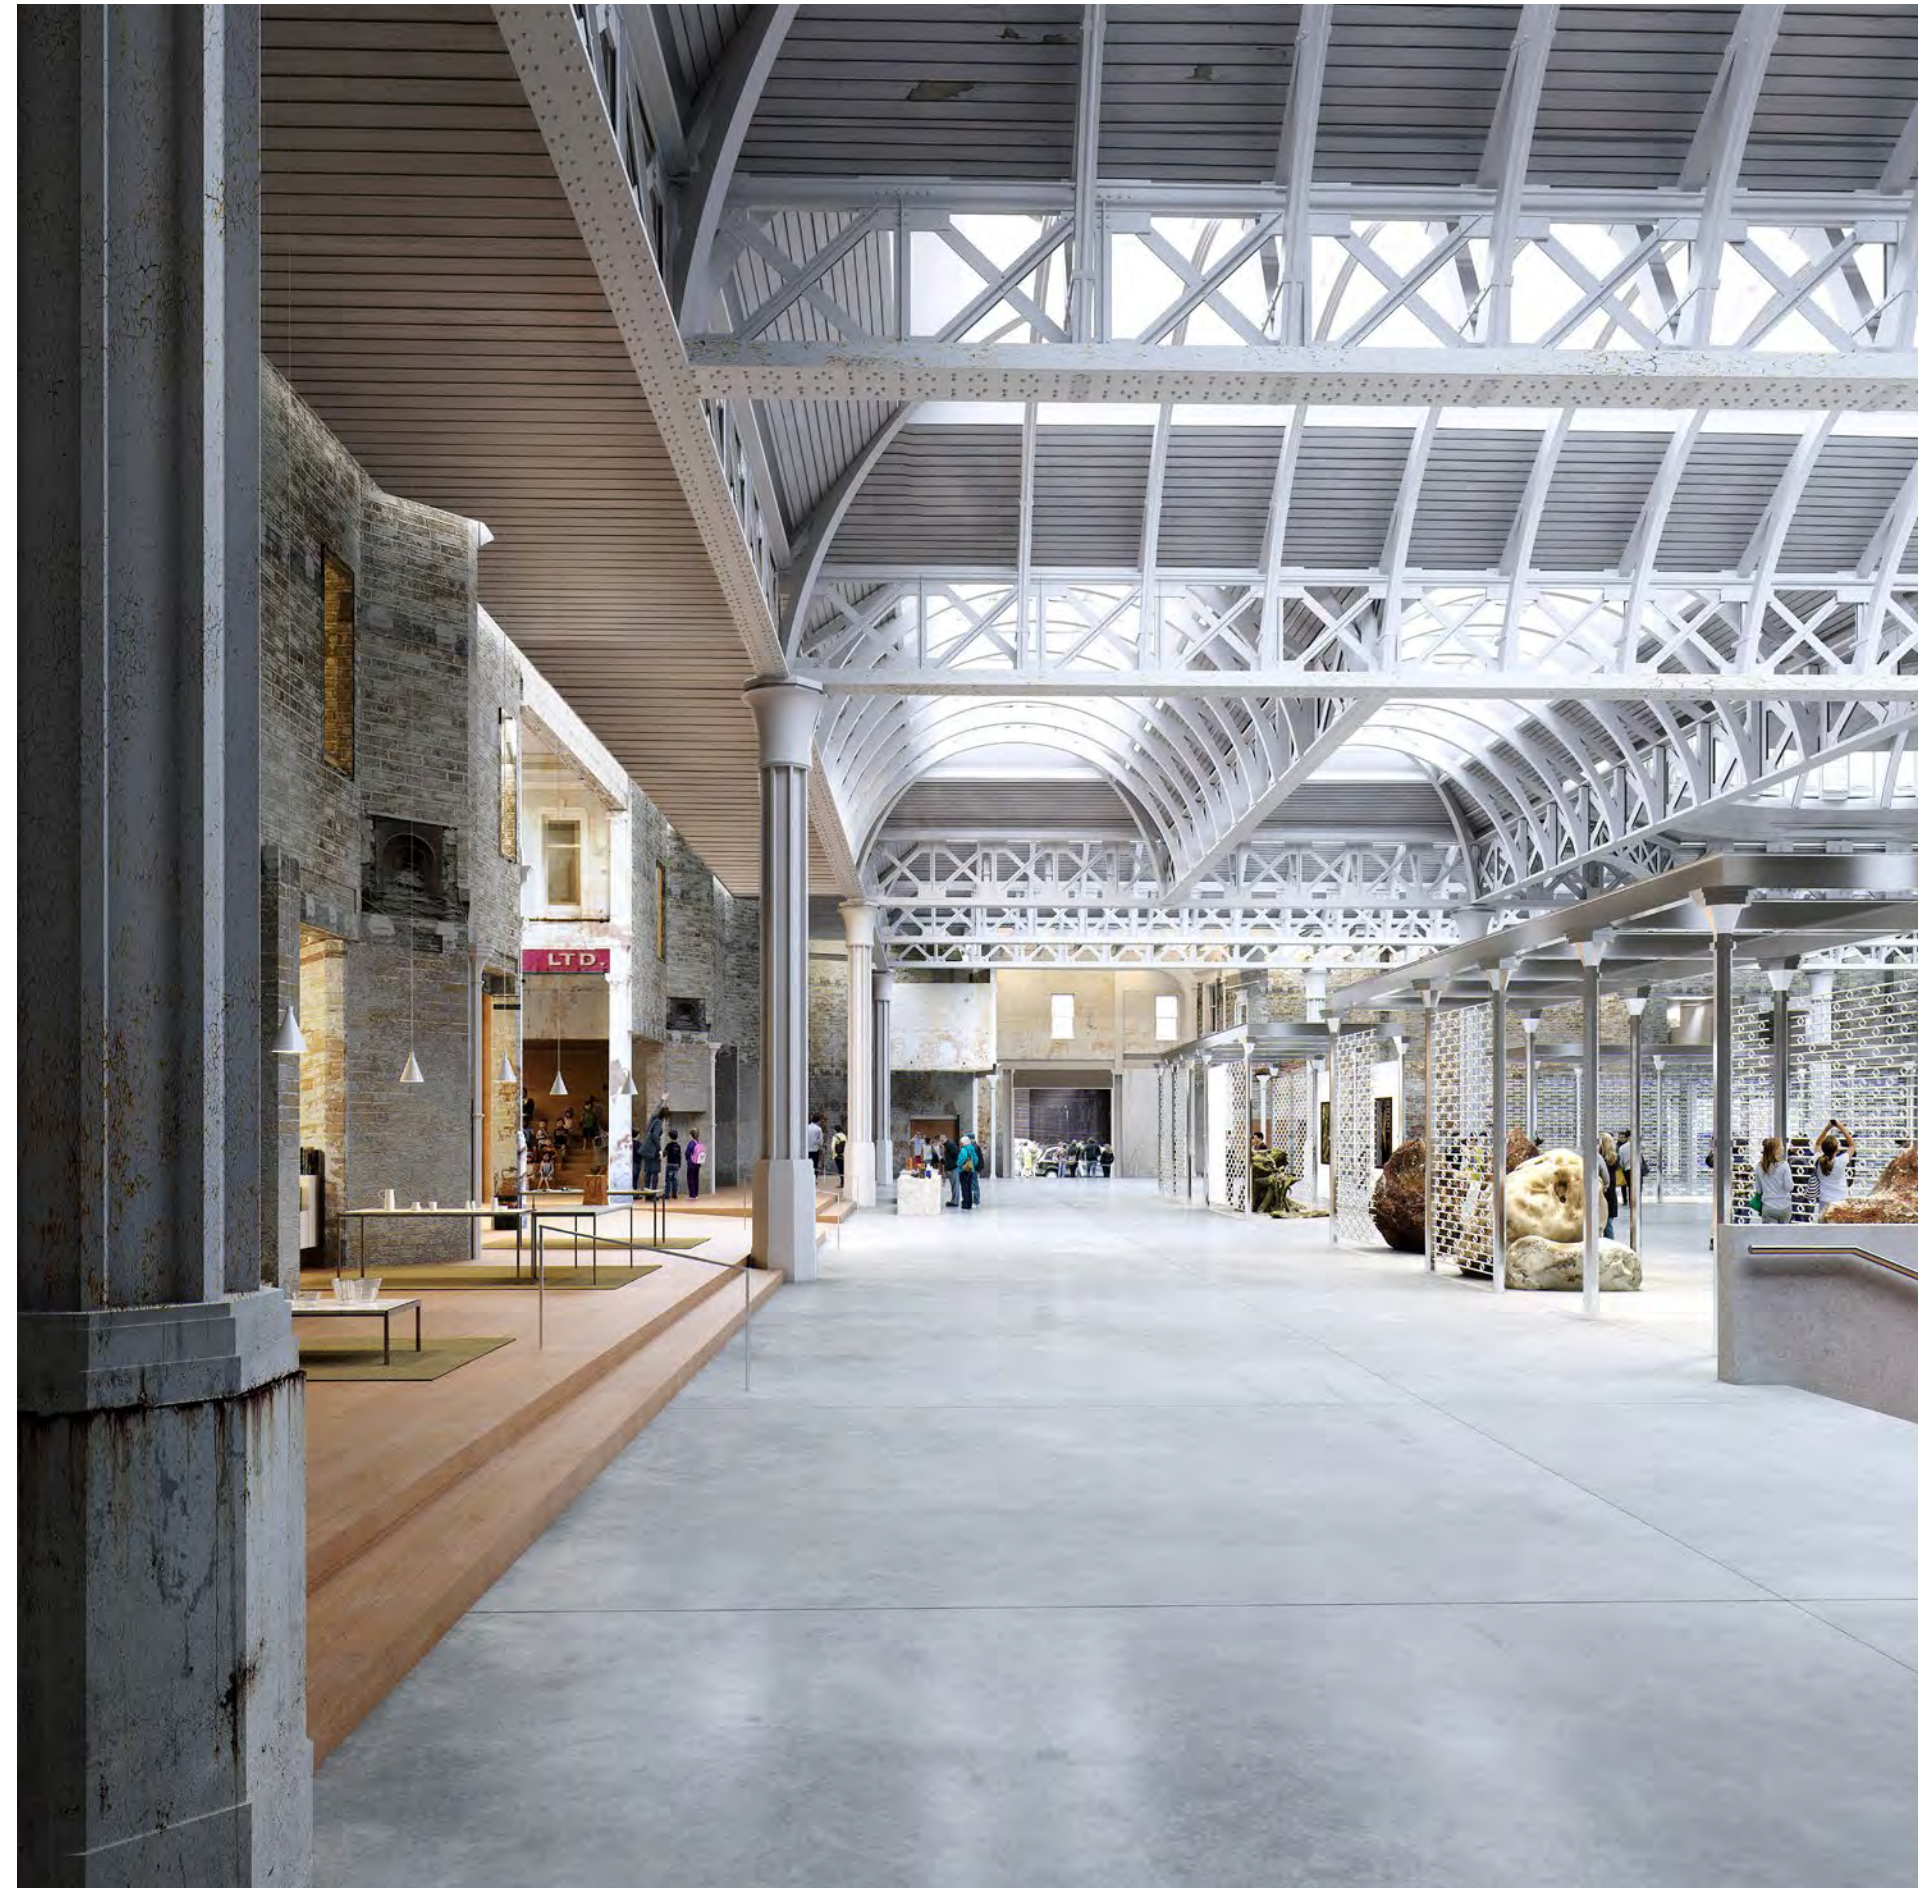
General Market - Proposed Ground Floor

Visualisation of the proposed ground floor of the General Market at the Museum of London West Smithfield. The image shows the proposed ground floor of the General Market at the Museum of London West Smithfield. The space is a large, open hall with a high, vaulted ceiling and a concrete floor. The left side features a brick wall with a small window and a red sign that says "LTD.". The right side has a display area with large, textured objects. People are visible in the background.

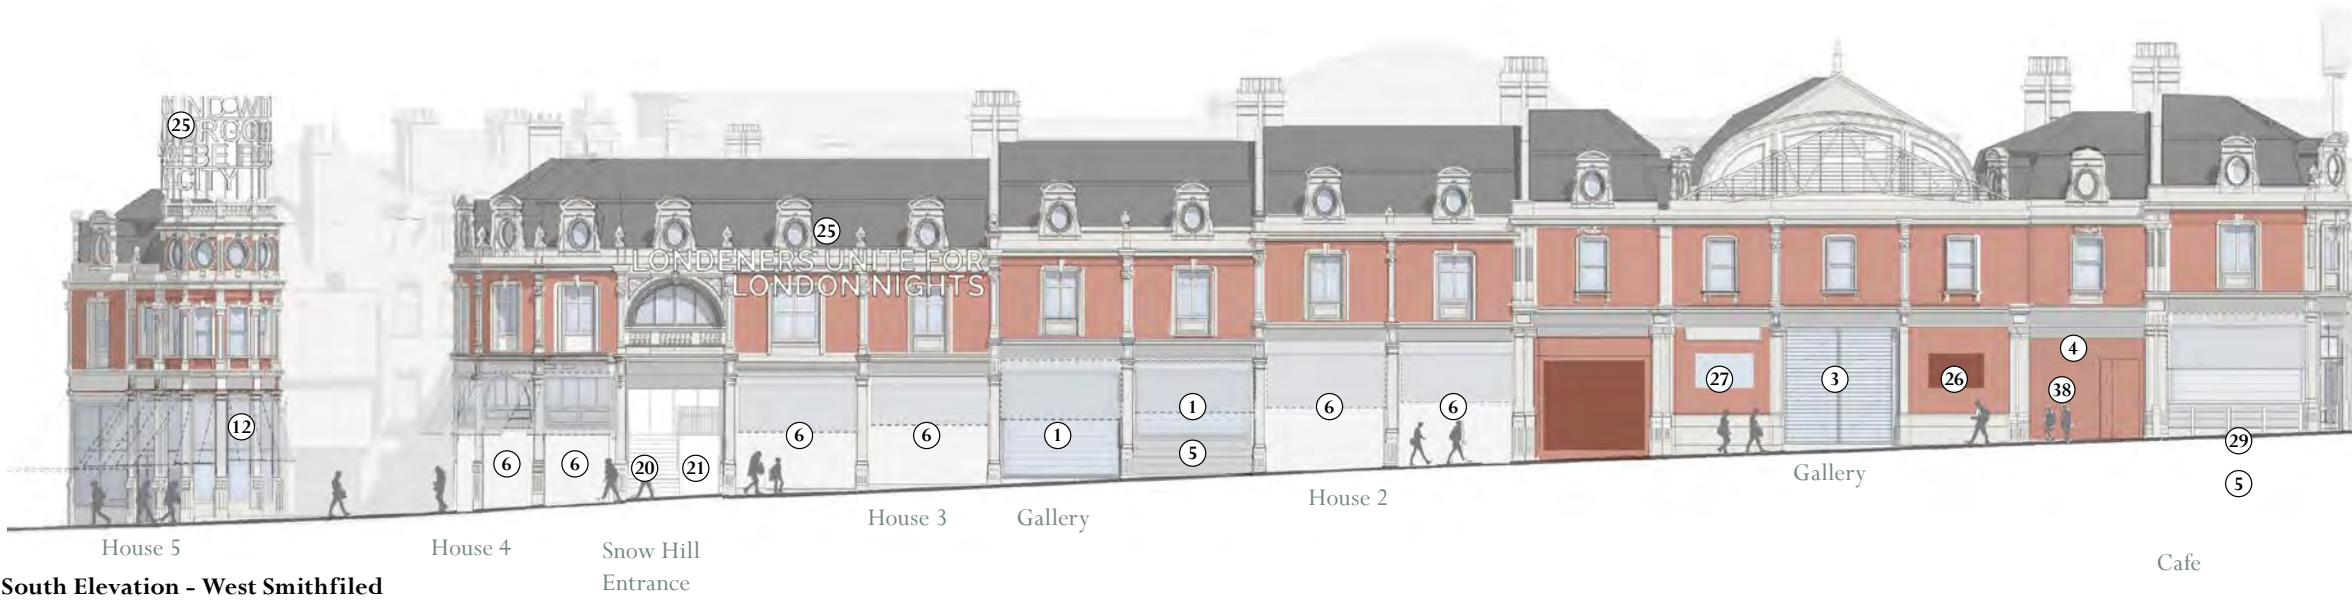
General Market Proposed Elevations

- 1 Proposed 'Museum Gallery Window'
- 3 Proposed 'Museum Doors'
- 4 Proposed infill, brickwork
- 5 Proposed stainless steel panels
- 6 Tenant shopfront
- 12 Restored historic shopfront
- 20 Proposed entrance stairs
- 21 Proposed platform lift
- 25 Proposed 'Art Canvas'
- 26 Proposed stained finish to existing brickwork
- 27 Proposed illuminated poster frame
- 29 Proposed 'Museum Window'
- 38 Existing brickwork rebuilt

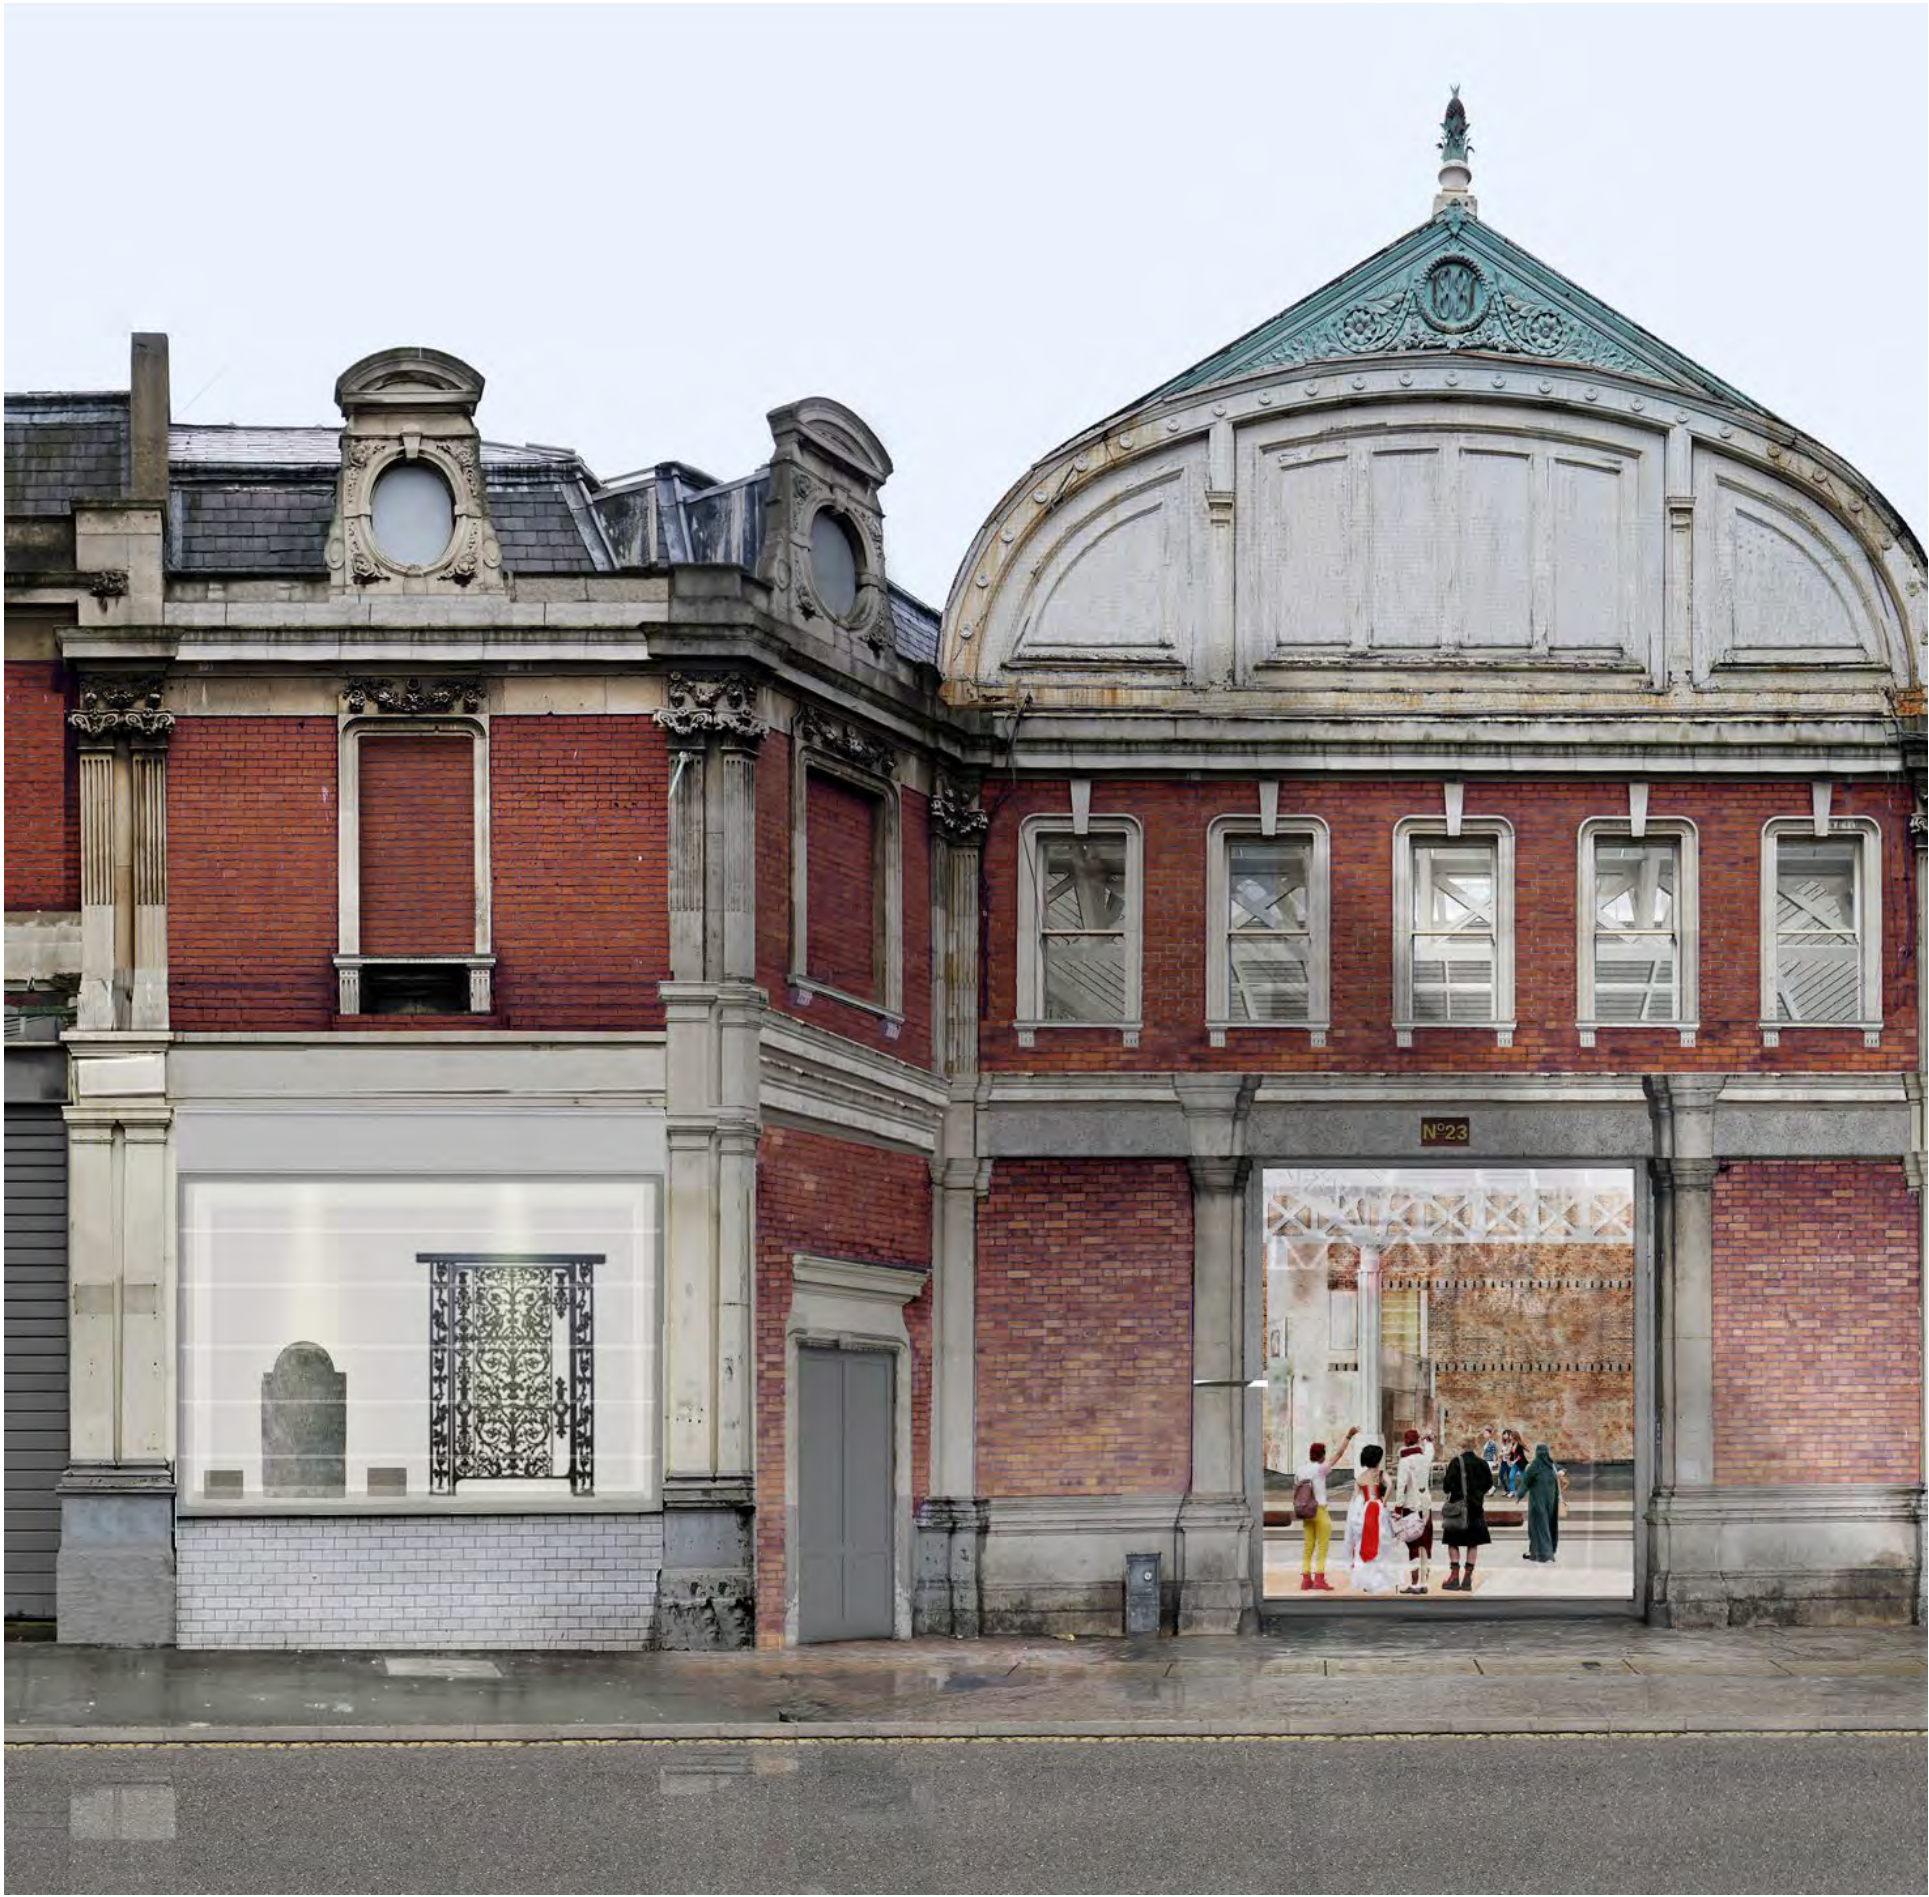
General Market Proposed Elevations - New Museum Vitrine

- Museum Vitrine
- Illuminated Museum Vitrine
- Existing shopfront vitrine

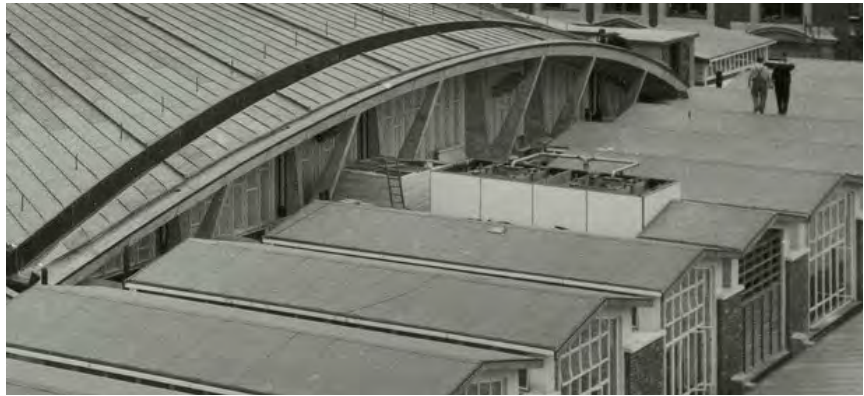
Archive photograph of East Poultry Avenue original roofscape showing precedent plant detail to monitor roof

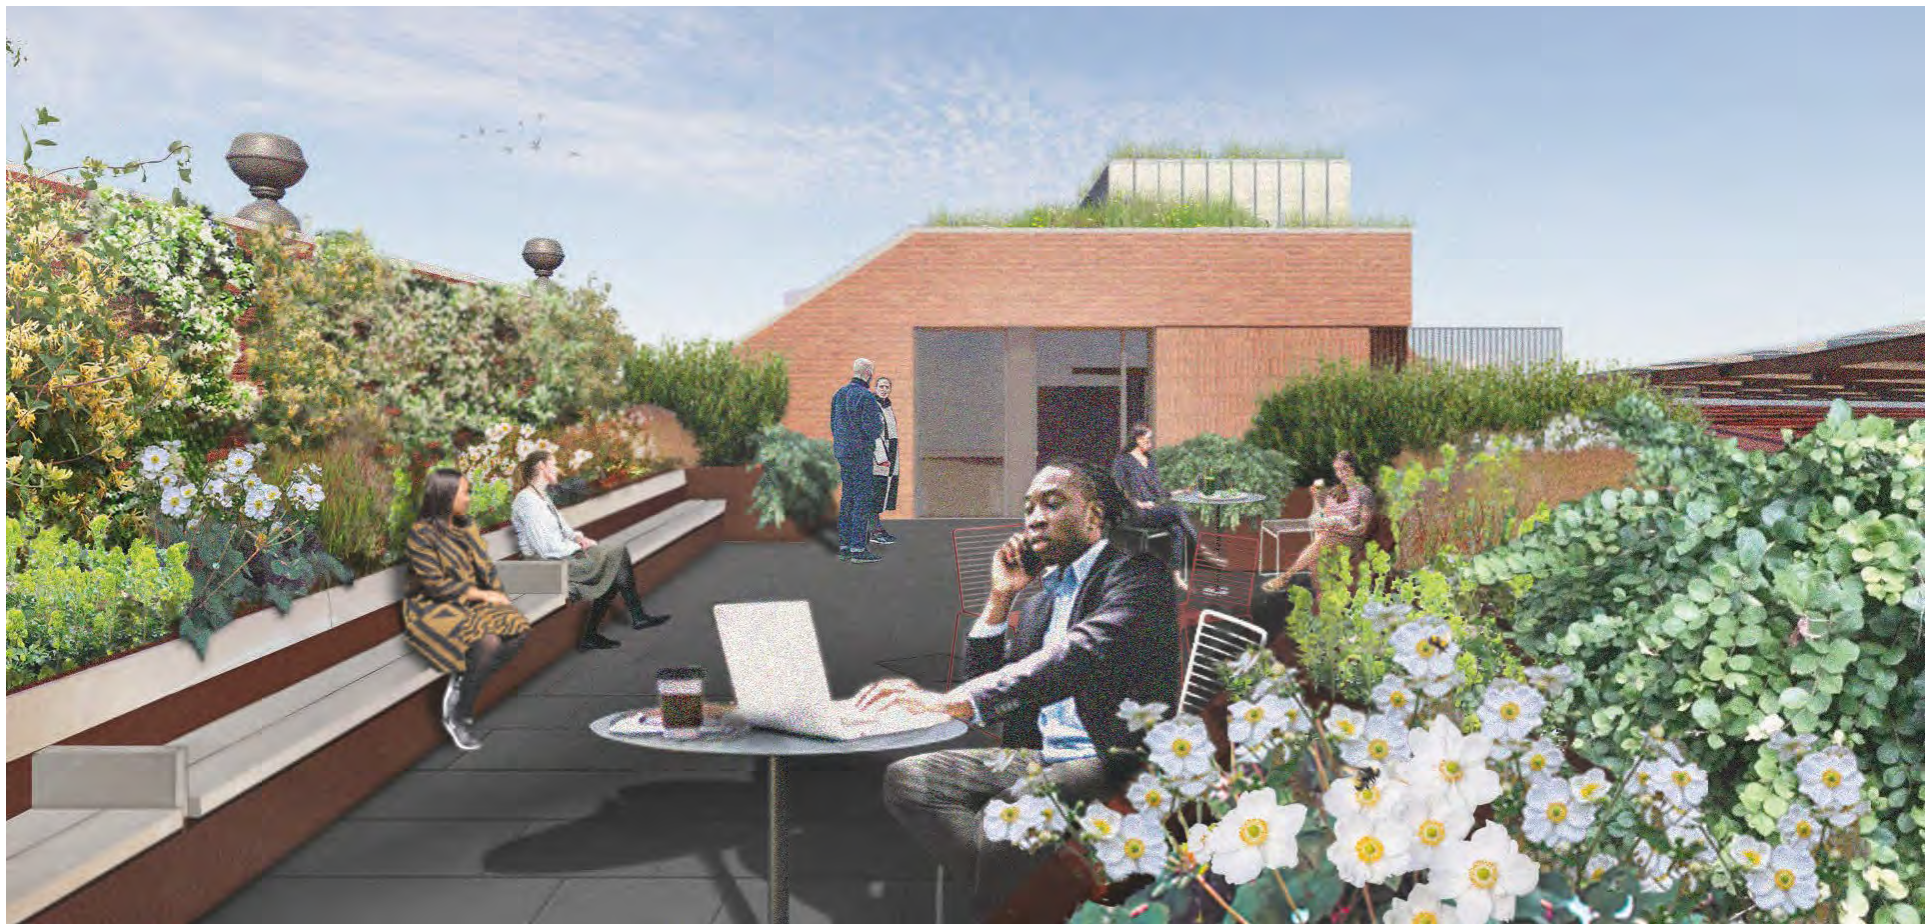
Roof Terrace Arrangement

- 1. Raised metal planter Q50/230
- 2. Bench with integrated lighting and power sockets Q50/220
- 3. Loose furniture FF&E provided by others
- 4. Roof terrace paving on pedestal Q25/195 Ceramic tiles 30 X 60cm 60 x 60cm and 60 x 120cm
- 5. Shingle edge J31/220
- 6. Shrub planting refer to planting plan and schedule
- 7. Climber support 'rope and rod system' H31/164
- 8. IM structural backspan: refer to SWA and AKT II info - Planter to be profiled accordingly
- 9. Red House core refer to SWA info
- Understorey planting refer to planting plan and schedule
- Climber planting refer to planting plan and schedule
