**CORPORATION OF LONDON**

**Feasibility Study and Report on The Heating And Hot Water Services**

**Middlesex Street Estate**

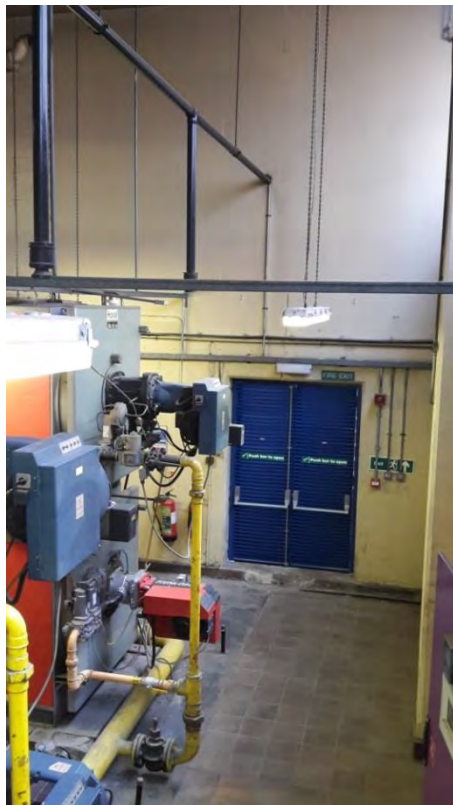
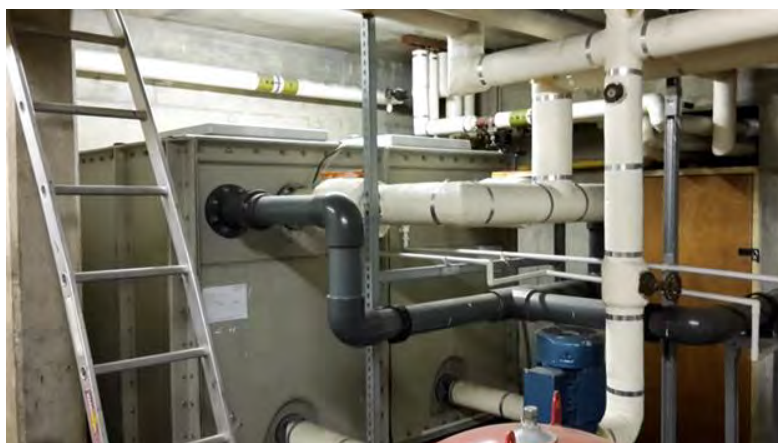
Lighting is inadequate with poor lighting levels and there are units which are non-functioning.

There are signs of leakage within the plant room mainly around valve glands.

Signage's within the plant rooms are poor and mostly outdated.

Condition Rating: Code 3

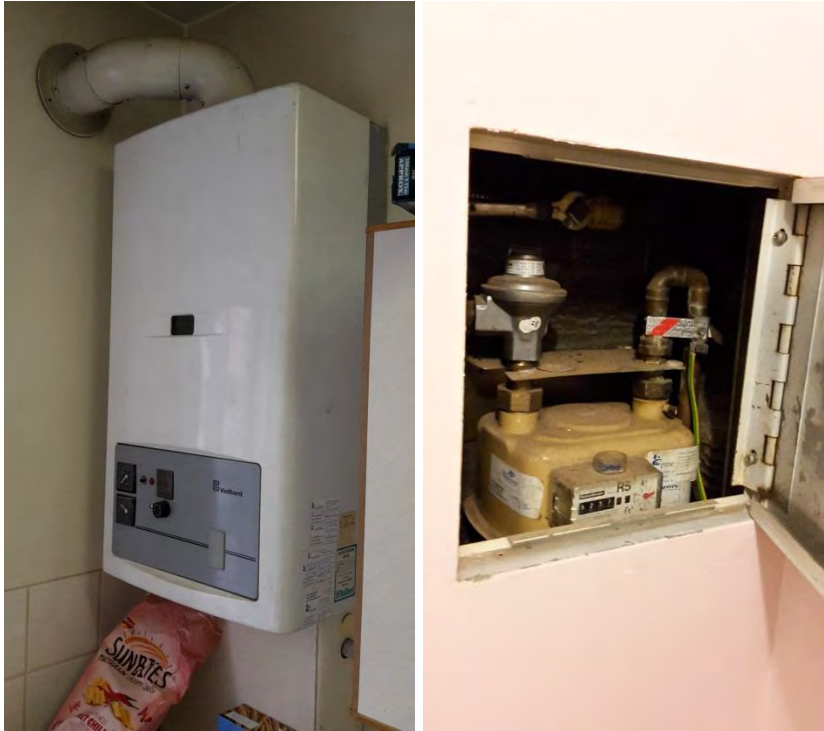
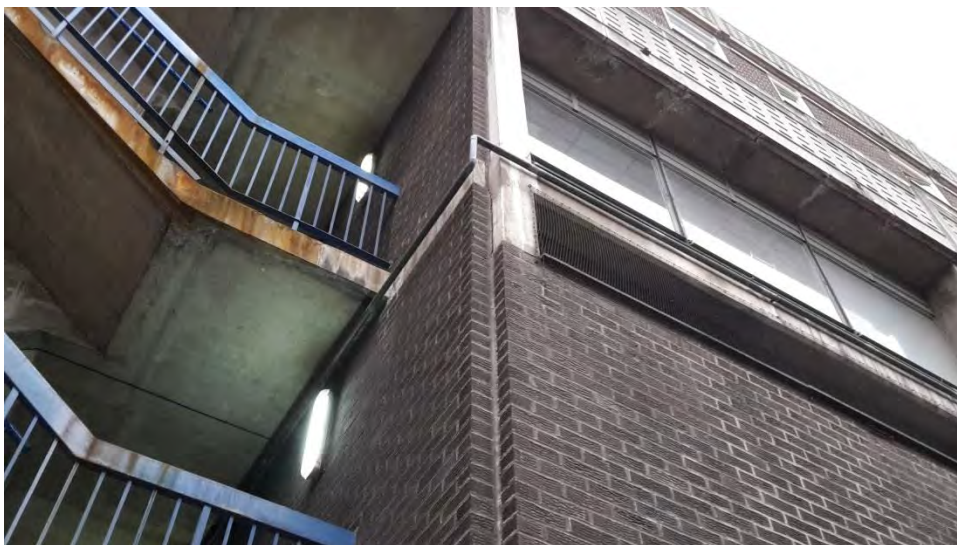
The domestic boilers surveyed were mainly 15 years+ of age and in fair to poor condition.

It is noted that the gas run supplying the domestic boilers externally has been run in copper pipe which has no identification label or colour coded. This requires rectifying ASAP as it does not conform to GSUIR 1998

Condition Rating: Code 3

These should be renewed and the systems brought into line with current regulations.

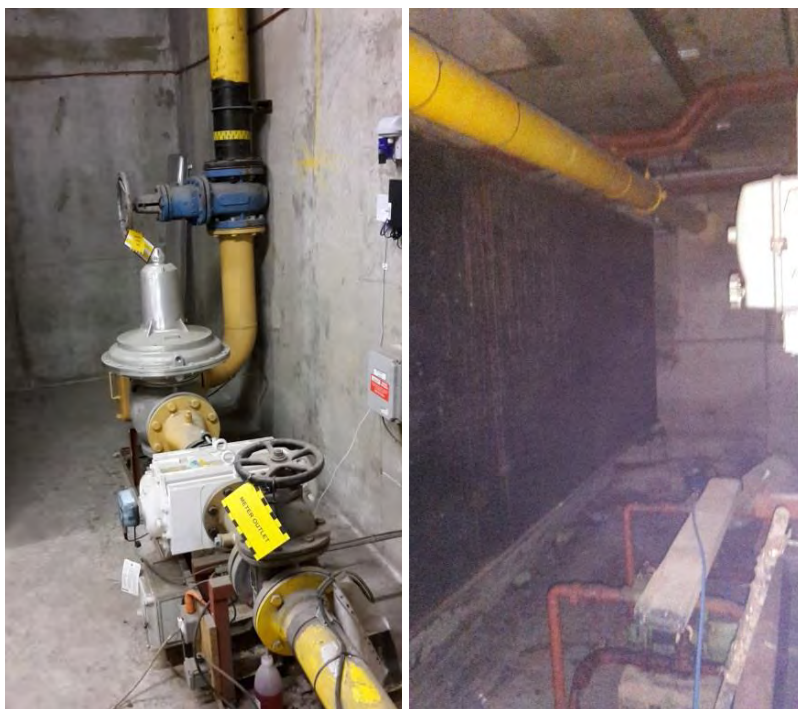
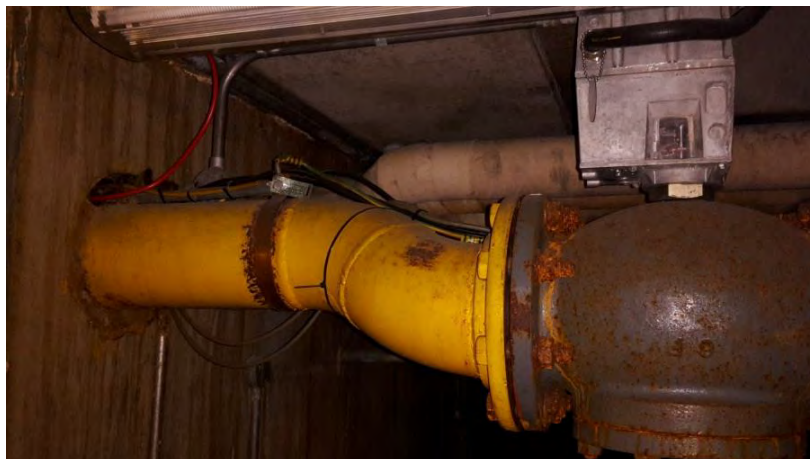
### GAS SUPPLY

The gas meter room is located within the basement area below the nearby dental surgery. The access door is next the Artizan Library entrance.

There is 1 x 150mm electronic gas safety valve in the oil tank room. This is a major cause for concern and will need to be assessed under the DSEAR 2002 regulations to clarify level of risk and remedial actions required.

It is not known whether the redundant oil storage tanks plant and associated pipe work have been degassed and rendered safe in accordance with the HSE guidelines.

Condition Rating: Code 2

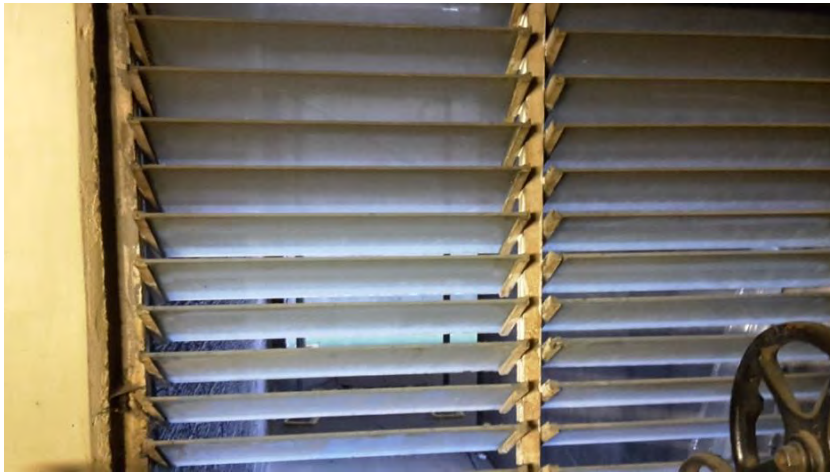
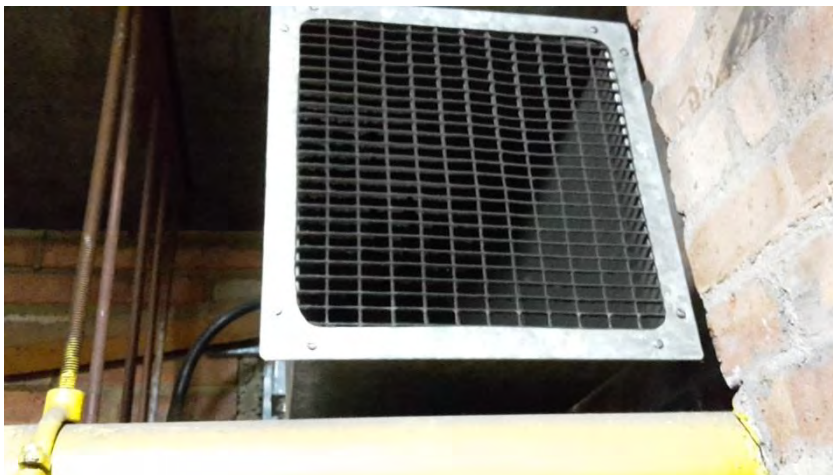
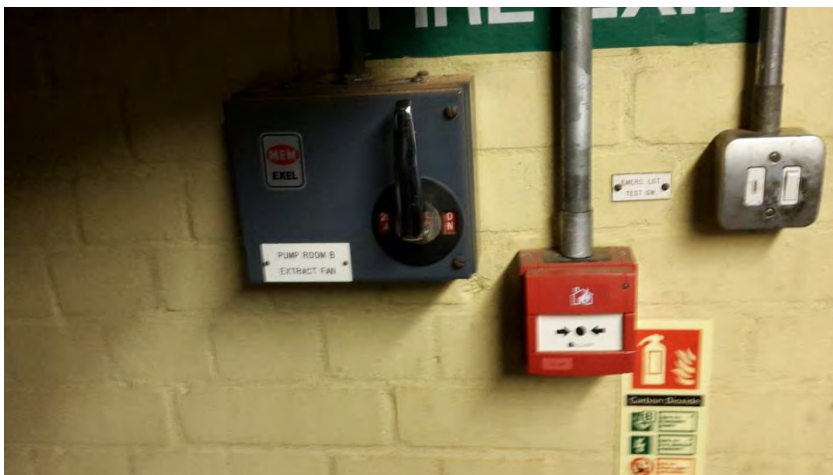
VENTILATION

The plant room is ventilated via combined high and low level grilles direct to outside. These are located above the windows and on the fire escape double louvred door.

There is also a Vent Axia inlet fan in one of the adjoining heating zone pump areas at high level above the pipe work at the back of the boiler plant room.

Condition Rating: Code 3

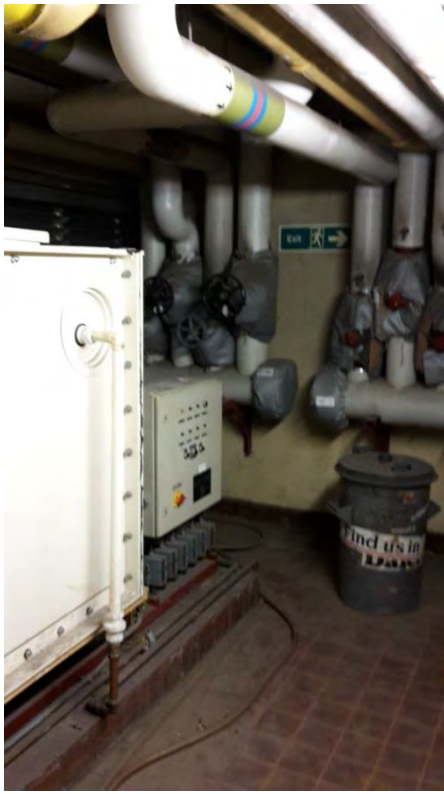
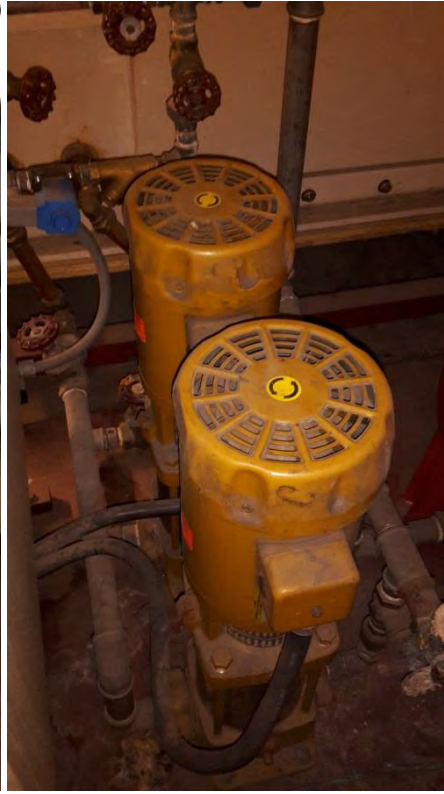
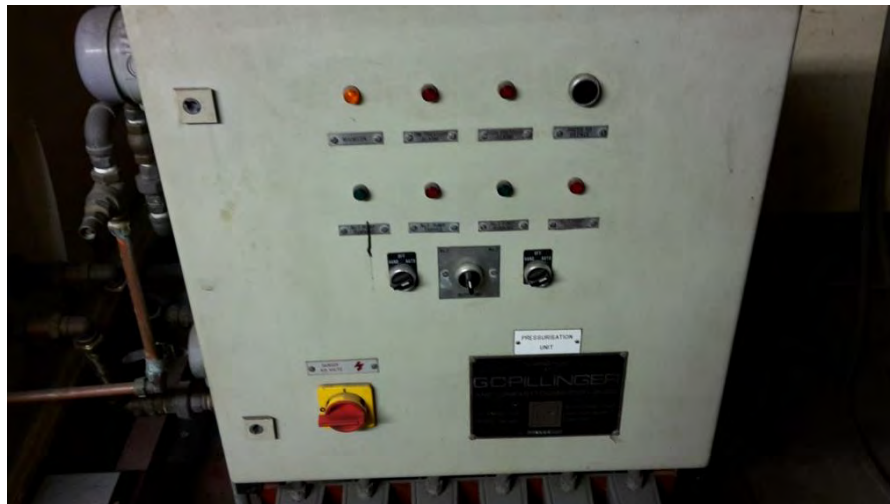
PRESSURISATION UNIT

The system is pressurised via a Pillenger Unit incorporating 2 x multi-stage pumps, 1000 litre break tank and a 100 litre expansion vessel. Approx. 15 years old and in poor condition.

Condition Rating: Code 2

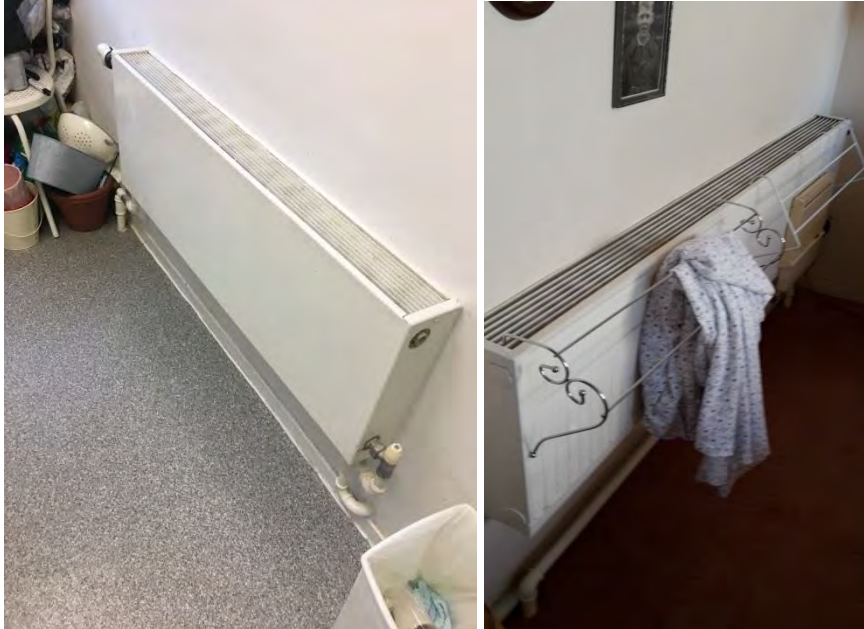
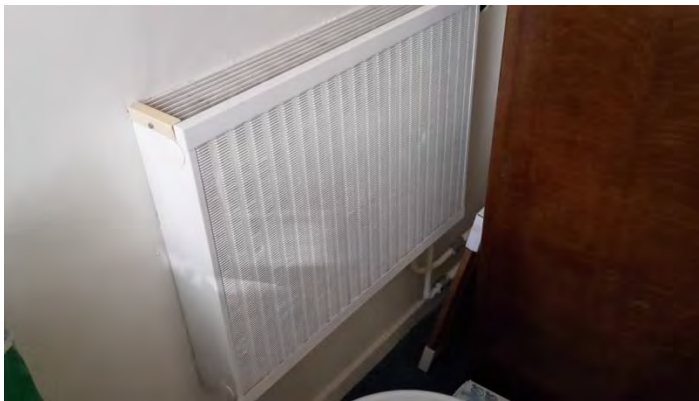
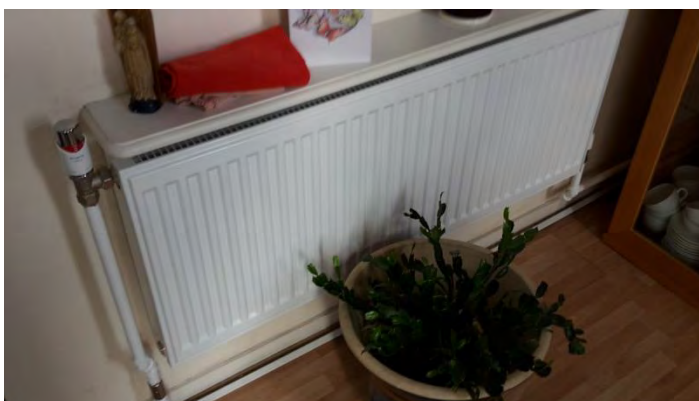
HEAT EMITTERS

In dwelling pipe work installation is fair. It is run mainly within the screed floor or through ceilings.

Does not conform to current Building Regulations L1 of the approved document, with missing radiator thermostatic controls valves, room thermostats or programmers.

Condition Rating: Code 3

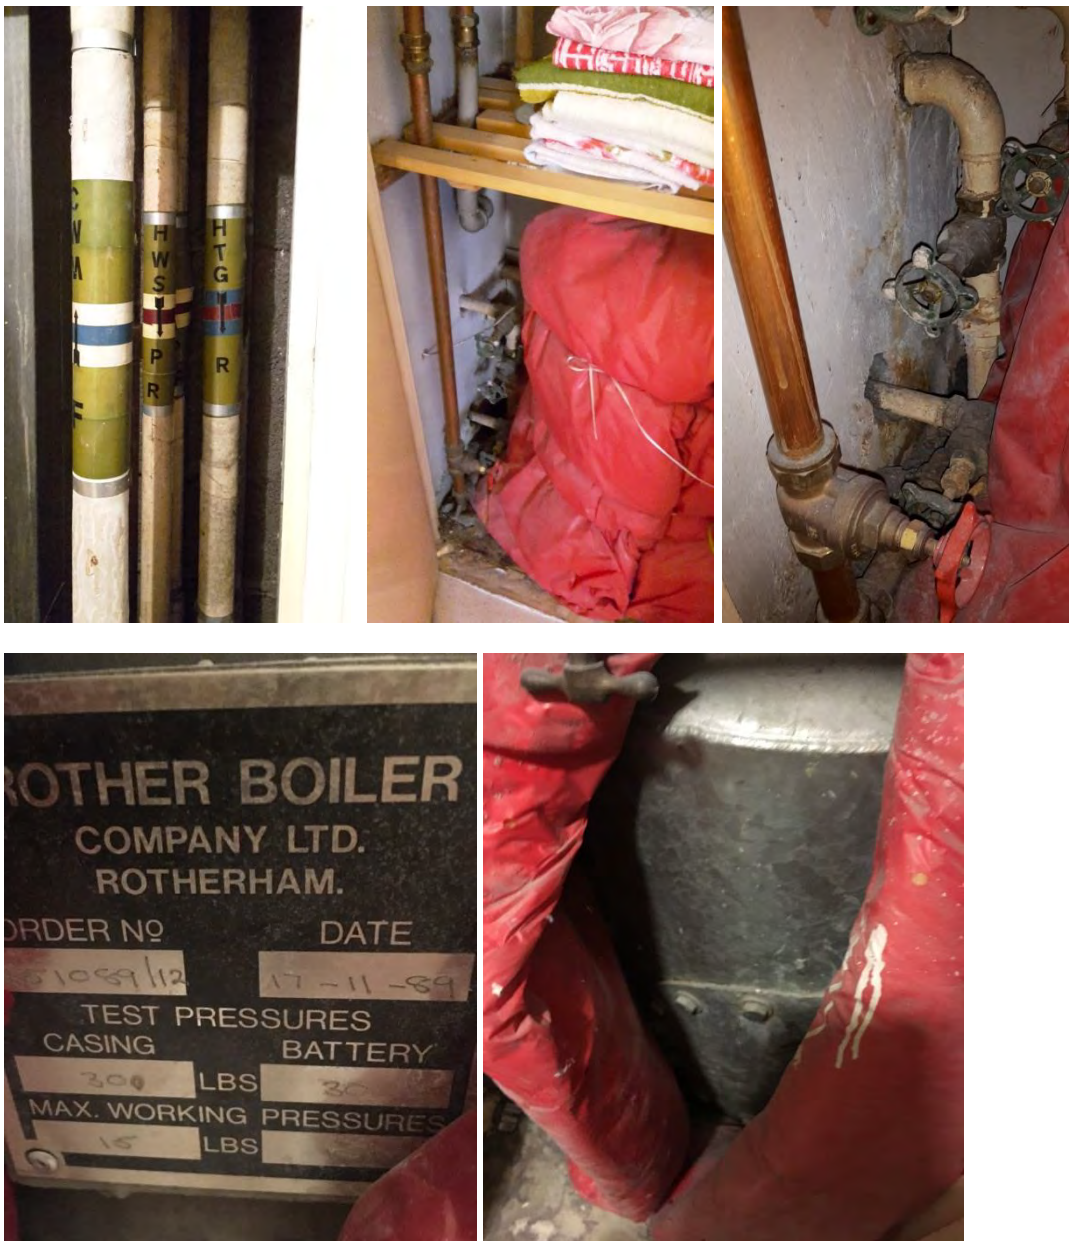
HOT WATER CYLINDERS (WITHIN DWELLINGS)

Of the 10% dwellings surveyed the pipe work installation is original and past its economic life expectancy, with missing insulation or inadequate sleeving, The pipe work rises through a central service duct then is run mainly within screed floor or through ceilings within the dwellings.

Hot water cylinders do not conform to current Building Regulations L1 of the approved document, with missing basic controls such as cylinder stats, regulating valves, insulation jacket and either damaged, missing or beyond economic life expectancy.

Condition Rating: Code 2

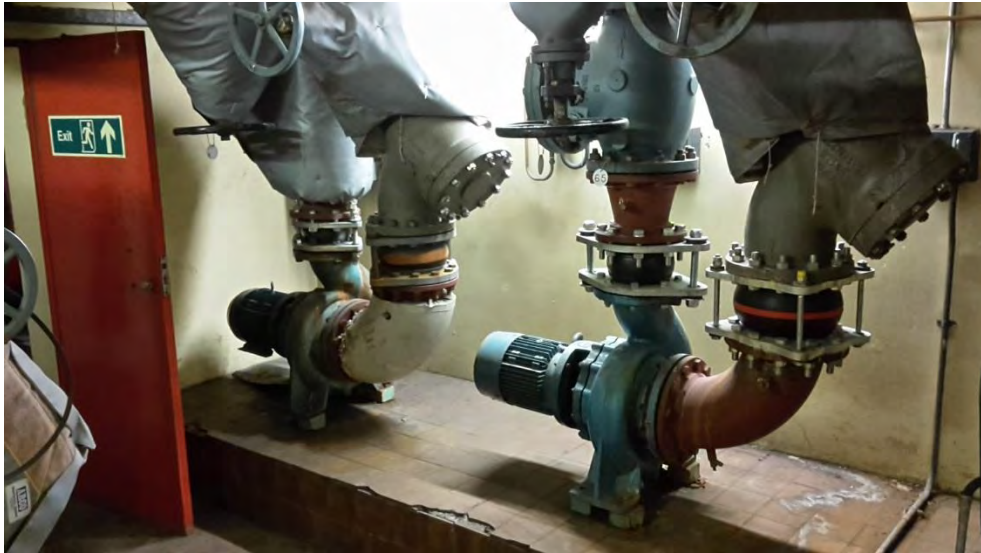
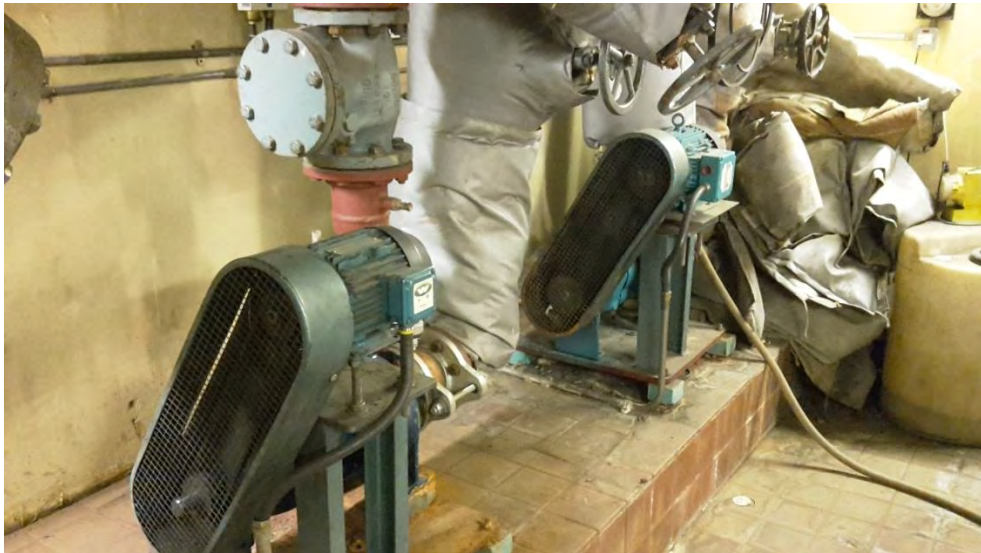
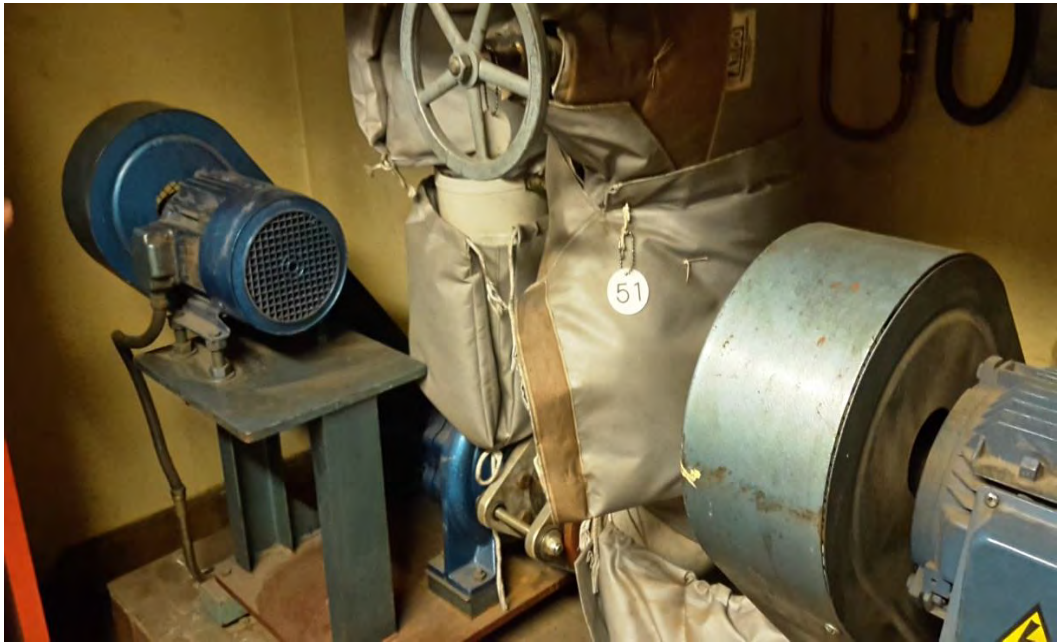
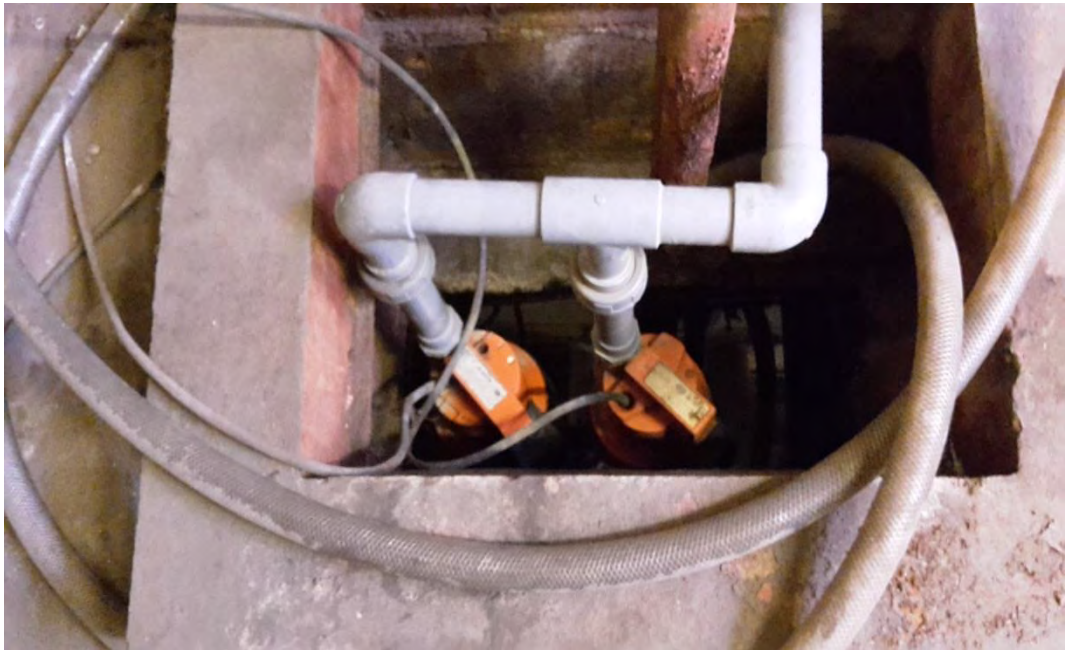
PUMPS

2 x Sump pumps

Condition Rating: Code 3

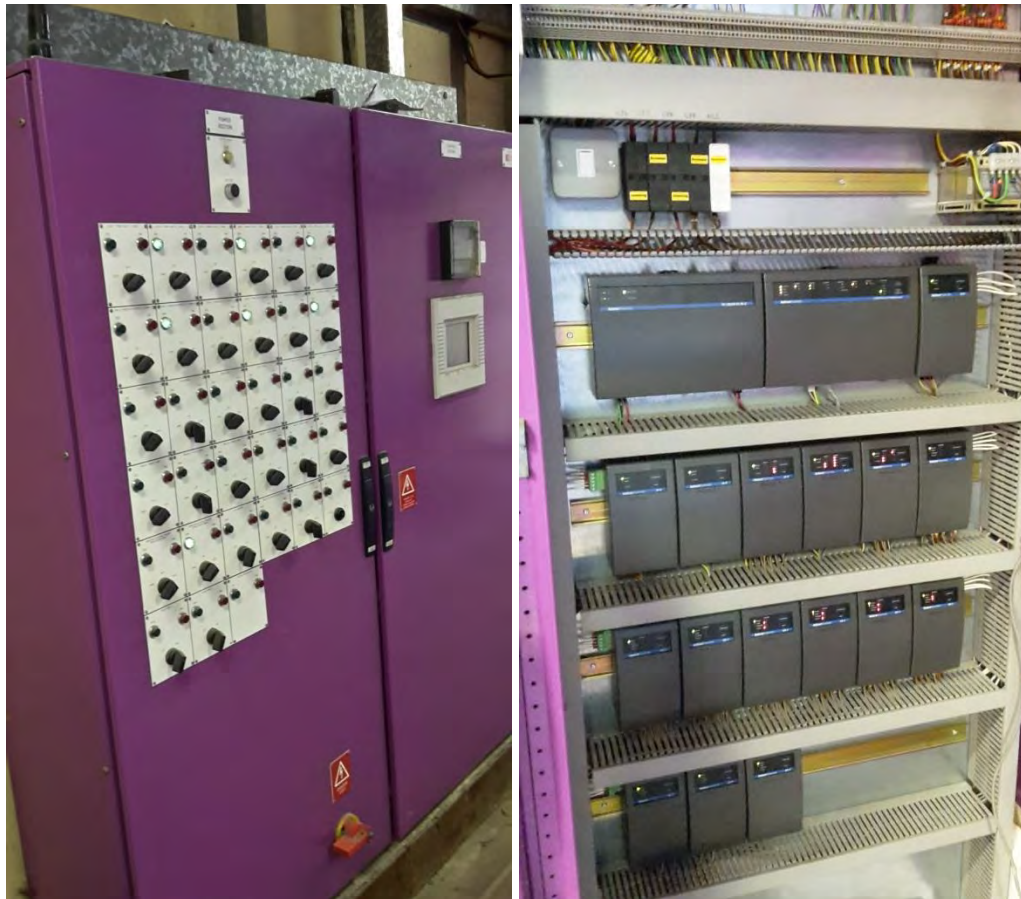
CONTROL PANEL AND CONTROLS

The controls panel and existing controls visibly are in fair condition.

The Landis Gyr three port motorised valves are showing signs of slight leakage

Generally all controls require renewal, as they are inefficient for today's standards and will not meet current Building Regulations of the approved documents.

Condition Rating: Code 2

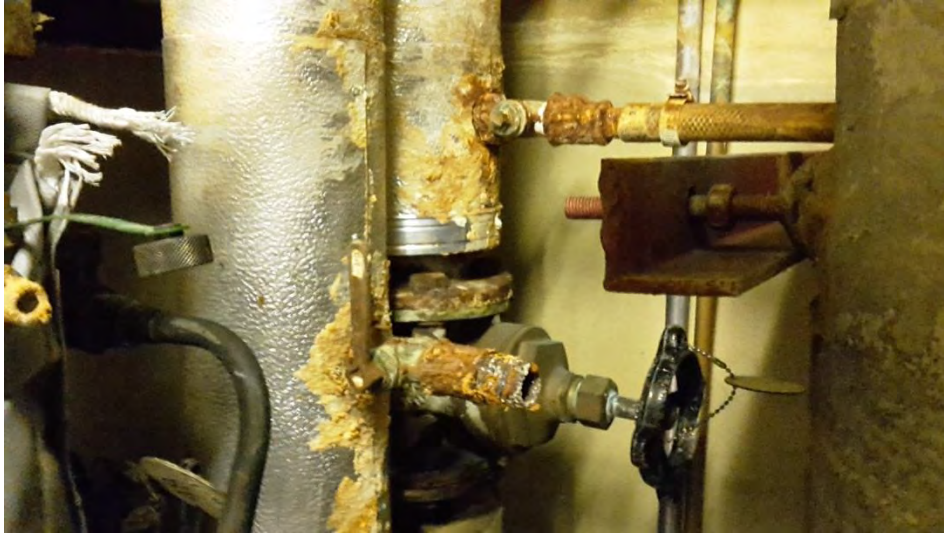
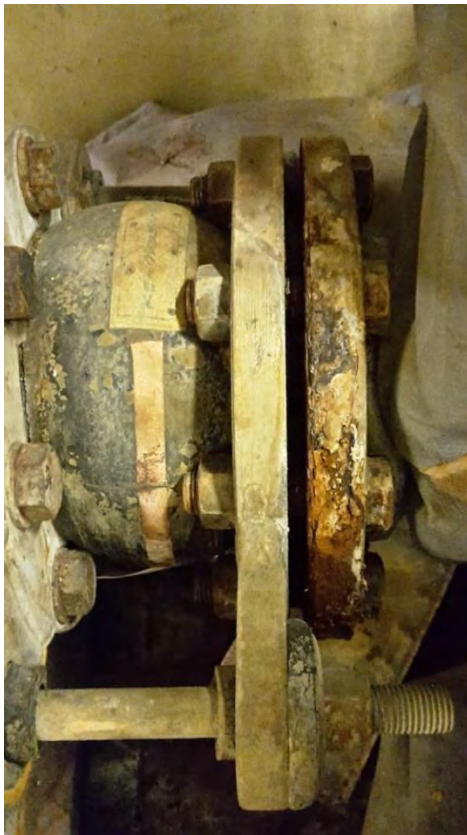
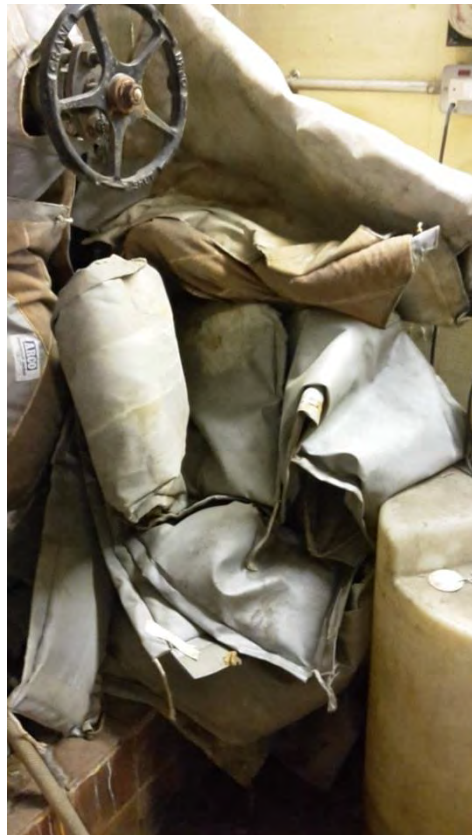
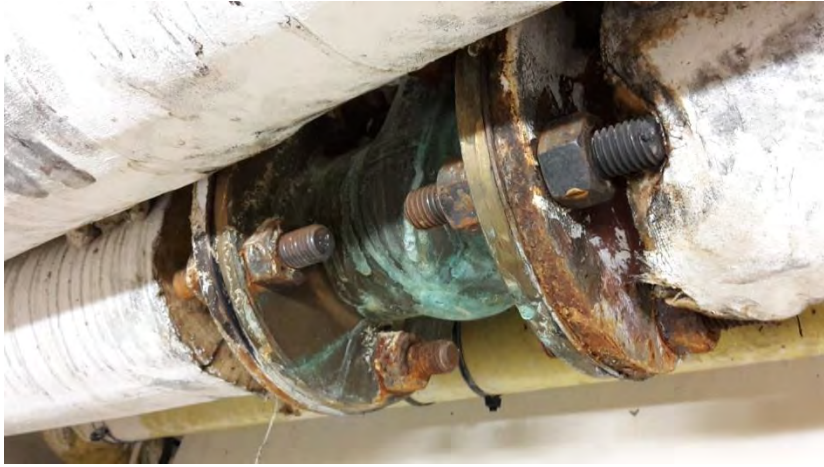
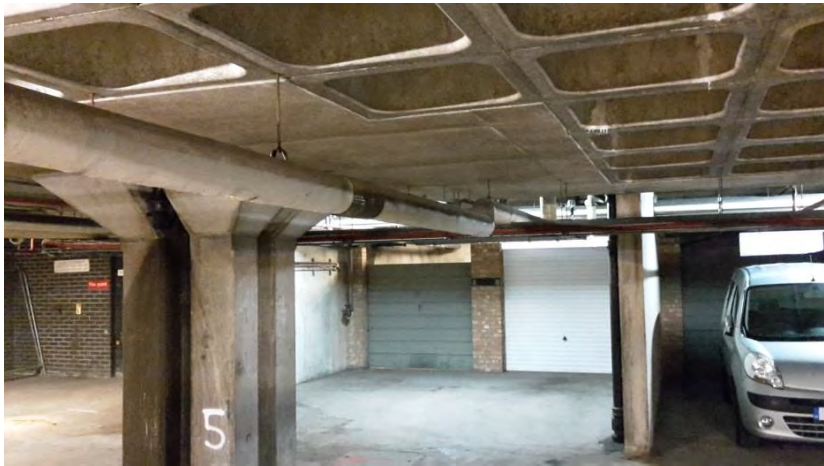
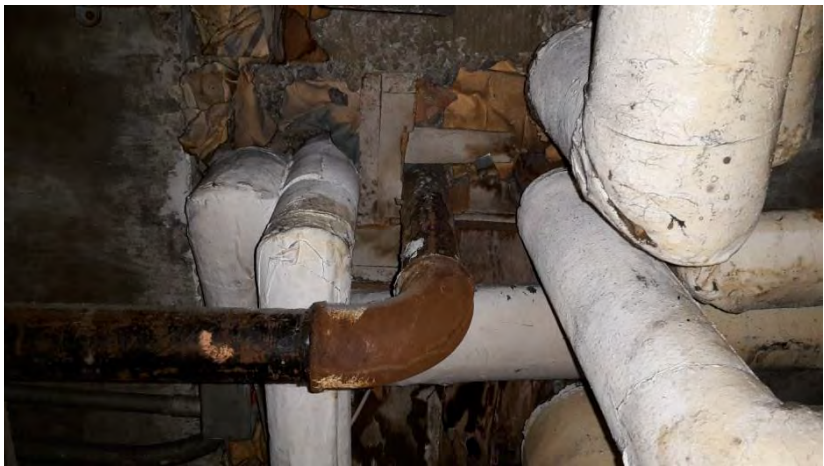
The valves generally are in fair/poor condition. There appears to be a lack of maintenance and signs of leakage. Some valves have been left open ended.

Pipework generally is in fair/poor condition, with signs of leakage. Valve wraps are either missing or not refitted.

Several sections of insulation is missing/damaged on main distribution pipe work externally

Pipe work within various areas is insulated in suspected asbestos material. No information available on site.

Condition Rating: Code 1

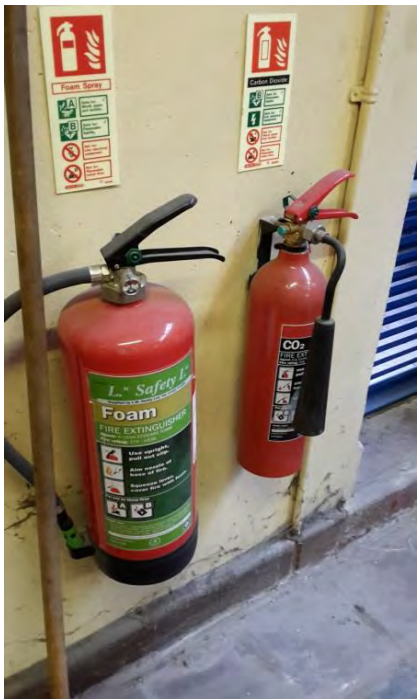
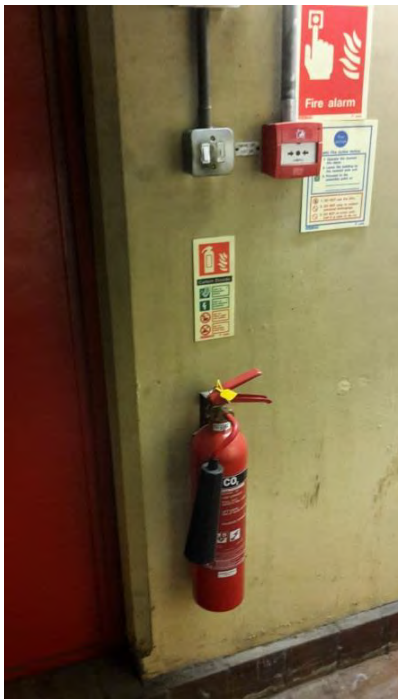
FIRE SAFETY DEVICES

Thermal links on boilers.

**No Gas leak detector in boiler room and gas meter room.**

**No fire proofing in shared riser ducts in all blocks**

Condition Rating: Code 3

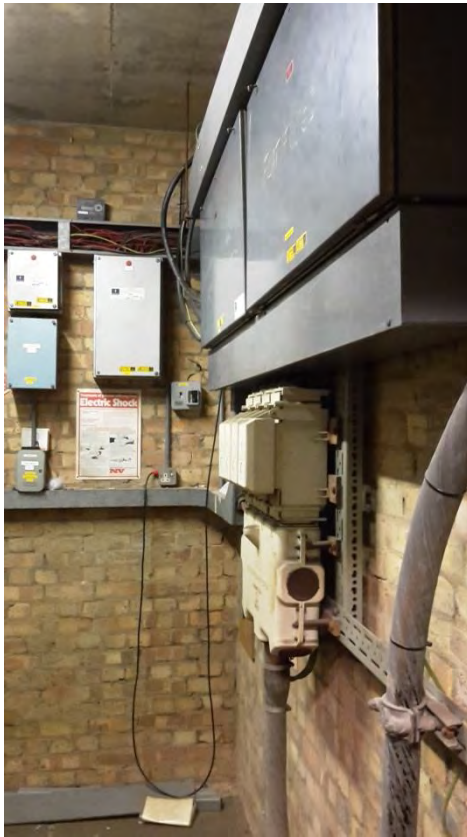
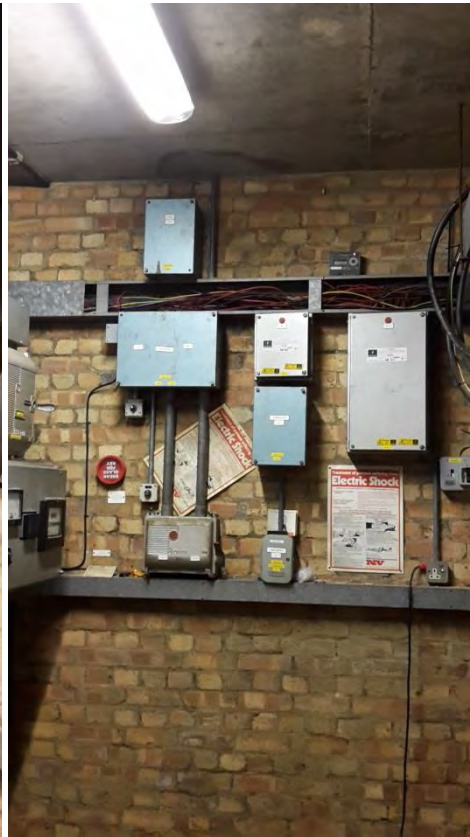
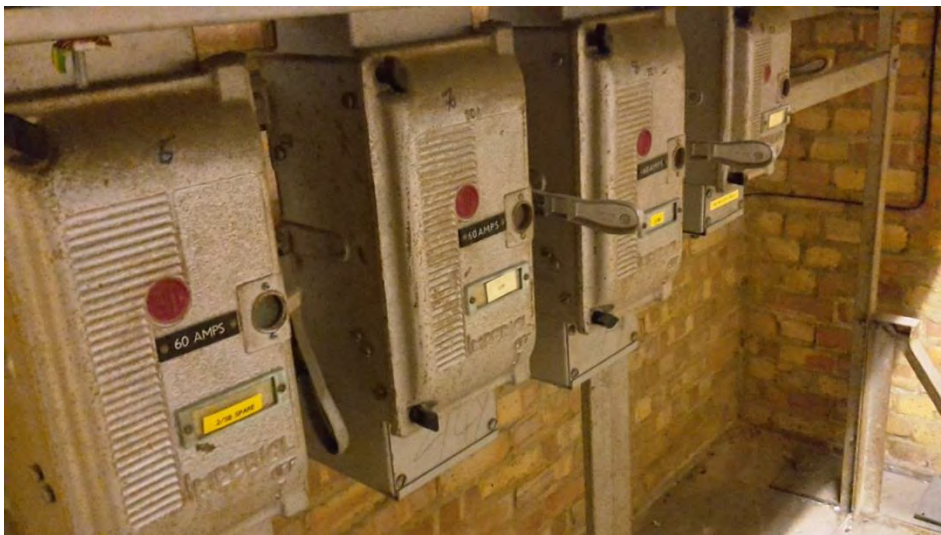
GENERAL WIRING AND CONTAINMENT

Wiring is visually mostly in a fair/poor condition, and original 30 years of age.

Condition Rating: Code 2

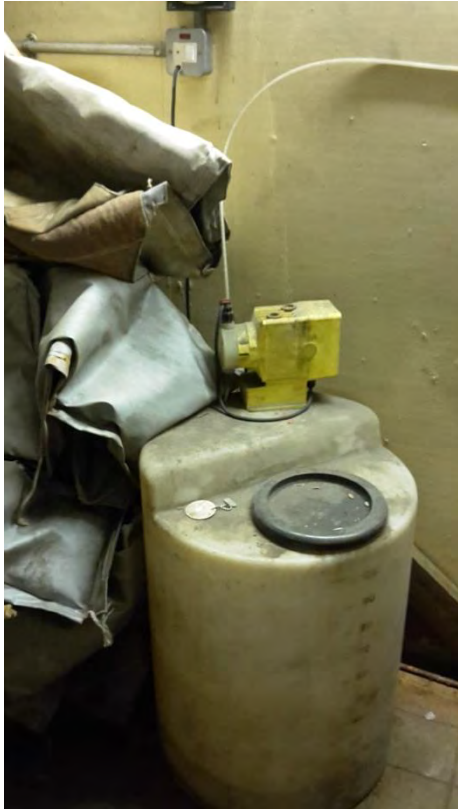
WATER TREATMENT/DOSING

Dosing pot in fair condition but not connected to the system.

Condition Rating: Code 3

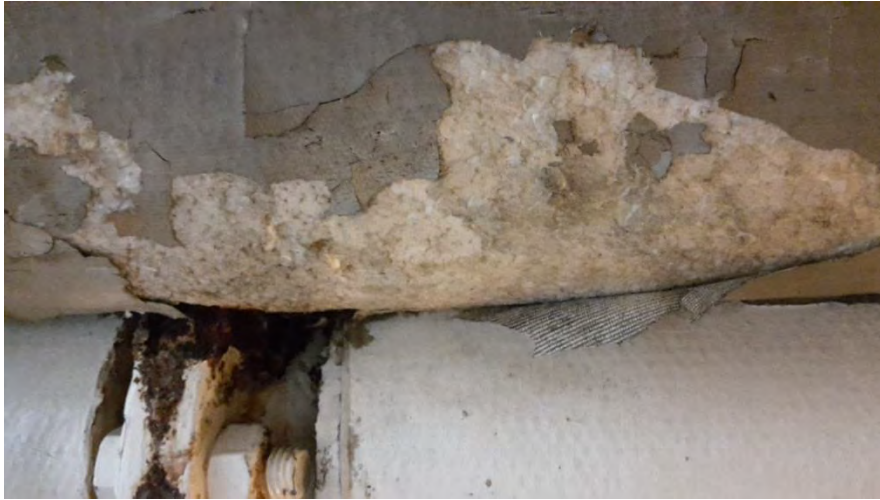
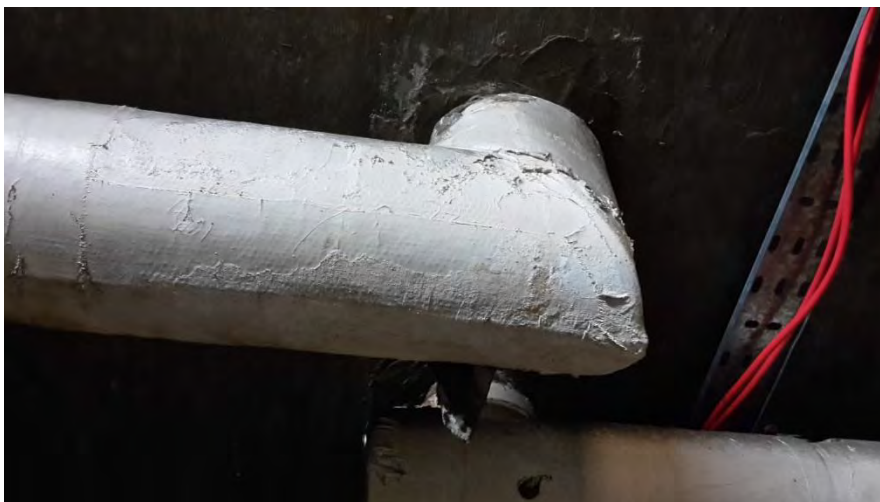
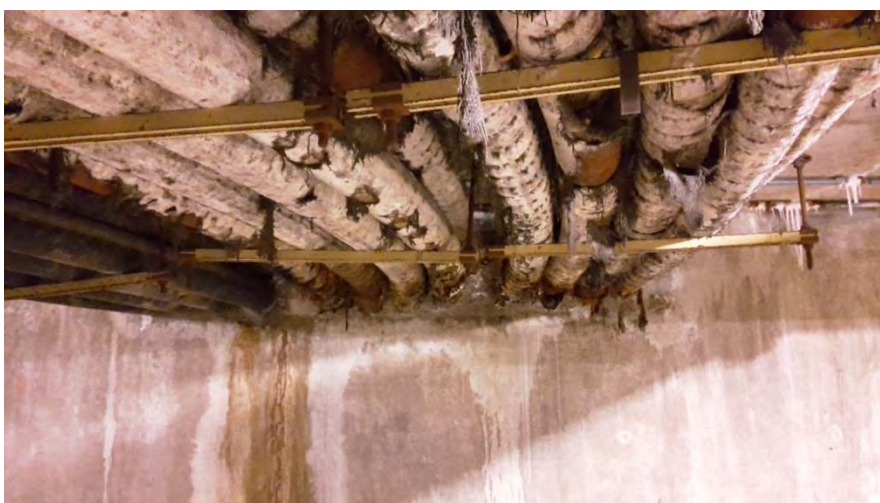
No asbestos information was available on site. However asbestos suspected material is likely to be in all areas. An assessment should take place. Insulation on pipe work should take priority as this is damaged and if asbestos content is confirmed then area is highly hazardous and requires urgent attention.

Condition Rating: Code 1

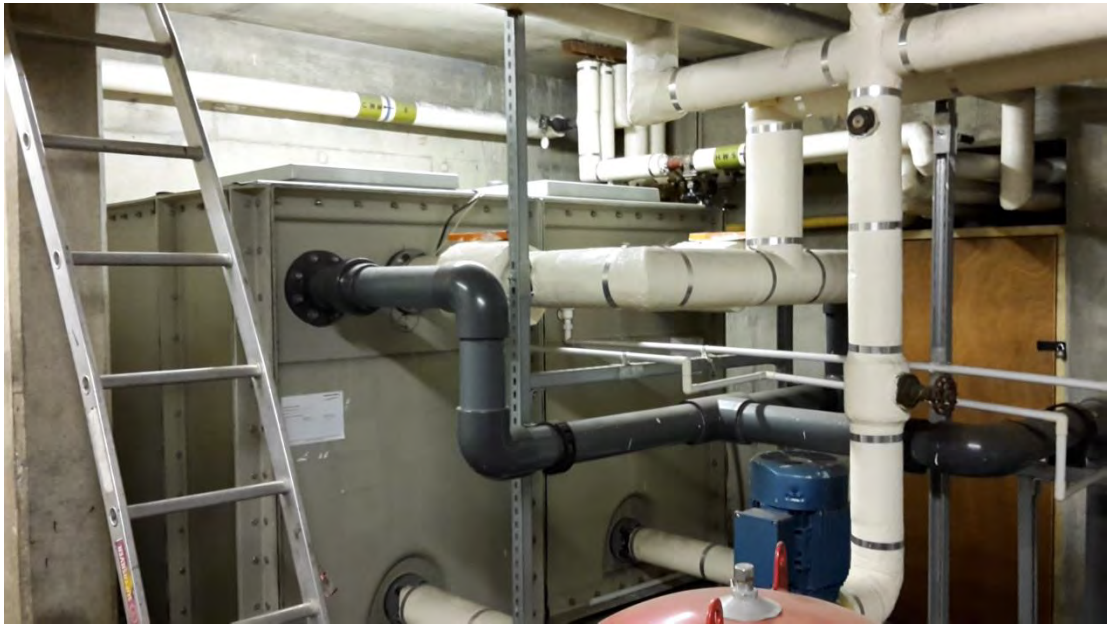
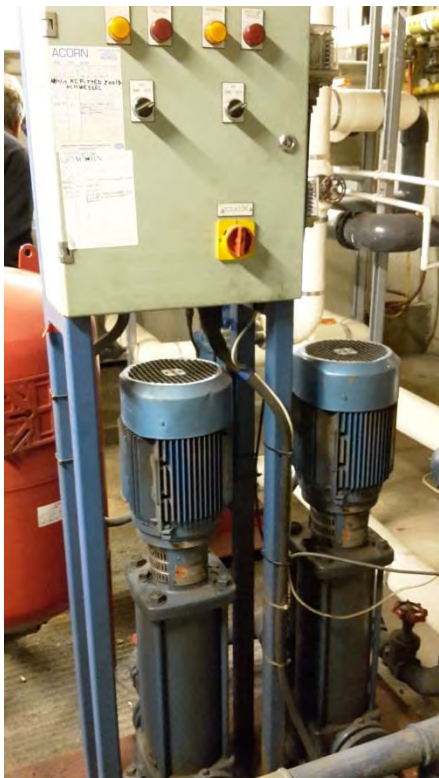
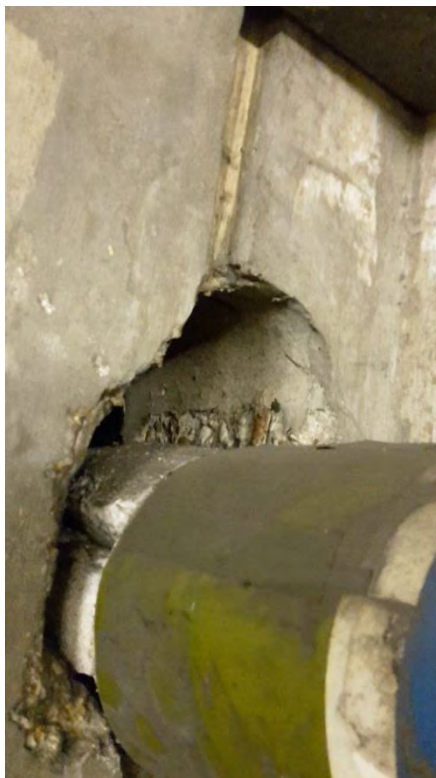
COLD WATER BOOSTER SETS

There is a central plant room in the basement area containing a cold water storage tank and duty and standby booster pumps set. Approx. 15 years old.

Plant rooms require a general tidy up and there is suspected asbestos material on pipework and fire proofing is required to some areas.

Condition Rating: Code 1

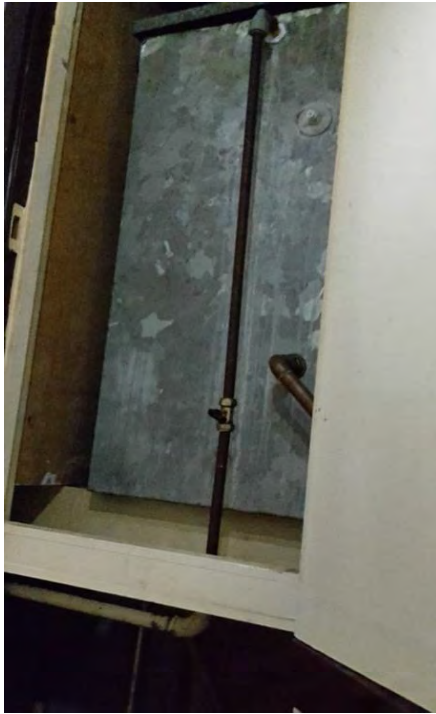
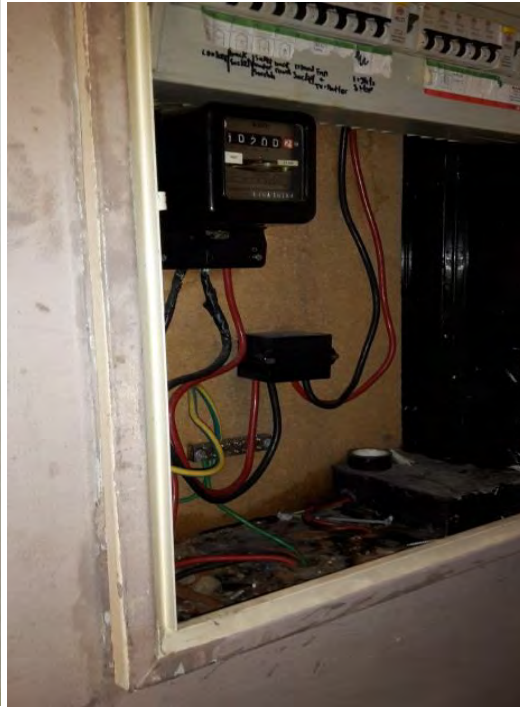
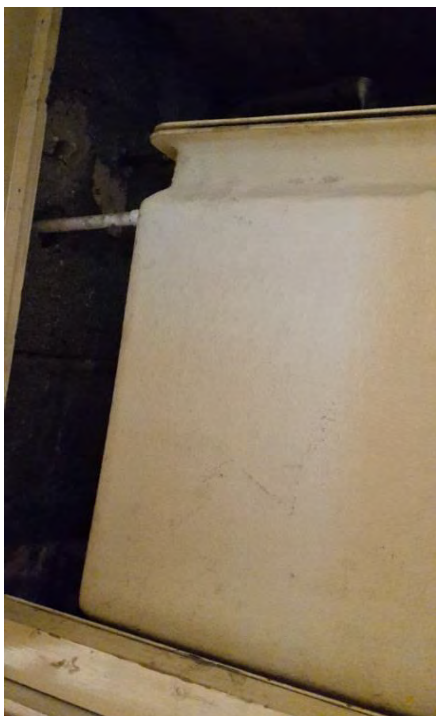
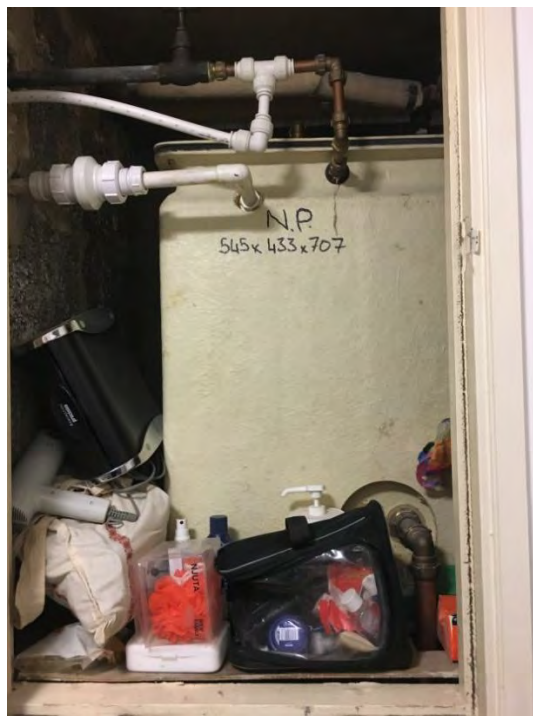
COLD WATER STORAGE TANKS

These are mainly GRP cisterns but galvanised also present in some locations, are located within each dwelling and are supplied via mains water or the booster plant.

Particular concern was the galvanised tank located within the "Tiffin Box" Restaurant which was badly leaking into the electrical fuse board. The Owner stated that this had already been reported to the Corporation of London. This requires urgent attention.

Condition Rating: Code 1 (Tiffin Box)

Condition Rating: Code 3 (generally)

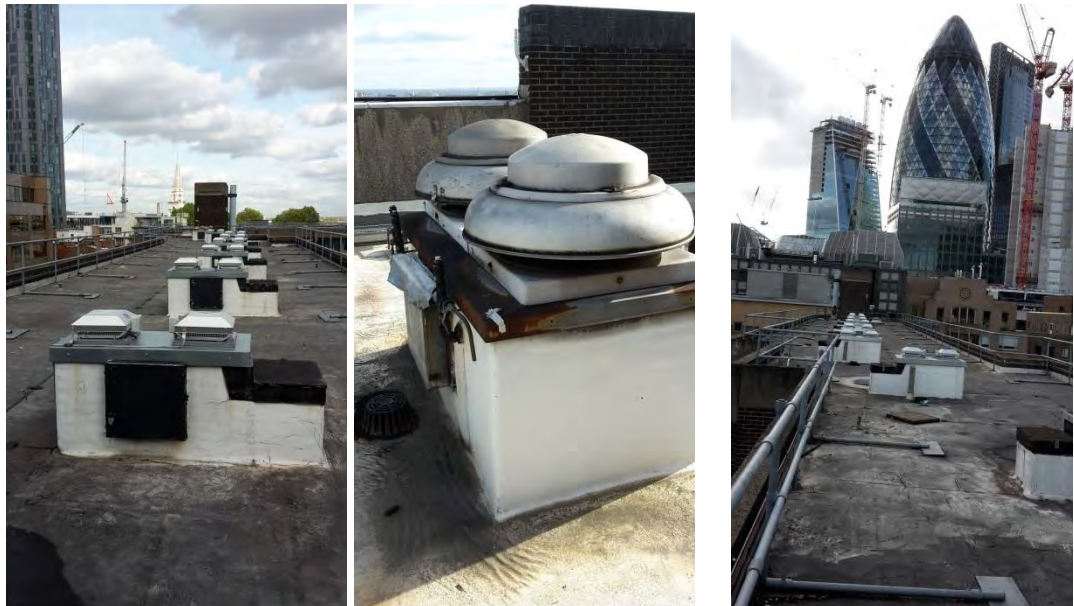
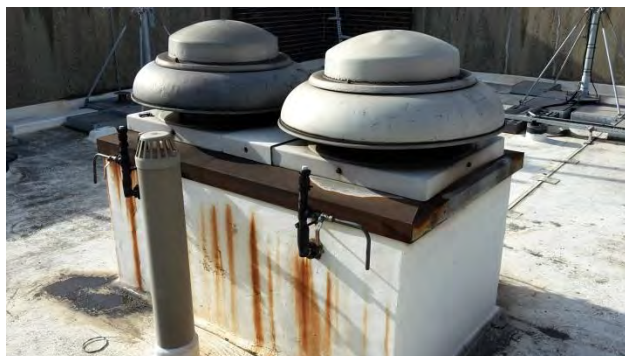
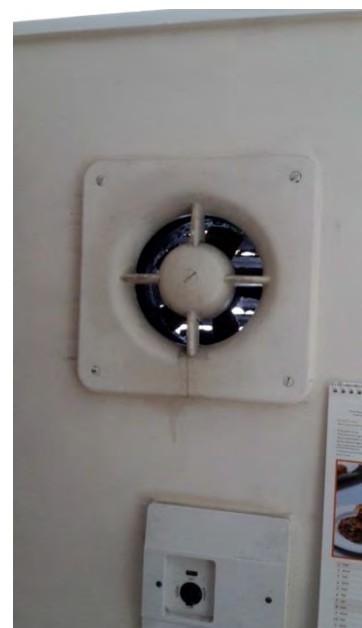
COMMUNAL FANS

There are Helios RDW 225/2 communal fans on the flat roofs of each block. The ductwork drops down each column of two flats in the service riser duct providing extraction for bathrooms.

The communal fans are in fair condition,

Condition Rating: Code 2

Where individual fans have been installed in kitchen areas these can either remain, be cleaned or replaced, depending on condition. Where none have been installed, new fans will be installed to comply with Part F of the approved document Building Regulations.
