**CORPORATION OF LONDON**

**Feasibility Study and Report on The Heating And Hot Water Services**

**Middlesex Street Estate**

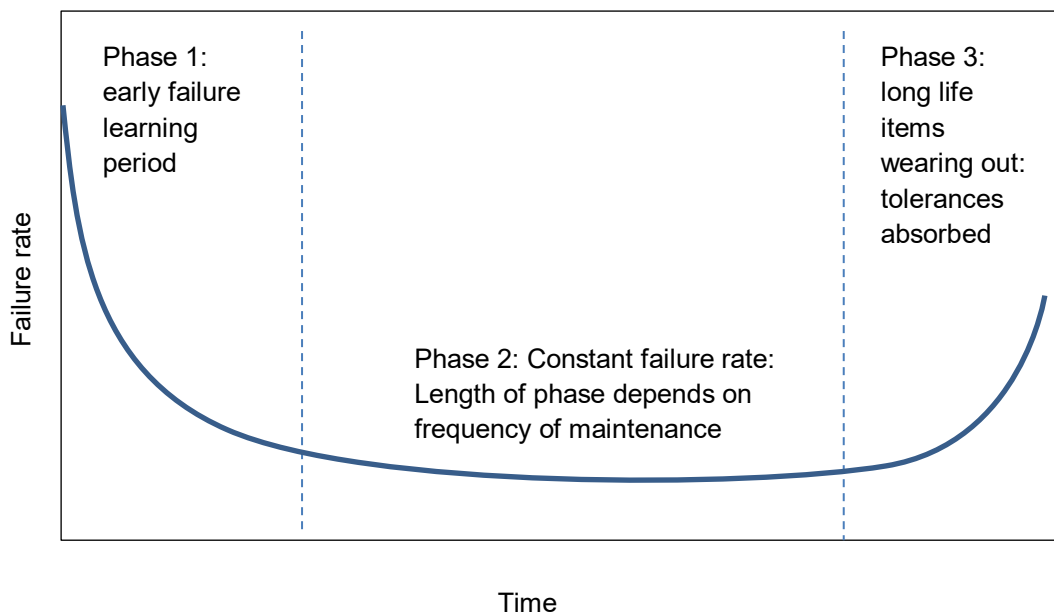
## **BATH GRAPH OF INDICATIVE MAINTENANCE REQUIREMENTS**

It can therefore be confirmed that most of the mechanical installation is beyond its indicative and economic life expectancy. The guide also takes this into account and describes the process as a bath graph (see below) where the plant operates in its early phase of life needing care and attention (phase 1). Then as time progresses failures and maintenance drop down level out for a period of years (phase 2), then as it ages the plant wears out, tolerances increase and plant failures increase (phase 3) to an extent where it should be replaced.

Phase 1: Decreasing Failure Rate: This occurs when the system is new and is a consequence of teething problems such as design and installation errors, faulty components and manufacturing faults among other matters.

Phase 2: Constant Failure Rate: In maintained systems, after the early failure period, the system will be in settled state, random isolated faults and failures will occur, and parts that wear will need repair and/or replacement from time to time as part of preventative maintenance. Such parts typically include bearings, seals, printed circuit boards, control components, motors, heat exchanger components and compressors on packaged heat pumps/air conditioners or multiple compressor chillers.

Phase 3: Increasing Failure Rate: This is the point where major components begin to fail and random failures increase with time. At this stage the cost of repair of plant and equipment begins to exceed the cost of replacement.

Therefore it should be noted that the age and condition of equipment within the building is in phase 3 part of our description, with the exception of the replacement primary pumps which are Phase 1, but could be considered Phase 2, as they are connected to existing poor water quality system.
