THE TEMPLE, WANSTEAD PARK
VOLUME 01: CONSERVATION MANAGEMENT PLAN
FINAL ISSUE
MARCH 2024

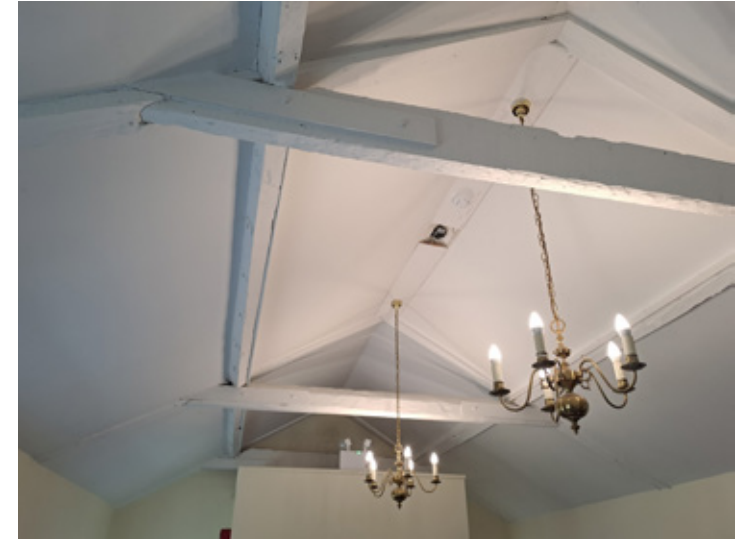
Figure 14 Rafters in the northern wing, upper-ground floor.

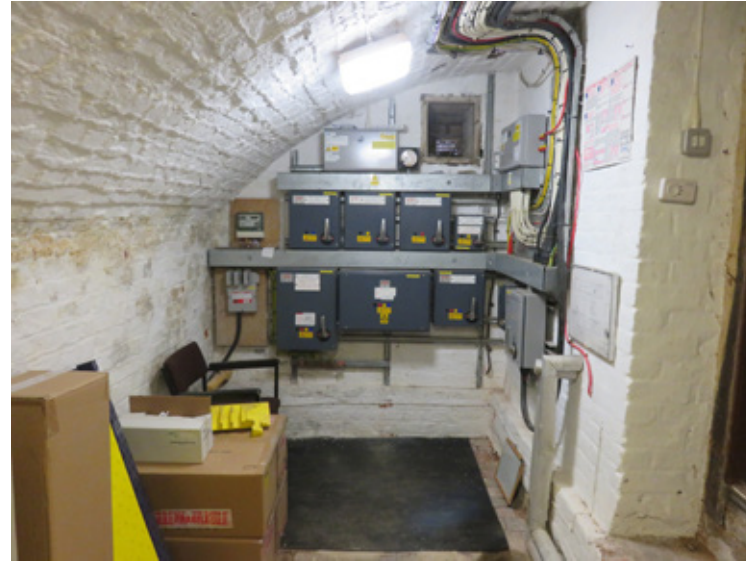
Figure 27 Interior of the brick vault on the lower-ground floor, beneath the portico, looking north.

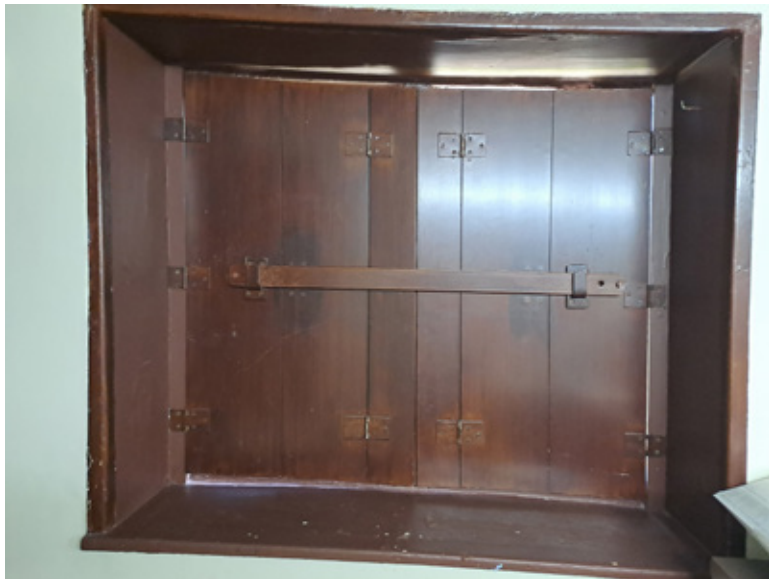
Figure 28 Modern security shutters on the lower-ground floor.

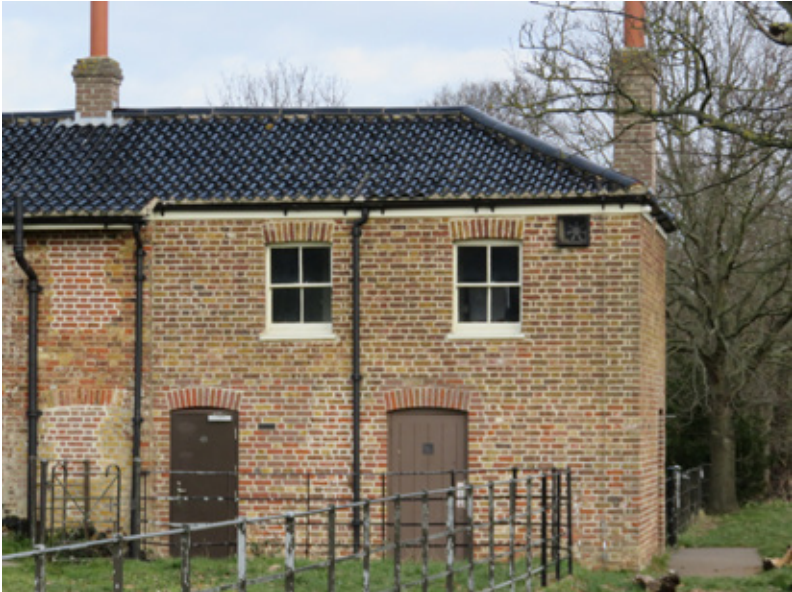
Figure 82 The extractor fan detracts from the front façade of the Temple

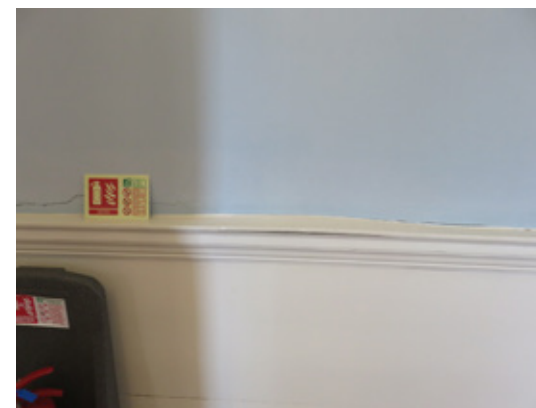
Figure 83 Example of the cracking in the central room

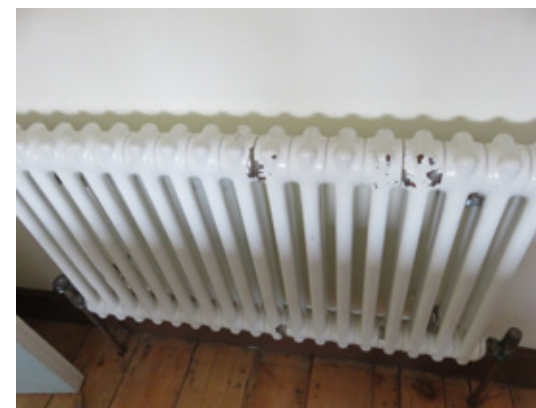
Figure 84 There are internal decorative failures such as to several of the radiators

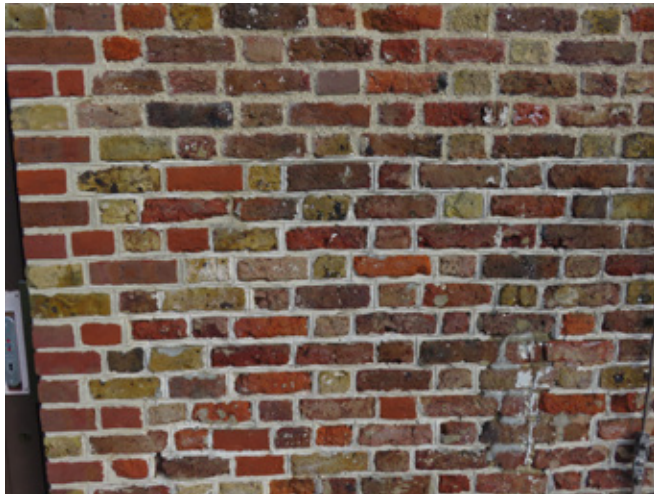
Figure 85 Some of the pointing is drude and there are small areas of cementitious mortar

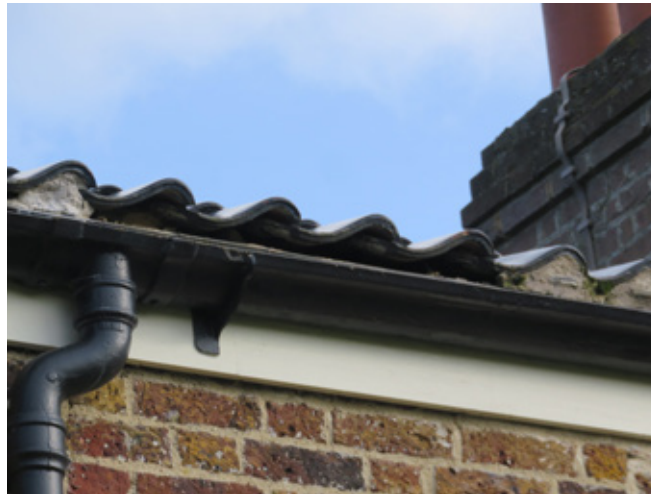
Figure 86 Failed mortar ends to the roof tiles

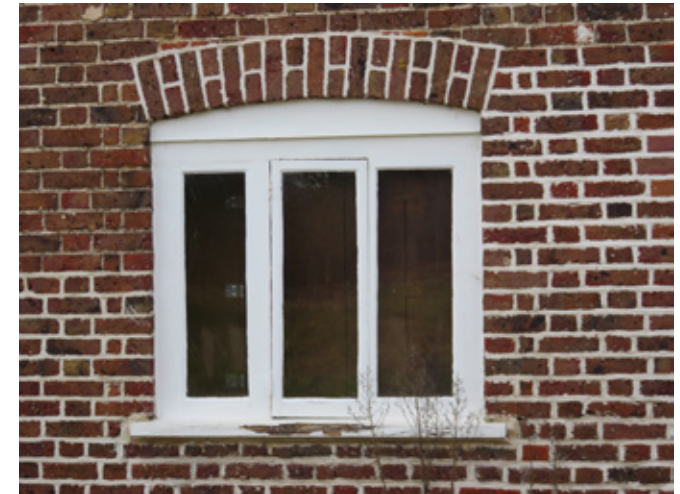
Figure 87 Rotting window sill

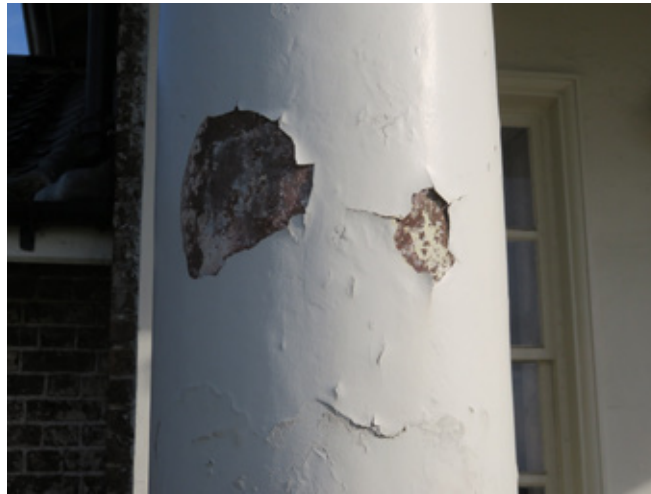
Figure 89 Failing paintwork to the columns

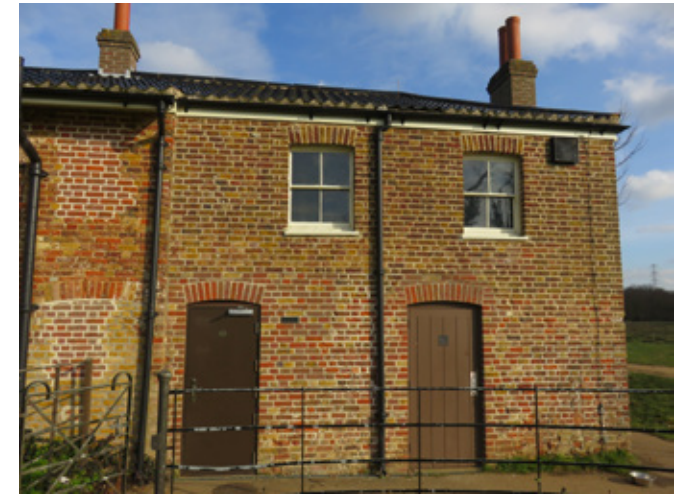
Figure 90 The estate railings have failed paintwork partly because they are climbed on, especially near the WCs
