THE TEMPLE, WANSTEAD PARK
VOLUME 04: APPENDICES
FINAL ISSUE
MARCH 2024

THE TEMPLE, WANSTEAD PARK: VOLUME 04: APPENDICES

CONTENTS

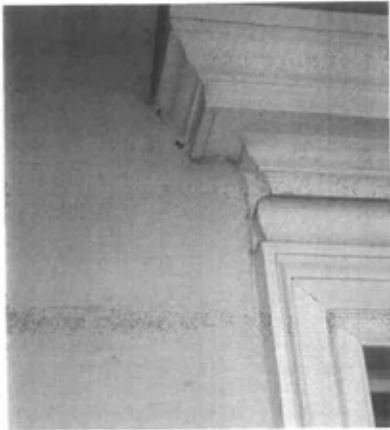
Rear wall and door architrave

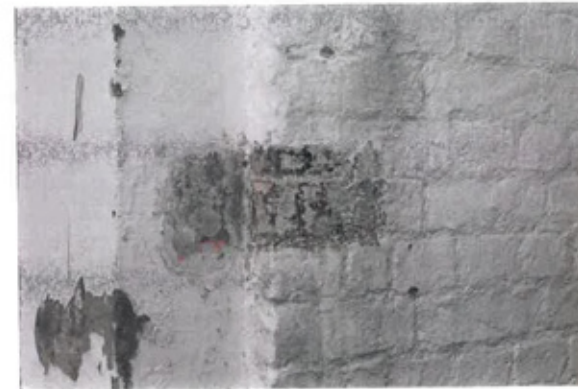
Plaster and brick wall
- southern side of portico

Samples were taken from plaster at the southern side of the portico and the brick wall did not show the heavy build-up of decorations found on the rear wall and architrave. The plaster and bricks both bore traces of a coarse golden brown layer. This is probably the layer identified during cleaning tests as a copperas based coating. Further research would be required to establish how this coating relates to the decorations applied to the main body of the Temple.

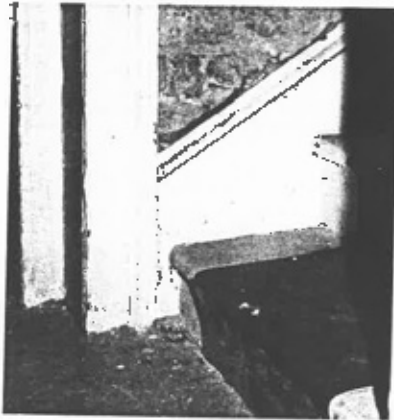
Sample location - skirting

WT/5/21 - skirting moulding

white
cream
brick red on grey etc.
grained decoration ?
(similar to second grained
decoration found in G2)
green
light green on
white etc.
brown dec.
(possibly grained)
cream oilpaint
cream oilpaint
dark brown
stripped

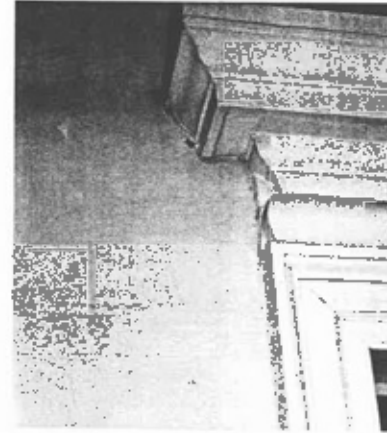
Rear wall and door architrave

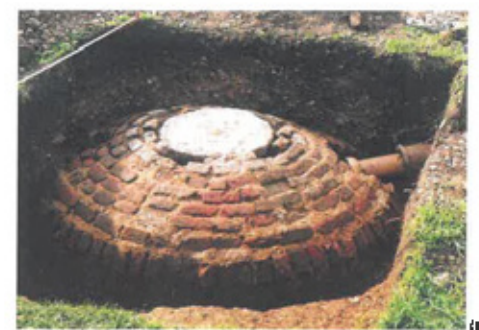
Images (a) Photograph of the well in excavation, from MoLA, 2002, Backfilled Pond and Field next to the Temple: A Report on the Evaluation.
