<b>Committees:</b>	<b>Dates:</b>	<b>Item no.</b>
Streets and Walkways Sub-Committee Projects Sub	27/09/2016 11/10/2016	
<b>Subject:</b> Ludgate Hill crossing (30 Old Bailey)	<b>Gateway 6</b> Progress Report	<b>Public</b>
<b>Report of:</b> Director of the Built Environment		<b>For Decision</b>

# Appendix 1 – plan and photos of the new crossing

### Appendix 3 – extract from Road Safety Audit (Stage 3)

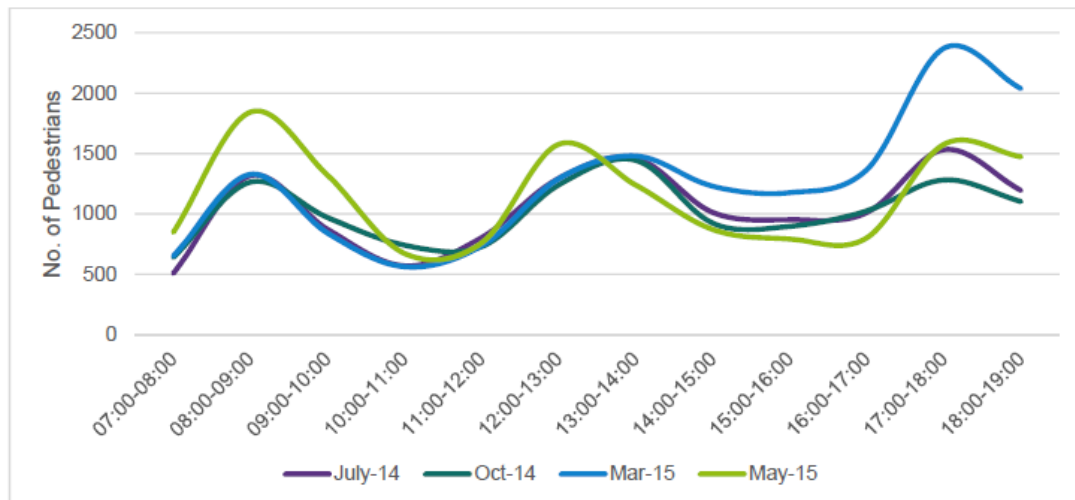
**Figure 1: Total pedestrian flows of adjacent footways**

Figure 1 shows that pre and post implementation results had similar trends with fairly pronounced morning, lunchtime and evening peak periods. Generally the graph shows that there has been an overall increase in pedestrian flows especially during peak periods.

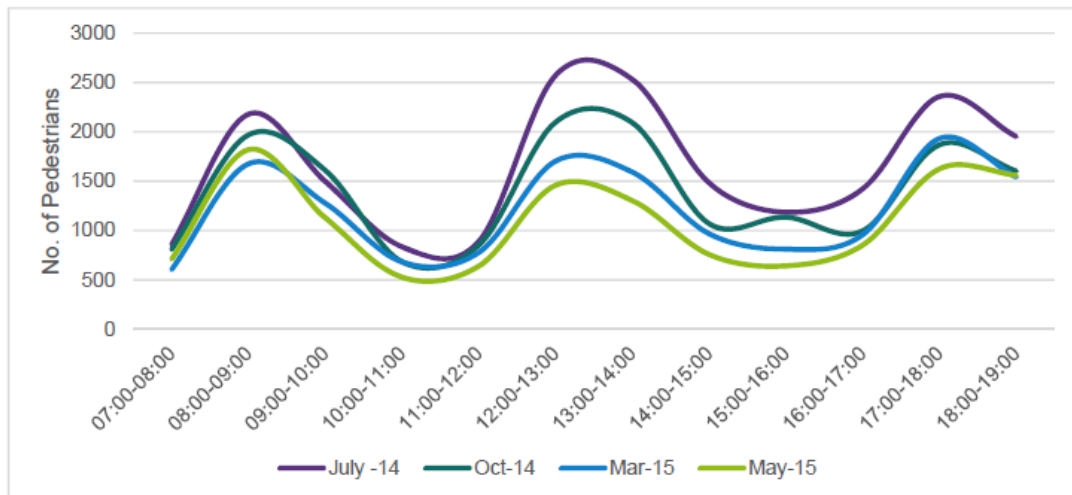
**Figure 2: Total hourly formal pedestrian crossing counts**

Figure 2 shows hourly total crossing counts (formal crossing) throughout the survey period. This shows that changing the crossing facility from a zebra to a signalised crossing has resulted in an overall reduction in the number of pedestrians using the formal crossing.

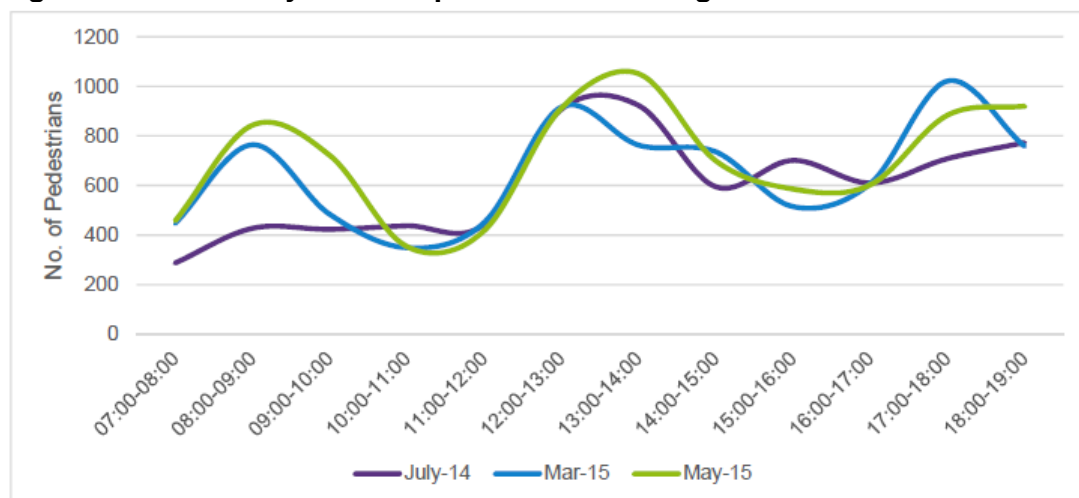
**Figure 3: Total hourly informal pedestrian crossing counts**

Before implementing the scheme, on average 50 pedestrians per hour were crossing informally in July and 22 pedestrians per hour in October. However post implementation results indicate that there was a big increase in informal crossing with an average of 85 pedestrian per hour crossing informally in March and 110 pedestrians per hour in May respectively. Figure 3 shows that overall there has been an increase in the amount of pedestrians crossing informally. It should be noted that due to an issue with the survey footage the October 2014 survey only counted informal crossing in a limited area so has been excluded from this comparison.

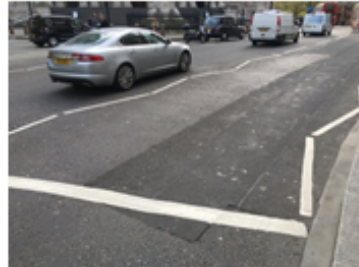
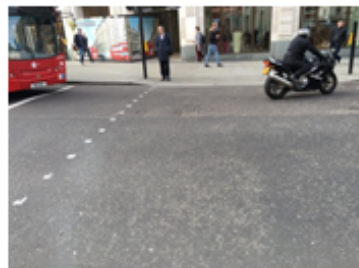
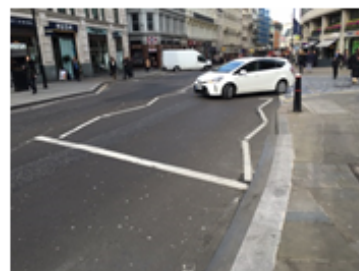
**Location:** General to scheme, multiple locations

**Summary:** Carriageway surface may pose a hazard to road users

The Audit Team are concerned that the carriageway surface may pose a hazard to road users, namely:

- On the westbound approach to the pedestrian crossing the higher friction surface (HFS) has not been laid, but the centre line marking has been relocated northwards. As a result, the nearside of the lane has the pre-existing HFS but the offside has no HFS installed. Westbound drivers may be subject to differential skid resistance, particularly in inclement weather conditions. An exacerbated potential for loss of control type collisions may exist as a result.

- In the centre of the crossing carpet a number of service covers have sunk. The sunken covers may pose a trip hazard to pedestrians with an exacerbated potential for trips and falls as a result.

- On the eastbound approach to the pedestrian crossing a trench has been cut and reinstated through the higher friction surface (HFS). As a result, the nearside of the lane has the pre-existing HFS but the offside has no HFS installed. Westbound drivers may be subject to differential skid resistance, particularly in inclement weather conditions. An exacerbated potential for loss of control type collisions may exist as a result.

Provide a consistent and adequate carriageway surface through the pedestrian crossing and its approaches. This may require the provision of higher friction surfacing and the raising of sunken service covers, or, resurfacing the carriageway.
