CS North-South Cycle Route (Phase 2) Concept Design (Rev 2A.1)

Stage 1 Road Safety Audit

Ref: 2462/VAR/A201/TLRN/2016

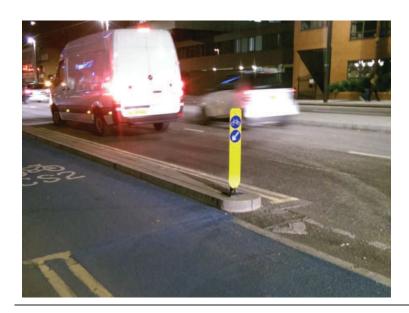
The cycle segregation is proposed at a width of 300mm with what appears to be a 100mm traffic wand at the commencement point. The Audit Team are concerned that the wand may not be adequately visible to approaching road users due to the narrowness of the vertical feature and the minimal lateral clearance to both the cycle track and the carriageway. Approaching drivers / riders may fail appreciate the presence of the island with an exacerbated potential for conflict and associated potential for personal injury as a result.

Part Accepted: There are two start points of the 300mm wide segregation, the northbound start point at the Charterhouse St junction and the southbound start point at the Greville St crossing. The latter is a crossing with no turning vehicles and the alignment of the carriageway means that vehicles would not normally be heading for the segregation strip but it is still important that it is visible. The start point at the southern end (Charterhouse St junction) is a higher risk because of vehicles turning onto Farringdon Rd northbound may not expect to see the segregation. Cycle logos, double red line no stopping restrictions, white lining, and the retro-reflective wands (similar to the photo below) highlight the segregation strip.

Maintaining a wide cycle facility is vital to the success of the scheme and narrowing the track at the most critical point, the start, would reduce usage at busy times. The cycle tracks are approximately 2m wide and to narrow them any further would mean cyclists would not be able to ride two-abreast or overtake, which could discourage cyclists from using the dedicated cycle track in favour of the general traffic lane, where provisions for cyclists have not been accommodated. The traffic lanes are already as narrow as operationally possible. For these reasons, the segregation strip is consistently narrow. The resulting situation is similar to where standalone wands are provided as semi-segregation and zero lateral clearance is required.

Also, any increase in the lateral clearance between the wand and the vehicles either side would reduce the physical space for those vehicles. A 0.8m wide length of segregation would be required to provide the lateral clearance specified in guidance and this would reduce the cycle track to 1.5m width. To mitigate against striking by handlebars and wing mirrors, the wands will be limited to 1m height above carriageway level. It should be noted that the wands are self-correcting.

It will be recommended to the detailed designers to add further visibility of the segregation start point by painting the vertical edge of the kerb with retro-reflective white paint.

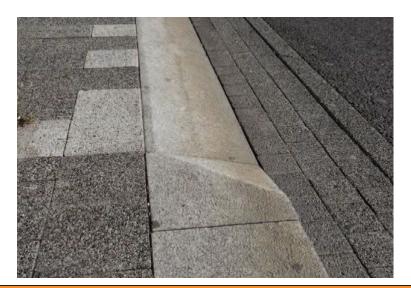
It is proposed to provide battered kerbs for powered two wheelers to cross the cycle track and access the parking bay. The Audit Team are concerned that riders of powered two wheeled vehicles may attempt to access the parking bay at an acute angle, and the presence of the battered kerb may destabilise the rider. An exacerbated potential for the rider to become unseated, with an associated potential for personal injury may exist as a result.

An example of the angled kerbs is shown in the image below. These have a gradient of 1 in 6 because the whole kerb is angled rather than just the edge battered. This type of solution will be recommended to the detailed designers.

Accepted: The current proposals show an angled 150mm wide kerb but given the concern noted, the new proposed angled kerb is 300mm wide with the same 50mm upstand. (See Rev2A.2 drawings)
