Appendix 1

Management of the Highgate and Hampstead Ponds

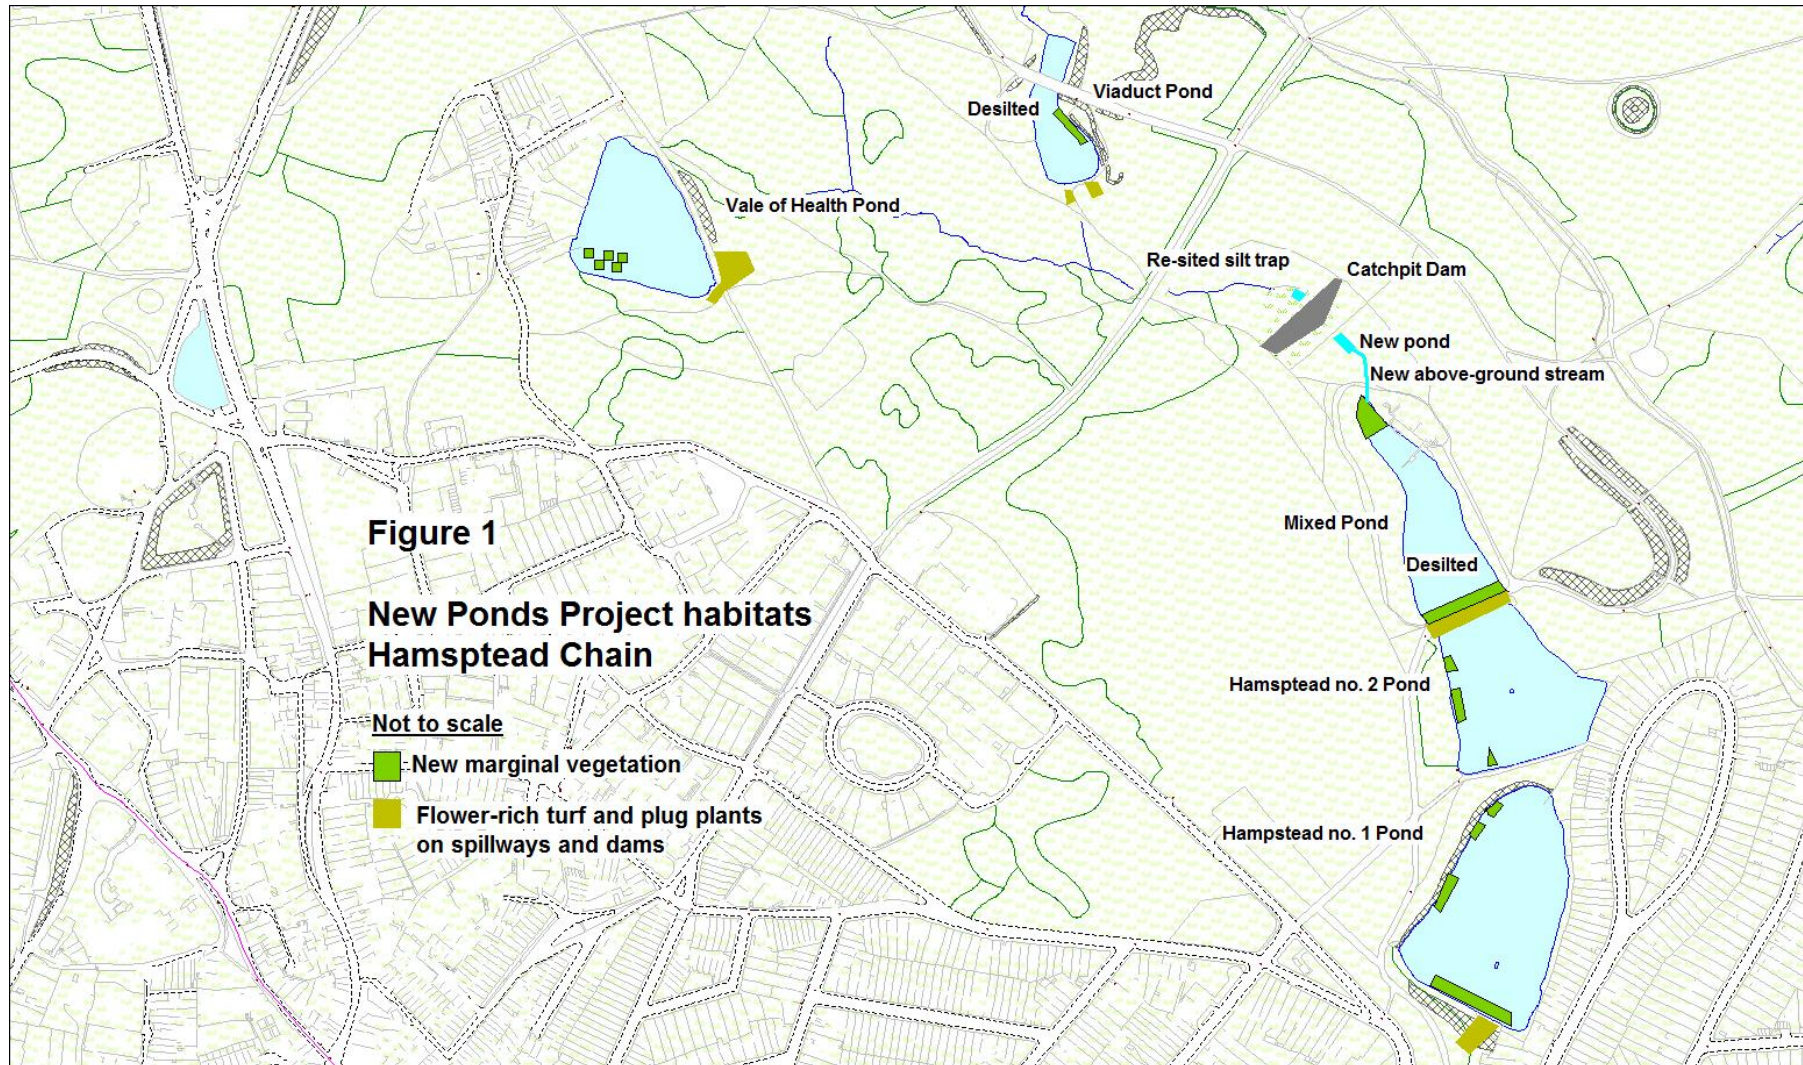
Figure 1: The new Ponds Project habitats on the Hampstead chain of ponds (not to scale)

A range of new habitats have been created through the Ponds Project; this section describes them and outlines their proposed management. Their locations are listed in Table 1 below and they are mapped schematically in figures 1 and 2.

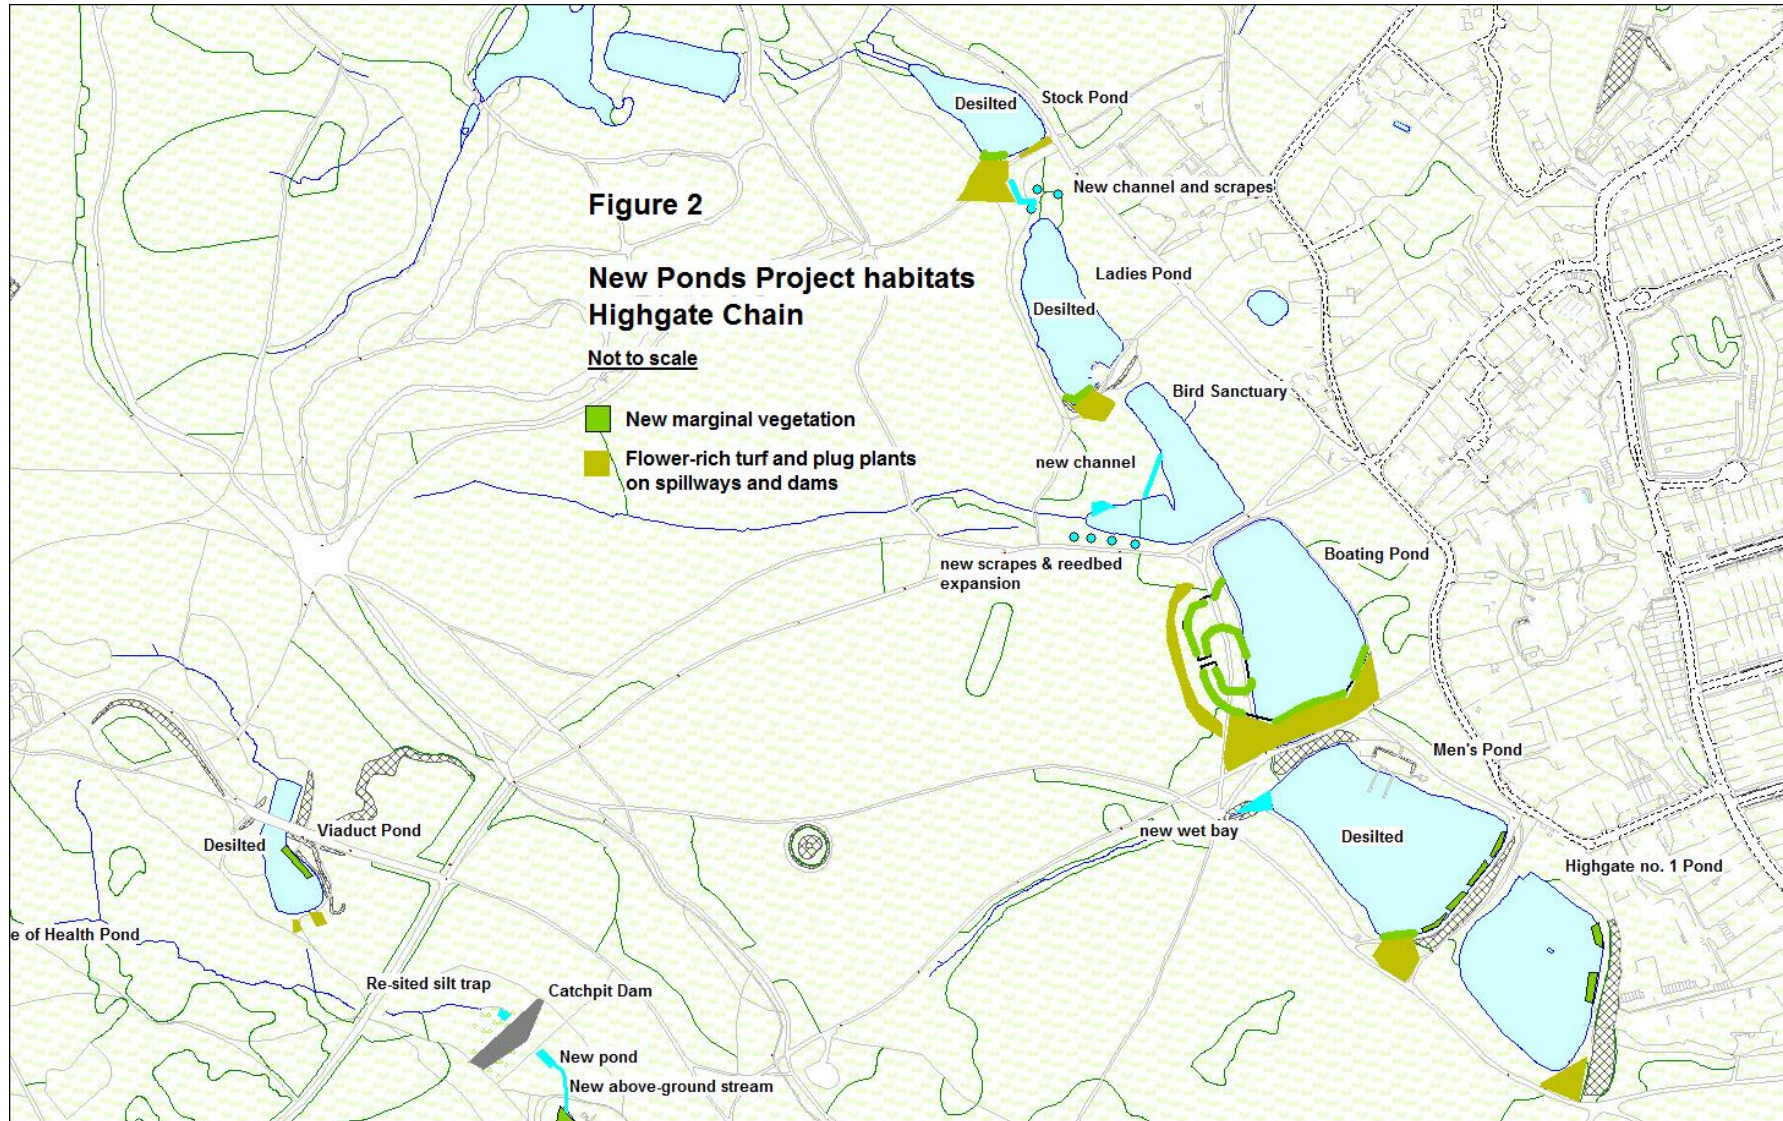
Figure 2: The new Ponds Project habitats on the Highgate chain of ponds (not to scale)
