Appendix 2 – Issue and Objectives / Assessment of Options Against Criteria

Project
GREENING CHEAPSIDE
 Location
 CHEAPSIDE

Client
 CITY OF LONDON

Drawing Name
**ST. PETER CHEAP CHURCHYARD
 OPTION 1 - FORMAL**

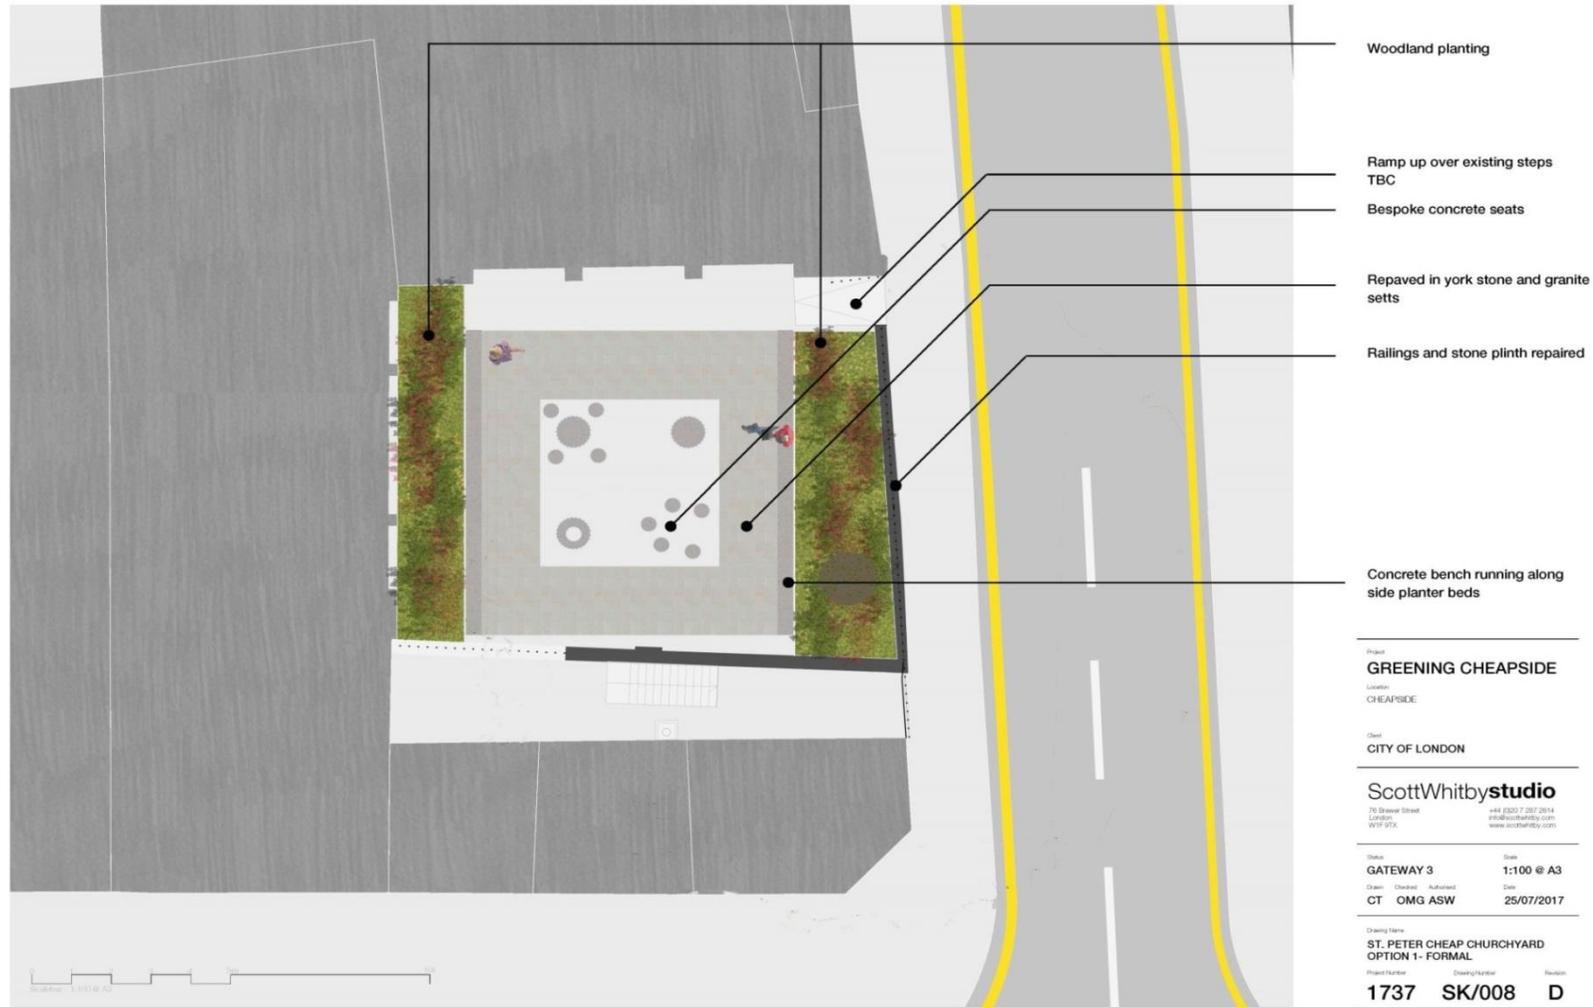
Appendix 5 – St. Peter Westcheap Churchyard **Option 1**

- Woodland planting
- Ramp up over existing steps
TBC
- Bespoke concrete seats
- Repaved in york stone and granite
setts
- Railings and stone plinth repaired
- Concrete bench running along
side planter beds

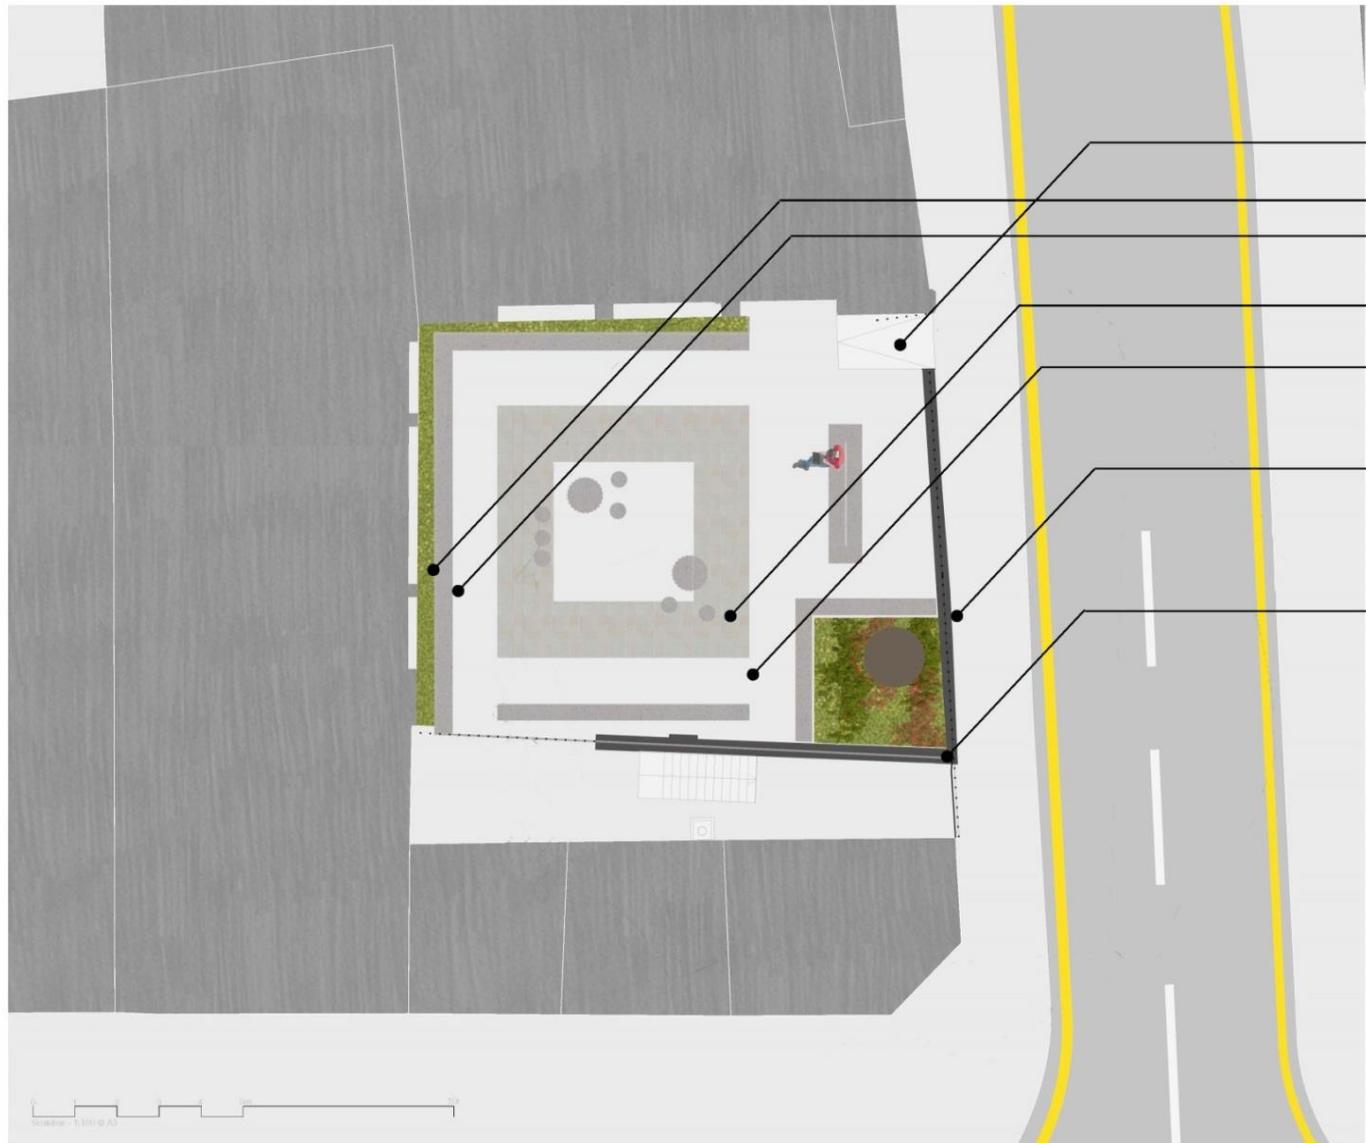
Appendix 5 – St. Peter Westcheap Churchyard **Option 2**

- Ramp up over existing steps
TBC
- Woodland Planting bed behind steel structure
- Concrete bench parallel to steel structure on west and north side
- Bespoke concrete seats
- Repaved in york stone and granite setts
- Railings and stone plinth repaired
- Galvanised Steel profile bent to form a "choir stall" type structure, to surround 3 sides of the site

Drawing Name
**ST. PETER CHEAP CHURCHYARD
OPTION 2- CHOIR STALL**
