Barbican Residential Committee

Date: FRIDAY, 17 JUNE 2022
Time: 1.45 pm
Venue: COMMITTEE ROOMS, 2ND FLOOR, WEST WING, GUILDHALL

Barbican Estate
Barbican Residential Blocks
Andrewes House - Fire Strategy
Report

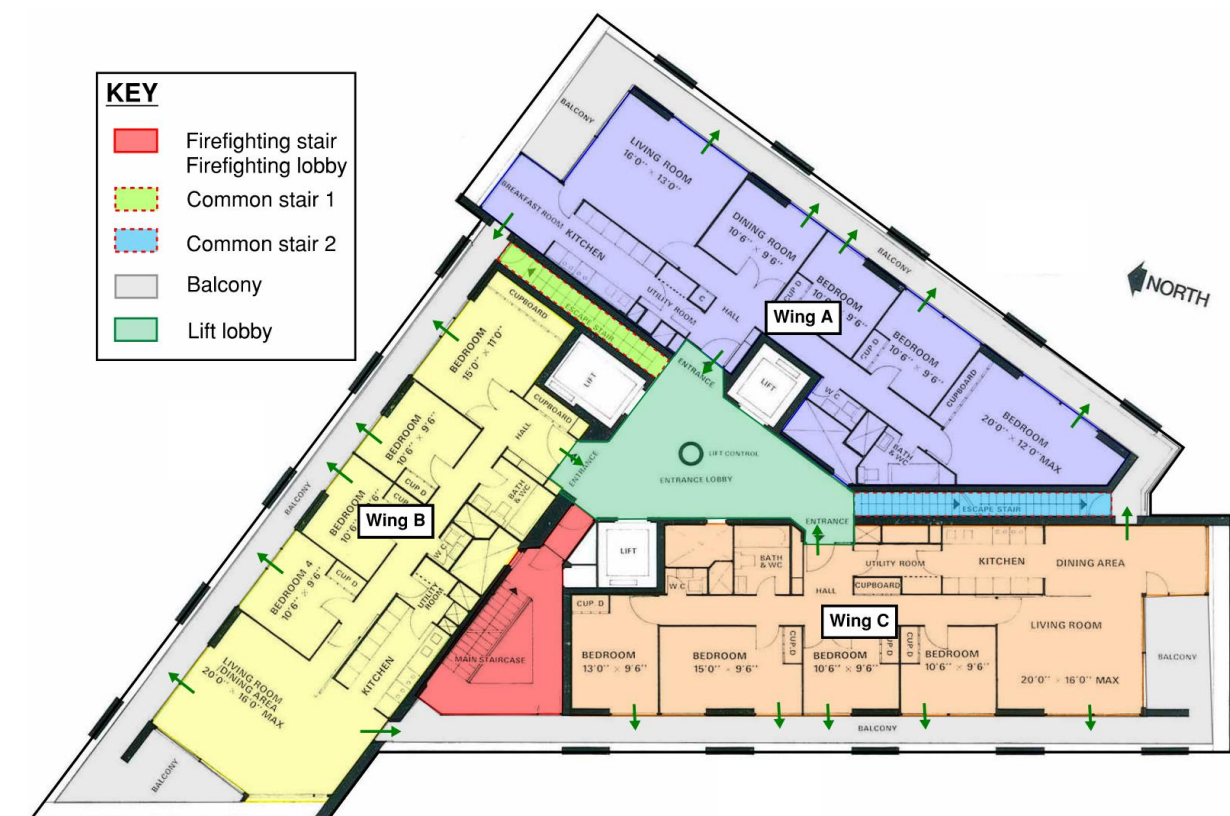
As shown in Figure 5, the original intention of the flat layout was to provide an internal hallway to separate all habitable rooms from the internal corridor. However, it has been confirmed by BE that most of the flats no longer have the door separating the internal hallway from habitable rooms which is a non-compliance to the current recommendations.

For able-bodied occupants (refer to Section 4.1.6 for evacuation of Persons with Reduced Mobility, PRM), this is considered acceptable if automatic fire detection and alarm system of Grade D1 Category LD1 is installed within the flats (refer to Section 4.1.9 for further details on the recommended fire detection and alarm system) and under the basis that the flats are provided with alternative escape routes as follows:

Figure 5: Available egress routes for a typical flat layout

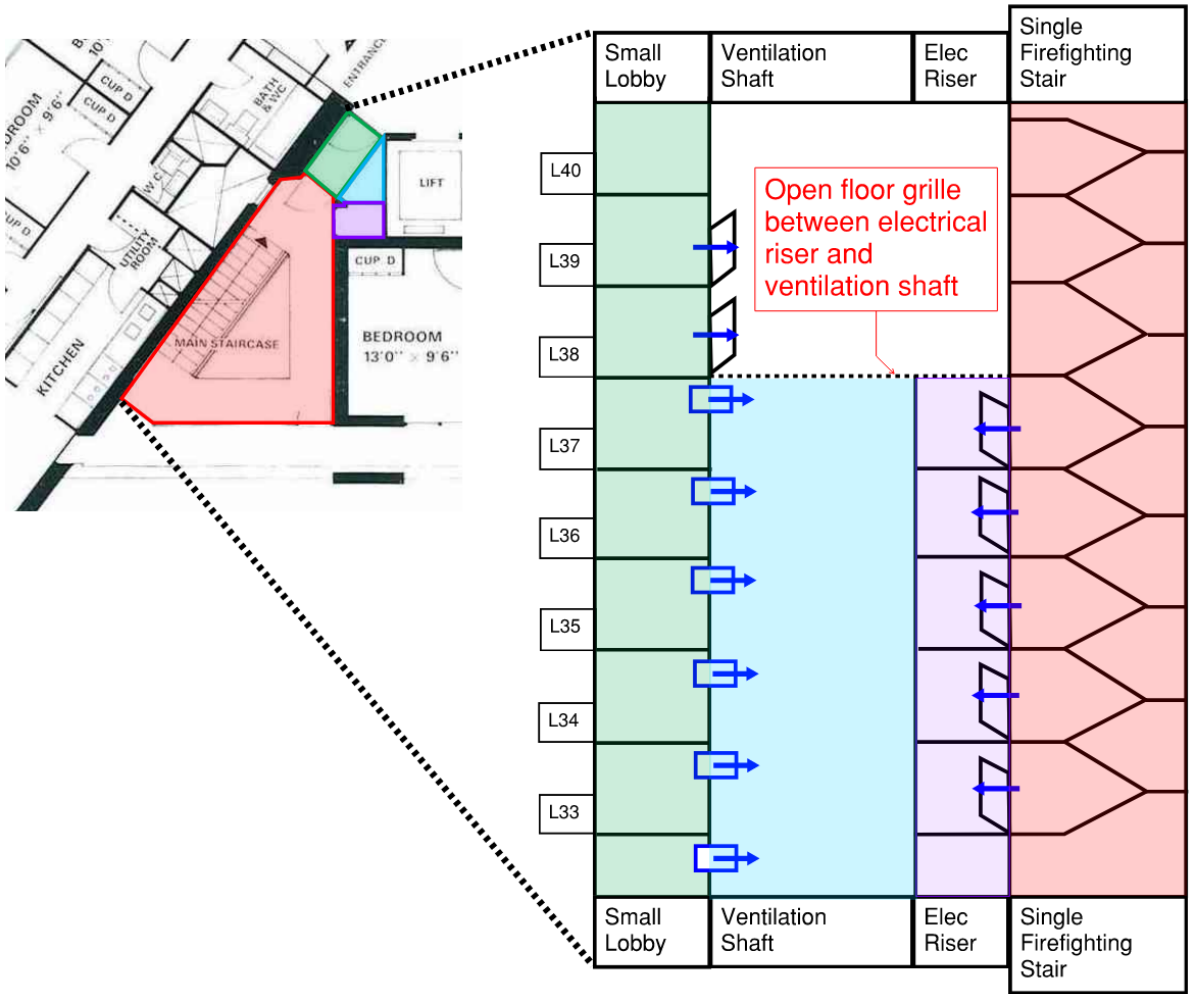
Figure 13: Current arrangement of small lobby, ventilation shaft, electrical riser and firefighting stair

As shown Figure 13, the small lobby is connected to the ventilation shaft on each floor, which is connected to the electrical riser on L37 and above. This is a risk as a fire in the electrical

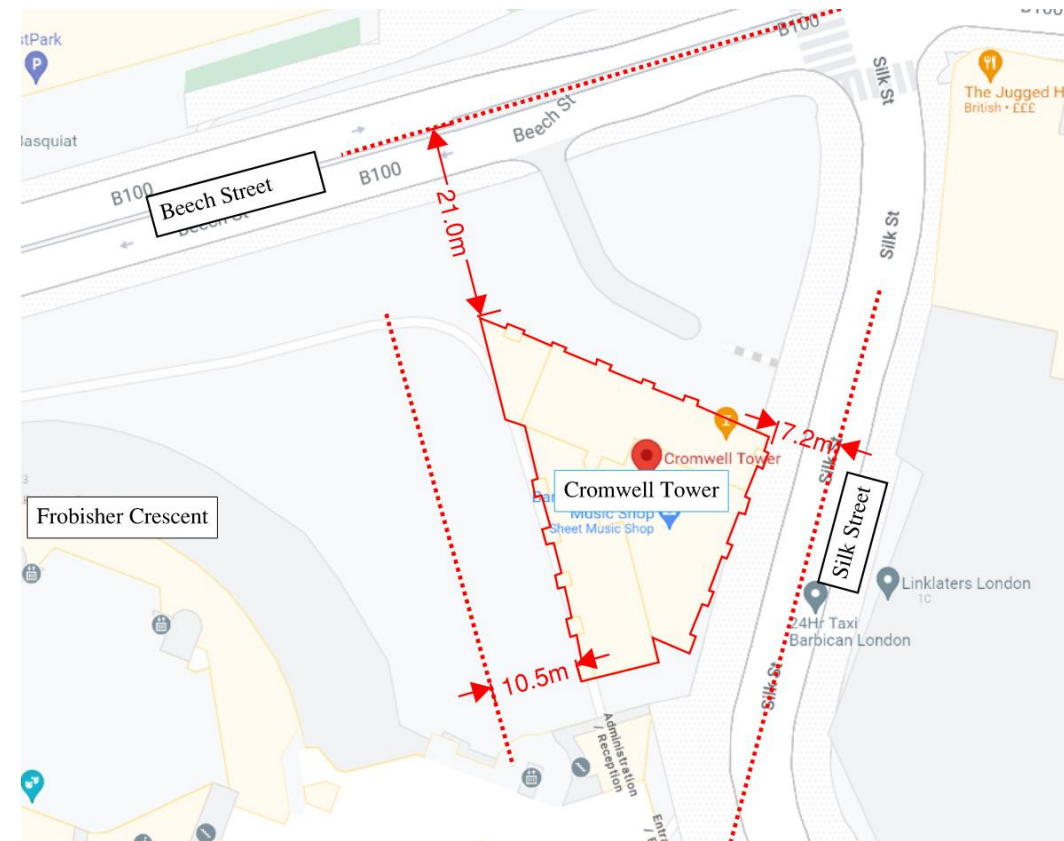
There is no information available on the location of the site boundary in relation to Cromwell Tower. If there are no site layout available, the building boundaries or the relevant boundaries will be measured using Google Maps as shown in Figure 19 and as follows:

An external fire spread calculation has been undertaken for a single flat using the above assumed boundary distances and Figure 19. The enclosing rectangle method in line with BR 187 was carried out. The results show that no protection is required to the facades. Please refer to Appendix B for the calculation.

Figure 19: Existing arrangement for Cromwell Tower and adjacent buildings

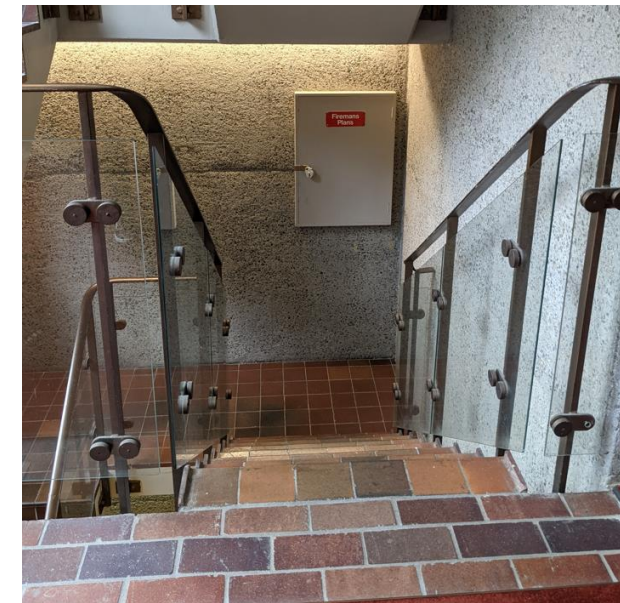
For the firefighting personnel to access the lower storage/plant levels (L02 – L03), they can travel through the internal open stair as shown in Figure 22.

Figure 22: Internal open stair (L03 - Podium level) on Street level

- Engagement with London Fire Brigade to ensure the access arrangement is clear.

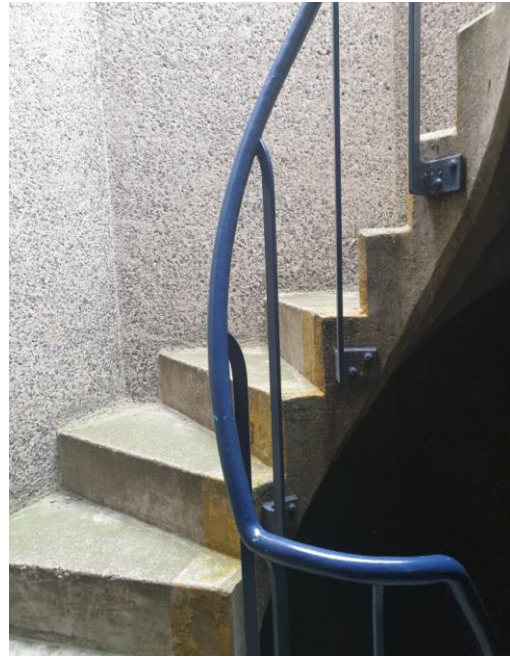
The firefighting stair in Cromwell Tower connects Podium level to Roof level with a width of 1000 mm. From L39, the firefighting stair extends to the Roof level (plant space only) as a helical stair as shown in Figure 23 below.

There are risers directly opening onto the firefighting stairs. Refer to recommendations in Section 4.3.3 for management procedures when there are works being done on the riser, refer to Table 4.

Figure 23: Helical stairs extending from the firefighting stairs to Roof level

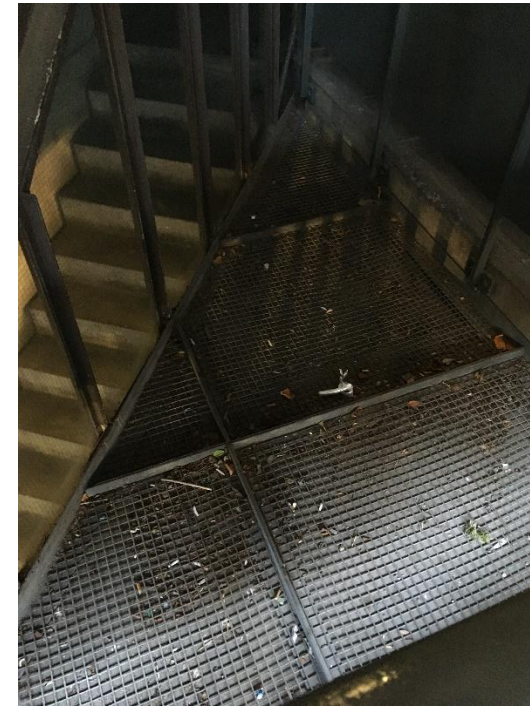
There is a permanently open grill at the bottom of the firefighting stair as shown in Figure 25 to provide make up air.

Figure 25: Permanent opening at the bottom of the firefighting stair at Podium Level

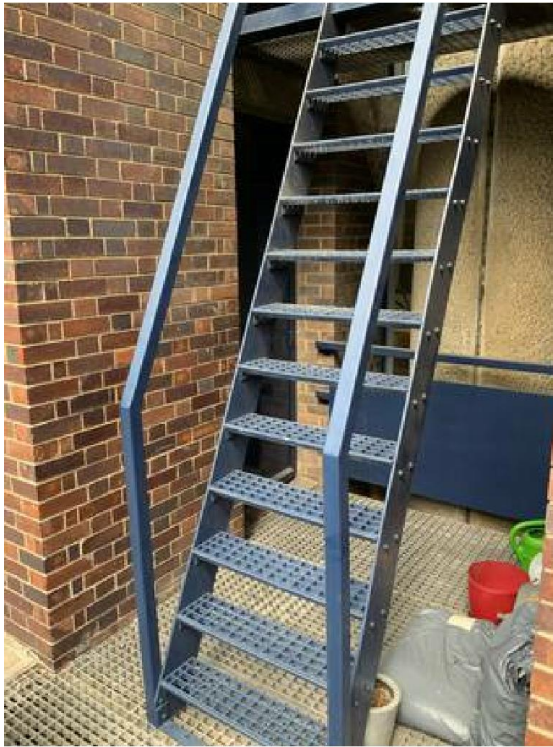
- Flat entrance – onto the same stair serving Level 1 to 7 above.
- Willoughby carpark via the gardens – all L02 flats each have a garden that is open to adjacent gardens. Occupants can evacuate through the gardens and travel to the Willoughby carpark to reach the final exit.
- There are also four L01 flats (SC49 end of Andrewes House) with external ladders leading down to L02 (refer to Figure 6). BS 9991 states that ladders should not form part of a means of escape route from any dwelling. Therefore, the ladder that connects L01 to L02 cannot be considered as an alternative means of escape.

Figure 6: Ladder from L01 to L02 leading to Willoughby Carpark through L02 garden.

The door that leads to the Willoughby carpark from the gardens is currently locked and can only be opened by a key. The lock should be changed so that it can be opened without the use of a key or other devices.

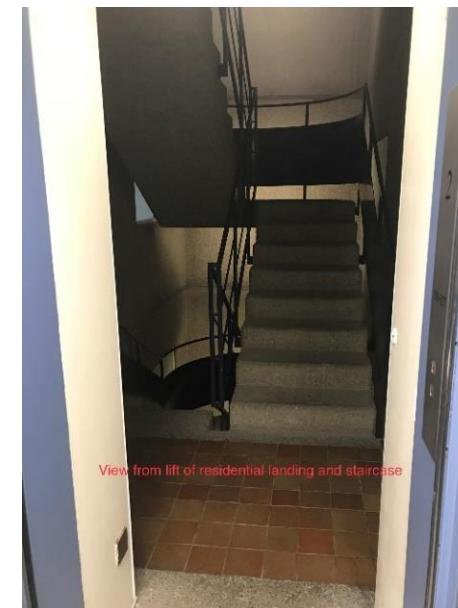
Figure 7: Typical stair in between two flats, viewed from the passenger lift

Except for the firefighting stairs, the other common stairs do not have protected lobby. Each apartment opens directly into the stair. This is not an issue for able-bodied occupants in flats above the Podium level due to the multiple escape routes via the balconies. However, the lack of protected lobby presents a risk to flats below the Podium level and PRMs anywhere in the building. Refer to Section 4.1.6 below describing the potential risk caused by the lack of protected lobby to PRMs and the mitigation measures.

There is currently no means for smoke ventilation in the common stairs (SC 39 to 43 and SC 45 to 48). Due to the common stair being the single means of escape and firefighting access for the flats below the Podium level and the use of the stair as protected refuge for PRMs (refer to Section 4.1.6), it is recommended to provide means for smoke ventilation to the common stairs. This could be in the form of automatically openable vents/doors to outside or a mechanical smoke ventilation system.

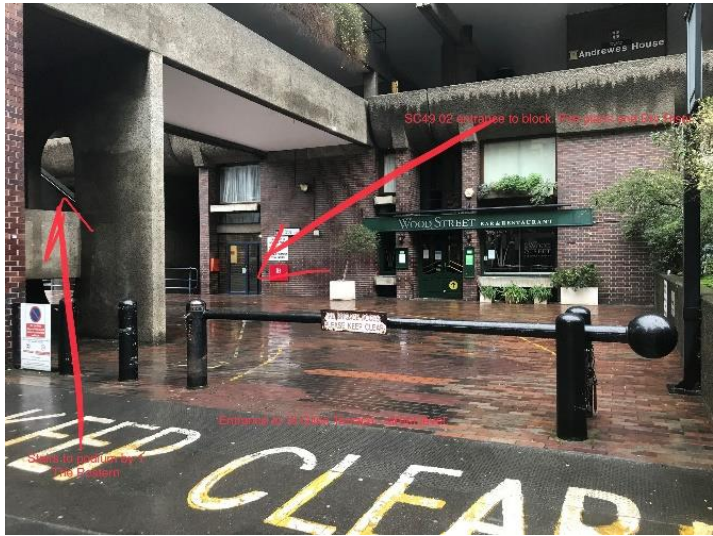
In the case of SC49, discharge is available at both Podium level and street level, adjacent to fire service vehicle access point. Refer to Figure 8 below.

Figure 8: Final exit for firefighting shaft SC49 at St Giles Terrace

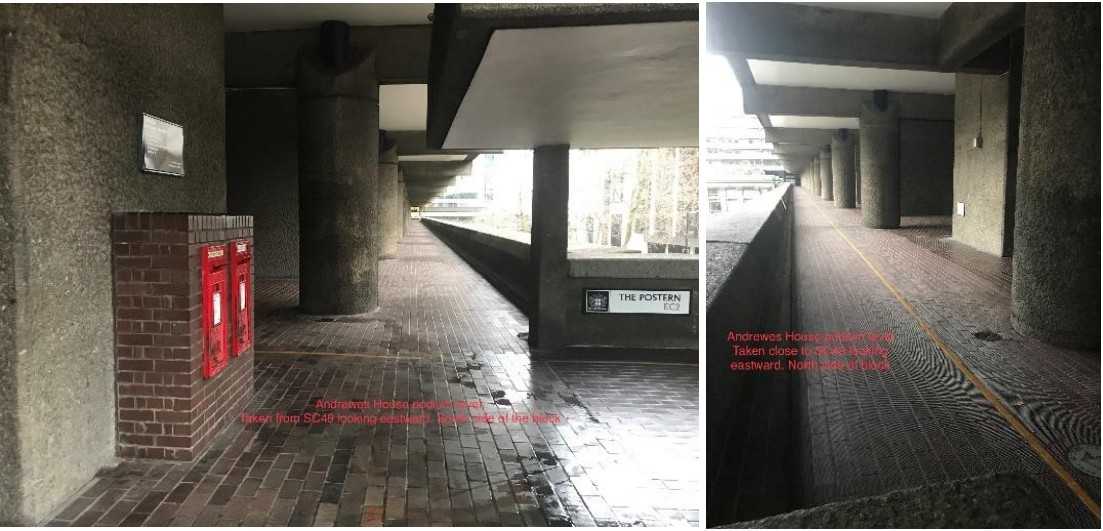
- Final exits should be sited such that they are clear of any risk from fire or smoke – the Podium is an open public walkway, mainly of non-combustible construction and with very low fire load content. The final exit of the stairs discharge onto the Podium, which is a low fire risk area. Refer to Figure 9 for the condition of the podium.

Figure 9: Podium underneath Andrewes House

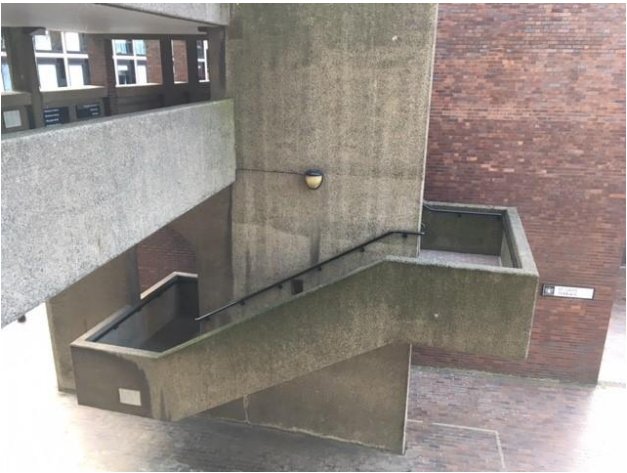
The nearest stair linking the Podium to street level for Andrewes House is an external stair adjacent to The Postern building on St Giles Terrace (see Figure 10). There are other stairs/lifts serving the Podium from street level across the Estate. This will allow for the dispersal of occupants away from Andrewes House in the event of a fire.

Figure 10: Stair down to St Giles Terrace, across a pedestrian bridge

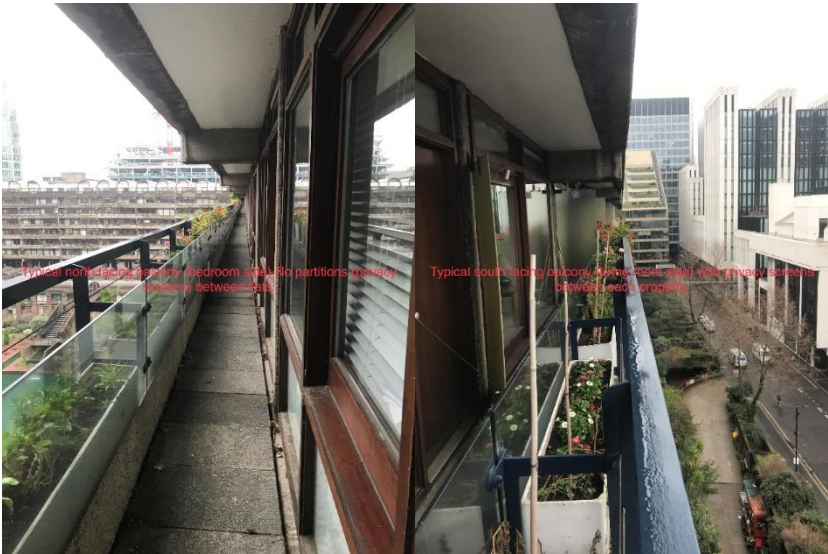
BE confirmed the distance from the balcony surface to top of the balustrade glazing is 960mm and from the top of the balustrade glazing to the soffit is 1430mm which is compliant as it is more than 50% of the vertical plane across the surface as shown in Figure 12.

Figure 12: Photos of both South and North facing balconies

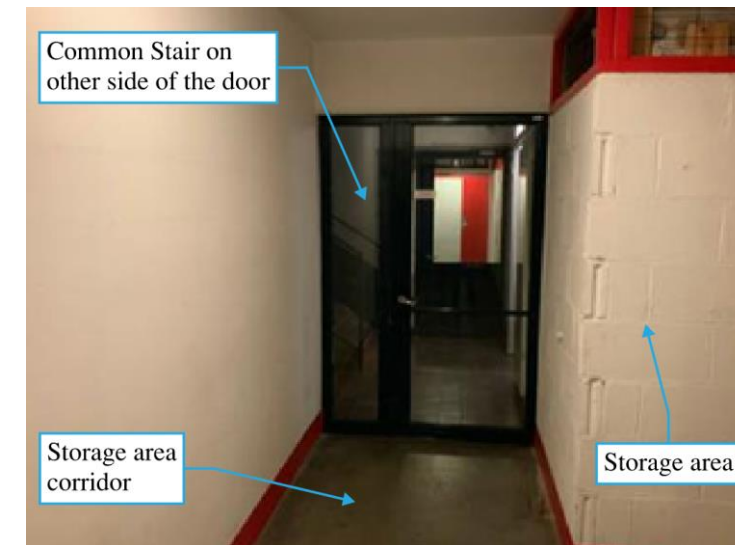
There are storage areas on L03 of Andrewes House which open directly into corridors leading to the common stairs and firefighting stairs. The storage areas are in separate rooms, designated to each of the flats. There is no fire separation between the storage rooms and the corridors serving the rooms. The corridors lead to the stairs and are only separated by glazing partitions and doors (Figure 13)

There is no exit signage, emergency lighting, automatic detection or alarms within the storage areas. This is a non-compliance against the current standards.

Figure 13: Storage area directly accessible from the stairs

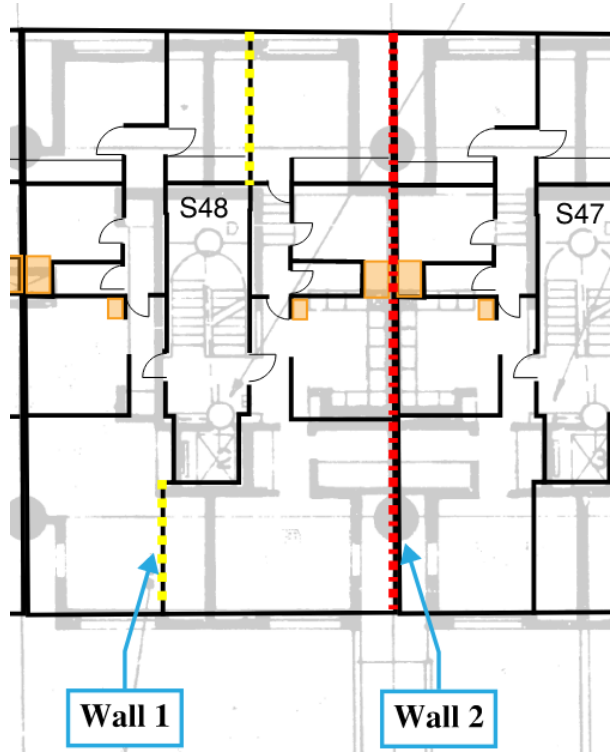
- Wall 1 has a thickness of 178 mm (drawing number 37 516) and verified on site by BE to be 180 mm. Such wall thickness is expected to achieve a nominal fire rating of 90 REI;
- Wall 2 has a thickness of 360 mm, as measured by BE. Such wall thickness is expected to achieve a nominal fire rating of FR120 REI.

Figure 14: Compartment walls separating the flats

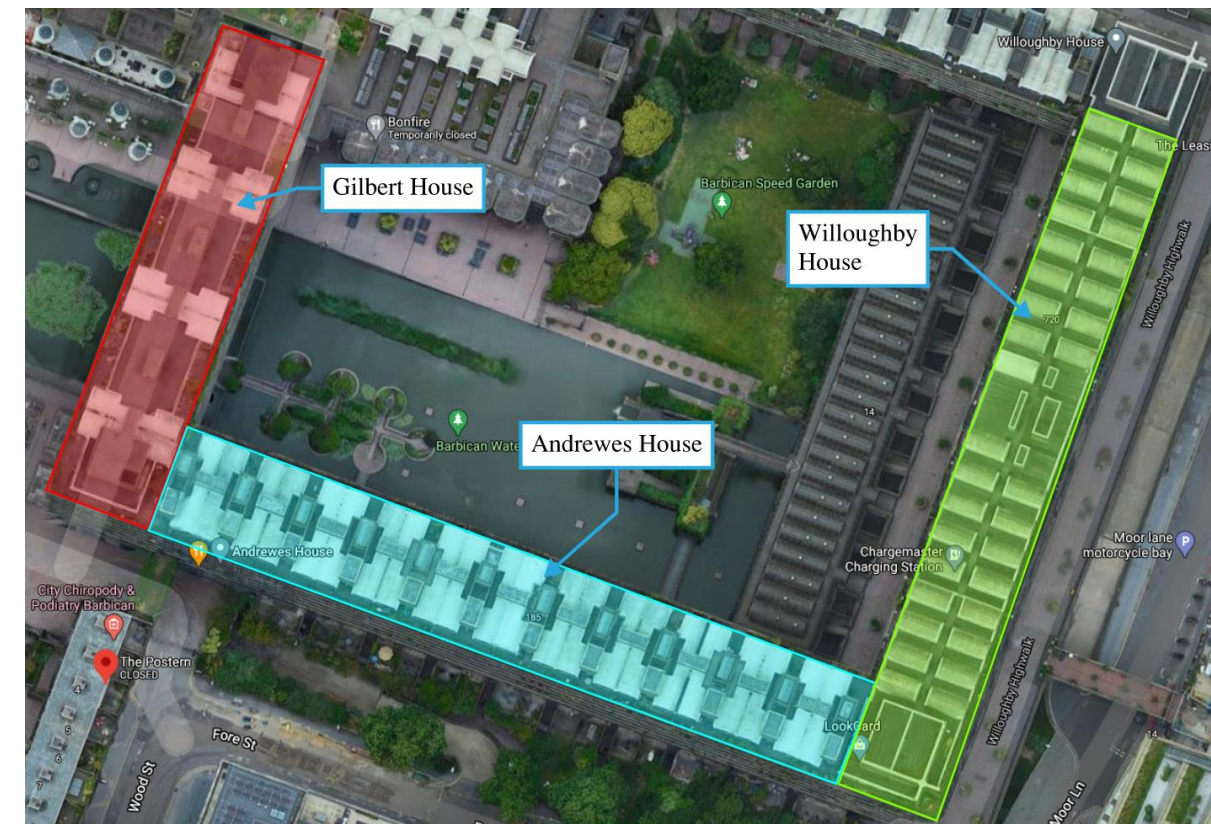
BRE 187 states unprotected areas can be discounted where the boundary and the building are at an angle of more than 80° to each other. As shown in Figure 18 below, both Gilbert House and Willoughby House are at an angle of more than 80° from Andrewes House and therefore it is not required to consider external fire spread.

Figure 18: Existing roof arrangement for Andrewes House and adjacent blocks

As shown in Figure 18, Willoughby House and Gilbert House are within 6 m of Andrewes House. There is a risk of fire igniting on the roof through the exposed felt layer. However this is considered acceptable to remain as existing due to the following:

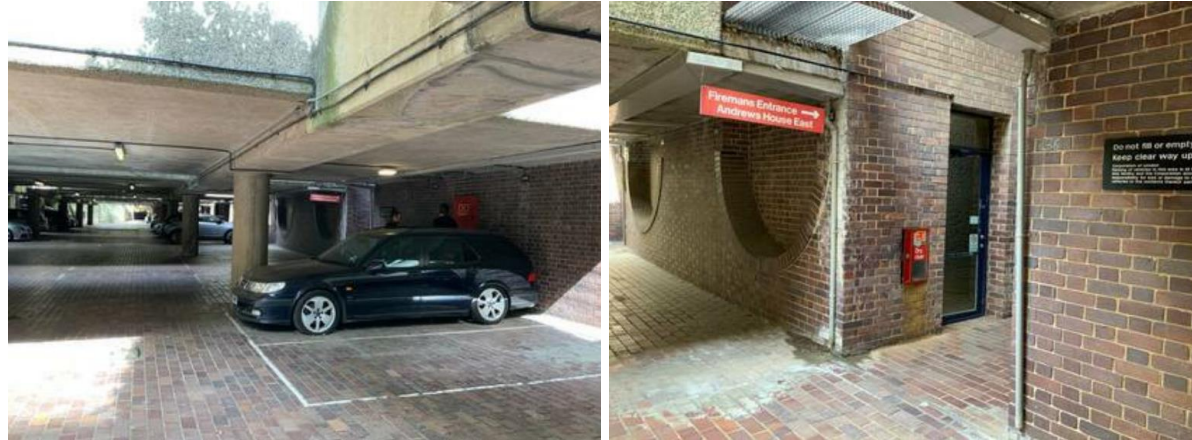
The carpark has large openings along the top and runs the entire length of Andrewes House, where fire service will be able to access the two firefighting shafts SC38 and SC44 as shown in Figure 19.

Figure 19: L03 Carpark level access to SC44

- As shown in Figure 19, there are large openings across the carpark to provide ventilation to the basement carpark level. This is not a basement in the traditional sense (i.e. enclosed underground space).
- BE advised that The London Fire Brigade is familiar with the Andrewes House configuration and firefighting access arrangement. This will help the firefighters to plan the most efficient access and set up, to suit the location of the fire.
- The access routes via the carpark involve shorter travel distances to the lifts, compared with access via the podium.

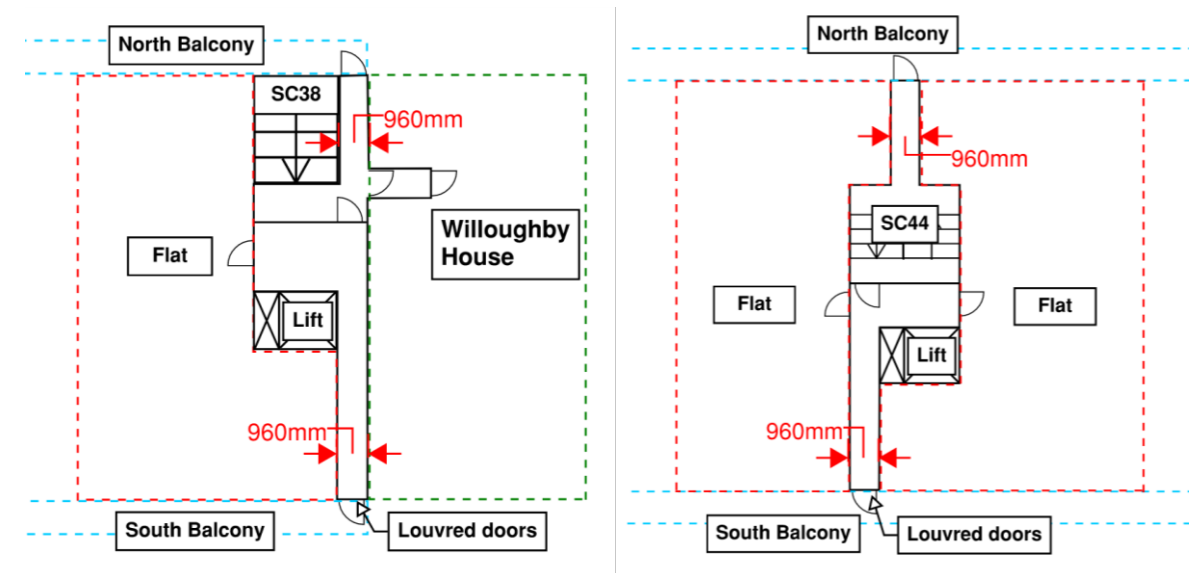
Existing provisions: the firefighting shaft layouts are shown in Figure 21 and Appendix A2. The current firefighting lobbies have approximate areas of 13.1 m² for SC38 and 49, and 7.6 m² for SC 44. These exceed the minimum 5m² recommended in BS 9999.

Figure 21: Current layout of firefighting shafts (not to scale)

- Consultation with London Fire Brigade to discuss and agree the reduced lobby/corridor width.

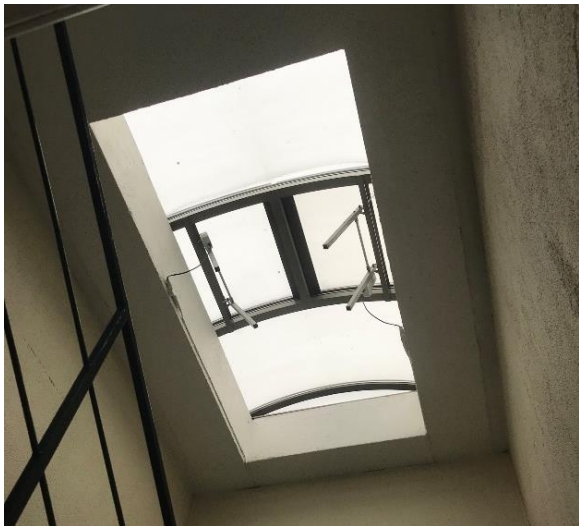
Existing provisions: all firefighting stairs are provided with automatically opening vents at the top of the stairs (see Figure 22 below). Each vent is operated by a switch located on the fire service access level, by the firemen’s lift. During the site visit, the dimensions of the vents were measured to be approximately 1.1 m by 0.8 m, which is less than the required ventilation opening.

Figure 22: Staircase 49 opening vent

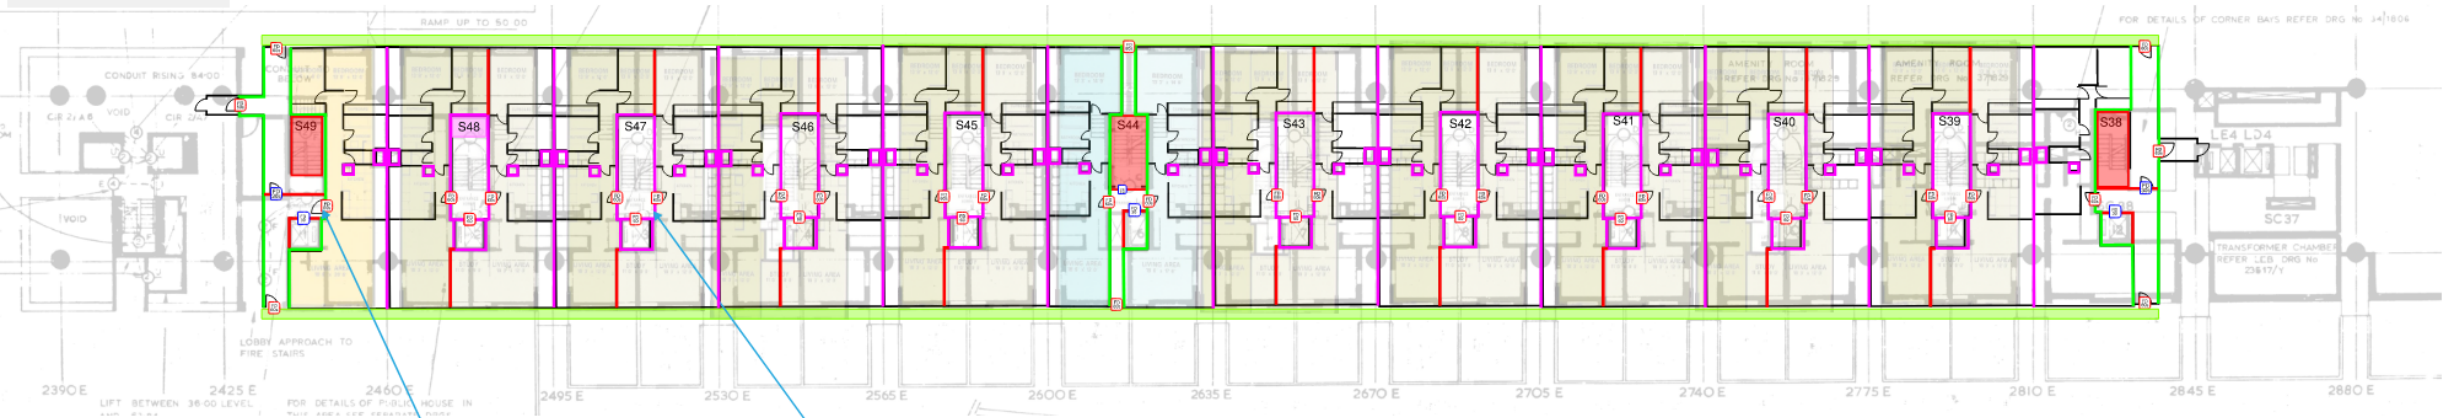
Refuse and post box lockers - Fire fighting lobbies
The doors between the fire fighting lobbies and the rubbish lockers should be in line with the flat front doors in terms of fire resistance (i.e. 60 minutes).

Refuse and post box lockers - Common stairs
The doors between the stairs and the rubbish lockers should be in line with the flat front doors in terms of fire resistance (i.e. 60 minutes).
